**Docket No. 217 – Development and Management Plan Inspection**

**Date:** November 10, 2005

**Location:** 345kV Underground Route

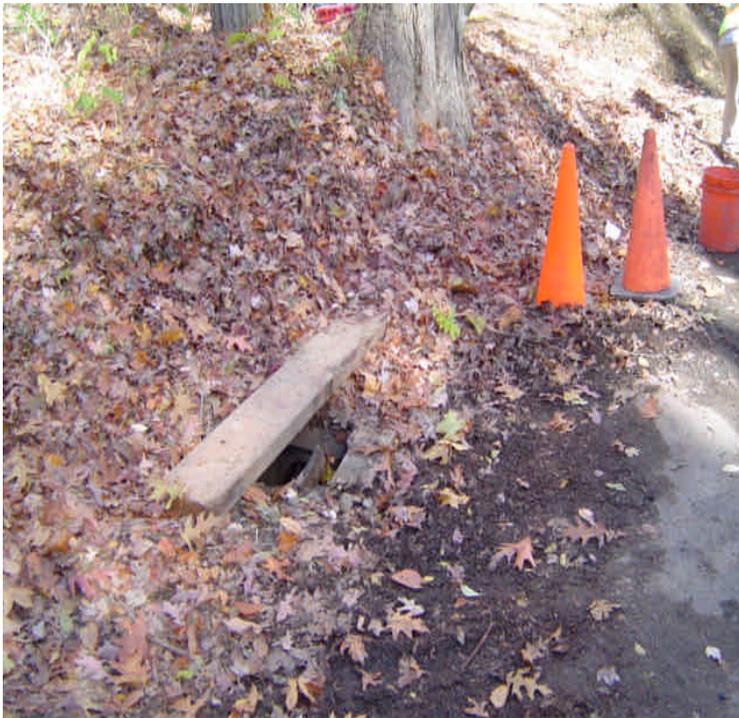
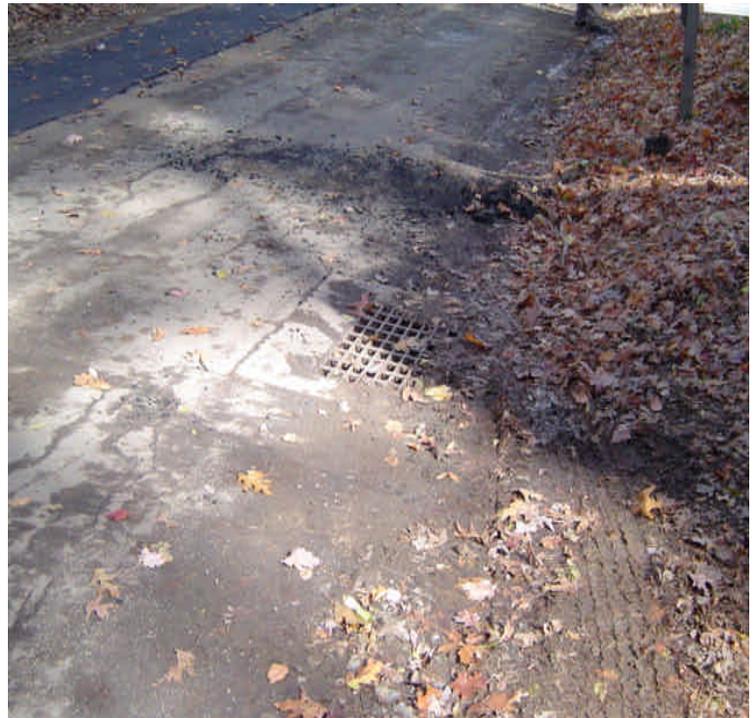
**345kV (Umpawaug Rd Daywork): Both photos show catch basins/inlets that did not have haybales or filter fabric to control potential sedimentation. These measures should be installed to help prevent similar issues to last week. 11/10/05**

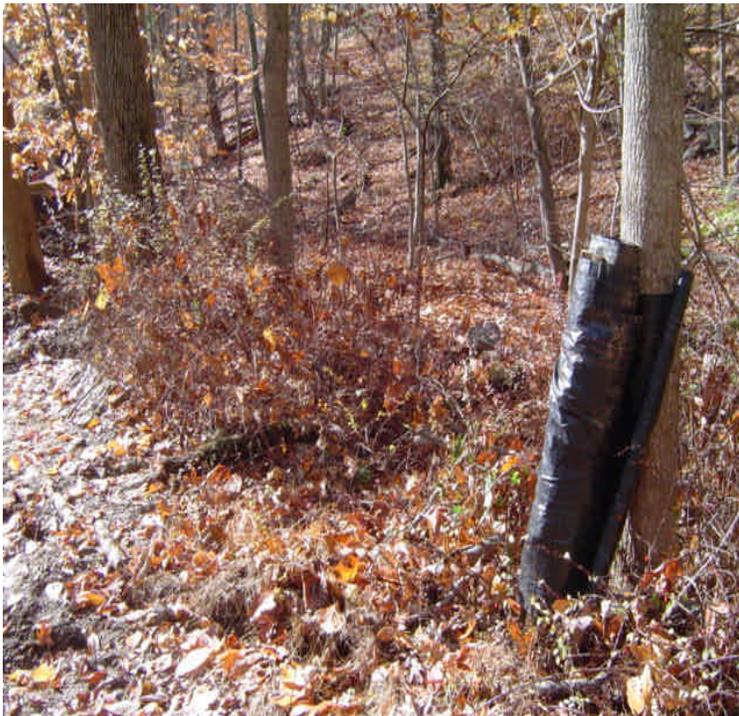
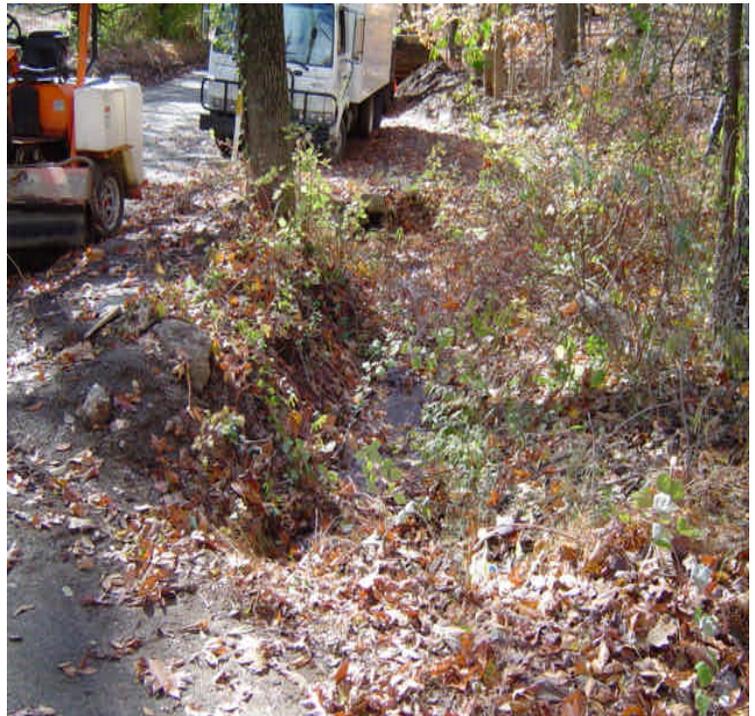
**Photo on the left shows silt fence on site waiting to be installed. Photo on the right shows a swale where some sediment had accumulated. Controls should also be placed along swales and inlets on the roadway. 11/10/05**

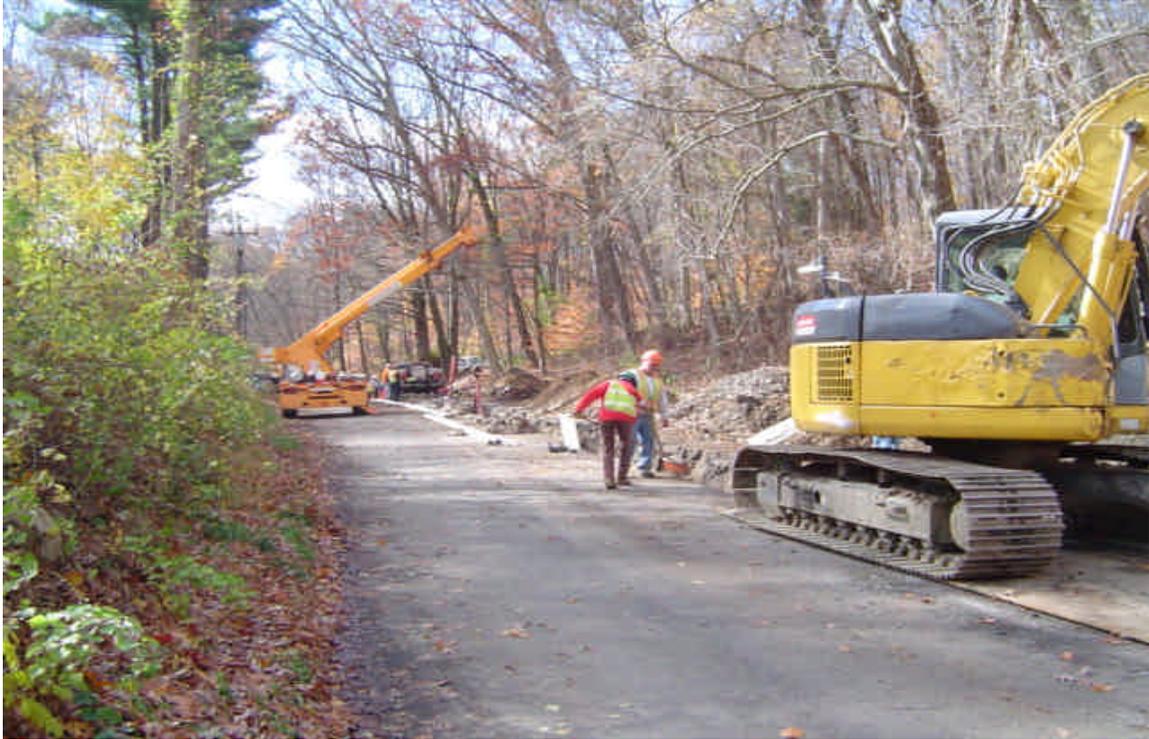
Umpawaug Road: View of the trenching and pipe installation occurring in the vicinity of #36 to a private drive. 11/10/05

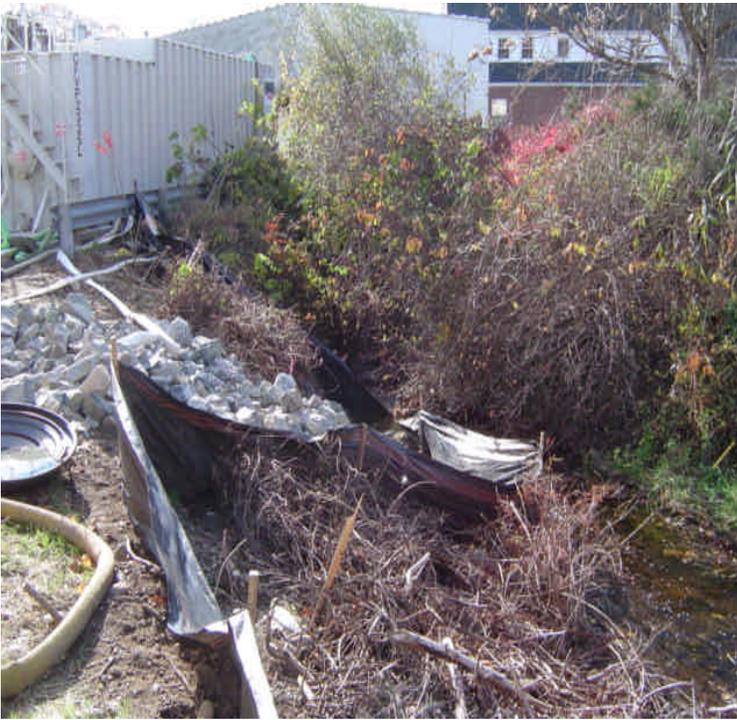
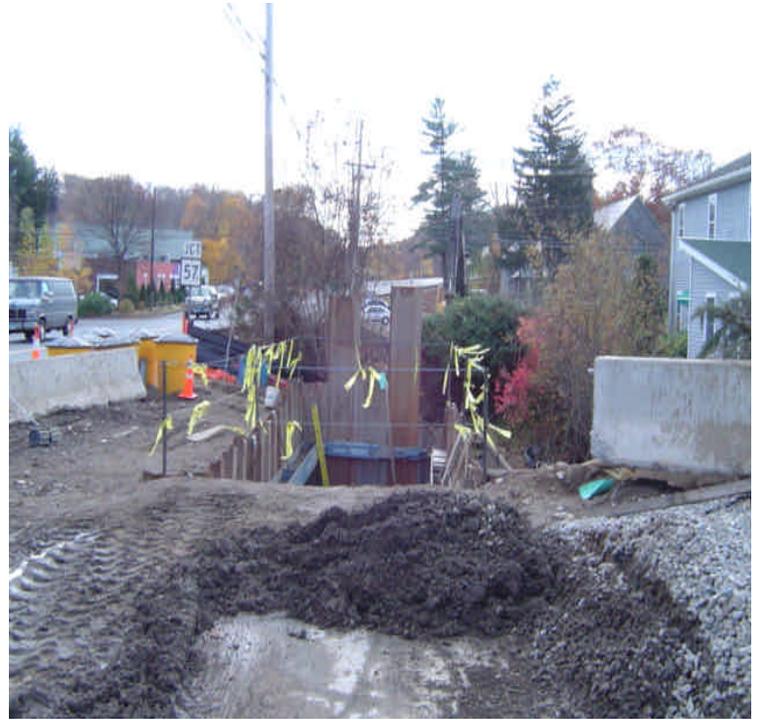
345kV (Georgetown Deli jack & bore) Photo on the left shows the dewatering point from the water coming from the pit. Photo on the right shows an overview of the jack and bore site. 11/10/05

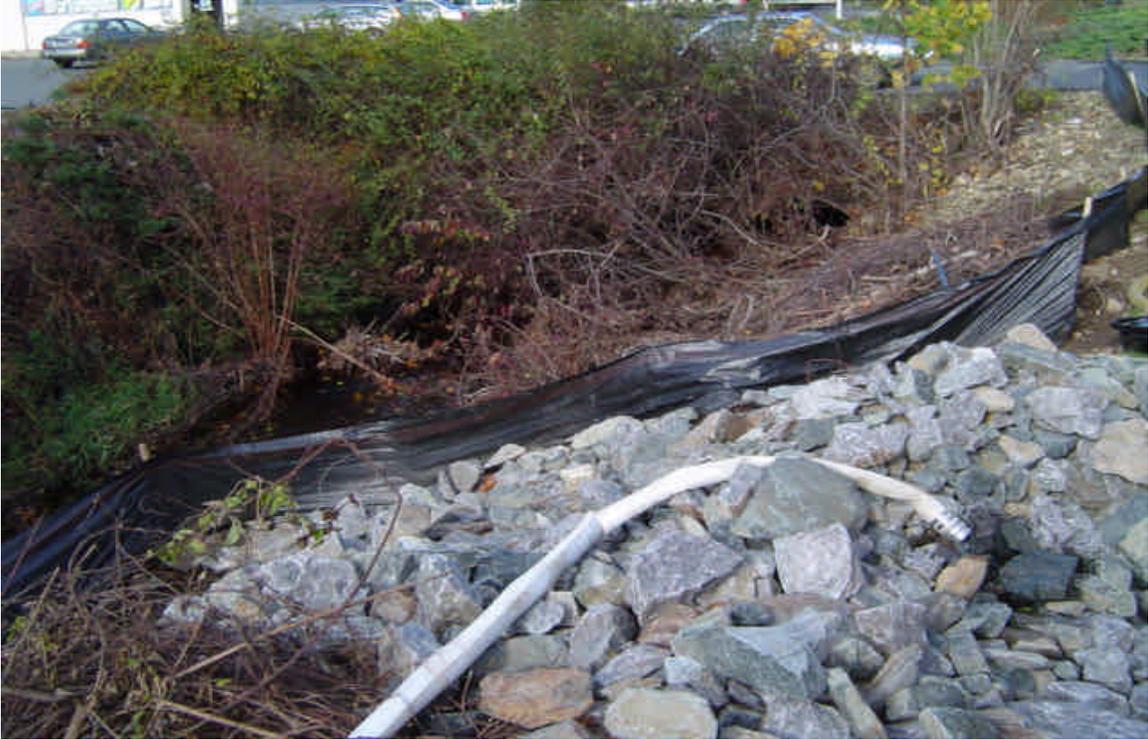
**Close up view of the dissipater pad for dewatering discharge. Water is pumped from the settling tanks to the riprap and let back into the stream. 11/10/05**

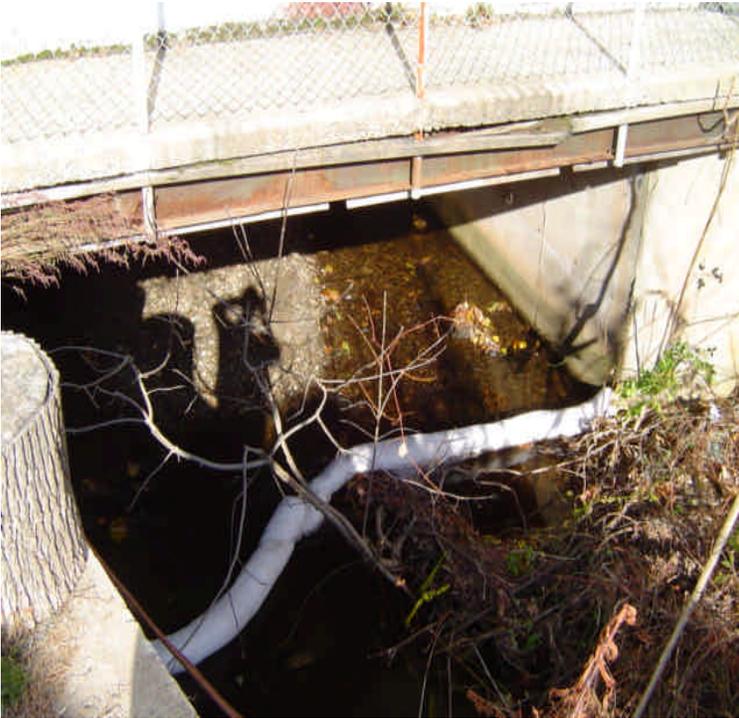
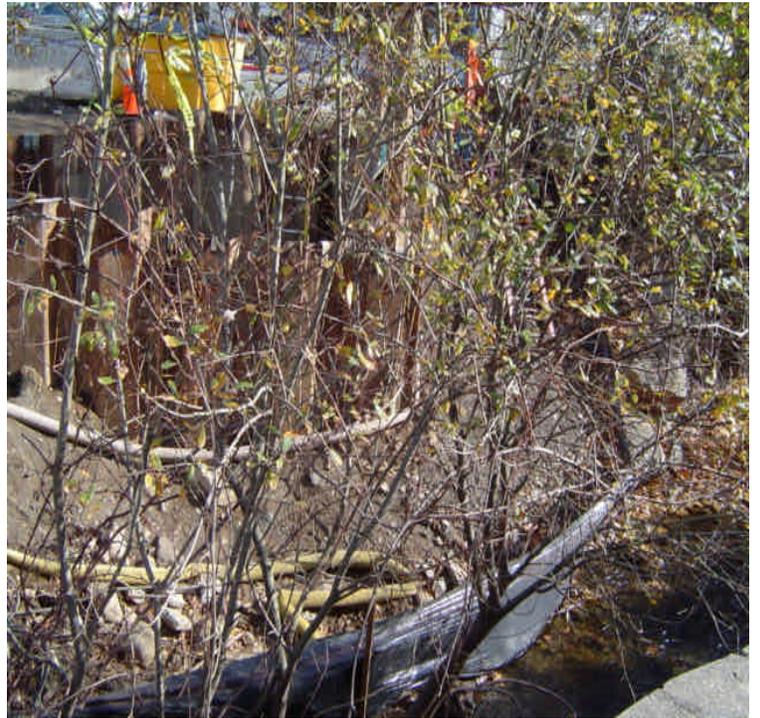
**Photo on the left shows the downstream portion of the stream with a boom in place and water running clear. Photo on the right shows the silt fence below the pit which should be monitored as it is beginning to need maintenance. 11/10/05**

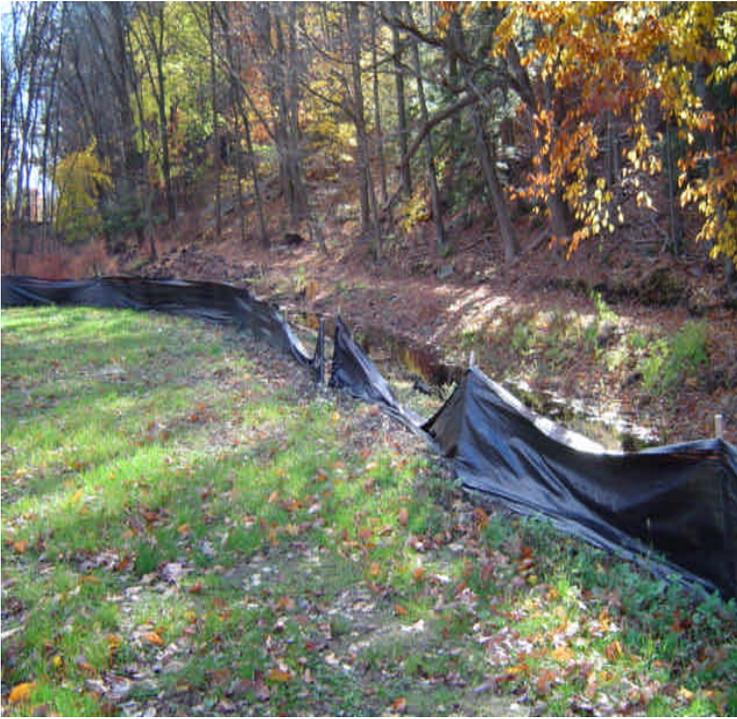
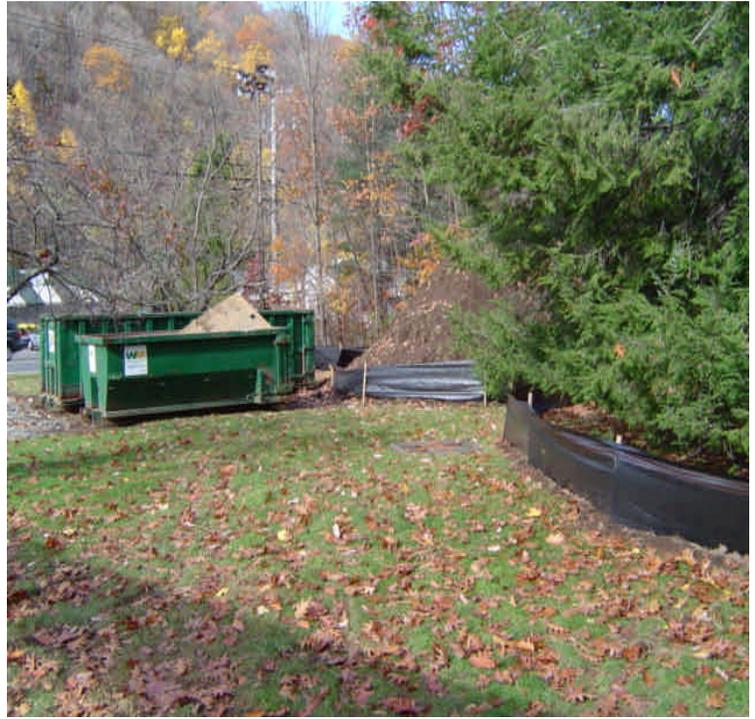
**345kV (Rt. 7 and CL&P yard): Photo on the left shows where fence is starting to come down at the storage yard again near #848. Photo on the right shows the CL&P yard with erosion controls and a construction entrance. 11/10/05**

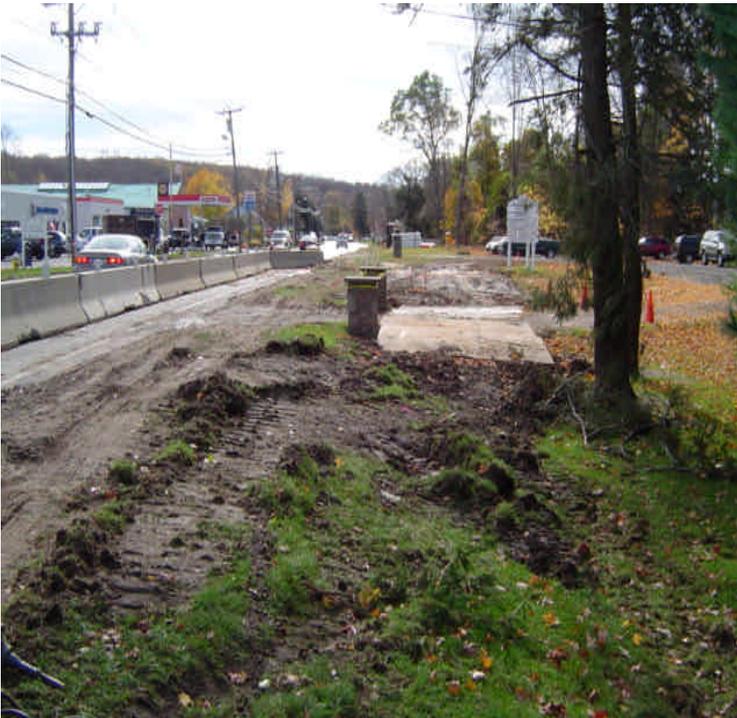
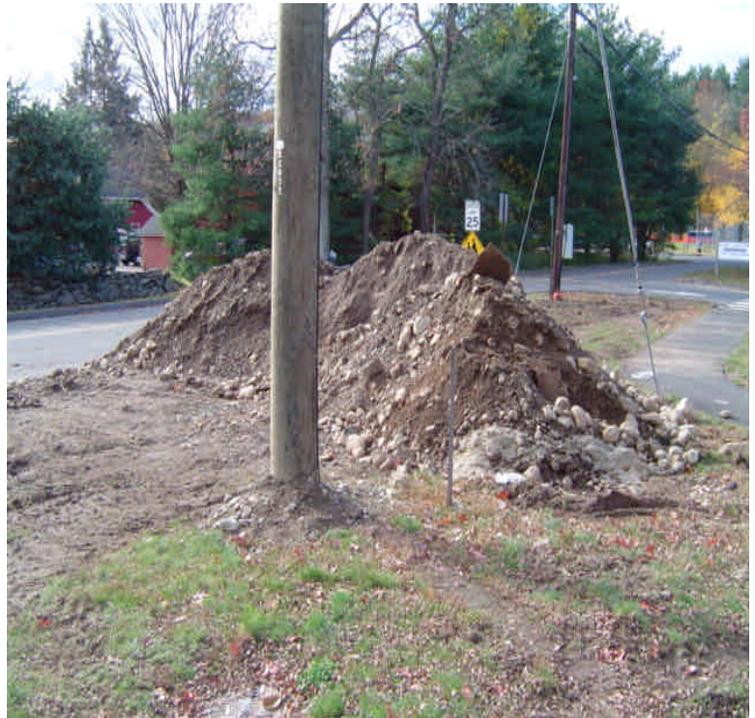
**345kV (Rt. 7): Photo on the left shows active trench work/pipe installation near Catalpa Rd off Rt. 7. Control measures were not observed in the catch basins. Photo on the right shows a stockpile present here. If this pile is left longer than the day, erosion controls are needed. 11/10/05**

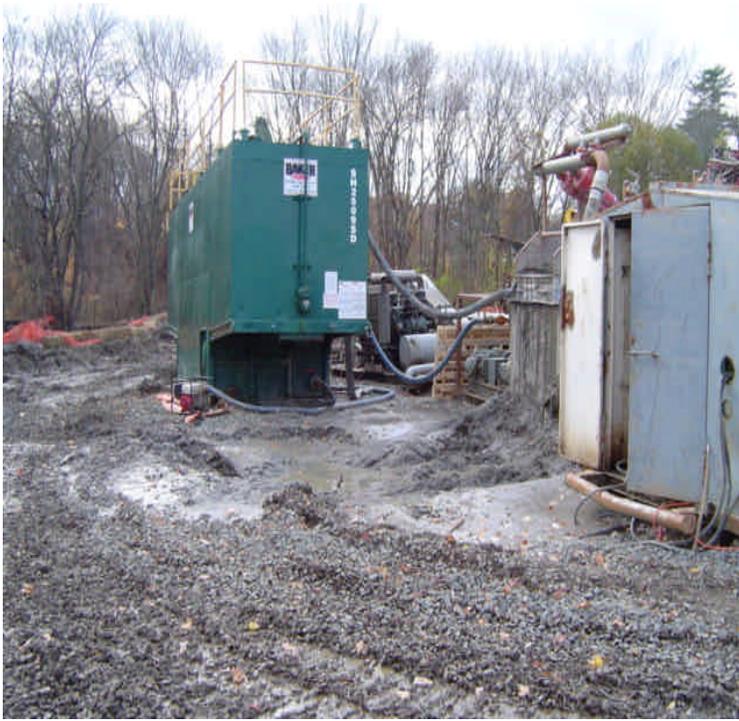
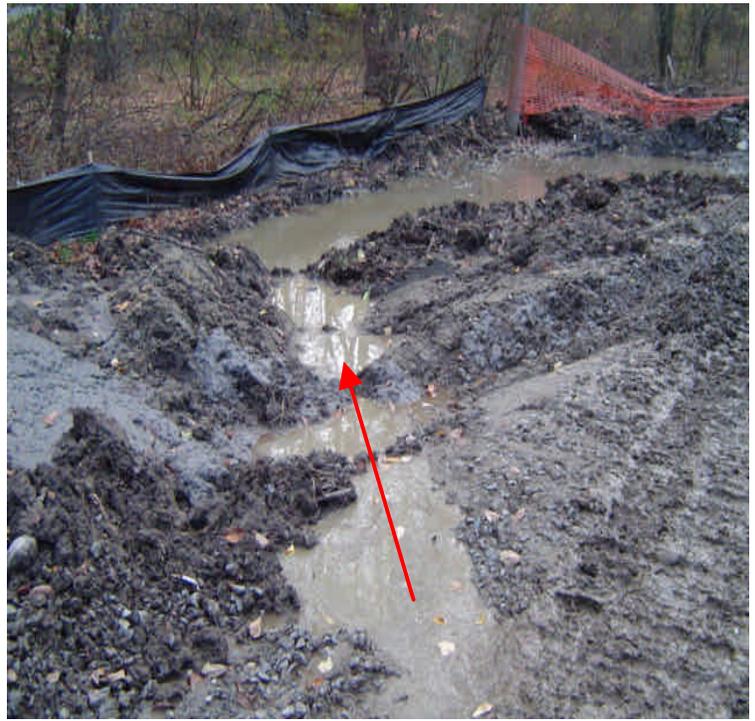
345kV (School Rd. HDD): Photo on the left shows the frac tank which is supposed to hold all drilling muds but there have apparently been some spills. Photo on the right shows where the muds and washout water are flowing towards the silt fence. 11/10/05

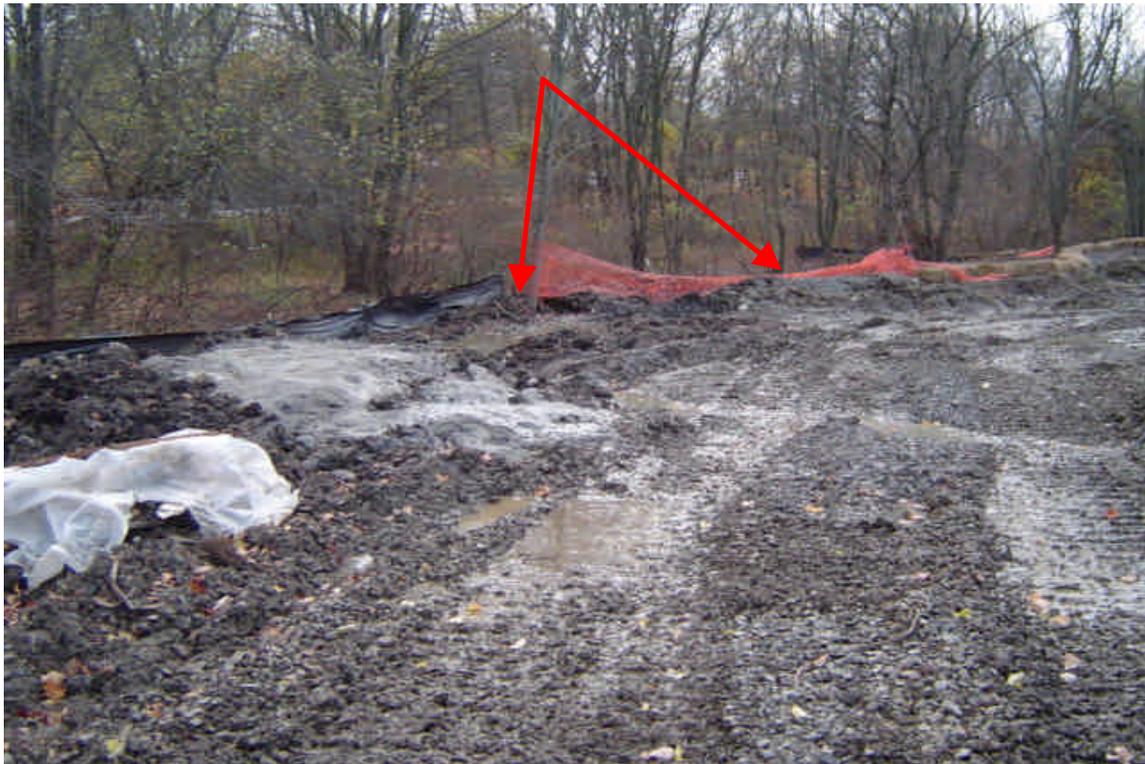
Additional views of the drilling muds and discharge water along the eastern edge of the site. Muds appear to have been deposited here and it needs to be confirmed whether this edge has the recommended extension made to the silt fence. 11/10/05

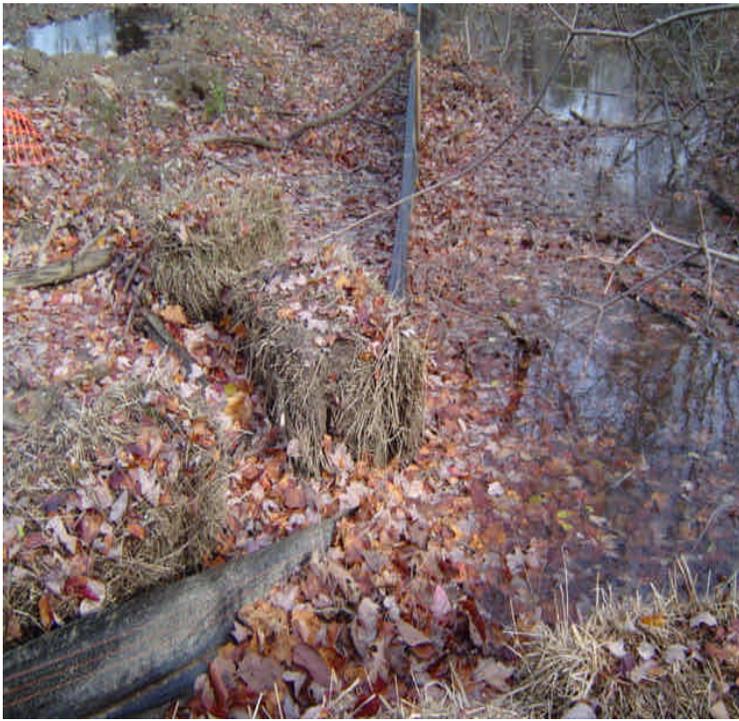
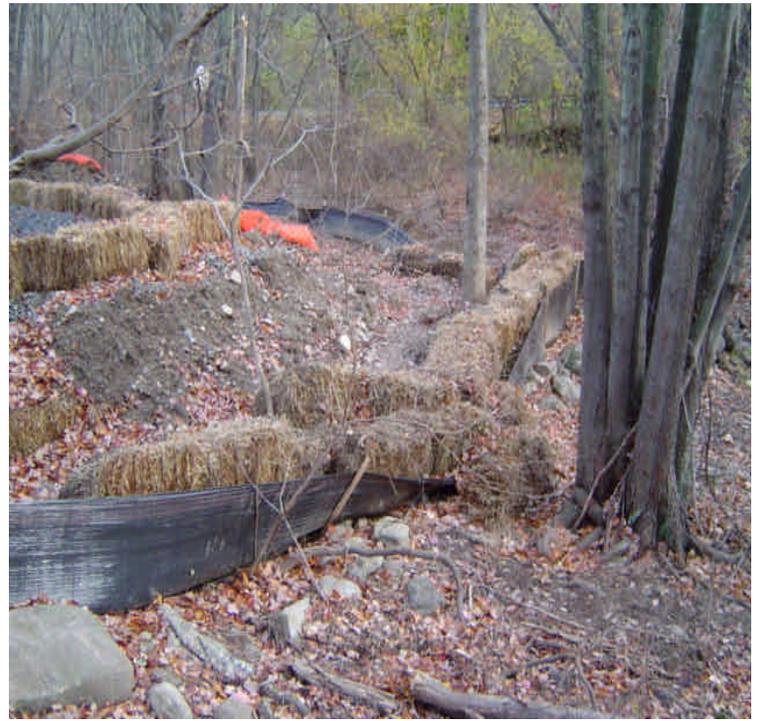
Both photos show areas along the outer perimeter controls where repairs are necessary. Internal controls are still in place but these provide an additional barrier to sediment. One spot has sediment that filtered under the fence. 11/10/05

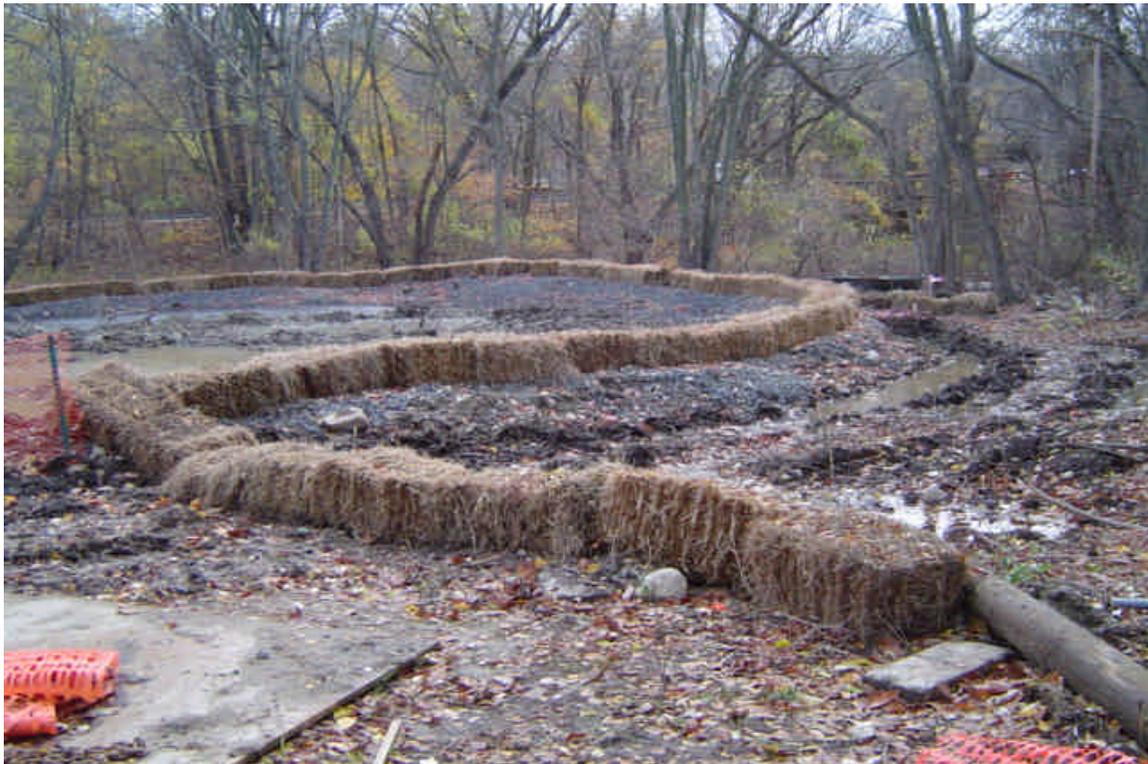
Photo of the basin built at the drill site to retain stormwater. Standing water was present at the time of inspection following the rain. 11/10/05
