Docket No. 217 – Development and Management Plan Inspection

Northeast Utilities Service Company Certificate of Environmental Compatibility and Public Need for the construction of a 345-kV electric transmission line and reconstruction of an existing 115-kV electric transmission line between Connecticut Light and Power Company’s Plumtree Substation in Bethel, through the towns of Redding, Weston, and Wilton, and to the Norwalk Substation in Norwalk, Connecticut.

Date: December 1, 2005

Location: 345kV Underground Route

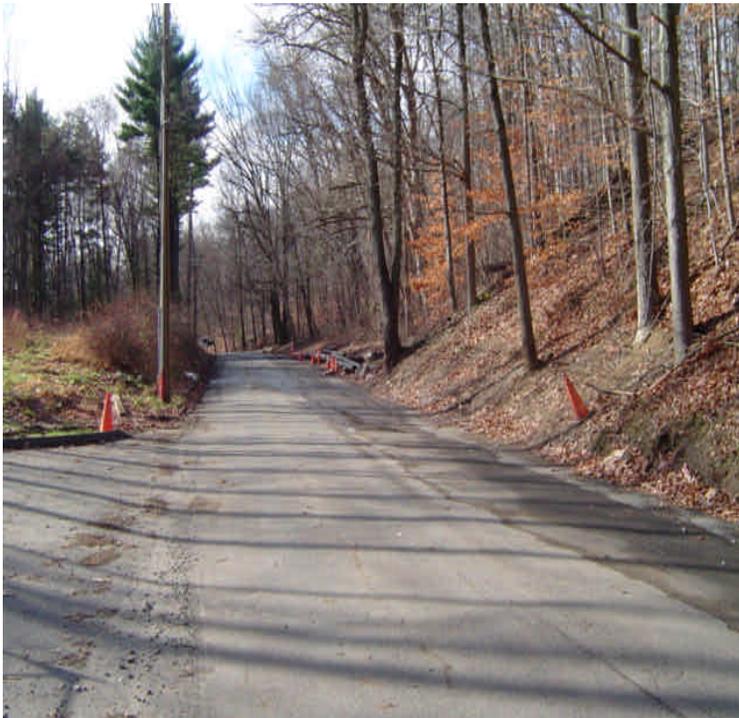
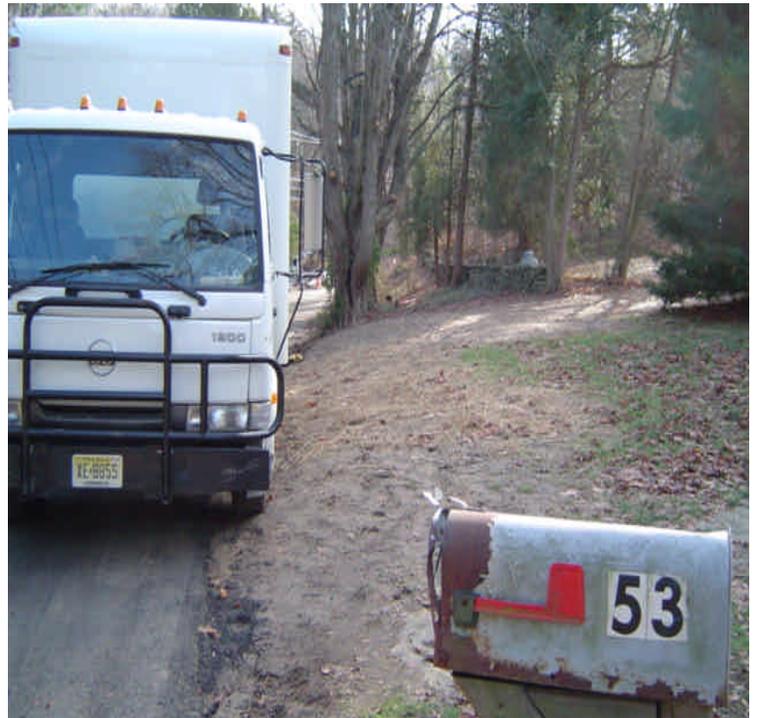
345kV (Umpawaug Rd Daywork): Both photos show efforts to restore bank cuts and disturbed areas along the side of the road with mulch. Several slopes along the road do require restoration when work is done. 12/1/05

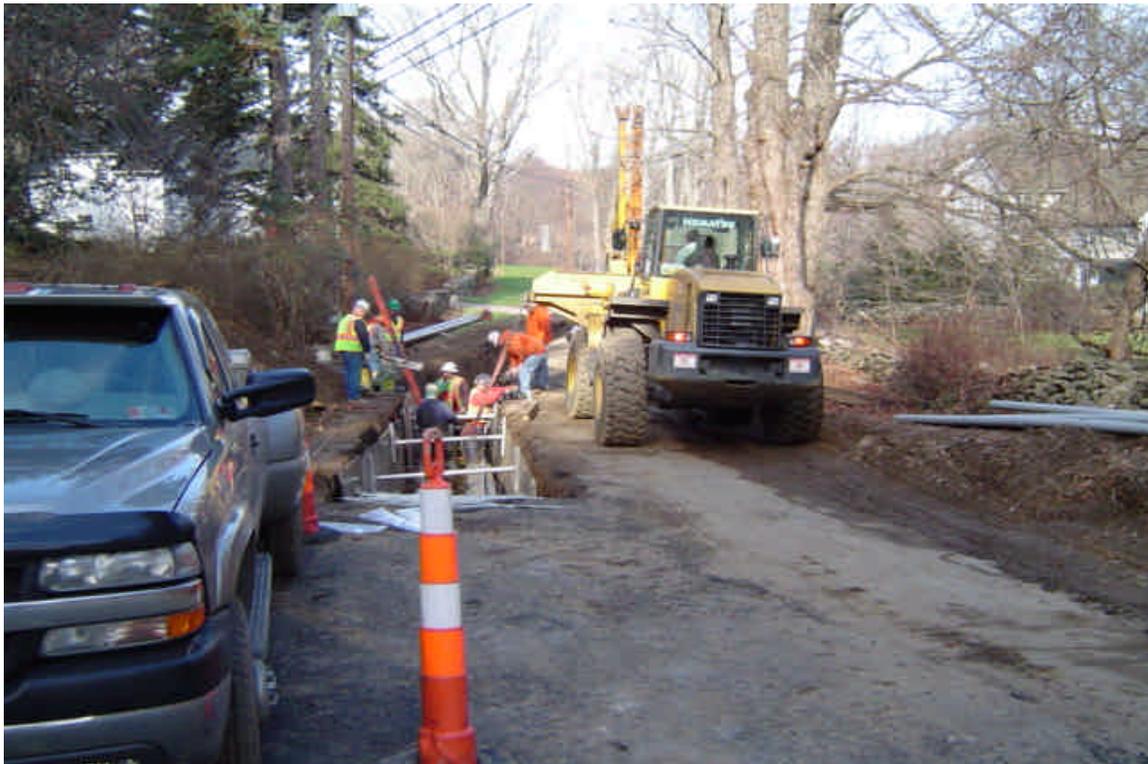
Over view of active trenching occurring in the roadway. The area is contained and no need for additional controls at this particular location. 12/1/05

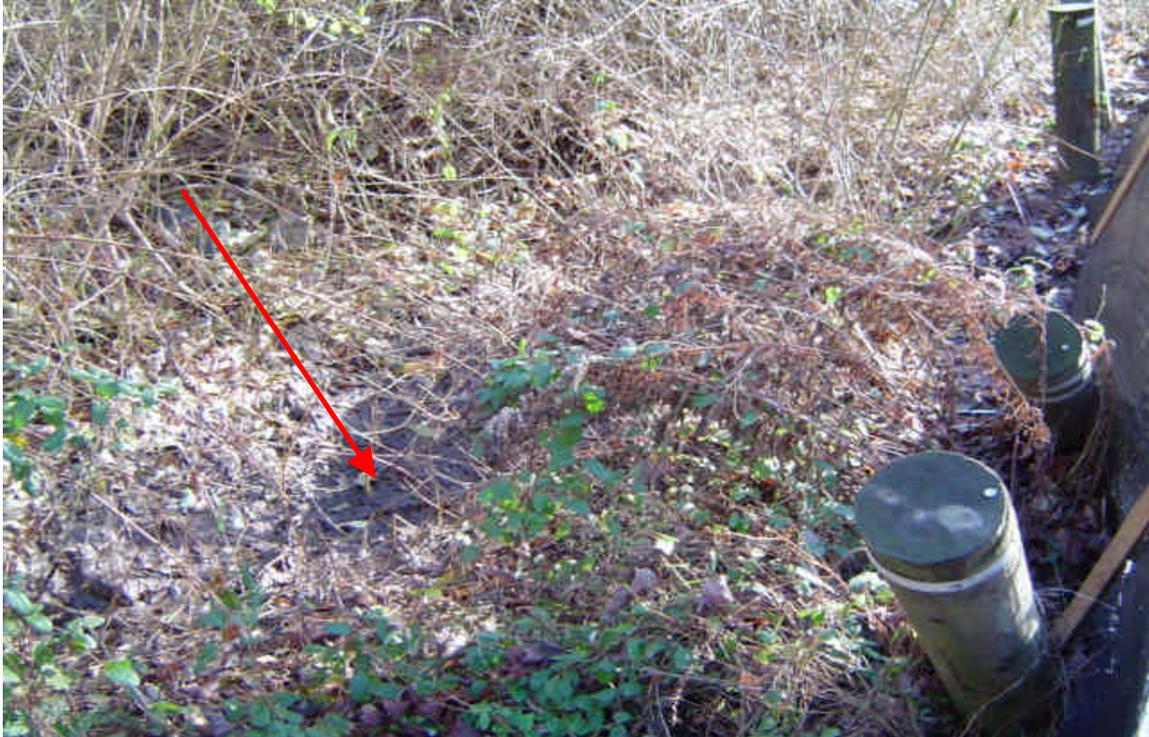
View of a culvert/swale located to the south of #53 where some sediment accumulation (possibly from sawcutting) was noted. The swale should be protected with controls. 12/1/05

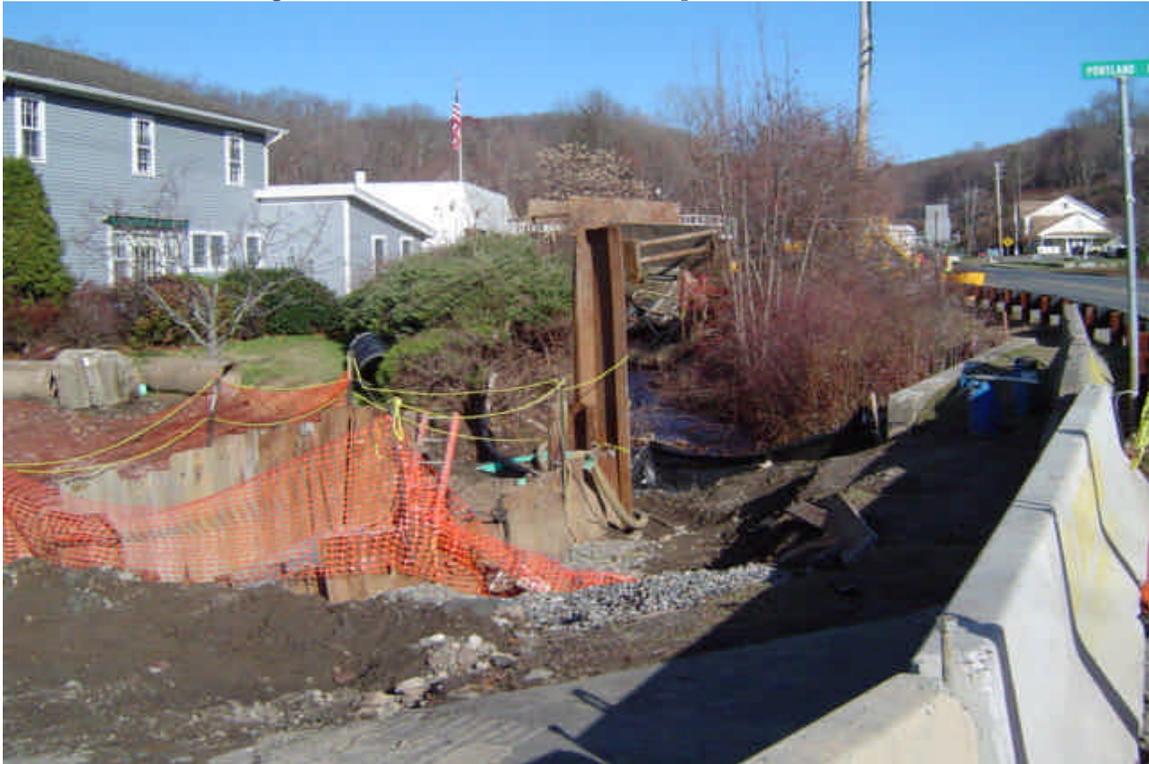
345kV (Georgetown Deli Jack and Bore): View of the site looking north. The receiving pit had been flooded by a rise in water following the recent storm. The water was pumped out through the filtration system. 12/1/05

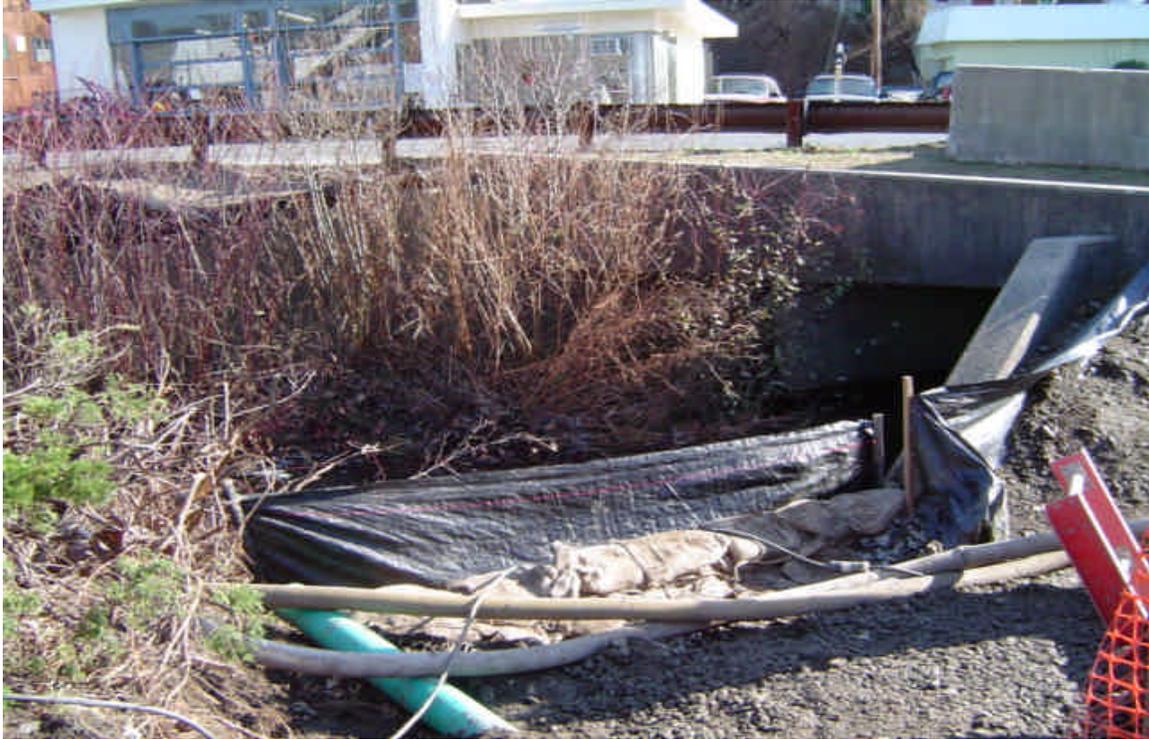
View of the stream in the vicinity of the receiving pit where additional silt fence and sands were installed following the flood event. It was noted that the far culvert has been clogged with vegetation and sediment prior to construction and may be a factor in the site flooding. 12/1/05

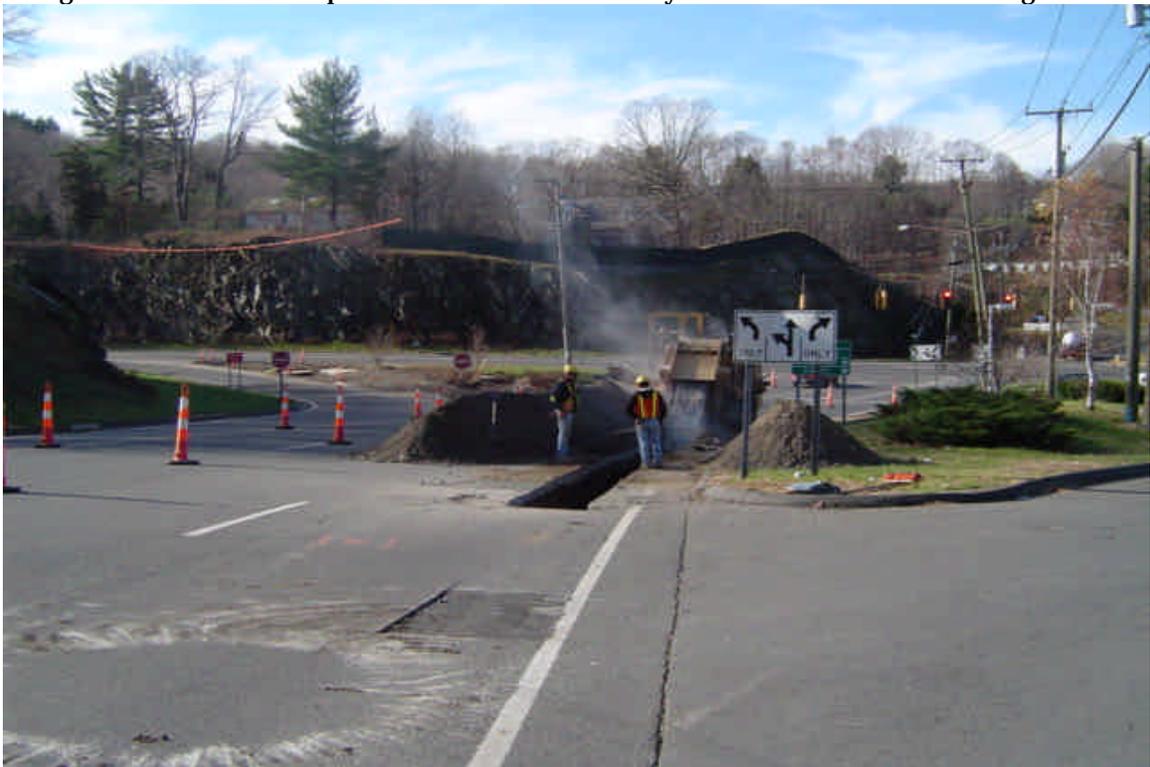
345kV (Rt. 107 Daywork): View of trenching occurring at the Rt. 107/7 intersection island. A catch basin located here requires installation of protection measures. 12/1/05

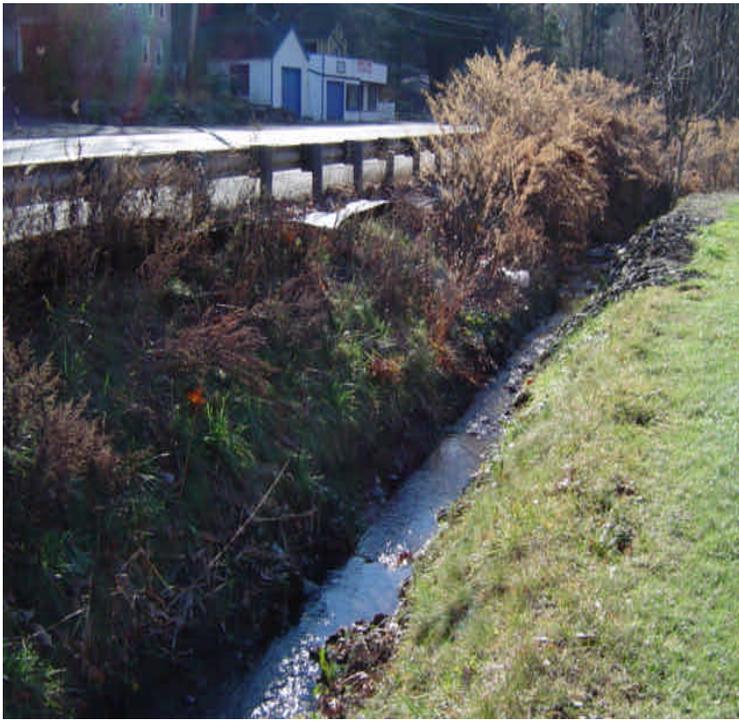
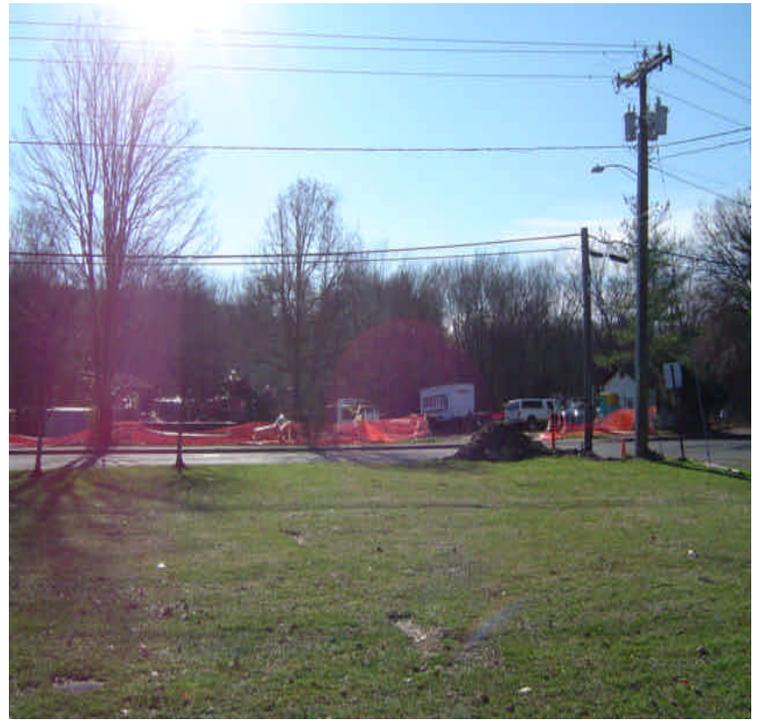
345kV (Route 7): Photo on the left shows the wetland swale near #848 at the storage yard. Landowner activities are also occurring here but monitor placement of materials to avoid sedimentation. Photo on the right shows a stockpile remaining at the intersection of School Rd. and Kristine Lilly Way. It is unclear whether this belongs to the project. 12/1/05

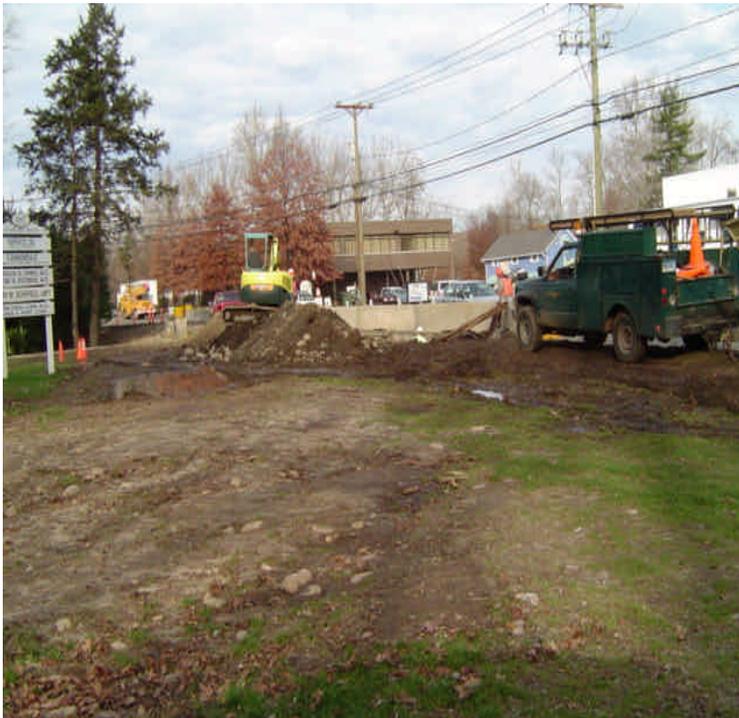
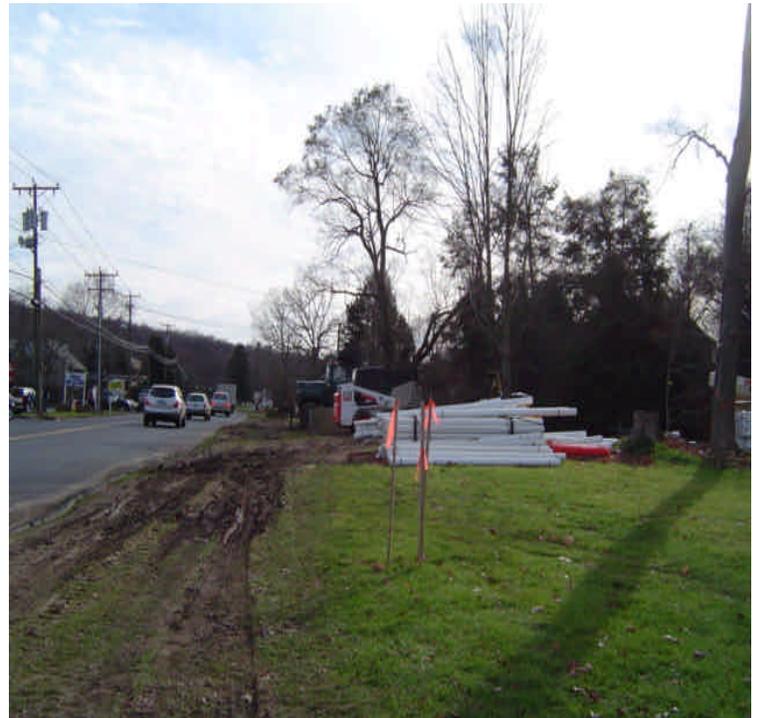
Both photos show continued activity near Catalpa Road. The area will require restoration when work is complete and catch basins in the area need protection measures. Stockpiles also require controls if they are in place for longer than 1 day. 12/105

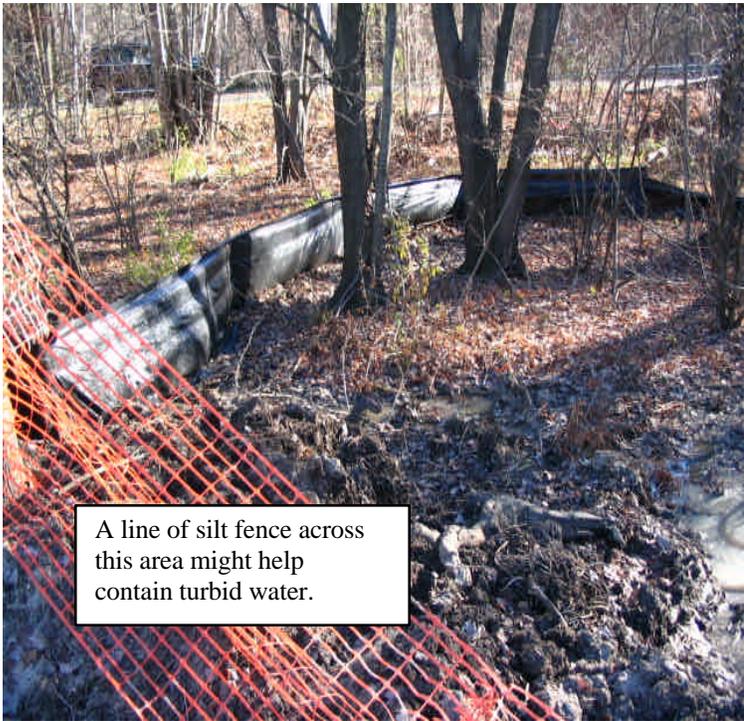
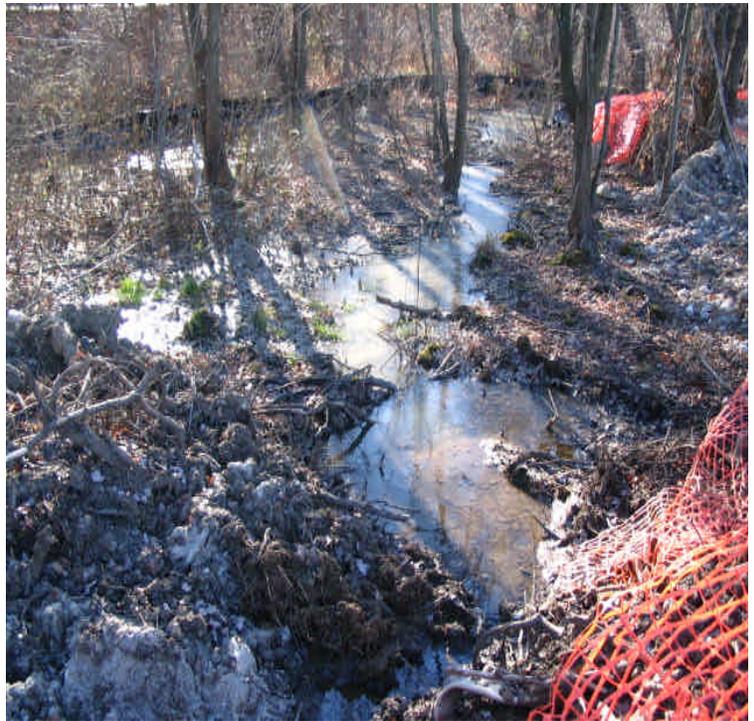
345kV (School Rd HDD): Both photos show the view towards the east of the site where standing water ponds in a wetland area adjacent to the basin. Silt fence has been placed around the perimeter here but a line across will also help to keep turbid area from this resource. Muds also are adding to turbidity issues. (Photos taken 11/23/05)

A line of silt fence across this area might help contain turbid water.

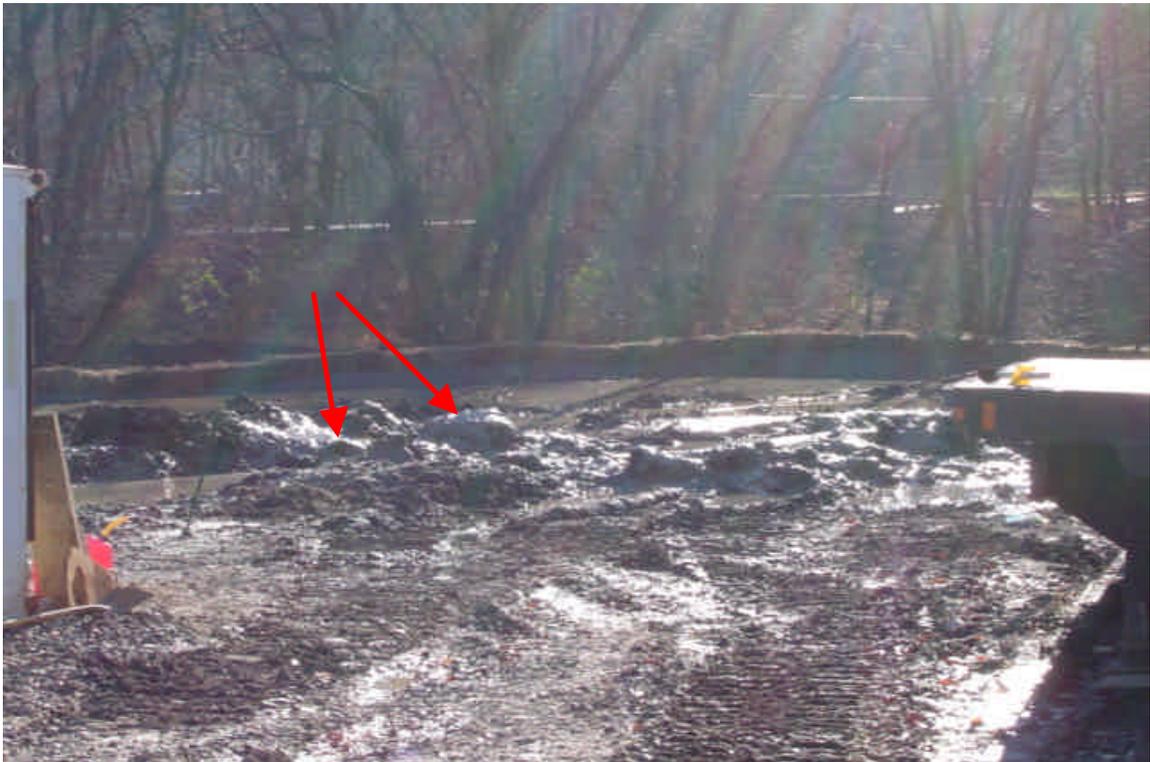
Additional piles of drilling mud are noted adjacent to and in the basin. Standing water here is still extremely turbid and muds need to be controlled. 12/1/05
