Docket No. 217 – Development and Management Plan Inspection

Northeast Utilities Service Company Certificate of Environmental Compatibility and Public Need for the construction of a 345-kV electric transmission line and reconstruction of an existing 115-kV electric transmission line between Connecticut Light and Power Company’s Plumtree Substation in Bethel, through the towns of Redding, Weston, and Wilton, and to the Norwalk Substation in Norwalk, Connecticut.

Date: December 8, 2005

Location: 345kV Underground Route

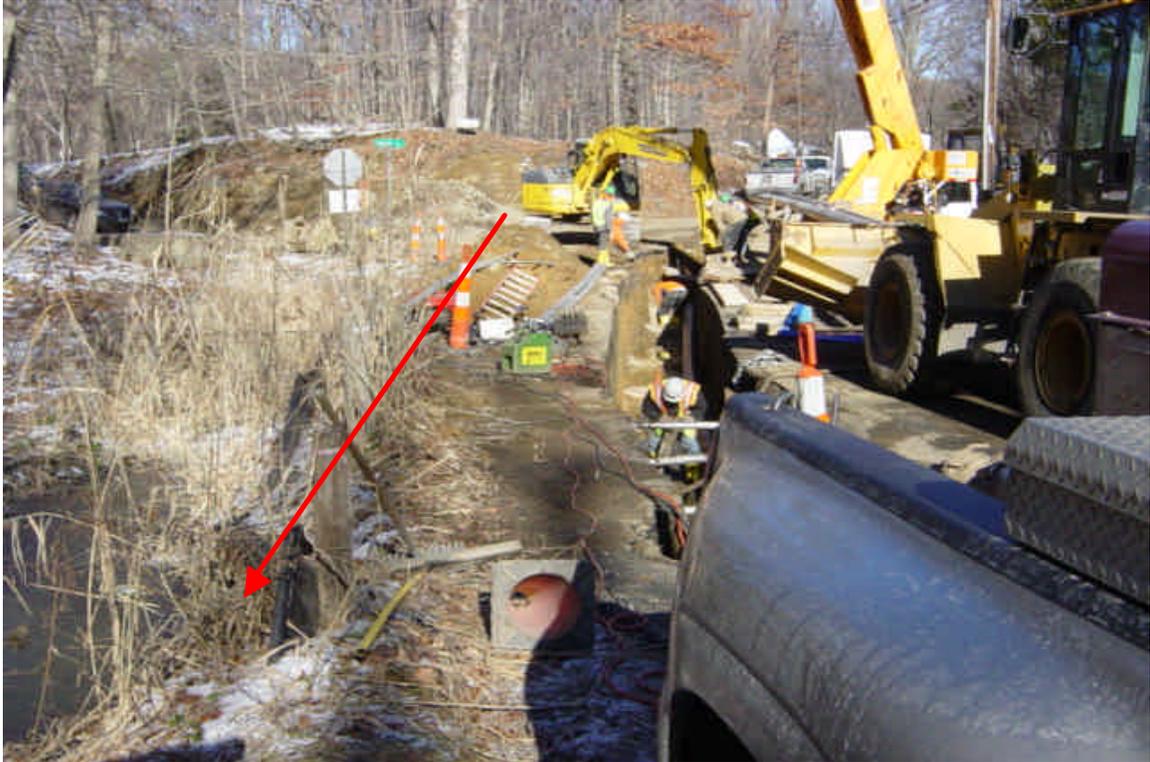
345kV (Umpawaug Rd Daywork): View of ongoing trenching work. A swale was noted immediately adjacent and it was lacking erosion and sediment controls. Silt fence should have been installed.

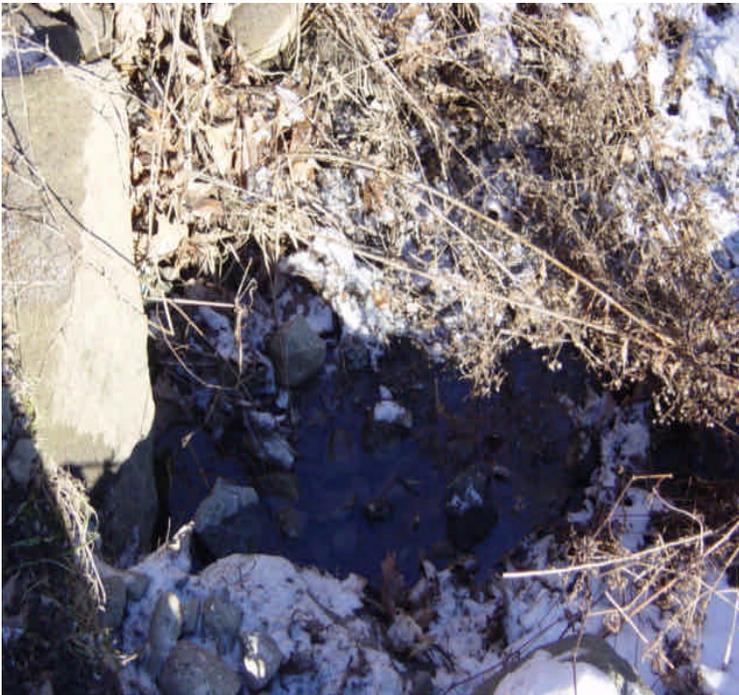
Photo on the left shows a close up the swale immediately adjacent to the work shown above. Photo on the right shows another area of work along the roadway where sediment is noted along the road. Be sure to perform street sweeping as needed. 12/1805

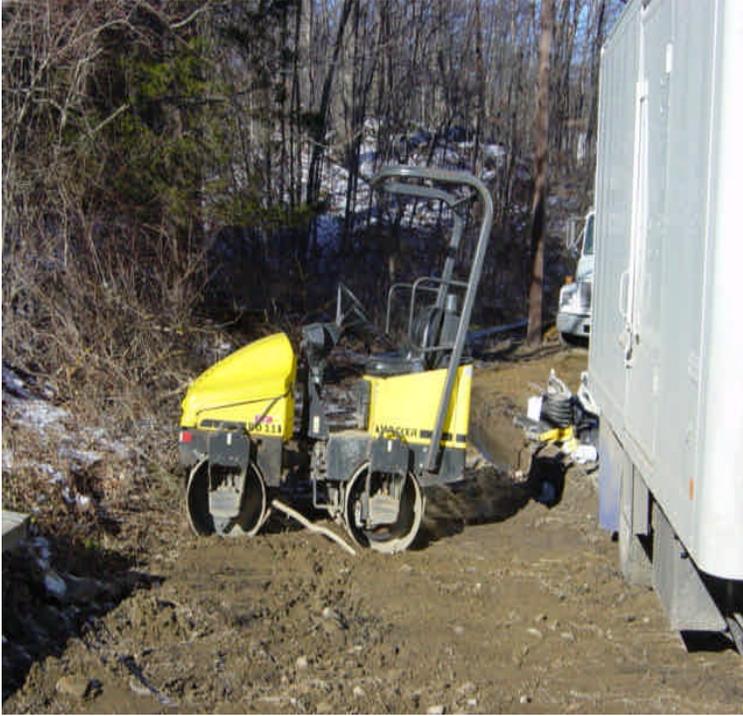
Photo on the left shows a small storage pull off area. Photo on the right shows a recently disturbed shoulder/bank that should be mulched when feasible. 12/8/05

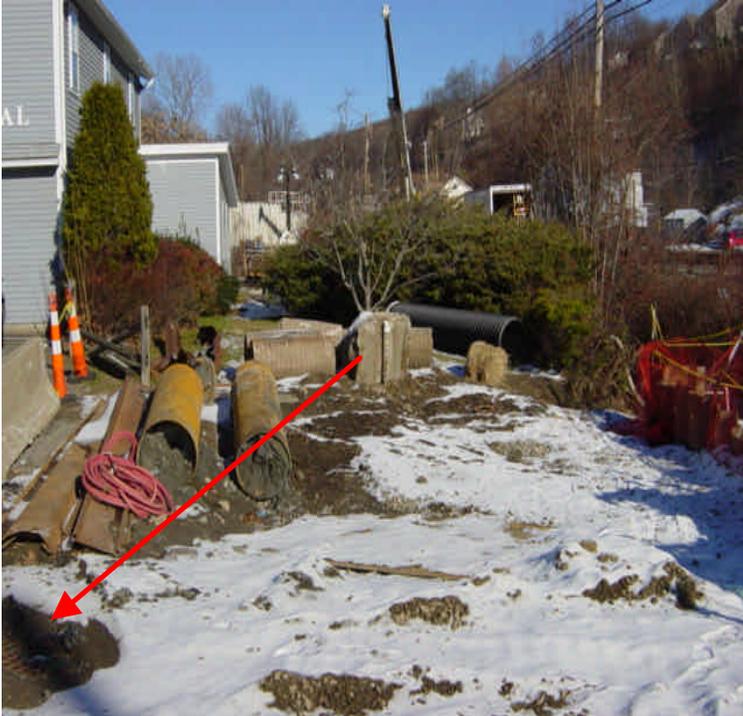
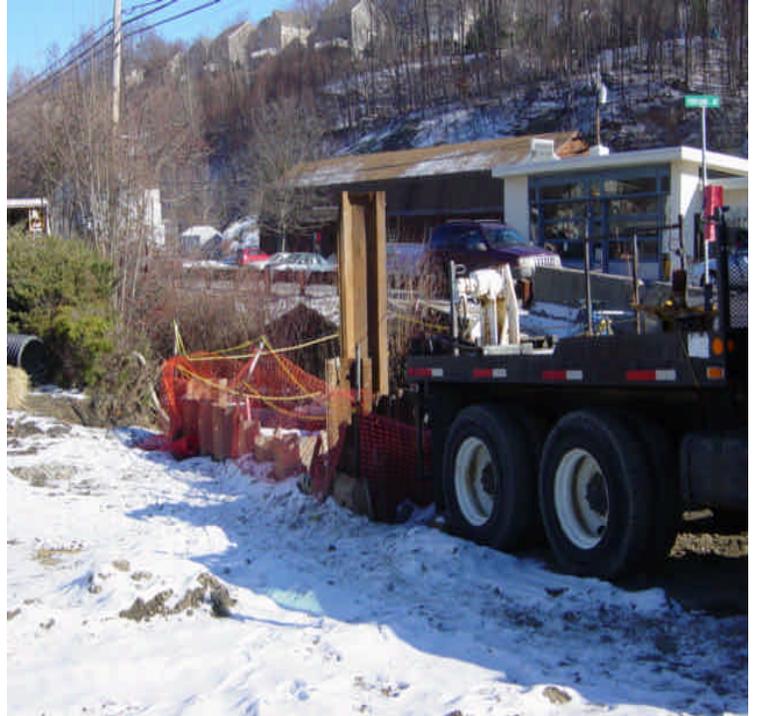
345kV (Georgetown Deli Jack and Bore): View of the site looking north. Photo on the left shows where some of the material is staged immediately adjacent to the receiving pit. A catch basin here is surrounded by disturbed soil and should be protected. 12/8/05

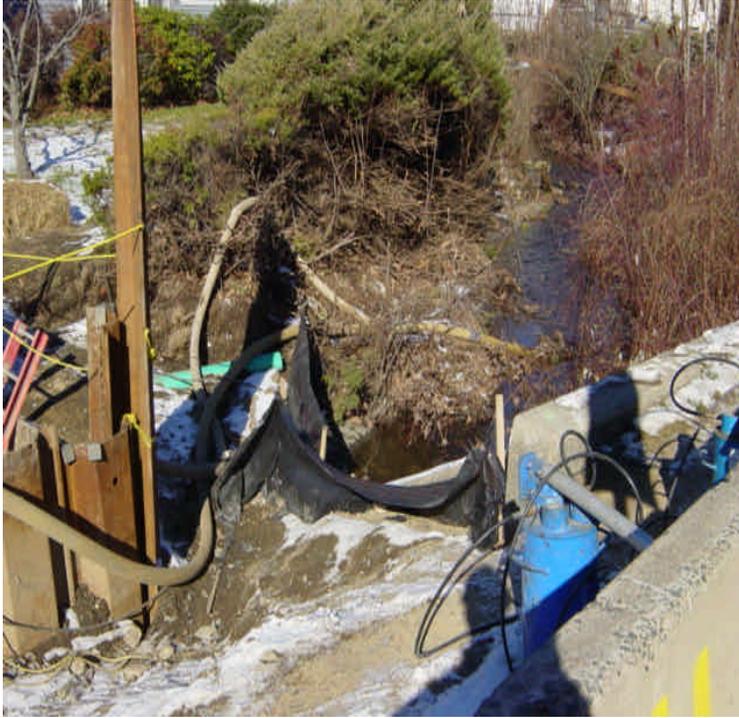
Photo on the left shows the silt fence and sandbags adjacent to the stream on the receiving pit side while photo on the right shows the silt fence and haybales in place adjacent to the stream on the bore pit side. 12/8/05

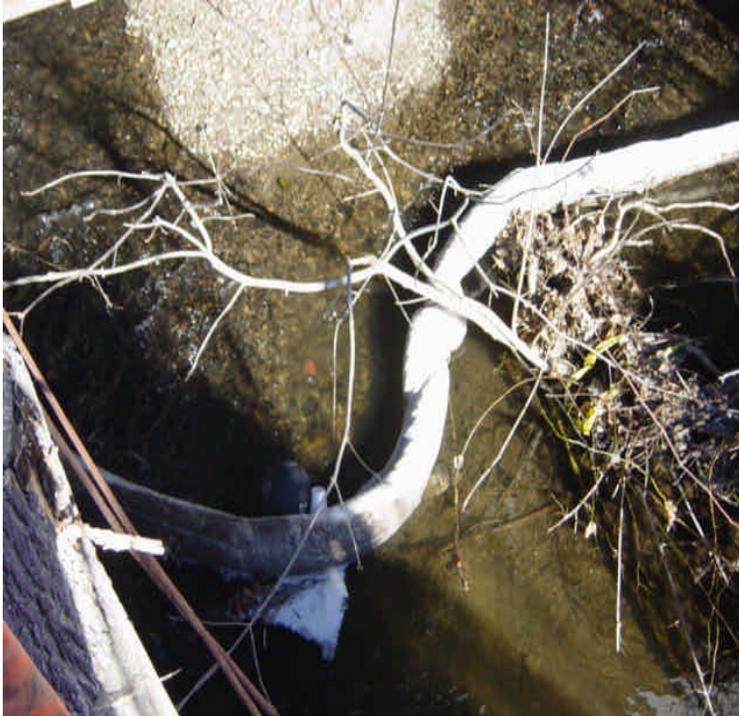
Photo on the left shows the stream quality still fairly clear but with a slightly more turbid cast than we have previously seen. Photo on the right shows the riprap pad and silt fence still in place and effective. 12/8/05

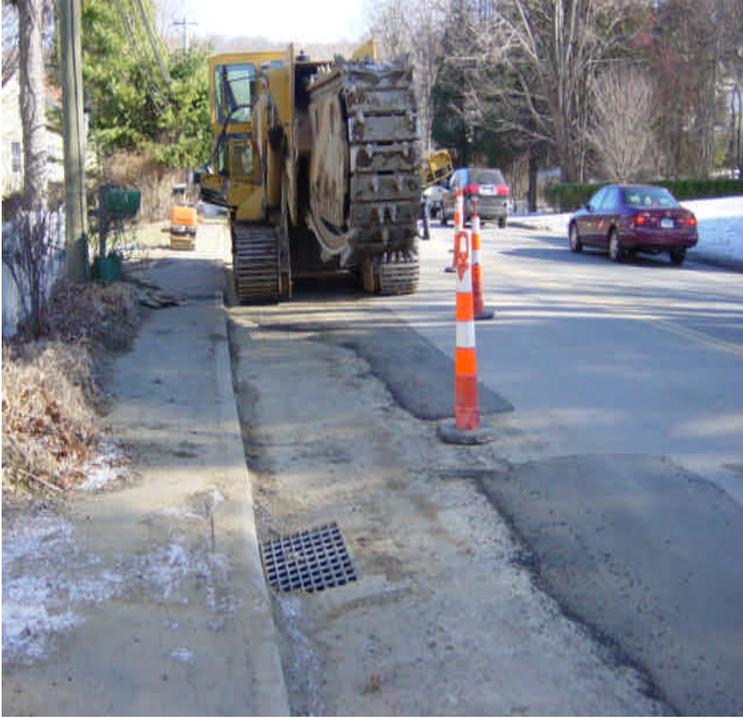
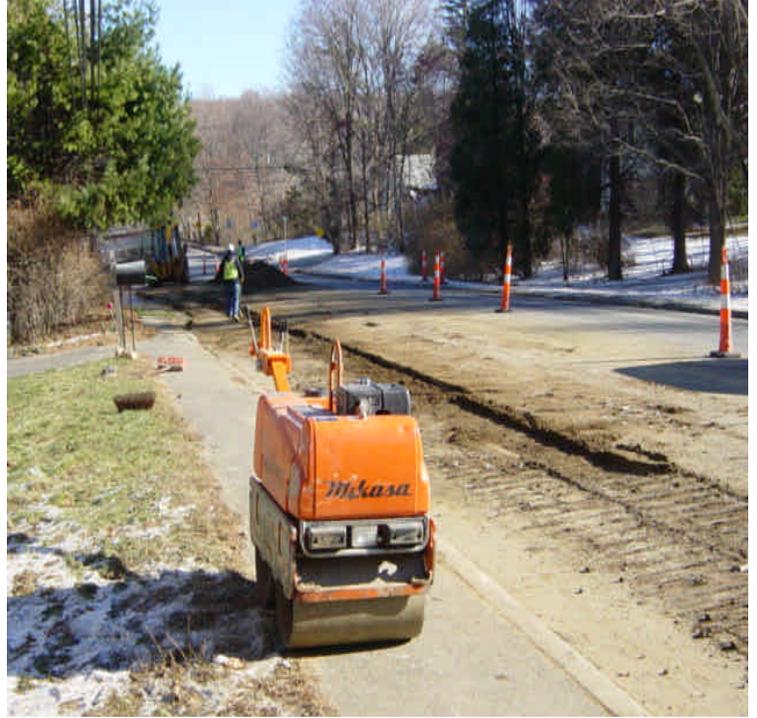
345kV (Route 107): Some additional street work was occurring along Rt. 107. Catch basins adjacent to the area were not protected and sediment was noted along the gutters. 12/8/05

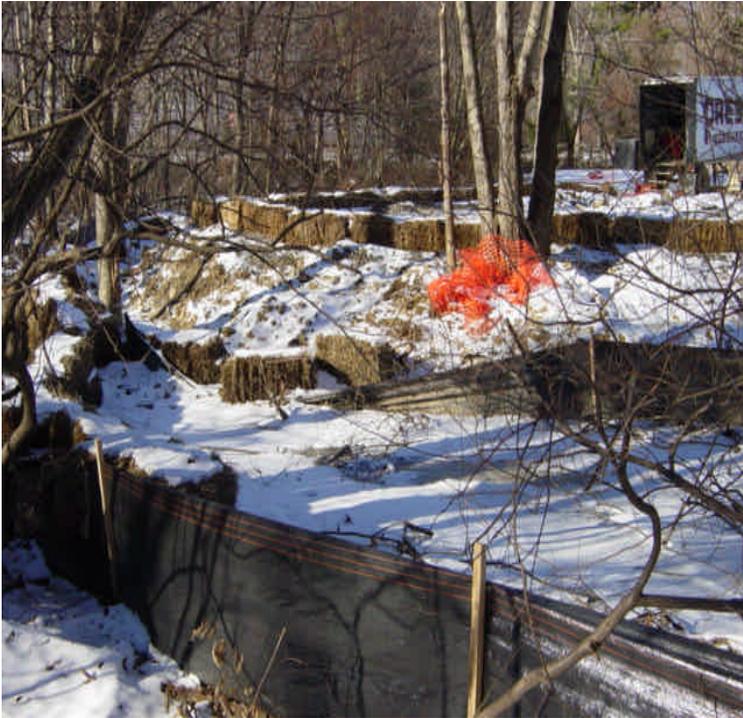
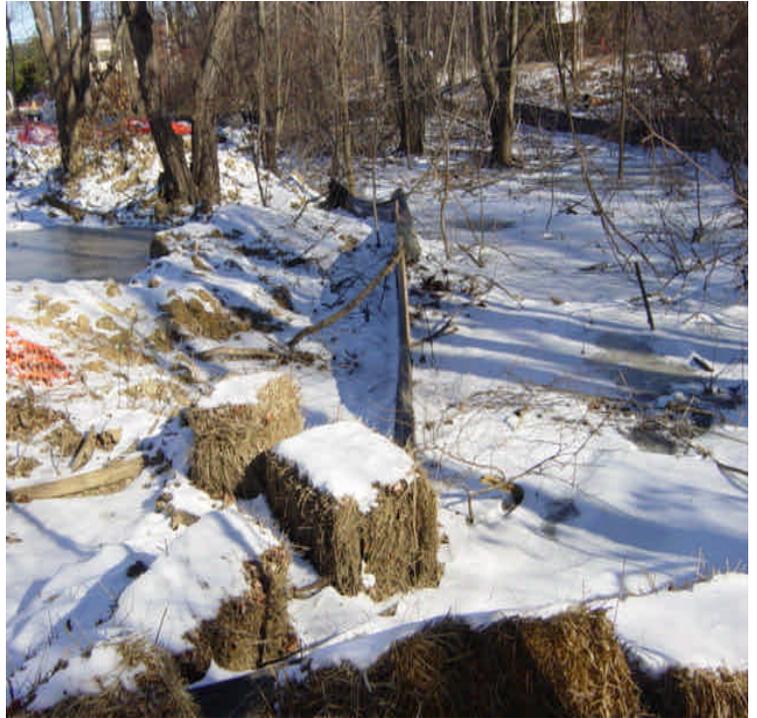
345kV (School Rd HDD): Both photos show the controls along and south of the basin. Controls shown in the right hand photo should be upgraded to protect the wetland area immediately adjacent. 12/8/05

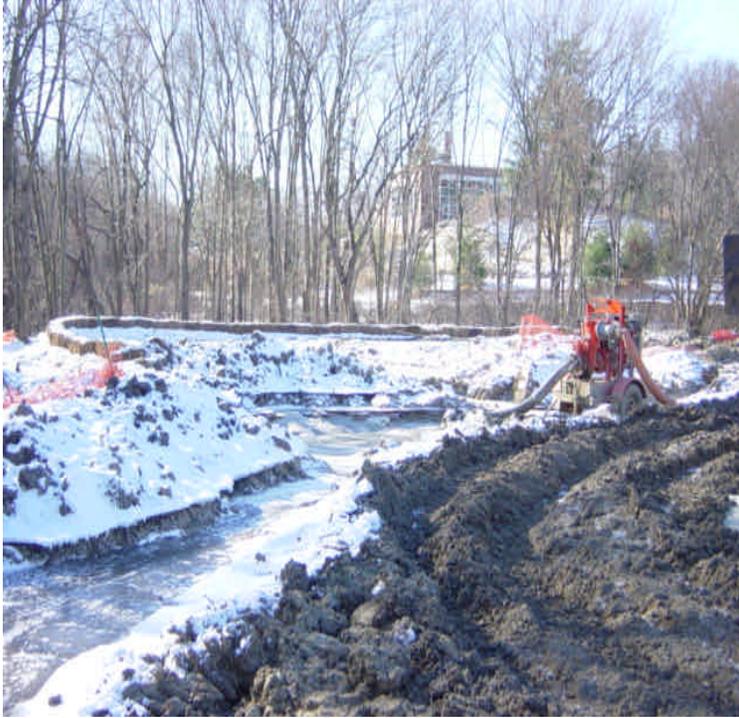
Photo on the left shows additional excavation/channeling towards the basin. Drill cutting piles had also been excavated and removed. Photo on the right shows a view back towards the equipment with significant amount of water present in the basin area. 12/8/05

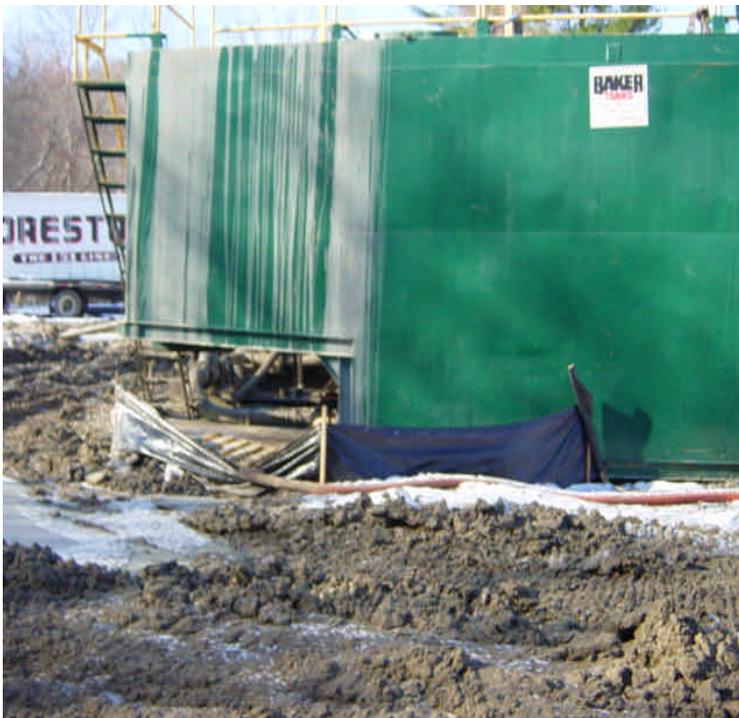
Photo on the left shows the silt fence that had been installed by the tank pushed down by a hose and turbid water present underneath. The photo on the right shows a pool of turbid water collecting adjacent to the tanks. This water must be controlled. 12/8/05
