Docket No. 217 – Development and Management Plan Inspection

Northeast Utilities Service Company Certificate of Environmental Compatibility and Public Need for the construction of a 345-kV electric transmission line and reconstruction of an existing 115-kV electric transmission line between Connecticut Light and Power Company’s Plumtree Substation in Bethel, through the towns of Redding, Weston, and Wilton, and to the Norwalk Substation in Norwalk, Connecticut.

Date: December 14, 2005

Location: 345kV Underground Route

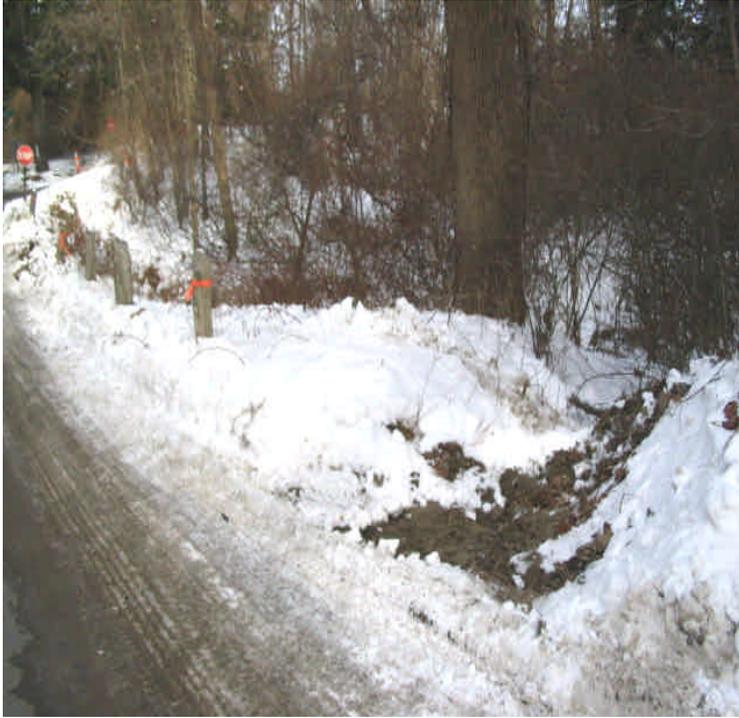
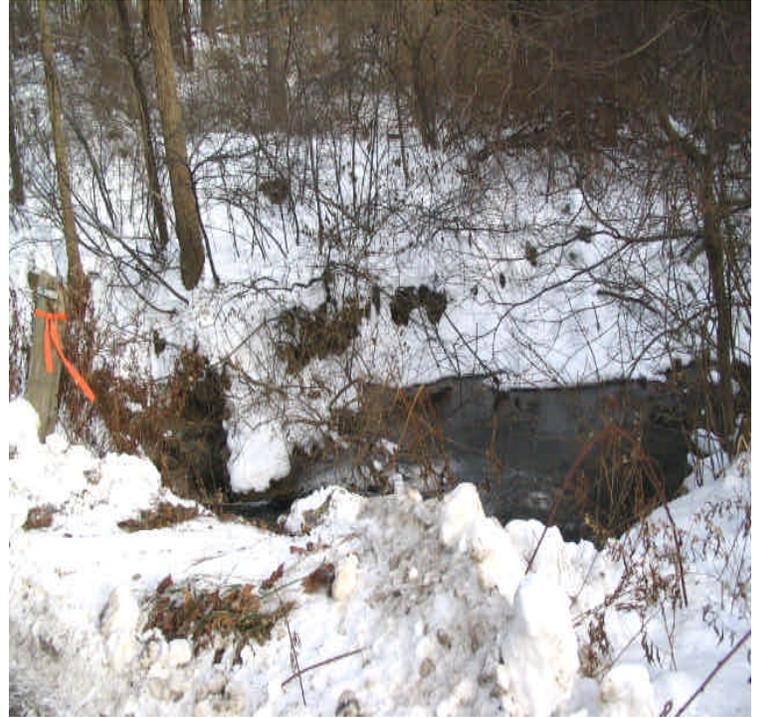
345kV (Umpawaug Rd Daywork): View of a stream and wetland near the Diamond Hill Rd. intersection. Several swales connect to the area as well. Erosion controls should be installed as work moves closer. 12/14/05

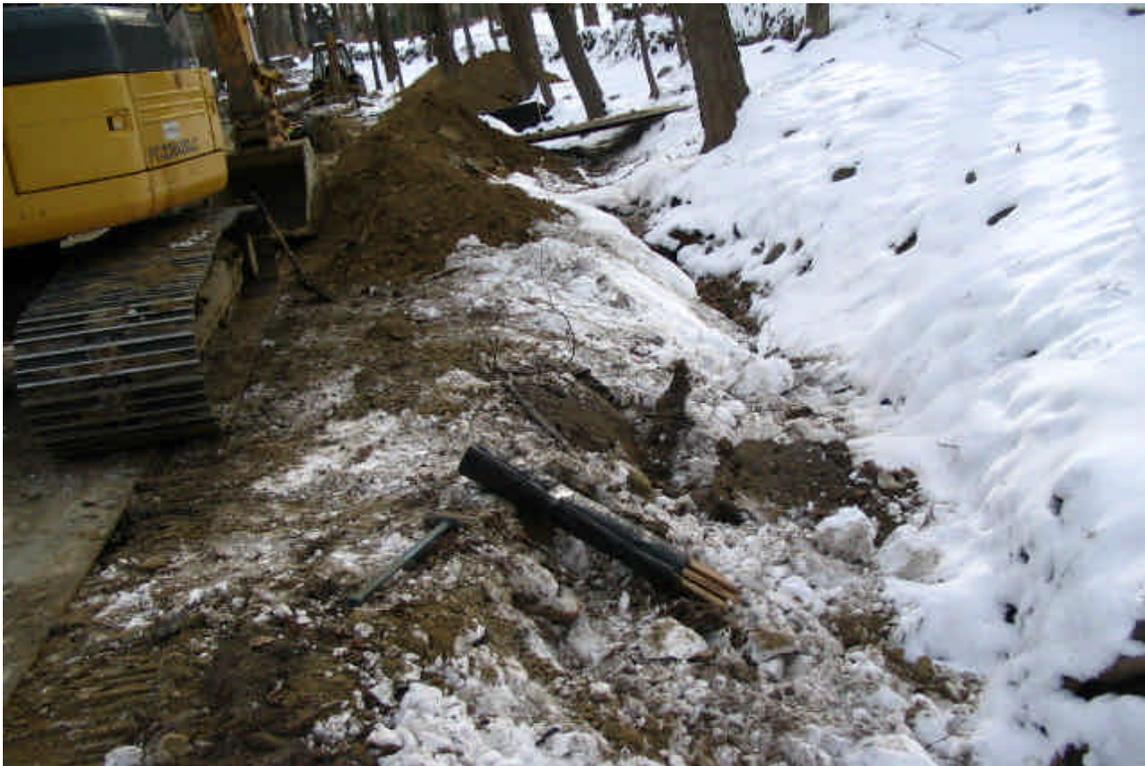
View of sediment stockpiled and pushed with the snow into a wet swale near #144 Umpawaug Rd. The sediment will be pulled back and silt fence was awaiting installation. Silt fence should be installed prior to soil disturbance if possible. 12/14/05

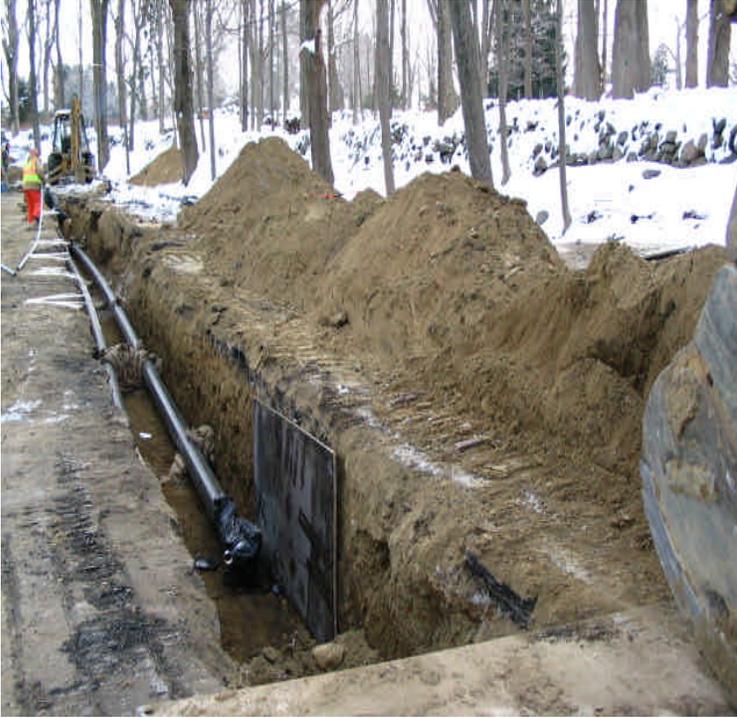
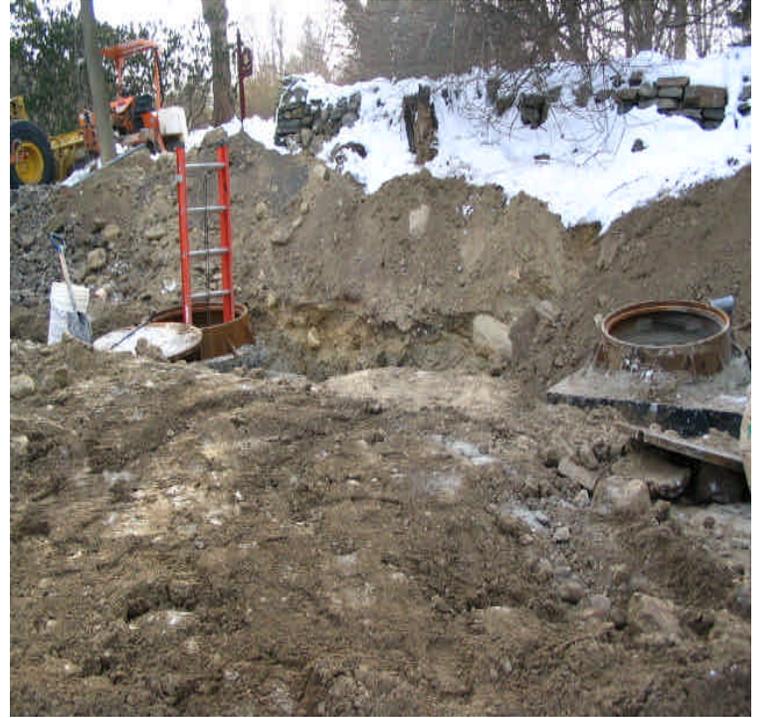
Photo on the left shows the continued active trench work in the street and adjacent stockpiles.
Photo on the right shows work at a vault area near #88 Umpawaug. 12/14/05

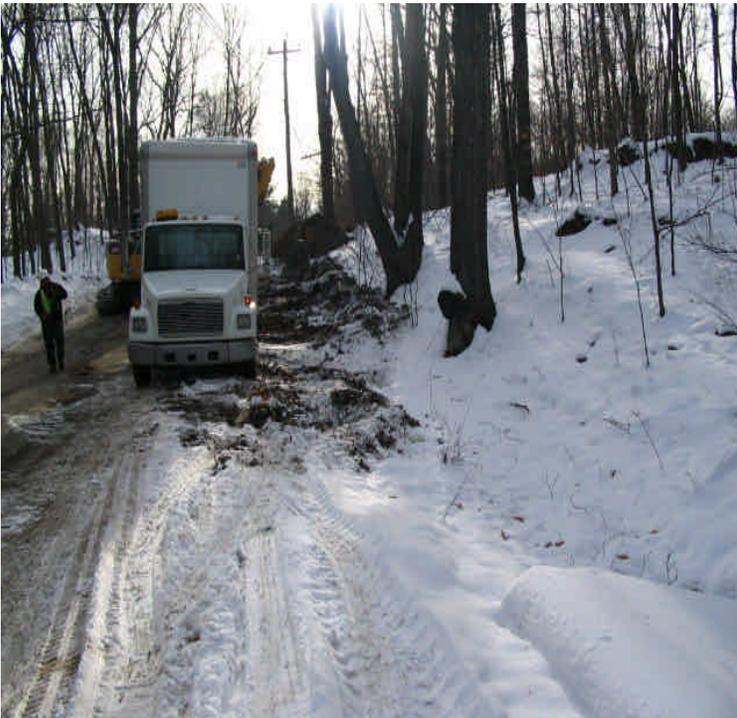
Photo on the left shows a similar situation at a work area at #77. Sediment was pushed towards the beginning of a wet swale. Silt fence will be installed across and along the swale. Photo on the right shows where trench boxes were placed in the swale. Attempt to keep material storage to upland areas. 12/14/05

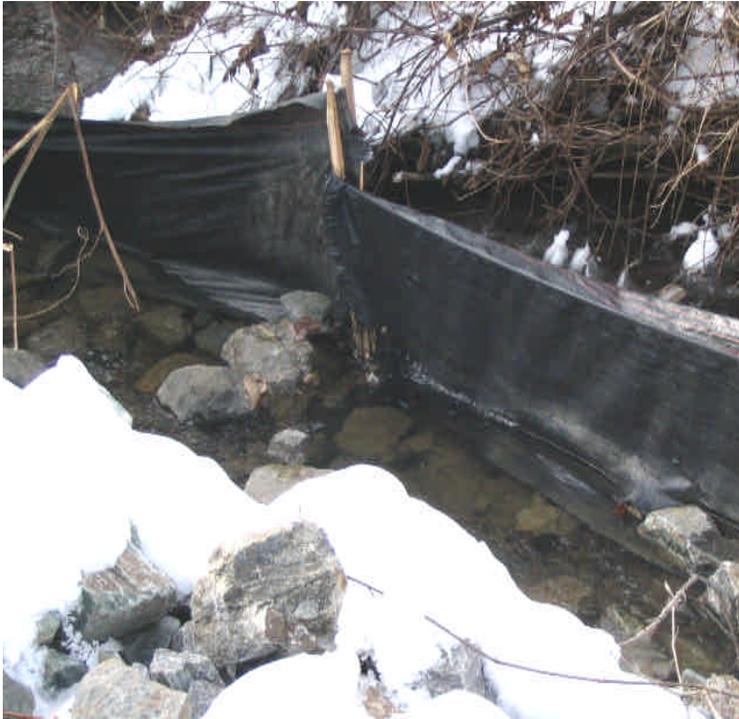
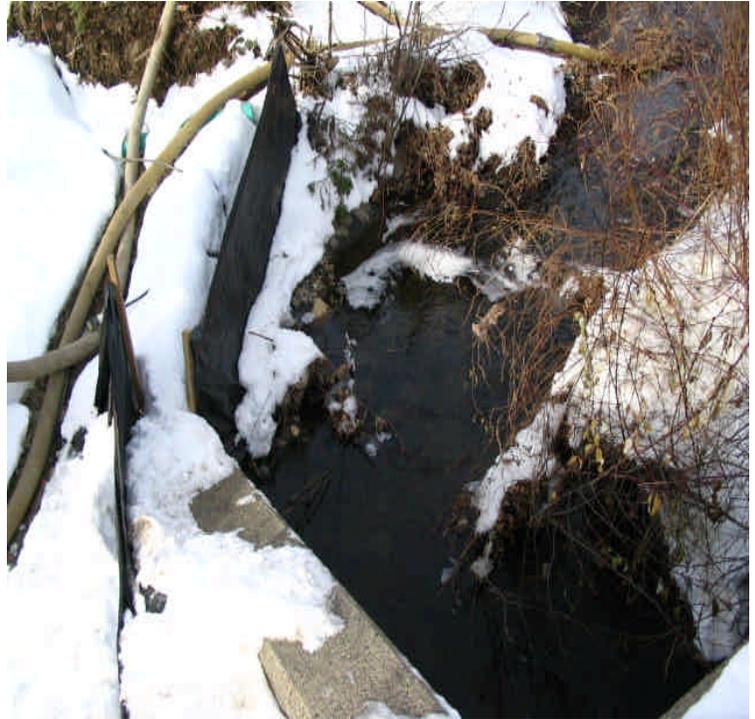
345kV (Georgetown Deli Jack and Bore): Photo on the left shows the clarity of the water entering the stream from the riprap outlet. Photo on the right shows the stream flowing clear as it leaves the project site. 12/14/05

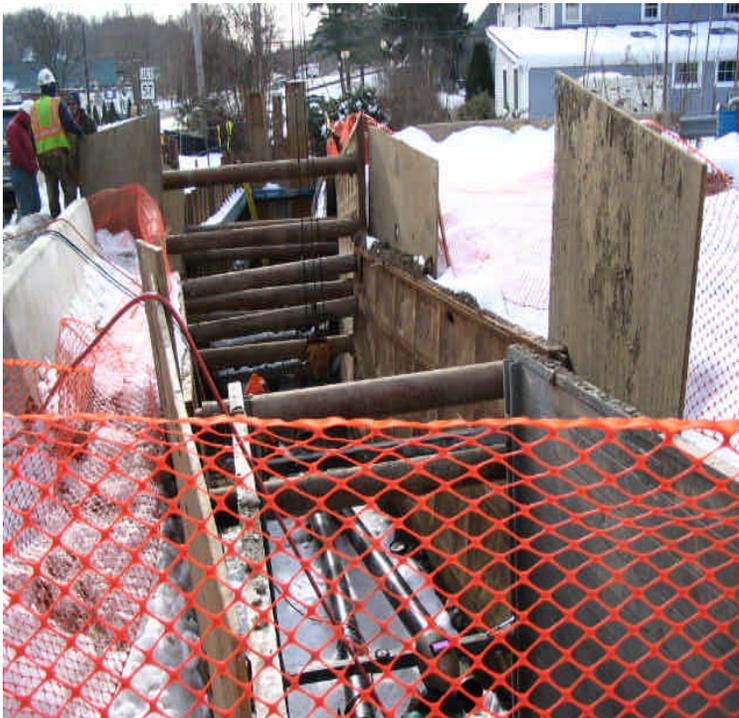
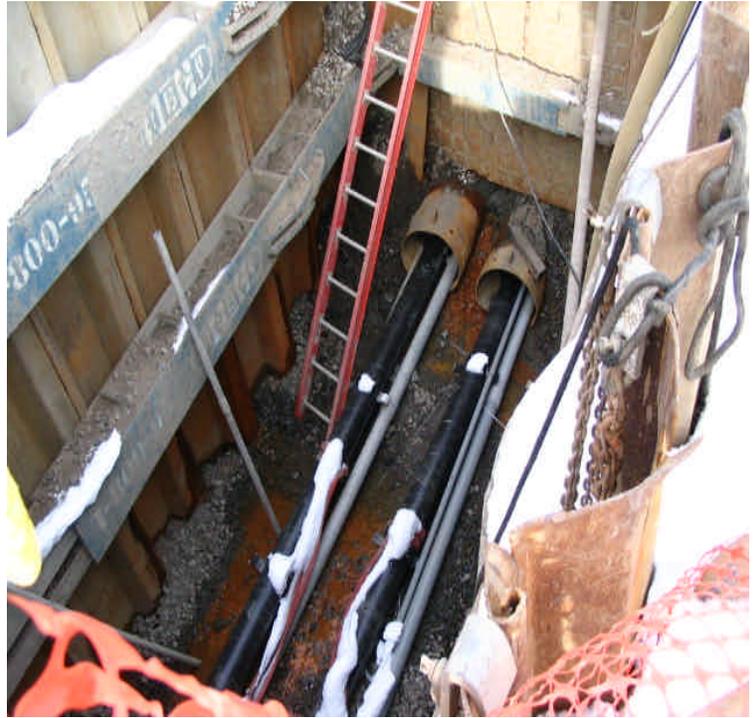
Photo on the left shows a view of the bore pit and trench that has been excavated leading back from the stream. Photo on the right shows the project infrastructure installed in the culvert pipe. 12/14/05

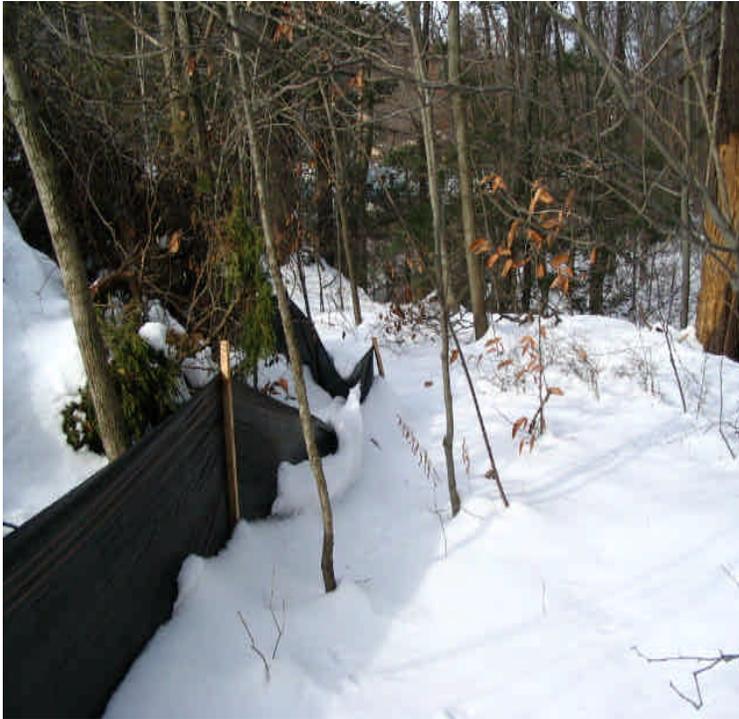
345kV (Rt 7 CL&P yard): Photo on the left shows an area where the silt fence around the stockpile is sagging. The fence should continue to be maintained . Vehicles and trailers are using the yard.
12/14/05

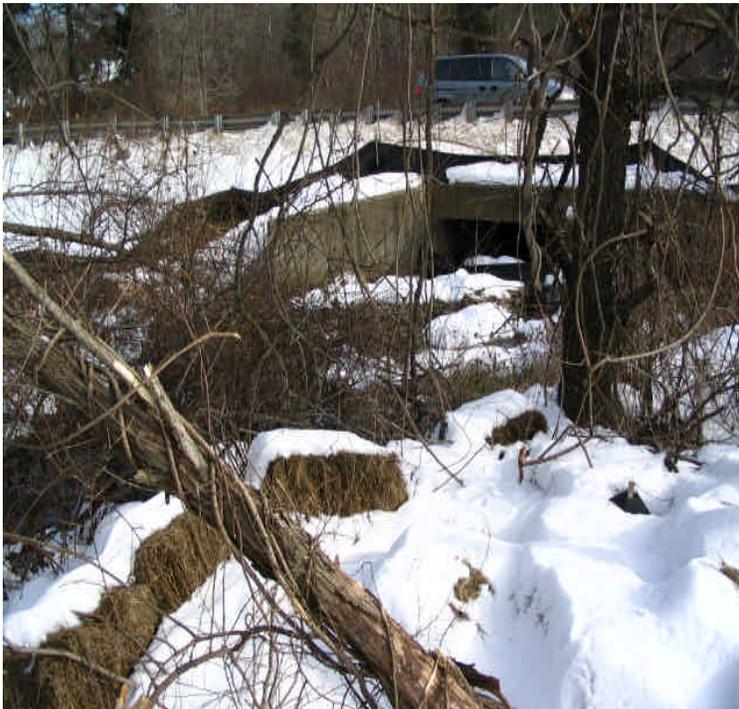
345kV (J&B and School Rd HDD): Photo on the left shows the remaining erosion controls at the old jack and bore site at the High School. Photo on the right shows where sediment deposition has occurred in a channel leading to the Norwalk River. A line of coloration could be seen at the edge of the main river. 12/14/05

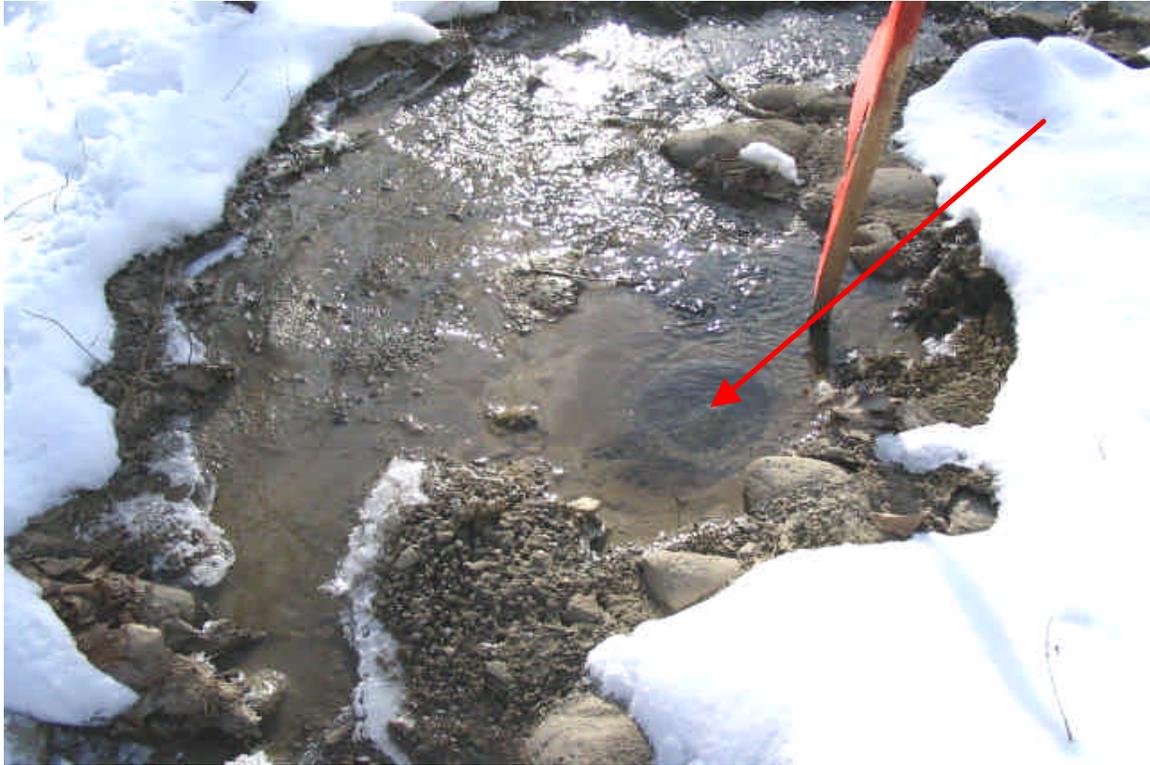
Areas of Inspection	Observation	Recommended Action
Waterways	<p>stream had some remaining accumulated sediment under the water which needs to be removed. 11/10-12/14/05</p> <p>-The stream at the Georgetown Deli jack and bore was running clear through the project site. 12/14/05</p> <p>- Bubbling, apparently from a ground fracture, was noted in the wetlands beyond the HDD site. An observable deposit of sediment had occurred into a channel adjacent to the Norwalk River. A line of coloration was noted. 12/14/05</p>	<p>controls in place. This needs to happen before spring rains disperse it. 10/27-12/14/05</p> <p>- Contractors state that they have been performing filter changes on a regular basis to prevent turbidity. 12/8-12/14/05</p> <p>- Contractors were to watch this spot carefully as well as clean up all deposited sediment. They were also going to install haybales at the confluence of the channel and the river. 12/14/05</p>

Photo shows where bubbling was occurring, potentially a small fracture where sediment likely emerged. The sedimentation into the channel began at this point. 12/14/05

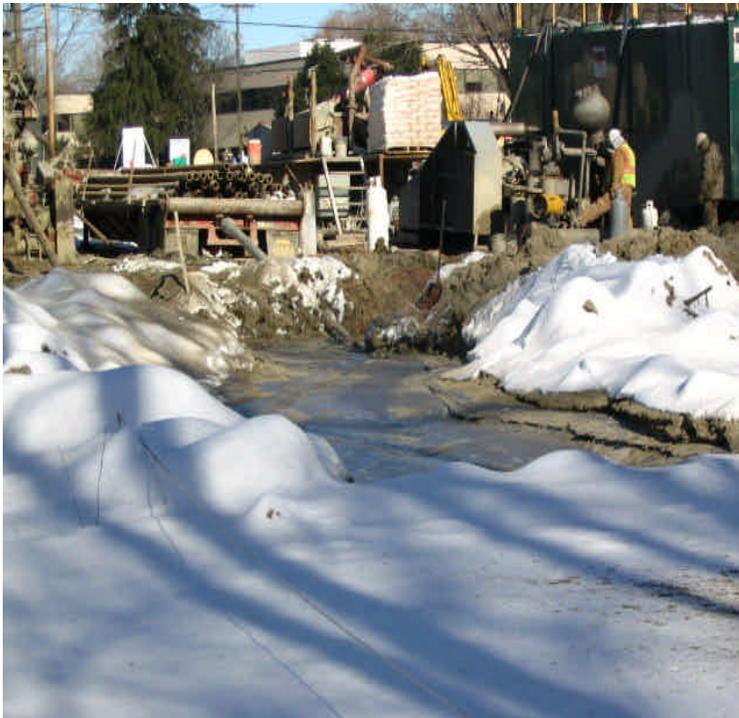
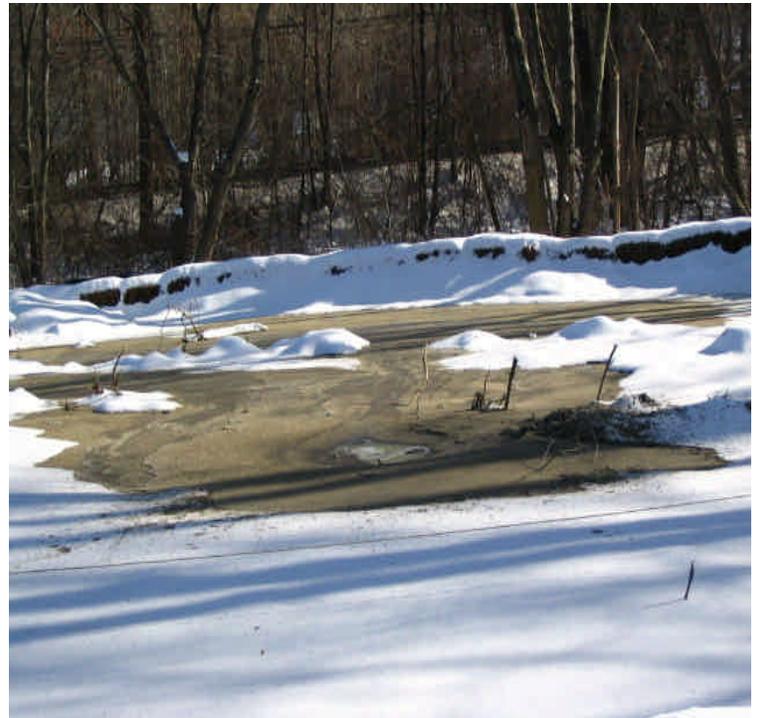
Photo on the left shows an overview of the work area and the initial portion of the bore. Turbid water is flowing from this point into the basin. Photo on the right shows that the turbid water in the basin is coming from the operation and not a storm event. 12/14/05

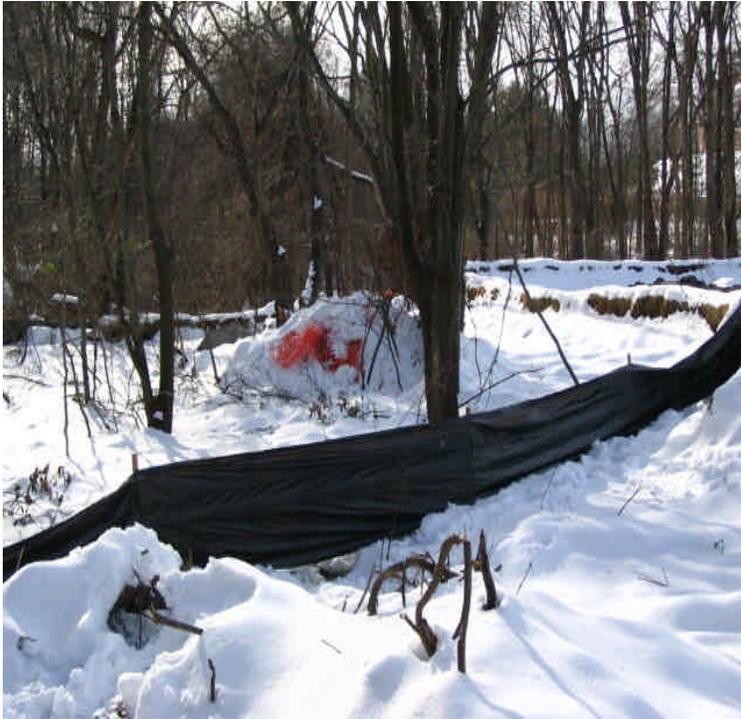
Photo on the left shows where the silt fence has been installed to the east across the wetland area but it could not be toed-in due to frozen ground conditions. The photo on the right shows where excavation has created a berm near the edge of the basin. 12/14/05

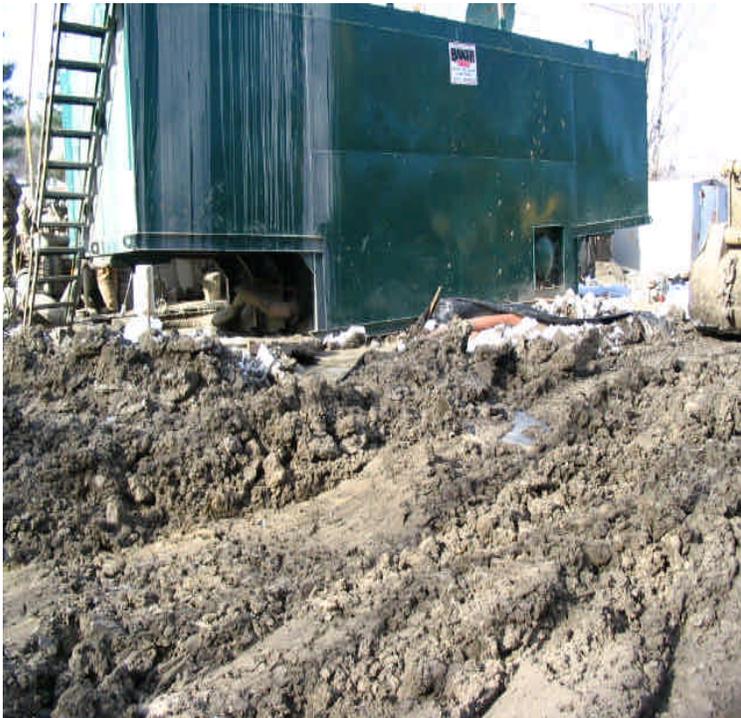
Photo on the left shows the disturbed soil surface near the tanks where the area has been excavated. The photo on the right shows additional disturbance and where turbid water is escaping to the basin. 12/14/05
