**Docket No. 217 – Development and Management Plan Inspection**

Northeast Utilities Service Company Certificate of Environmental Compatibility and Public Need for the construction of a 345-kV electric transmission line and reconstruction of an existing 115-kV electric transmission line between Connecticut Light and Power Company’s Plumtree Substation in Bethel, through the towns of Redding, Weston, and Wilton, and to the Norwalk Substation in Norwalk, Connecticut.

**Date:** December 30, 2005

**Location:** 345kV Underground Route

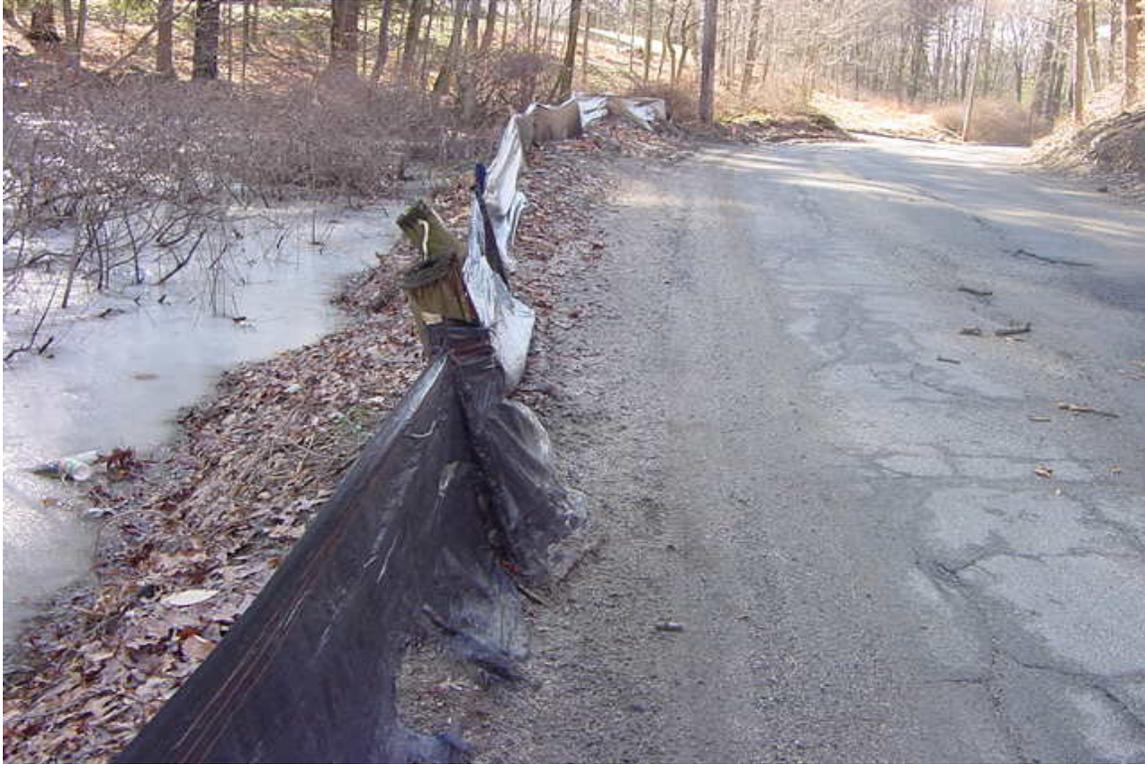
345kV (Umpawaug Rd Daywork): No active trenching was occurring. Good controls remain along most swales. Some repairs are needed here at Wayside Lane IF active work returns. 12/30/05

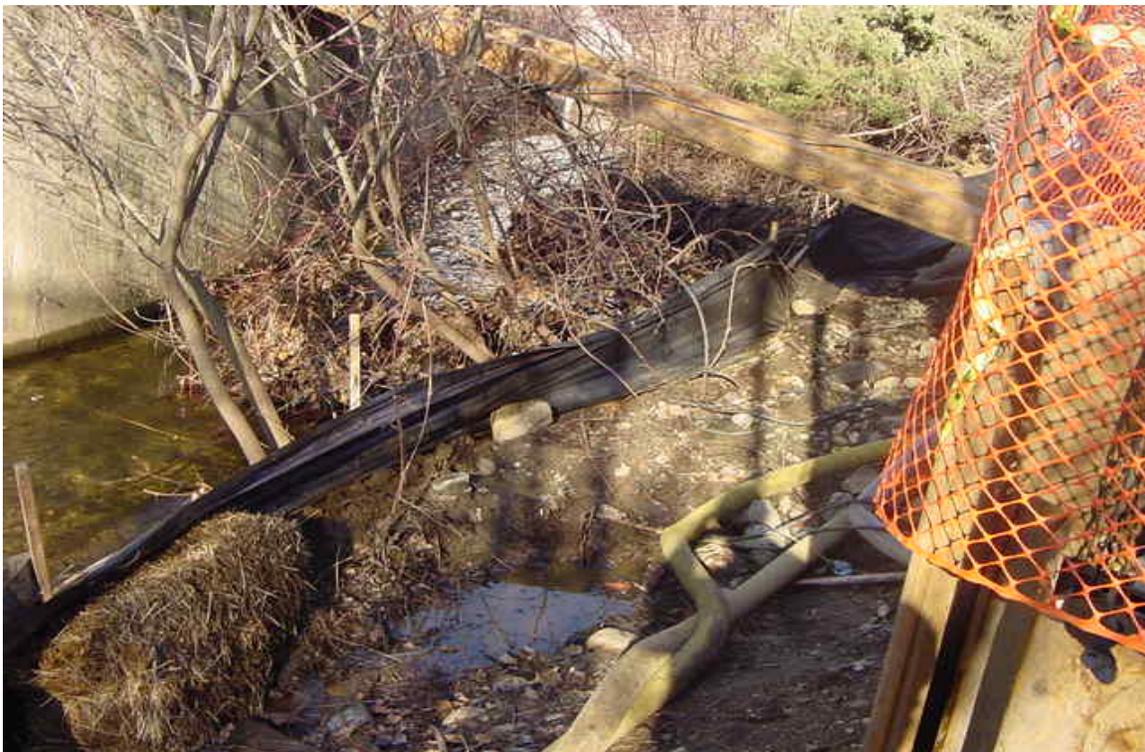
345kV (Georgetown Deli Jack and Bore): Photo shows the bore pit adjacent to the stream. Additional haybales were recommended here. 12/30/05

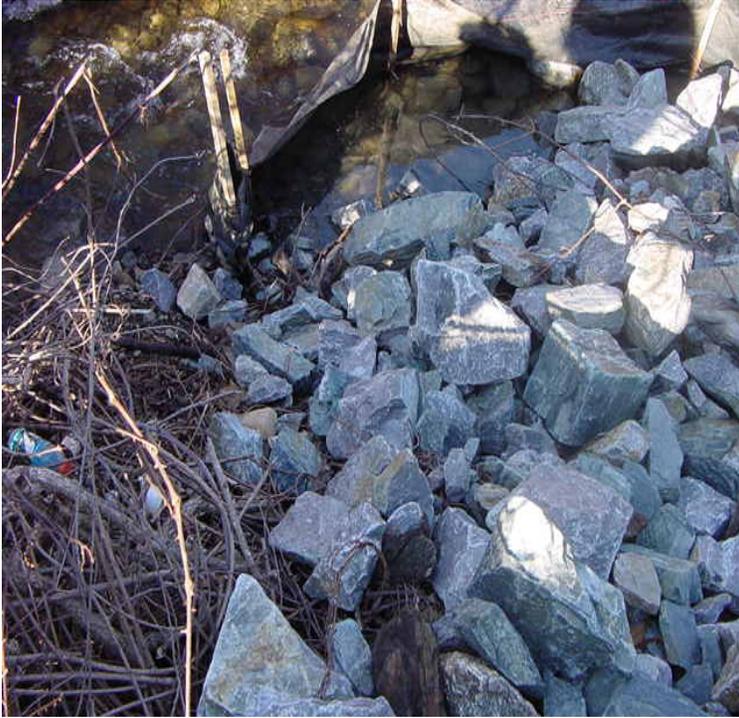
Photo on the left shows where the silt fence at the dewatering outlet was being repaired. The stream was running clear. Photo on the right shows a view of the pit which is currently being backfilled and moving towards completion. 12/30/05

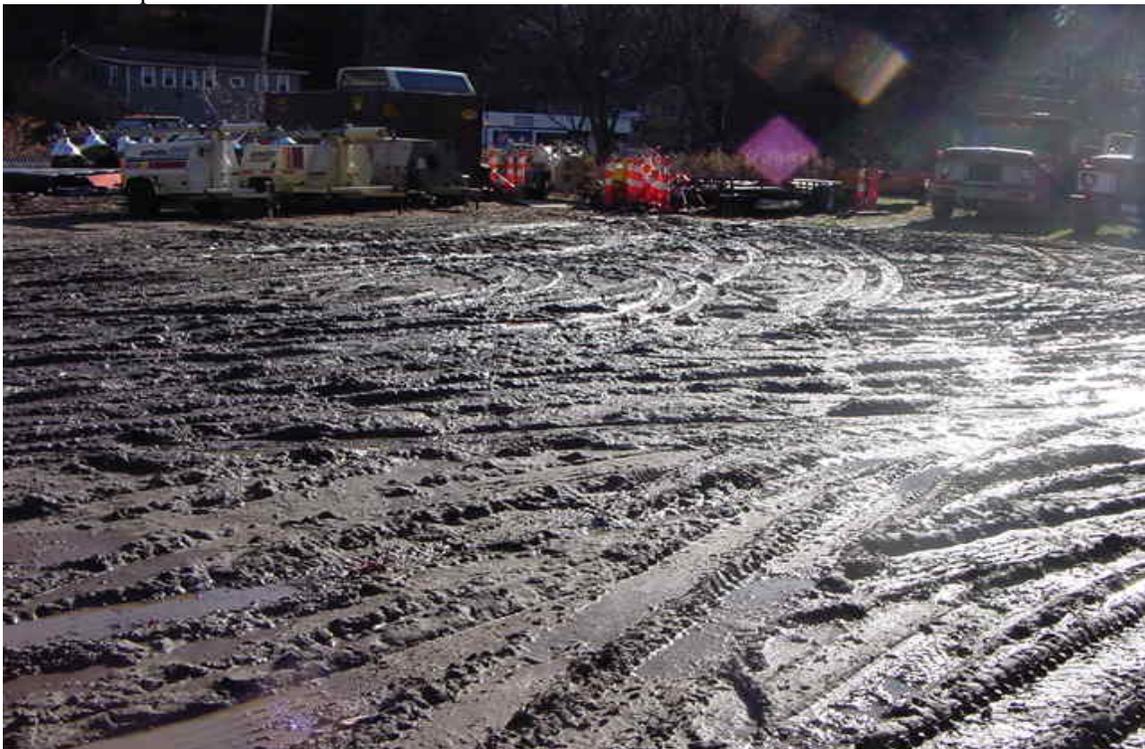
345kV (Storage Area) Equipment is contained but the surface of the yard is muddy due to thaw periods. 12/30/05

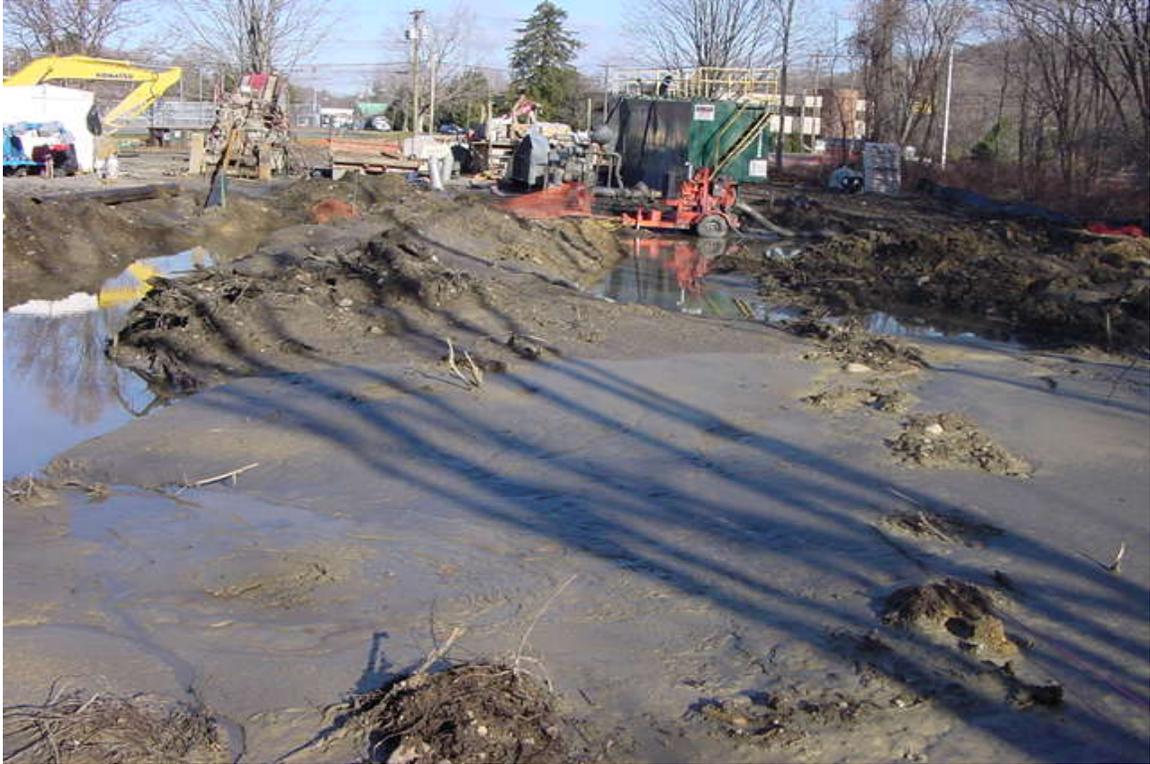
345kV (HDD School Rd.) The photo shows a view of the settling basin, still receiving turbid water and mud. Work or corrective actions were not occurring at the time due to the holidays. 12/30/05

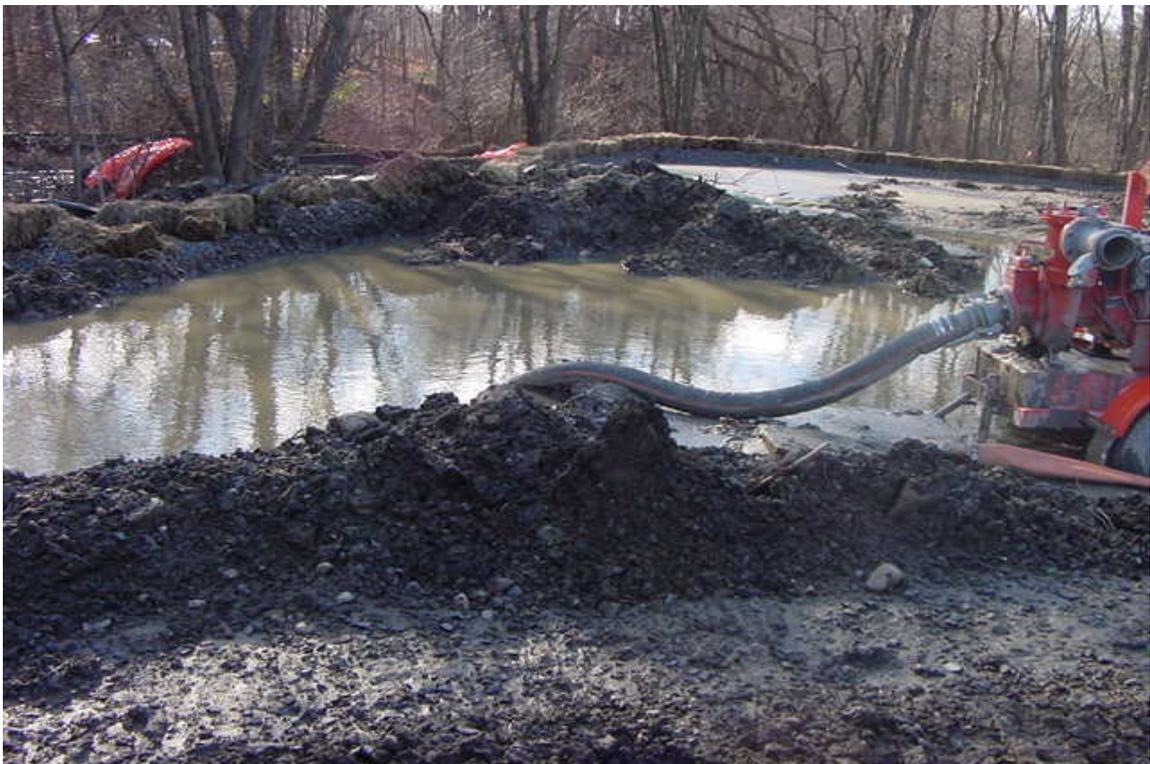
Additional view of the turbid water and disturbed soil surfaces on site. 12/30/05

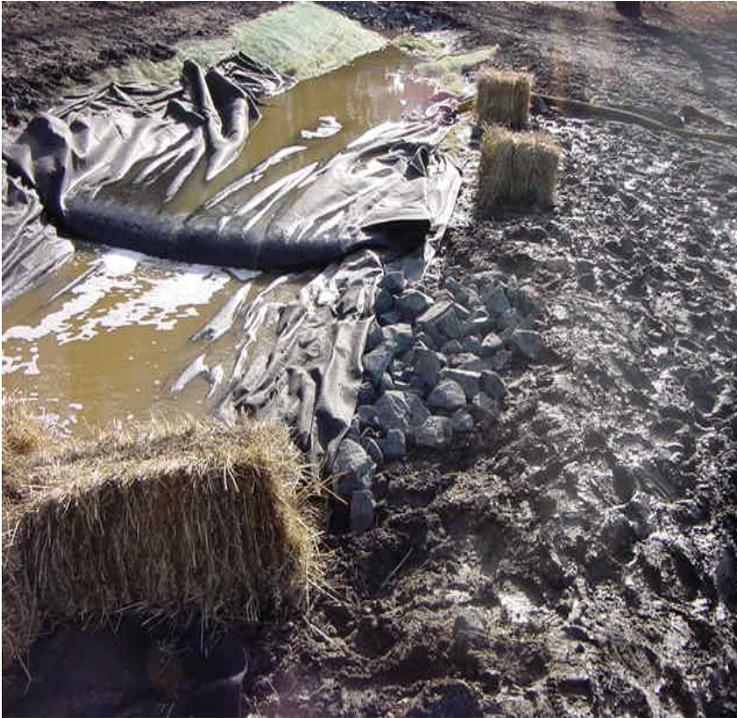
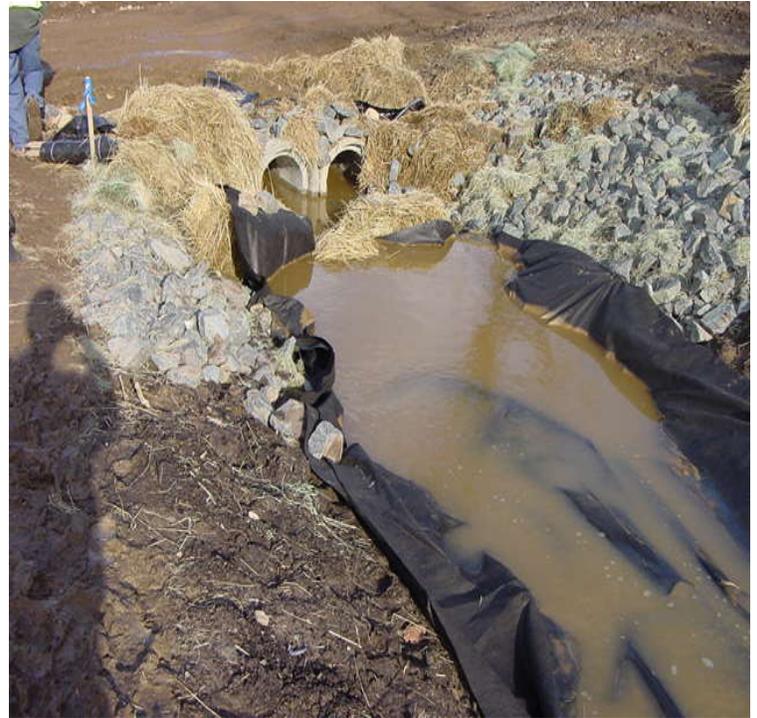
345kV (Vault Installation-Norwalk Junction) Photo on the right show a number of good controls in place to filter dewatering discharge- including fabric lining the swale, filter bags and haybales. A filter bag had previously broken, resulting in this additional turbidity. 12/30/05

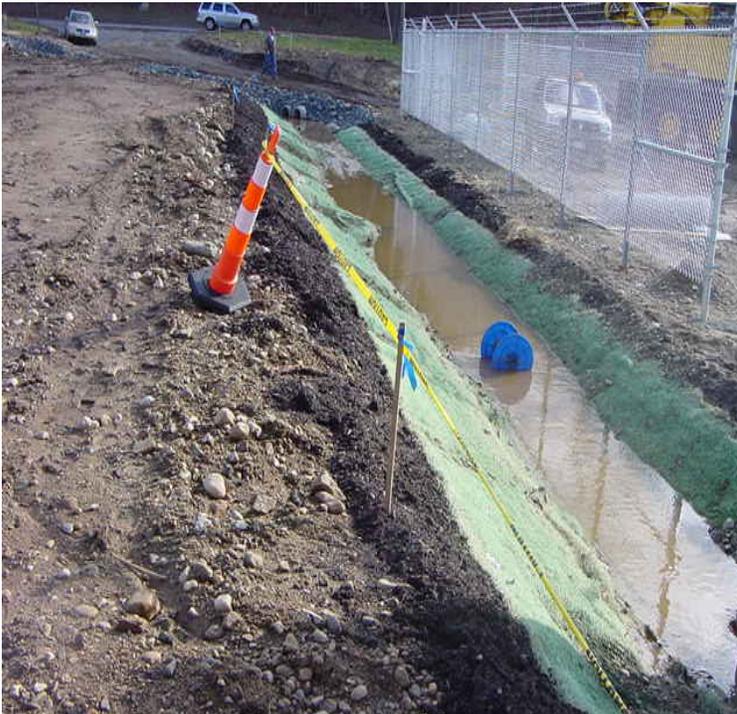
Photo on the left shows the turbid water continuing down the swale where some site run-off may also have contributed. The photo on the right is a view of the turbidity in the wetland adjacent to the Norwalk River. It is difficult to completely separate out the portion of the turbidity resulting from the 345kV work and what was a result of run-off/erosion from the site and the soil swale. From these photos however, it seems the broken filter bag had certainly contributed. 12/30/05
