**Docket No. 217 – Development and Management Plan Inspection**

Northeast Utilities Service Company Certificate of Environmental Compatibility and Public Need for the construction of a 345-kV electric transmission line and reconstruction of an existing 115-kV electric transmission line between Connecticut Light and Power Company's Plumtree Substation in Bethel, through the towns of Redding, Weston, and Wilton, and to the Norwalk Substation in Norwalk, Connecticut.

**Date:** October 27, 2005

**Location:** Overhead Line (Composite 345kV and 115kV Gallows Hill to Archers Lane)

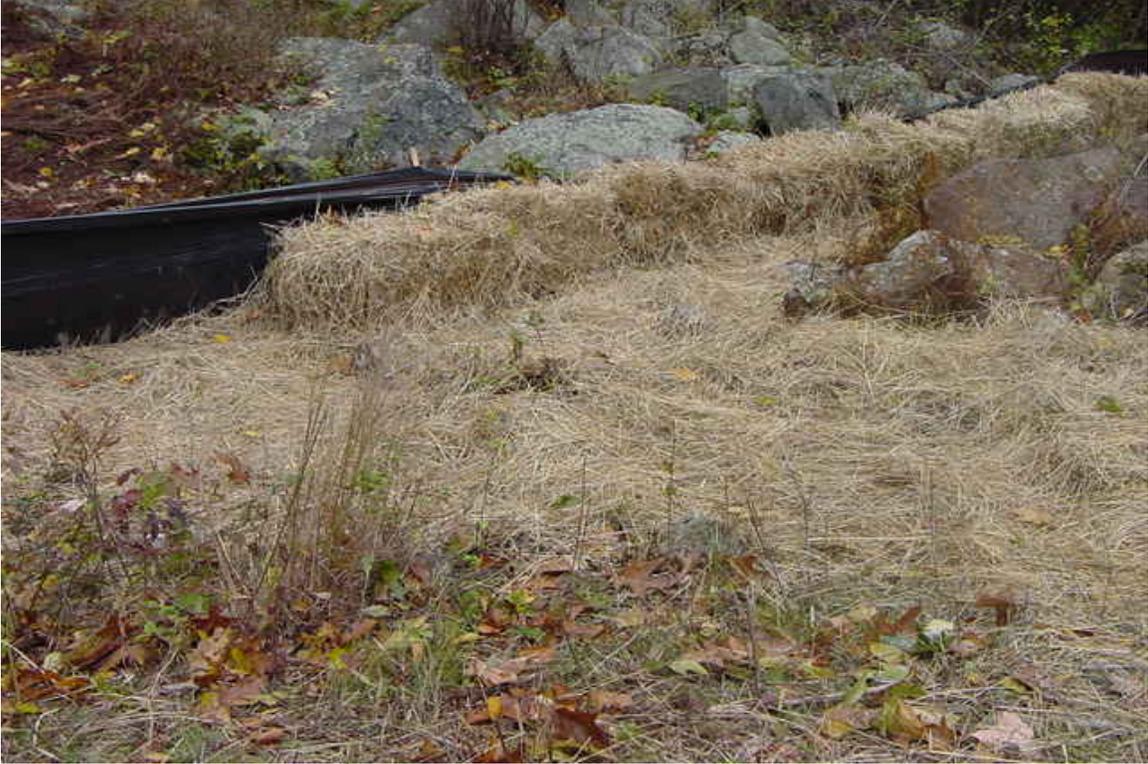
Overhead ROW: View of the 2<sup>nd</sup> structure in from Gallows Hill where haybales were installed as additional controls as requested to prevent sedimentation to the adjacent wetland. 10/27/05

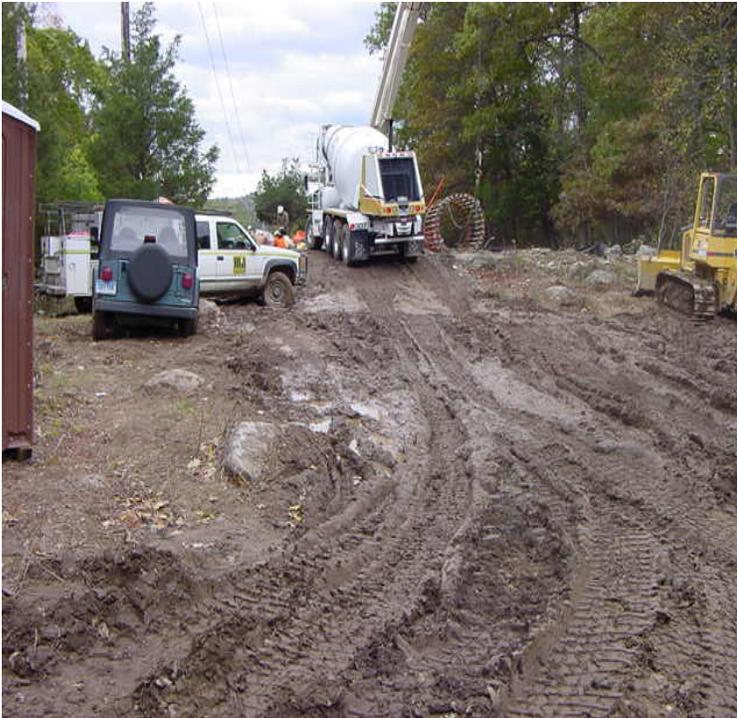
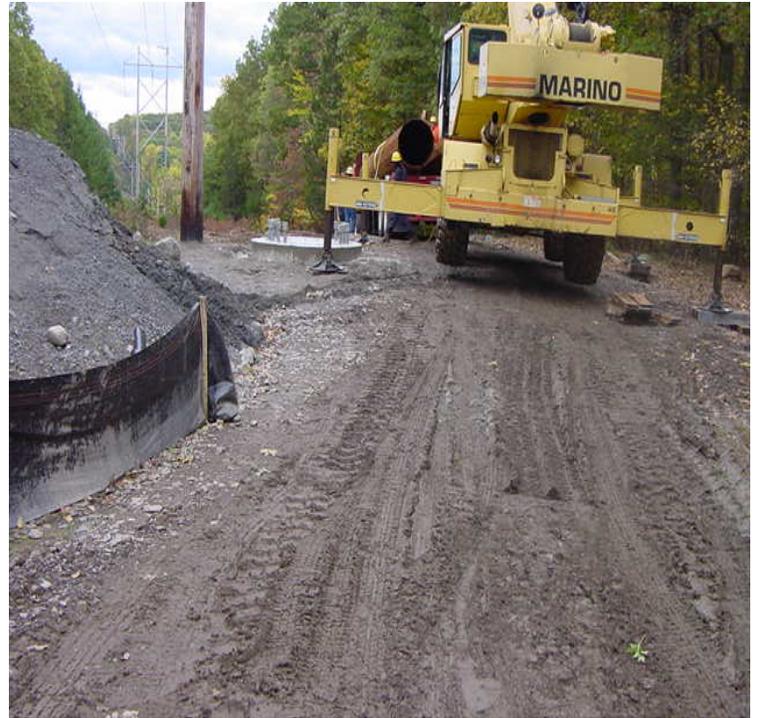
Photo on the left shows concrete being poured for a pole foundation. Photo on the right shows a pole structure about to be installed. (10/27/05)

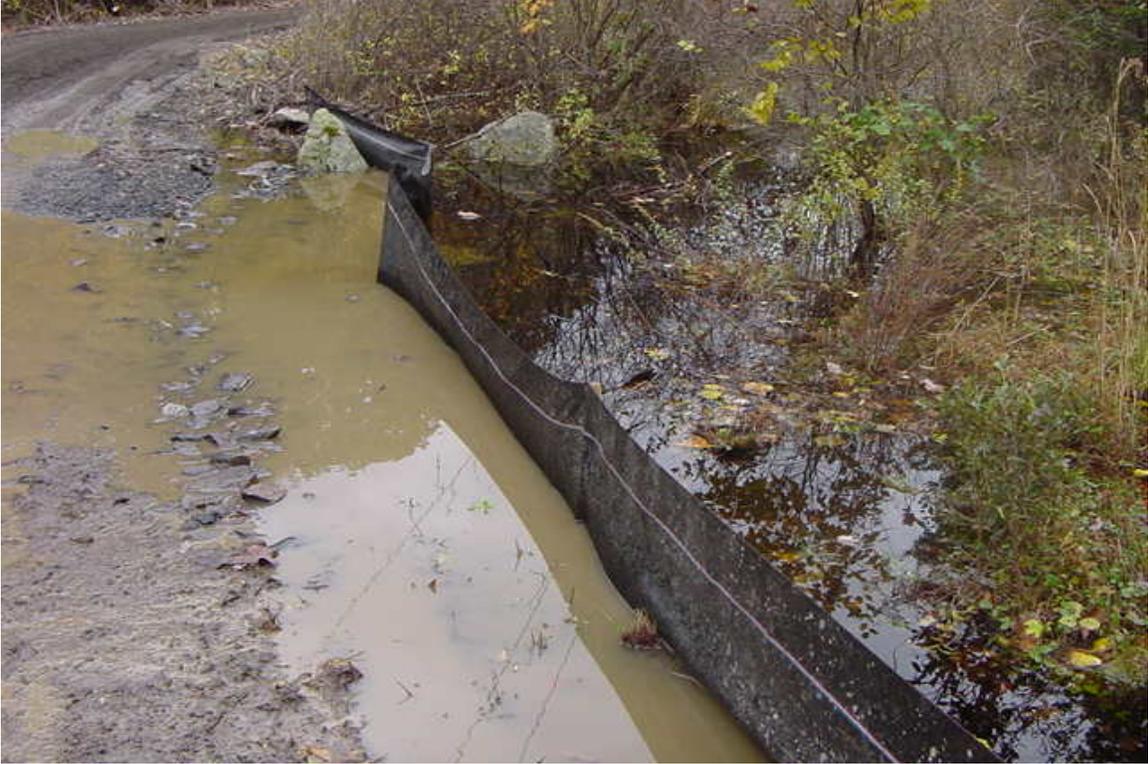
View of the flooded low spot/wetland crossing where the silt fence is doing a good job of keeping turbid water out of the wetland. These crossings were well installed. 10/27/05

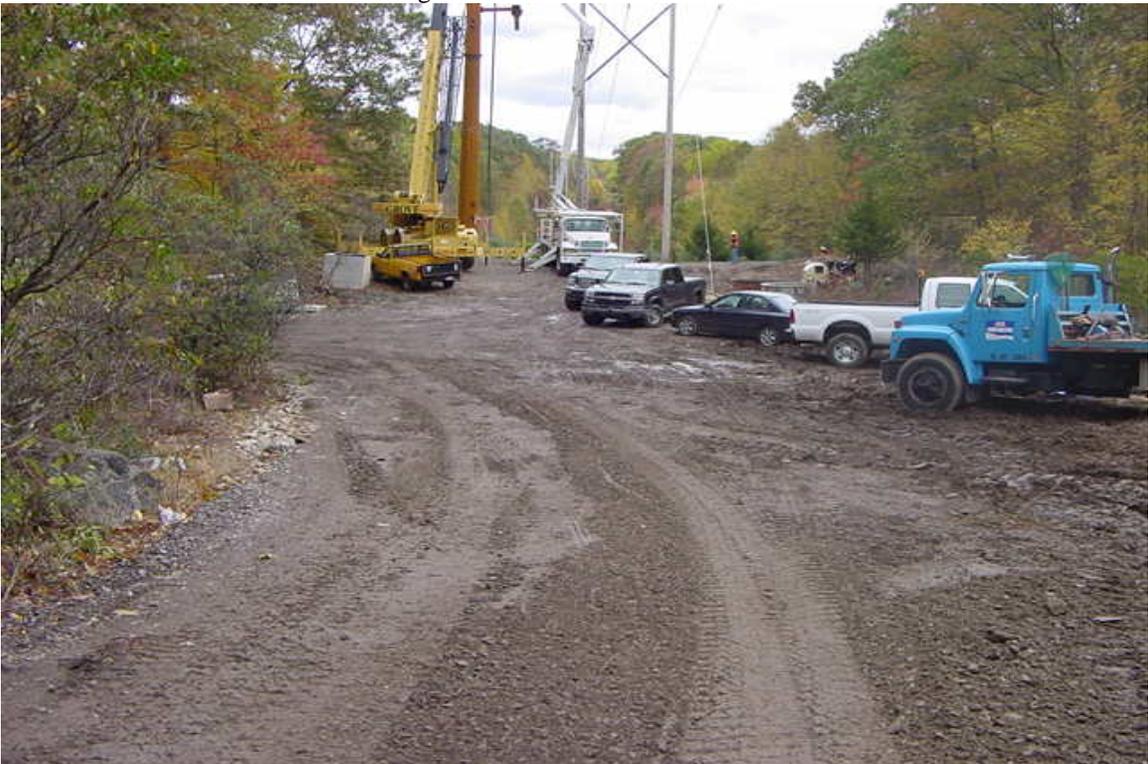
View of the first structure at Gallows Hill Rd where cable is being pulled through the recently installed conduit up to the pole. 10/27/05

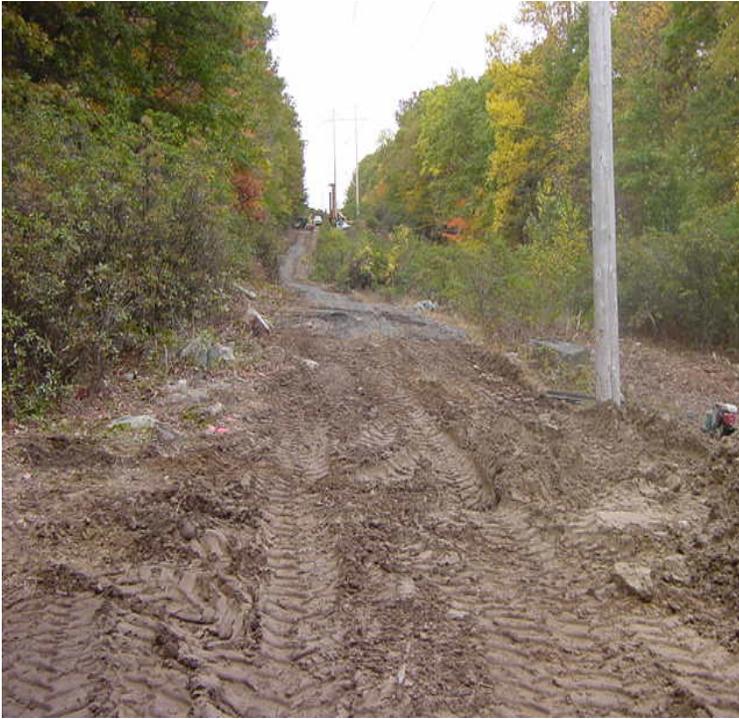
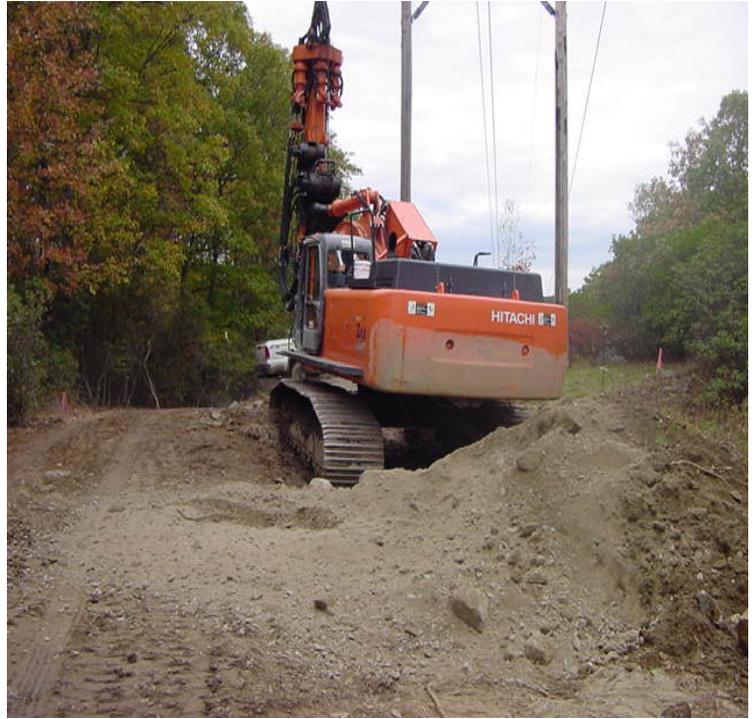
Photos shows work on the Archers Lane side of the ROW where excavations are also being drilled for pole installation. The poles site are all fairly muddy along the ROW. 10/27/05

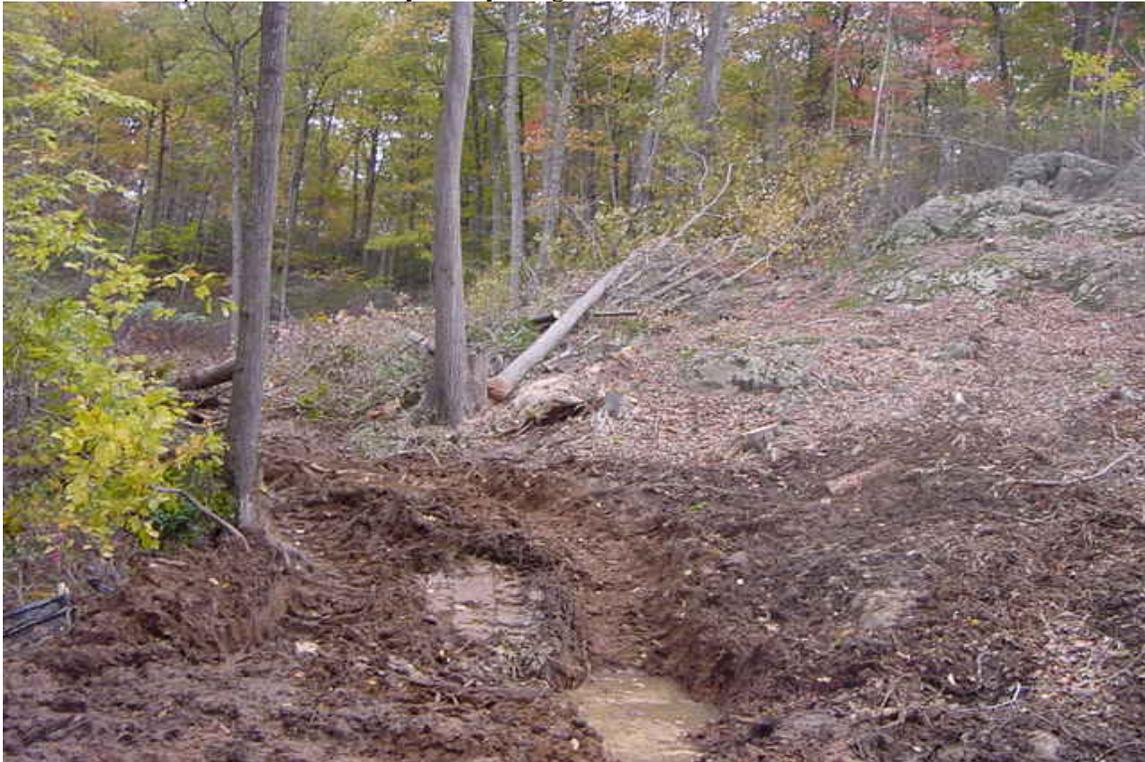
Some clearing by CL&P was noted near the Archers Lane station/ROW edge. It should be confirmed what the clearing is needed for and whether it was within project limits. Erosion control may need repair or extension- (bottom left corner of photo). 10/27/05
