Docket No. 217 – Development and Management Plan Inspection

Date: November 17, 2005

Location: Overhead Line (Composite 345kV and 115kV Gallows Hill to Archers Lane)

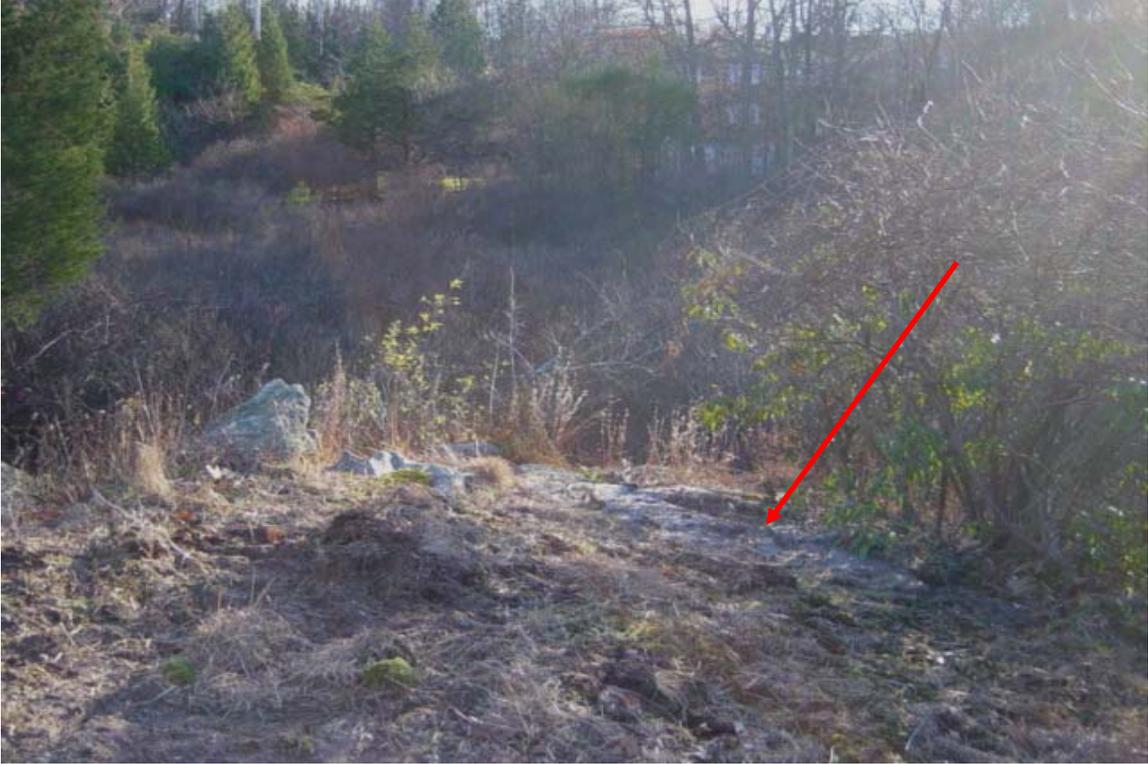
Dewatering	<p>- As stated previously, dewatering from an excavation may have occurred in an uncontrolled location to a wetland. 11/17/05</p> <p>The tarp basin near Gallows Hill remains on the ROW. 11/2-11/17/05</p>	<p>-Remove any sediment accumulation from the ground here. 11/17/05</p> <p>- Release water to the ground only in well vegetated areas and if it will not reach any resource areas. 11/17/05</p>
Blasting	-No blasting has been necessary at this time on the ROW. 11/17/05	-None at this time. 11/17/05

Overhead ROW: Either turbid dewatering from an excavation or a concrete washout was noted along the ROW immediately to the left of the access road coming in from Archers Lane. 11/17/05

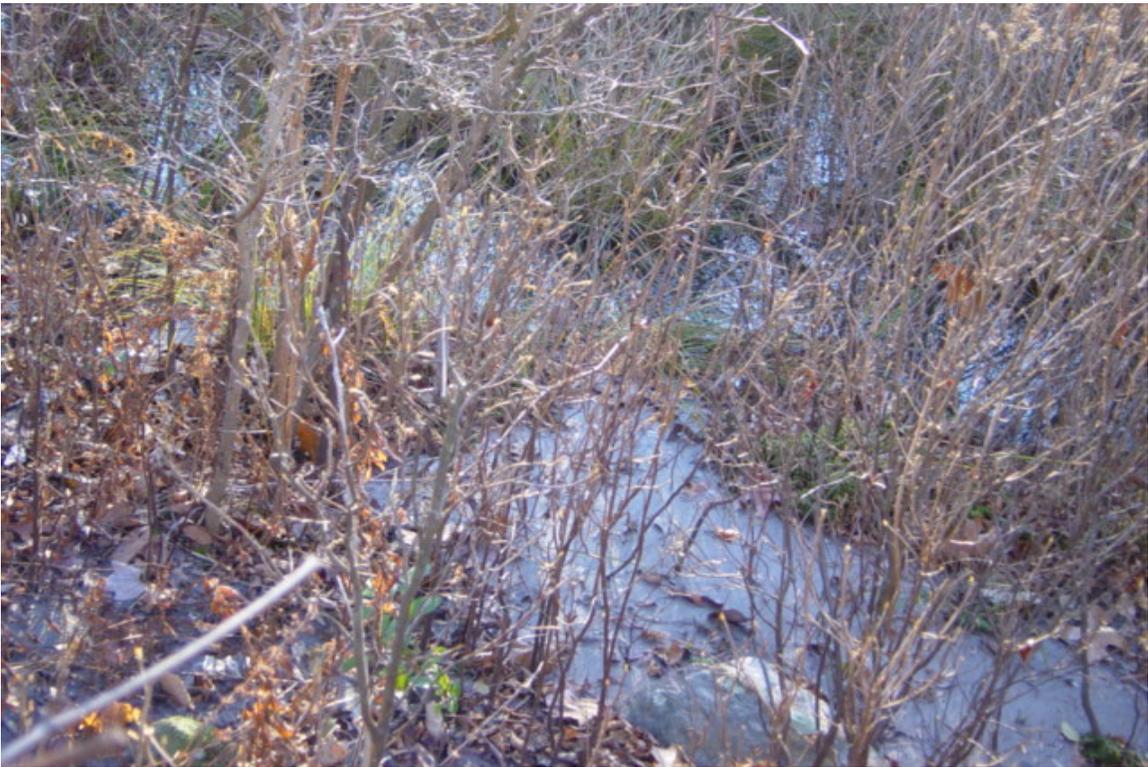
The dewatering or washout had drained to a potential wetland area here. It is difficult to determine what the component was as they look similar but either way, the discharge should have been controlled here. 11/17/05

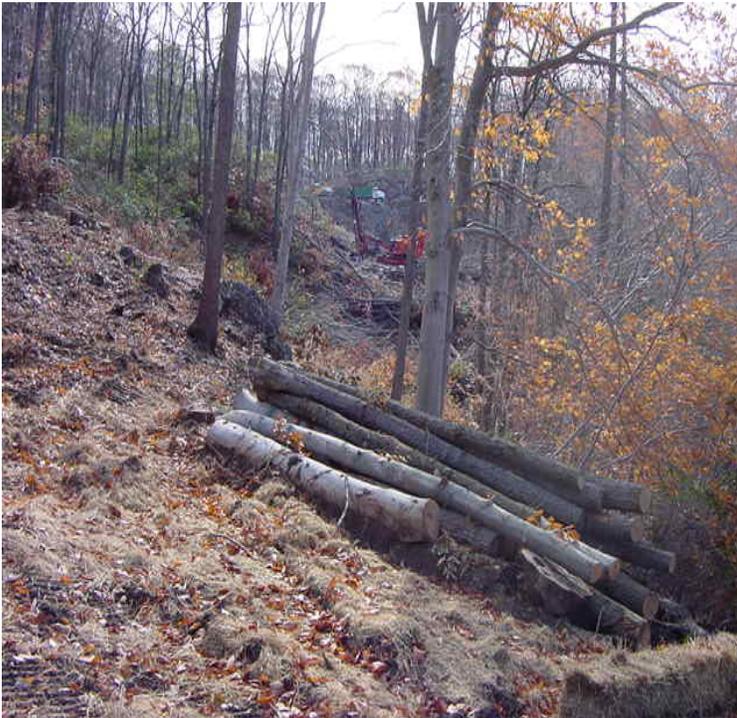
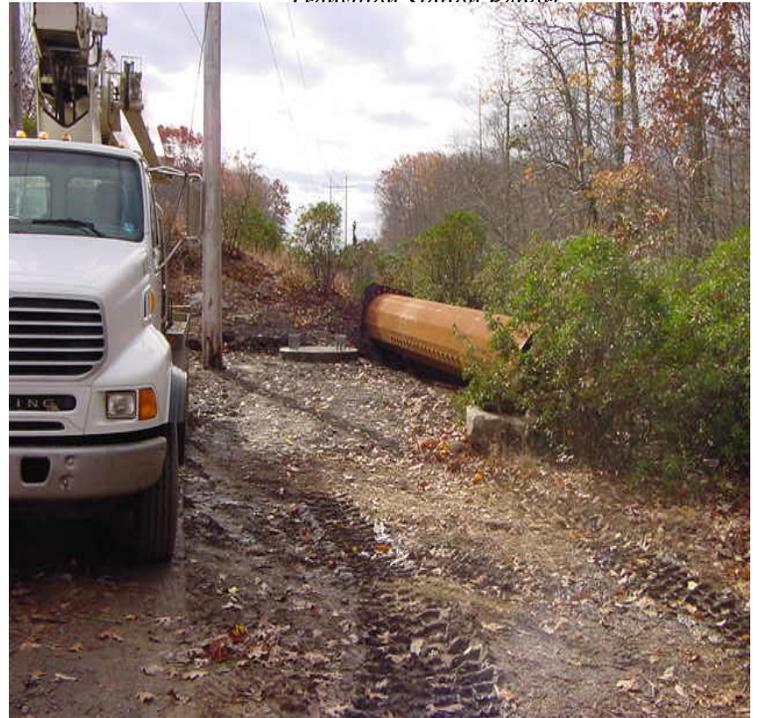
Photo on the left shows a view of the clearing near the Archers Lane/ROW intersection. Photo on the right shows a pole in place for installation. (Photos taken on 11/10/05)

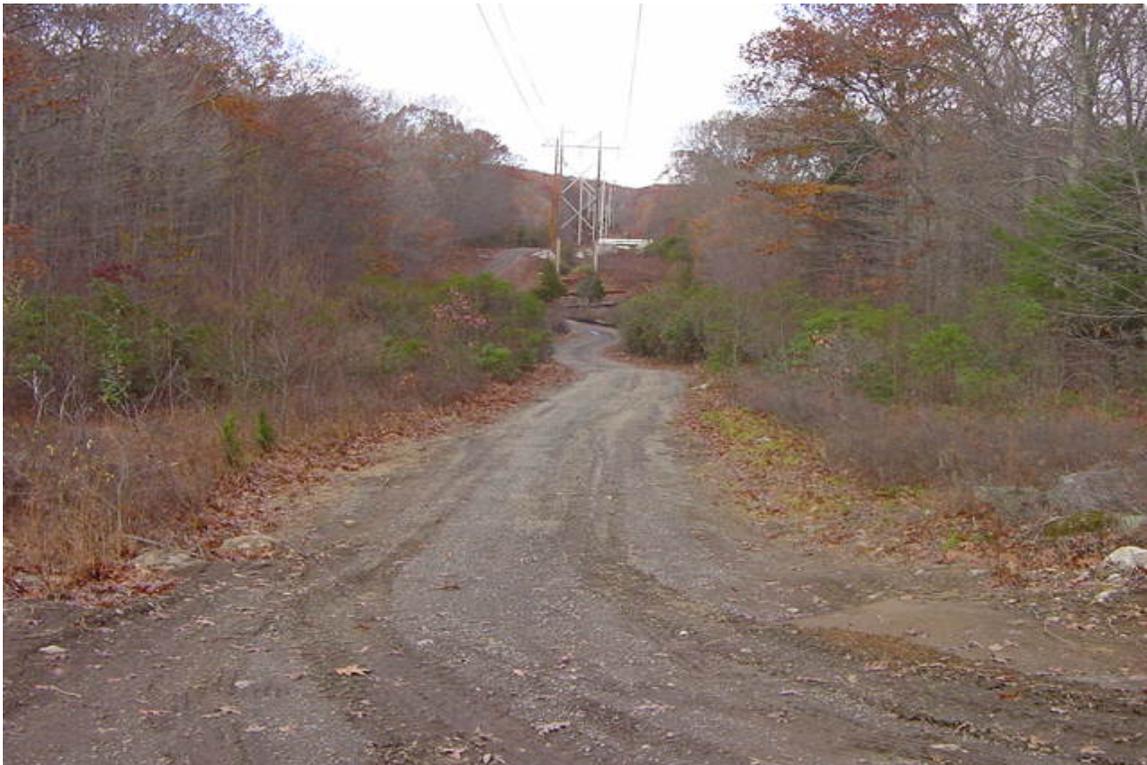
Overall view of the access road leading down the ROW with a structure installed in the distance. (Photo taken on 11/10/05)
