Docket No. 217 – Development and Management Plan Inspection

Northeast Utilities Service Company Certificate of Environmental Compatibility and Public Need for the construction of a 345-kV electric transmission line and reconstruction of an existing 115-kV electric transmission line between Connecticut Light and Power Company’s Plumtree Substation in Bethel, through the towns of Redding, Weston, and Wilton, and to the Norwalk Substation in Norwalk, Connecticut.

Date: November 23, 2005

Location: Overhead Line (Composite 345kV and 115kV Gallows Hill to Archers Lane)

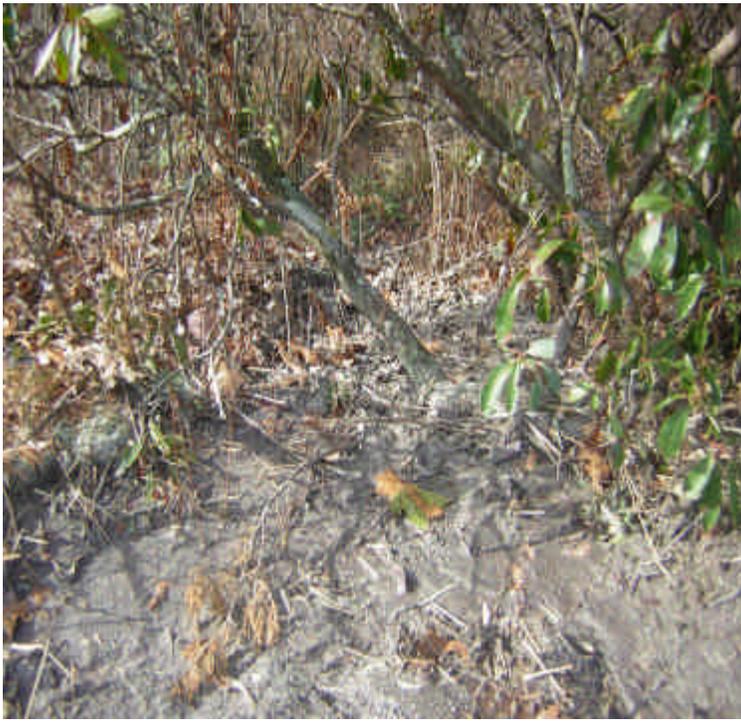
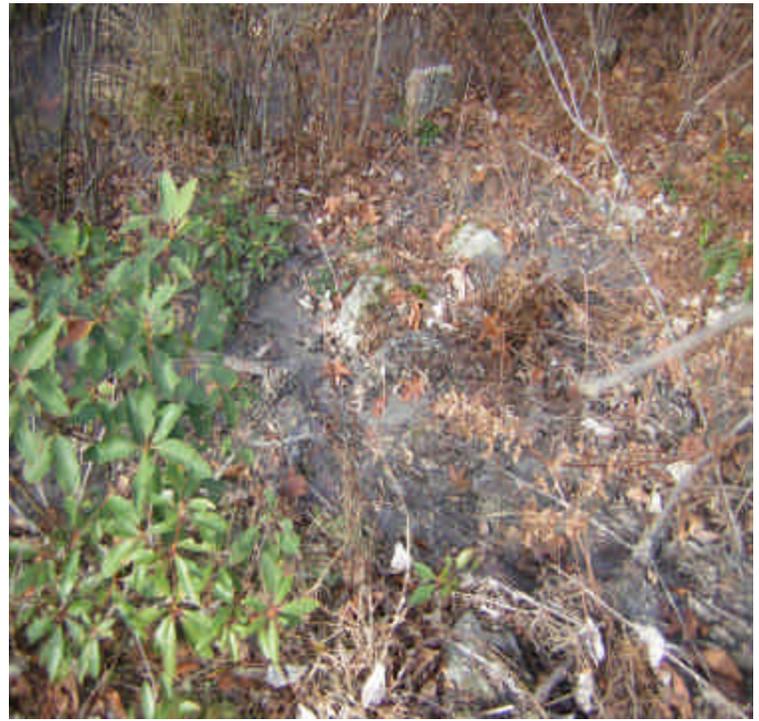
Overhead ROW: Apparently turbid dewatering from an excavation remains along the ROW at the first structure immediately off the left fork of the access road coming from Archers Lane. The sediment was placed at the top of slope (left photo) but has drained to the wetland below (right photo) 11/23/05

Areas of Inspection	Observation	Recommended Action
	<p>uncontrolled location at the top of slope and drained to a wetland. 11/17-11/23/05</p> <p>Tarp basins remain in place on both portions of the ROW. 11/2-11/23/05</p>	<p>dewatering or wet excavation near resource areas. 11/17-11/23/05</p> <p>- Release water to the ground only in well vegetated areas and if it will not reach any resource areas. 11/23/05</p>
Blasting	-No blasting has been necessary at this time on the ROW. 11/23/05	-None at this time. 11/23/05
Spills and Material Storage	<p>- No further spills or drips were noted at this inspection and the issue last week was handled appropriately. 11/23/05</p>	<p>- Continue to keep all vehicles maintained well (i.e. no apparent fluid leaks) if they will be used or stored on site</p> <p>- Keep adequately size fuel kits for worst case scenarios.</p> <p>- Report spills immediately, even if they are being controlled.</p> <p>- Take care not to get carried away and to be vigilant when refueling. Avoid refueling in the areas near the wetlands. Use proper storage for all materials.</p>

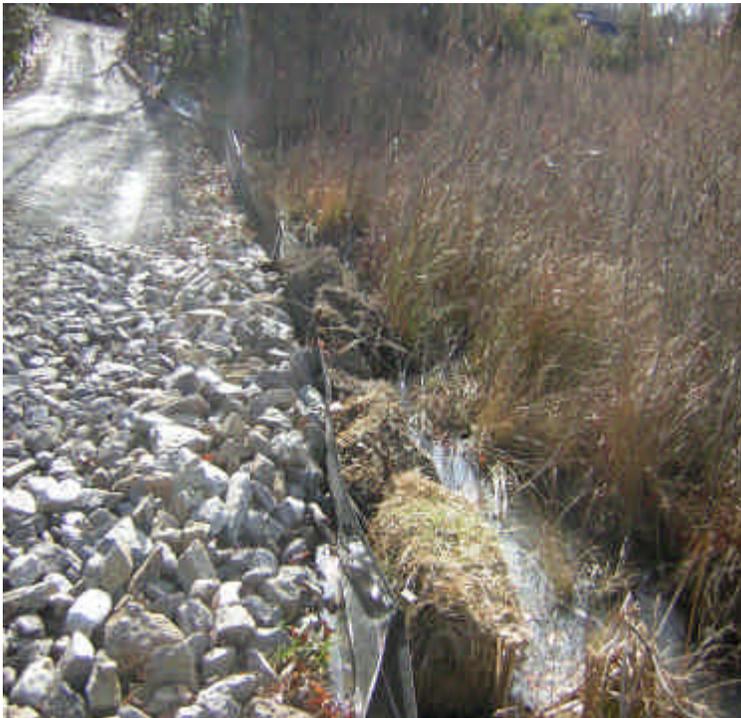
Photo on the left shows one of the wetland crossings along the access road with standing water being filtered well. Photo on the right shows erosion controls in place including check dams along a slope. 11/23/05

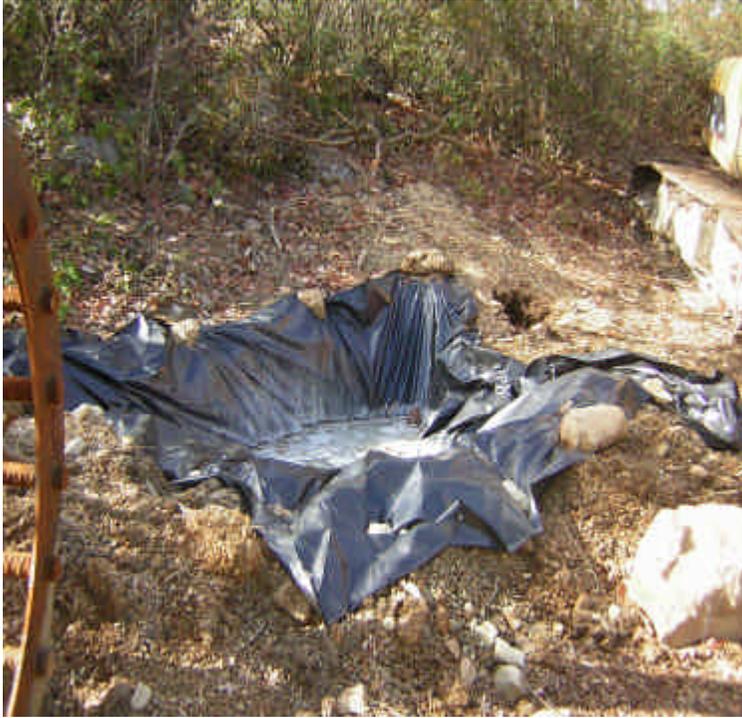
Photo on the left shows a temporary dewatering pit set up to contain turbid discharge. Photo on the right shows a portion of the ROW with some muddy conditions. Sedimentation was not an issue at this time but continue to monitor and recontour the area when work is complete. 11/23

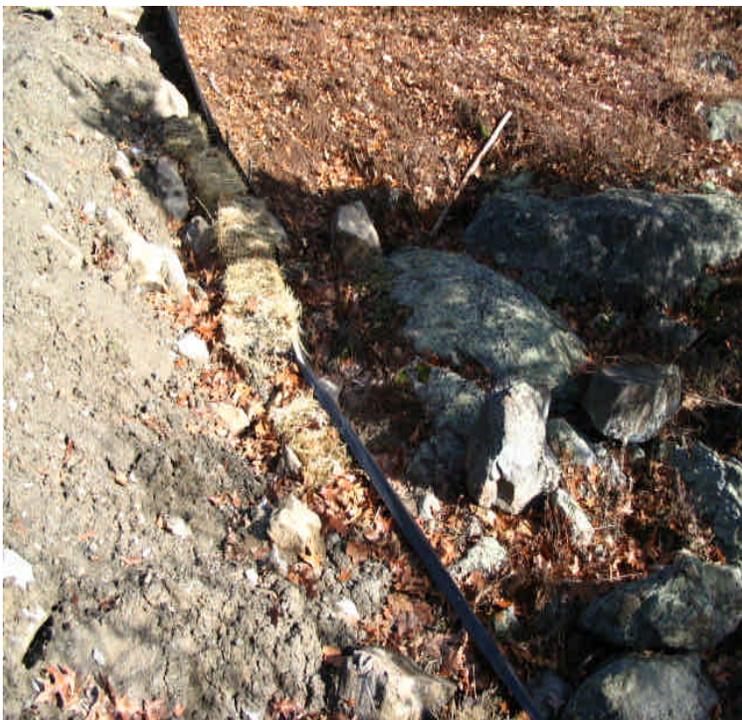
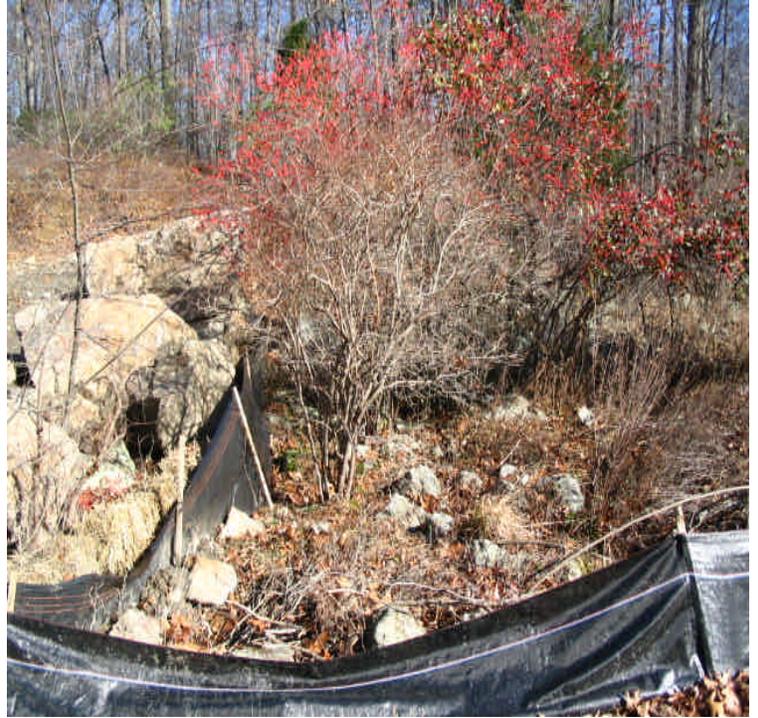
Photos shows a view of the wetland crossing near Gallows Hill R.d. The bare slope of sediment is still present immediately adjacent to the wetland but controls are in place. Regrade and restore the area when practicable. 11/23/05

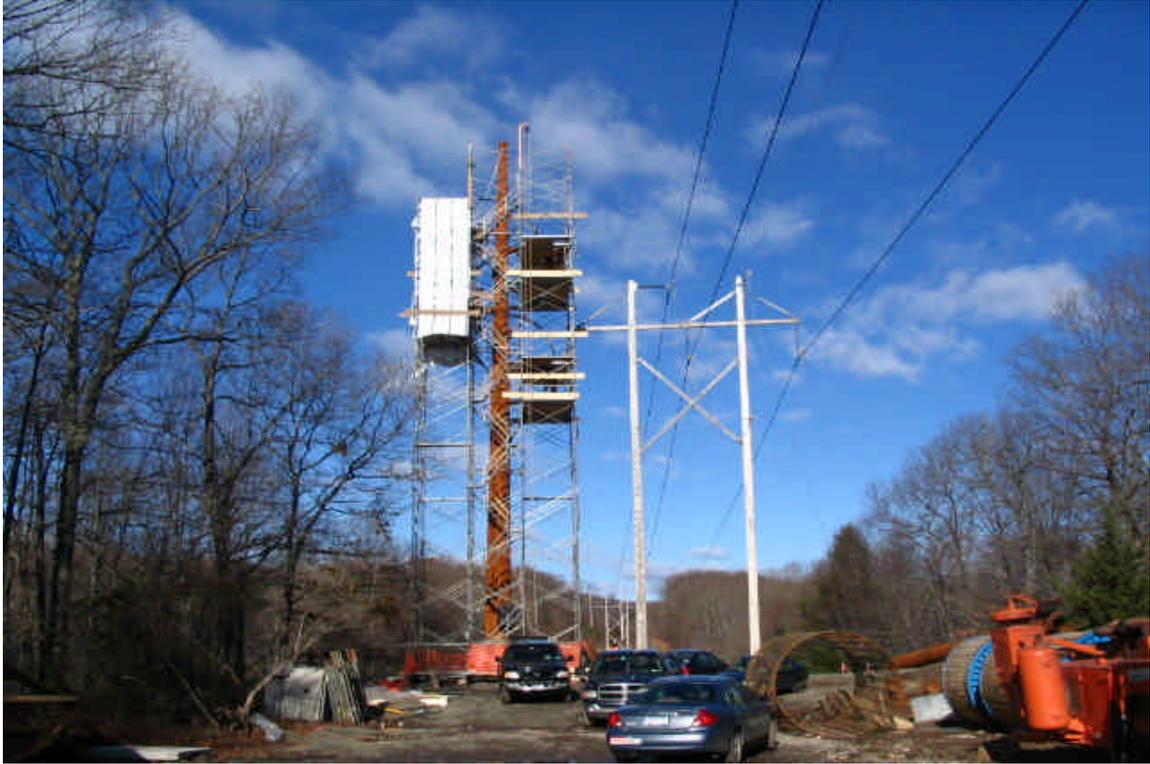
View of the structure off Gallows Hill where risers are being installed and the structure prepared for line work. 11/23/05)

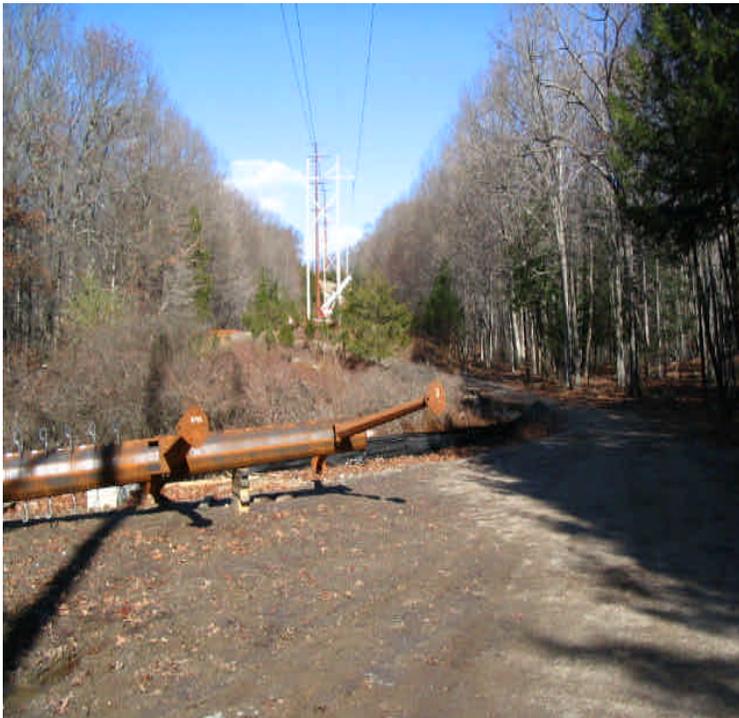
Photo on the left is looking along the access road towards Gallows Hill where several poles have been installed. Photo on the right looks across Redding Rd to Archers Lane at the structures installed here. 11/23/05
