Docket No. 217 – Development and Management Plan Inspection

Northeast Utilities Service Company Certificate of Environmental Compatibility and Public Need for the construction of a 345-kV electric transmission line and reconstruction of an existing 115-kV electric transmission line between Connecticut Light and Power Company’s Plumtree Substation in Bethel, through the towns of Redding, Weston, and Wilton, and to the Norwalk Substation in Norwalk, Connecticut.

Date: December 8, 2005

Location: Overhead Line (Composite 345kV and 115kV Gallows Hill to Archers Lane)

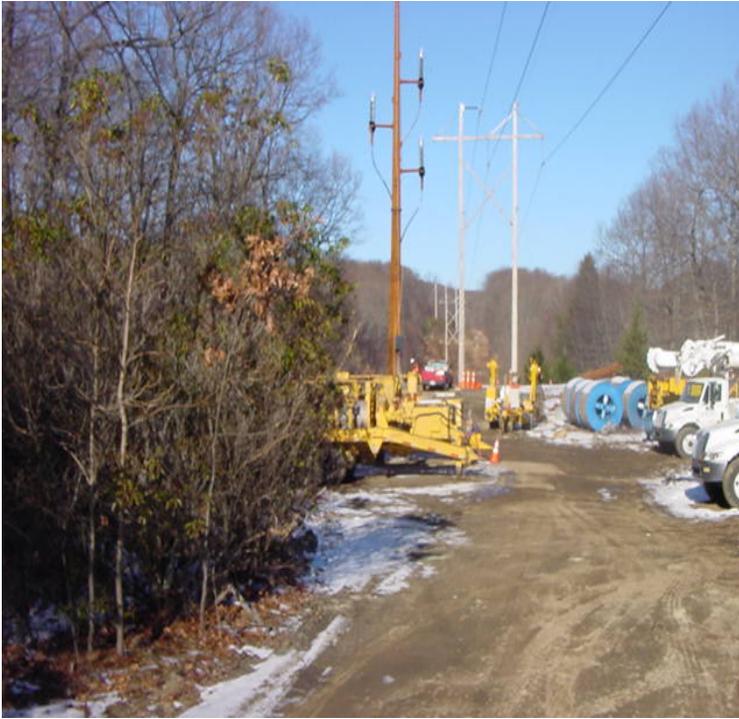
View of the structure off Gallows Hill where scaffolding has been removed and structure work is complete for now. Photo on the right shows the line trucks parked here and a small sand pile covered with tarp.
12/8/05

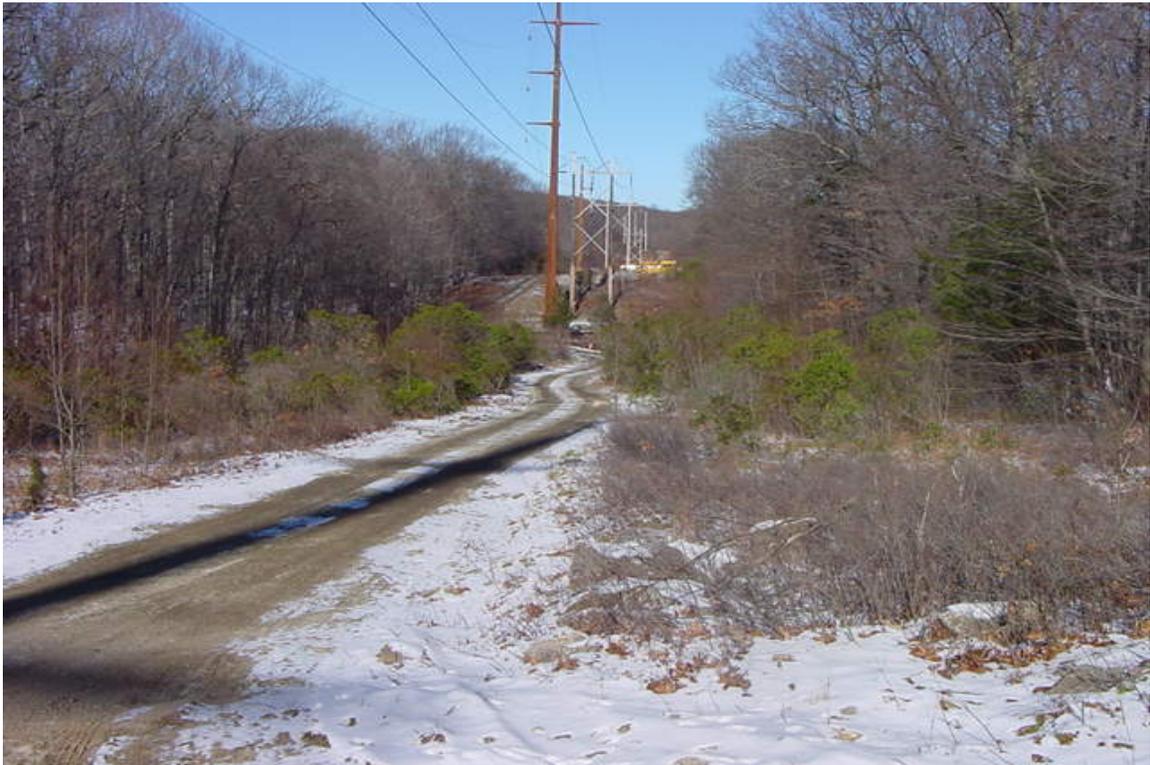
Photo is a general view looking along the access road on the ROW at the installed structures. 12/8/05

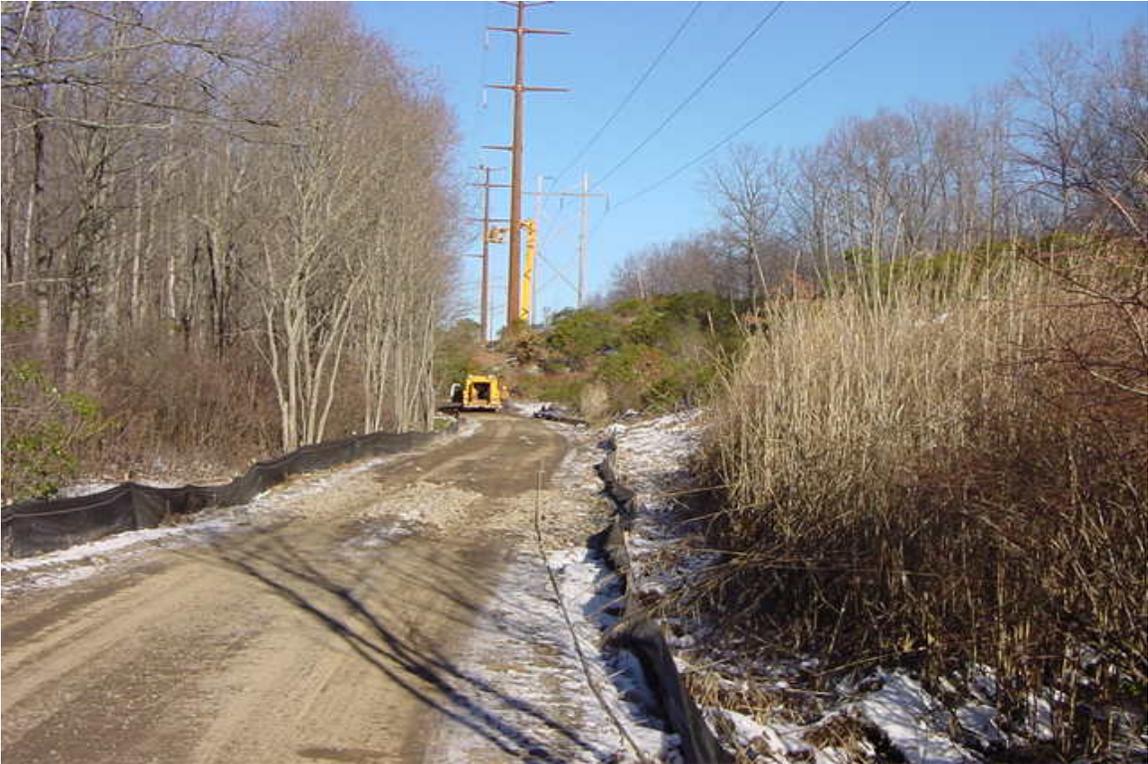
View of the crews pulling rope between the pole structures in preparation for line/cable pull work. 12/8/05

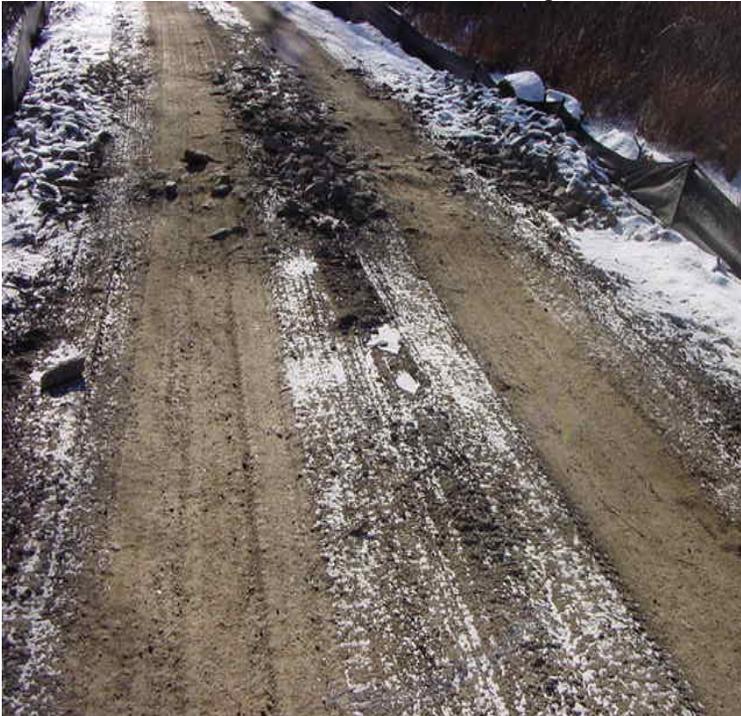
<p>Inland Wetland and Watercourse encroachment and mitigation</p>	<p>-The D&M plan approved stone on geotextile fabric at the wetland crossings has worked well, but the wetland near Archers Lane had received some turbid water last week. The area is now frozen over. Continue to toe in and/or extend the fence as necessary. 12/8/05</p> <p>-There was what appears to be excavation-dewatering discharge that drained to a wetland area off the left fork access road near Archers Lane. 11/17-12/8/05</p>	<p>-The crossings have been used consistently. As the access is considered temporary, the stone will be removed when final work ends so the wetlands can be restored. 12/8/05. Extend and/or toe in areas of silt fence where necessary to prevent additional turbidity during thaw periods. 12/8/05</p> <p>-It just needs to be confirmed that all solid sediment was contained and removed. 11/17-12/8/05</p>
<p>State species of concern, threatened and endangered species</p>	<p>- This particular portion of overhead work includes state-listed turtle habitat area. 9/15-12/8/05.</p> <p>-The Eastern box turtle has not been observed since the first sighting and are likely in the process of hibernating. 12/8/05.</p>	<p>-Crews had been doing daily sweeps for any turtles in the work areas and noting the results of their efforts on daily construction reports although turtles would no longer be active. 12/8/05</p>

Photo on the left shows the low spot/wetland crossing near Archers Lane where turbid water had pooled

through to the wetland. It is currently frozen over. Photo on the right shows the pole foundation installation on going, adjacent to the transition station. 12/8/05
