Docket No. 217 – Development and Management Plan Inspection

Northeast Utilities Service Company Certificate of Environmental Compatibility and Public Need for the construction of a 345-kV electric transmission line and reconstruction of an existing 115-kV electric transmission line between Connecticut Light and Power Company’s Plumtree Substation in Bethel, through the towns of Redding, Weston, and Wilton, and to the Norwalk Substation in Norwalk, Connecticut.

Date: February 2, 2006

Location: Overhead Line (Composite 345kV and 115kV Gallows Hill to Archers Lane) and (345kV H-Frame Hoyts Hill to Gallows Hill)

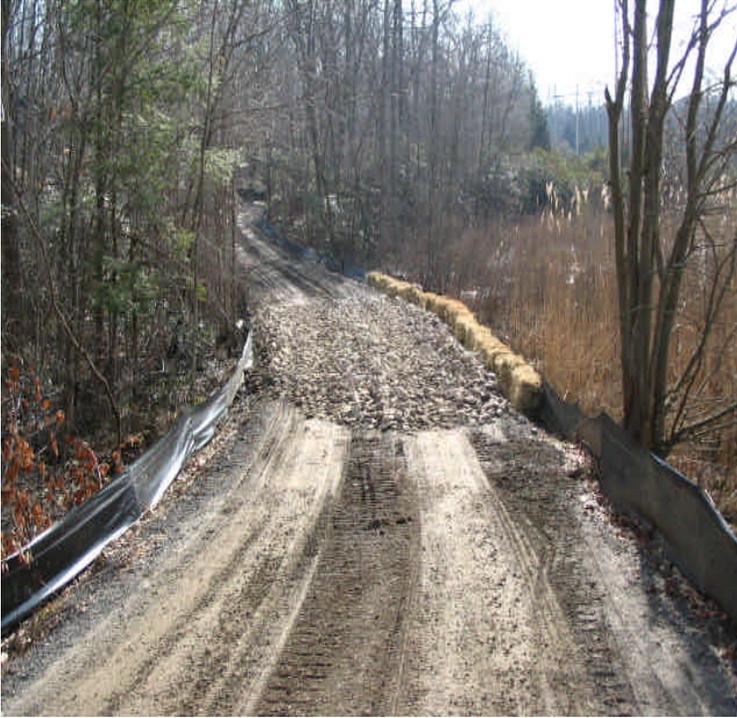
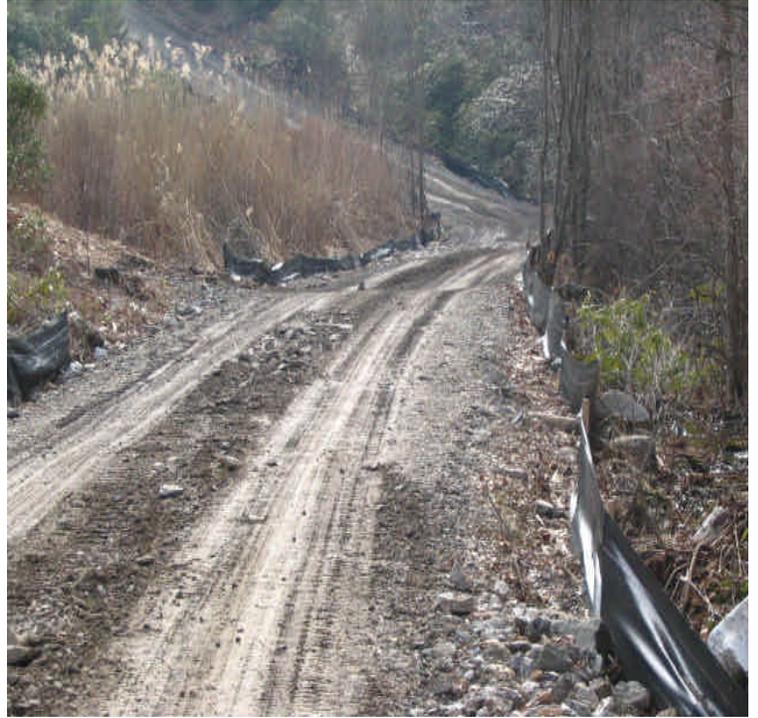
(Composite Section): Photo on the left shows a view of the 2nd crossing along the road from Archers Lane. The water has receded and the crossing is improved with stone and haybales. Photo on the right shows the 3rd crossing. Some minor siltation has occurred in the wetland.

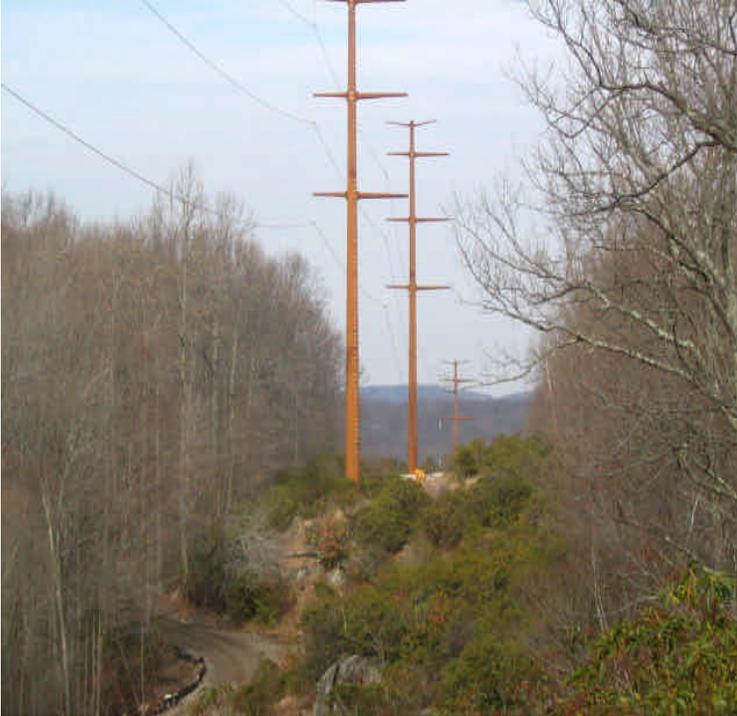
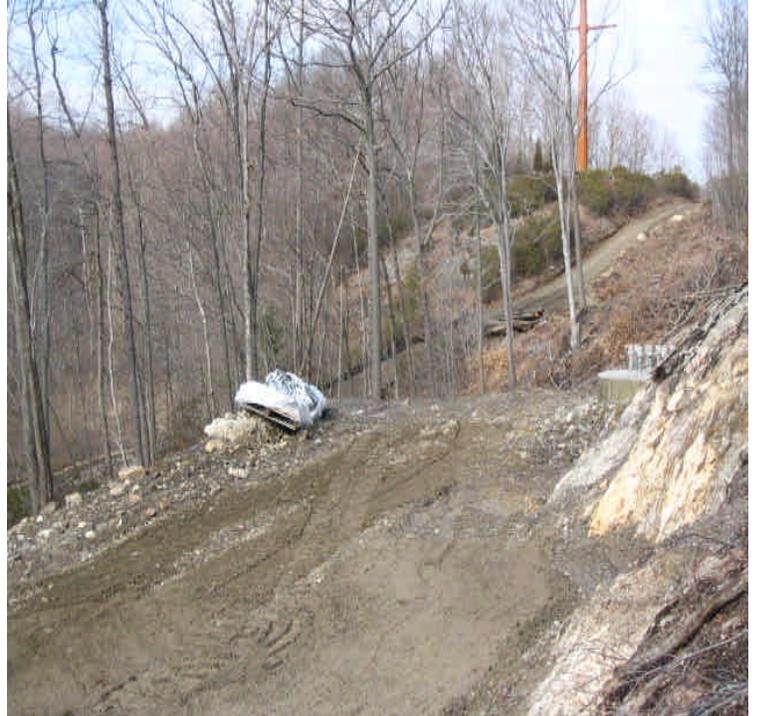
Photo on the left shows a view along the ROW. Wooden poles have been removed. Photo on the right shows the foundation structure immediately adj. to Archers Lane station. Erosion controls were installed at the base of the soil pile here. 2/2/06

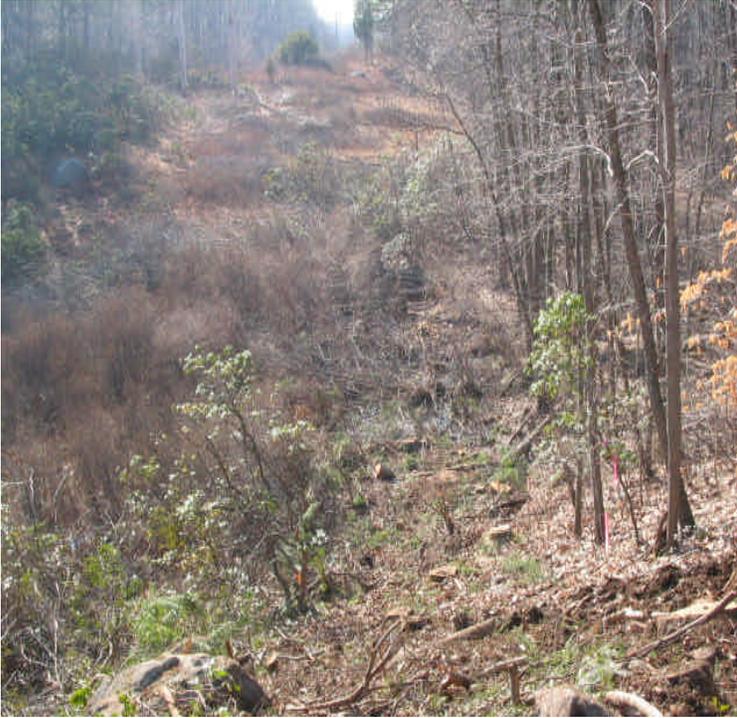
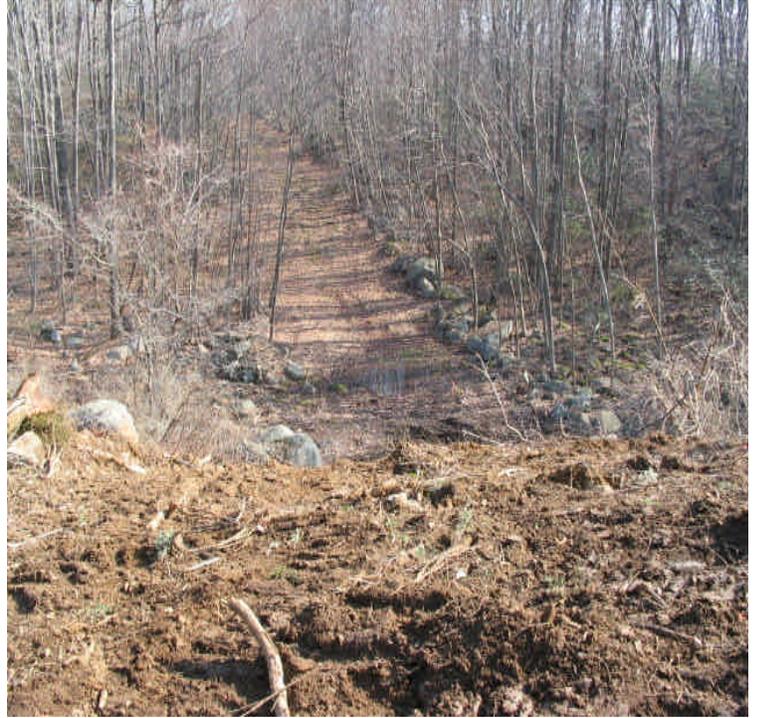
345kV (H-Frame Section): Photo on the left shows the view from proposed pole #21. Wetlands are located at the base of slope. Photo on the right shows an access road clearing crews have used. The area at the base of the slope is also wet and should be protected if access continues. 2/2/06

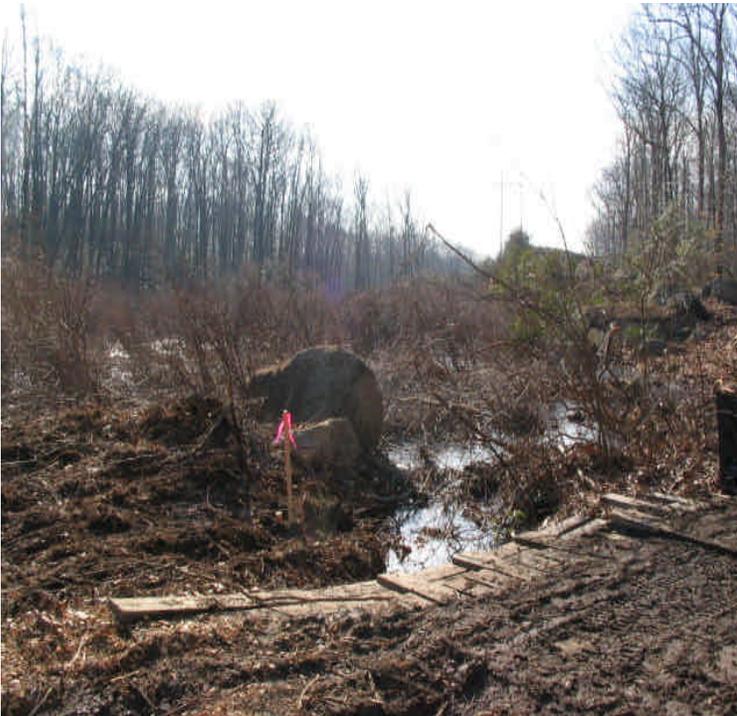
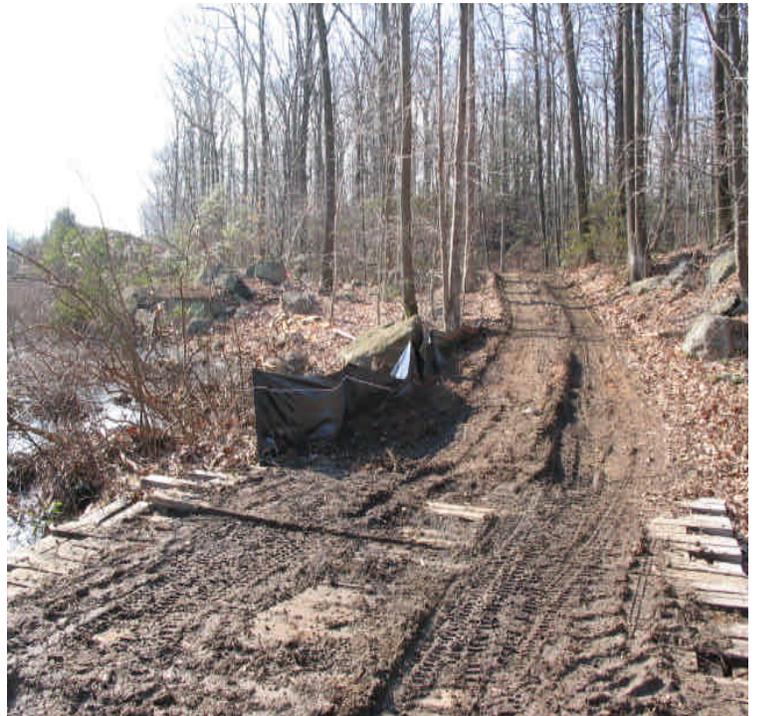
Photo on the left shows the location of proposed structure #19 immediately adjacent to a wetland. Erosion controls are proposed. Photo on the left shows the mat crossing here with the beginning of silt fence installation. The crossing is muddy and stone should be considered on the approach to the mat. 2/2/06

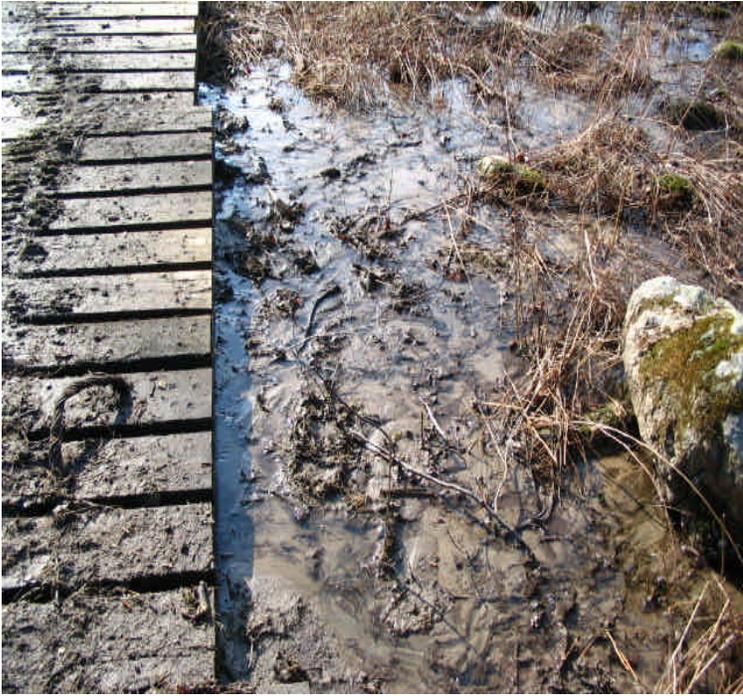
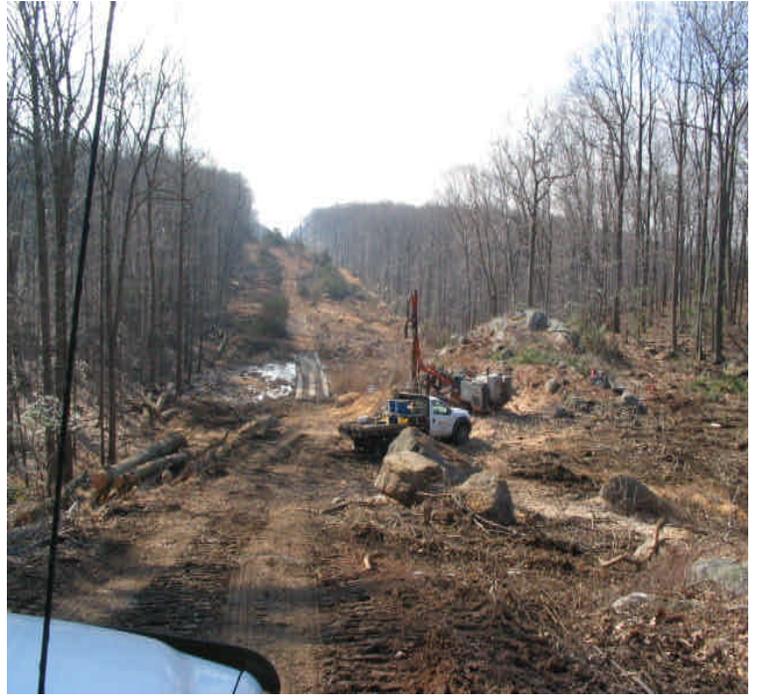
Areas of Inspection	Observation	Recommended Action
	<ul style="list-style-type: none"> - The matted crossing between proposed poles #10-11 is becoming increasingly muddy. Controls are not in place on the approach. 1/26-2/2/06 - Similar issues were noted at the crossing between #17-18 which is also increasingly muddy. Sedimentation was noted in the water below the mat here. 2/2/06 - Mats near proposed pole #19 were also increasingly muddy. Silt fence installation was beginning here. 2/2/06 -Silt fence was recommended at this structure as well due to its proximity to wetlands. 1/12-2/2/06 -Some clearing access was noted past proposed pole #21. Wetlands are at the base of slope here. 2/2/06 	<ul style="list-style-type: none"> - Install silt fence or haybales at the “four corners” of the mat. Consider stone on the access road approach to remove some of the sediment accumulation. 2/2/06 - Place controls, consider stone installation and carefully remove accumulated sediment in the wetland. 2/2/06 - Consider stone installation and continue placement of controls. 2/2/06 -Install fence as necessary. Work had not yet reached this structure but the location was staked. 1/12-2/2/06 - If access continues, install proper controls and crossings. 2/2/06

Photo on the left shows sedimentation that has occurred at the wetland crossing in the vicinity of proposed poles 17 and 18. Photo on the right shows a long view of the approach to this area with foundation drilling ongoing. Erosion controls are needed and the source of the sedimentation needs to be removed. 2/2/06

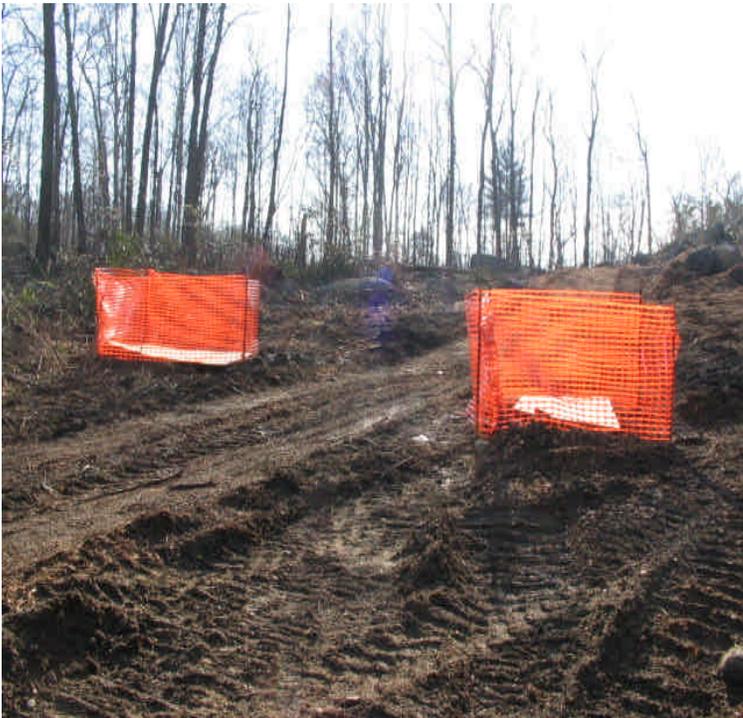
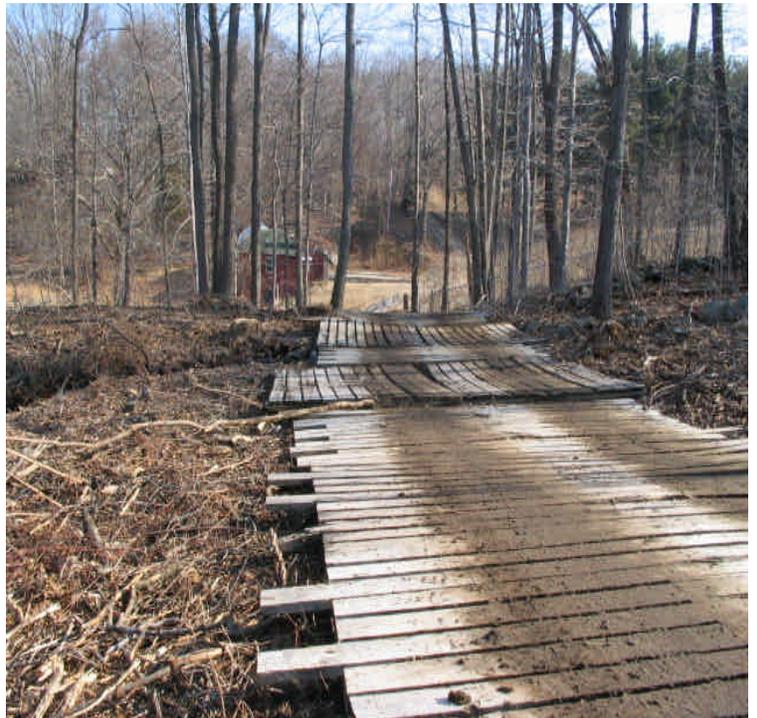
Photo on the left shows excavations for the wooden poles of one of the new structures. Photo on the right shows the crossing on the stream in from Bethel Reservoir. Make efforts to preserve low shrubs and brush, esp. along streams. This does not seem to have occurred in all locations.

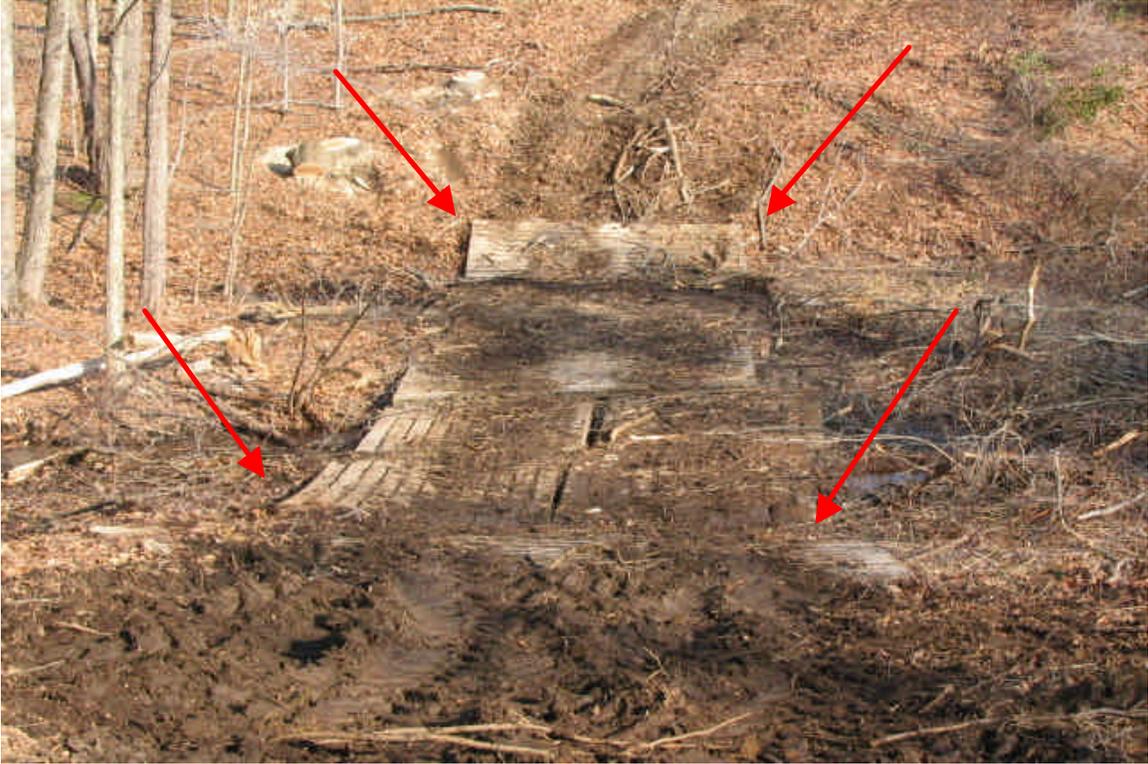
Photo shows a view of the wetland crossing on the stream just north of the Bethel Reservoir access. Mats and the approach are getting muddy and there are no controls to protect the stream. Place silt fence at the “four corners” of the crossing. Consider stone prior to the mat. 2/2/06

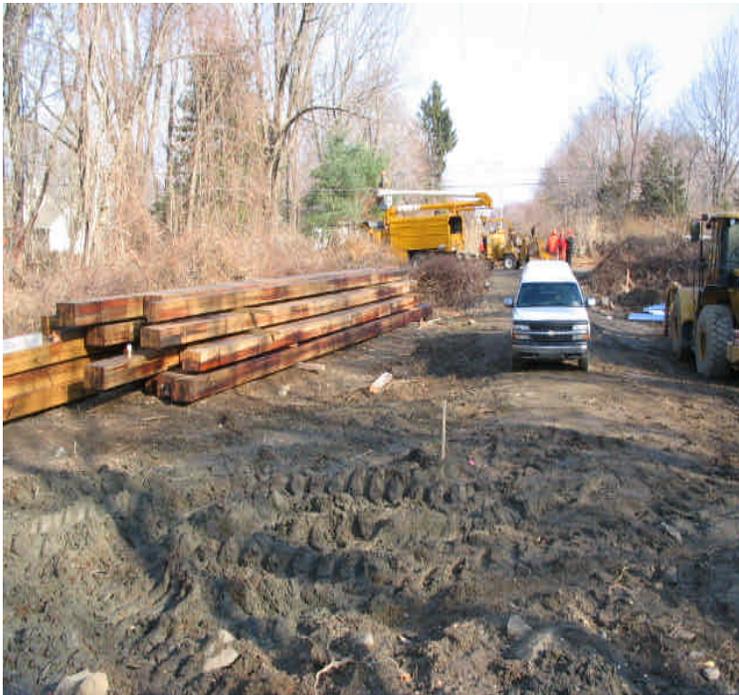
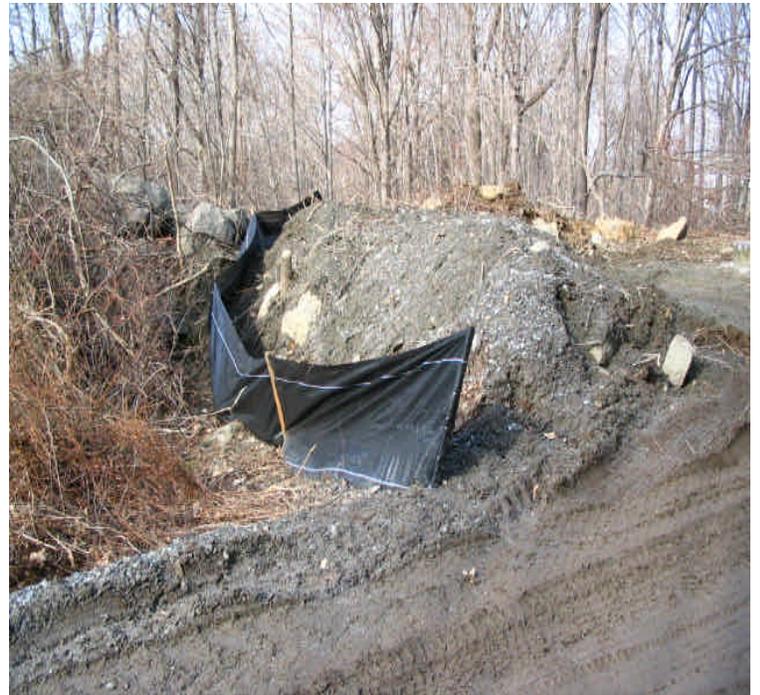
Adj. to Nashville Rd: Photo on the left shows the work and stockpile of structure materials at proposed structure #10. Chestnut Ridge Rd.: Photo on the right shows erosion controls installed at a stockpile left behind at structure #8. 2/2/06

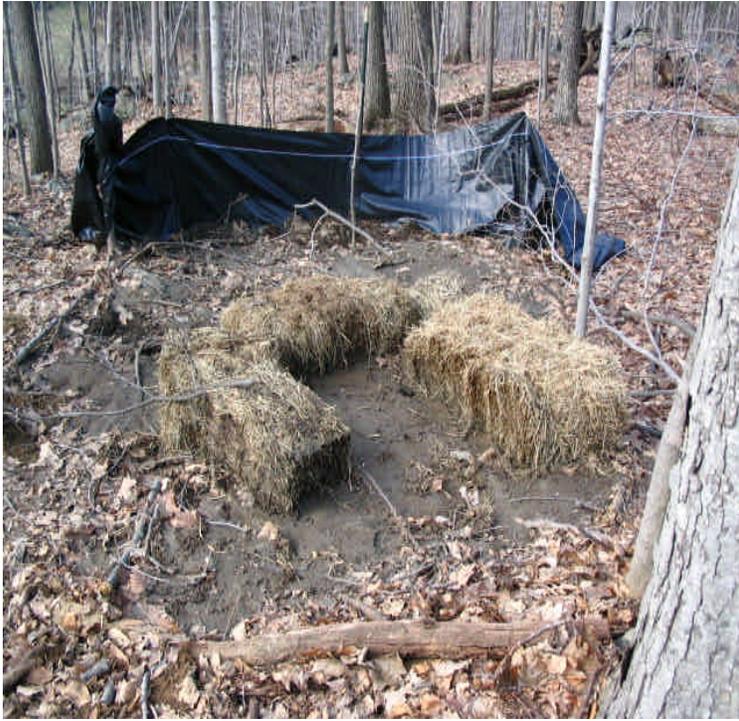
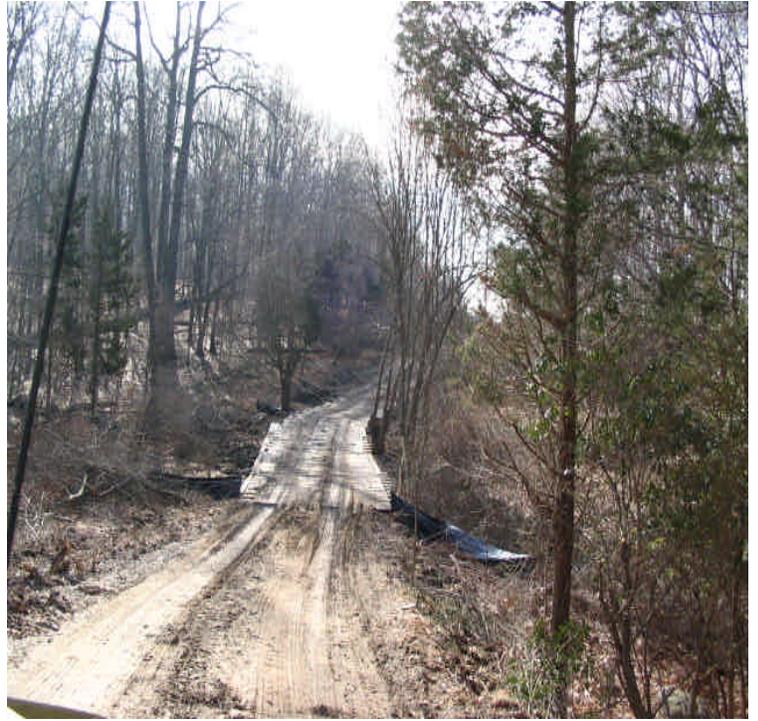
Photo on the left shows the inadequate dewatering set-up near structure #6. It does not appear to have been used since it was noticed several weeks ago but exposed sediment remains down the slope. Photo on the right shows the wetland crossing with controls in place at all sides. 2/2/06

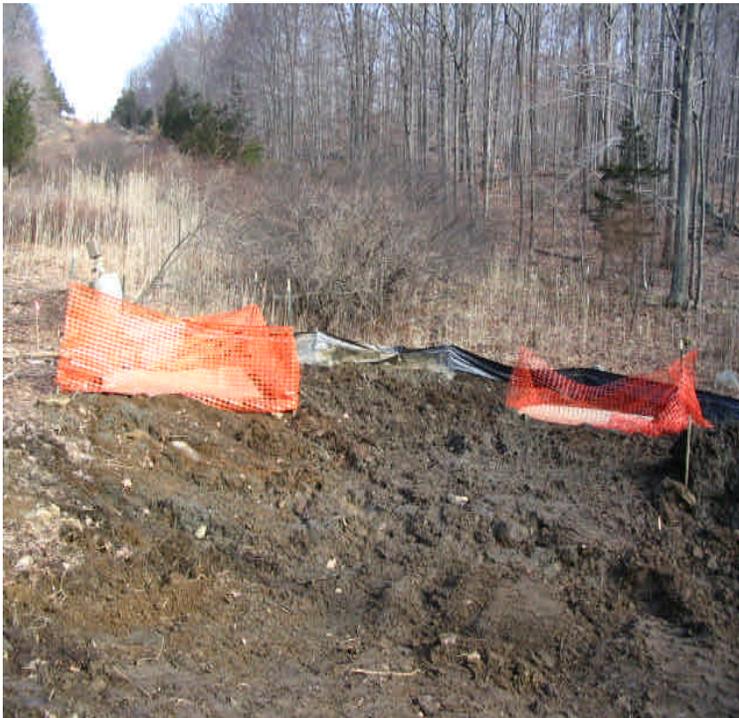
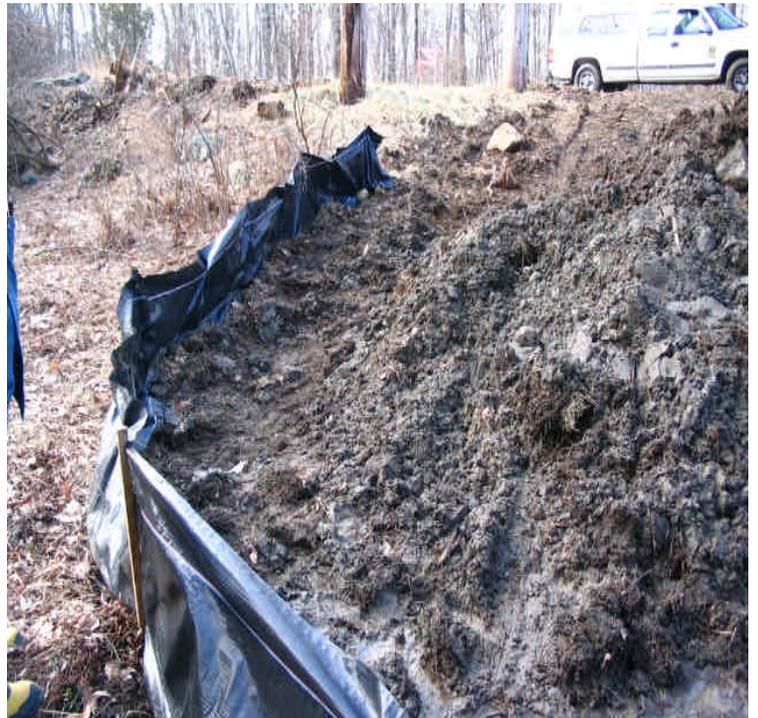
Photo on the left shows the excavations for the wooden poles at proposed structure #6. Photo on the right shows that contractors did make efforts to pull soil back from the silt fence. However, the soil pile itself and the silt fence remain in a wetland. The entire area should be cleaned up as soon as feasible. 2/2/06
