Areas of Inspection	Observation	Recommended Action	Corrected Action
<p><b>345kV H-Frame</b></p>	<ul style="list-style-type: none"> <li>- A skidder had slipped off the road into the 3<sup>rd</sup> wetland area 2/16/06. Haybales had been placed but ruts in the wetland remain. 3/9/06.</li> <li>- Work along the access roads continues in the vicinity of Hoyts Hill., Chestnut Ridge Rd, Costa Lane, and John Todd Way sections. Wood chips were placed along portions of the roads. 2/16-3/9/06.</li> <li>-Stone dust is used in the latter areas. 3/2-3/9/06</li> <li>-Mats are in place at the wetland locations in the Bethel Reservoir section. Watch the crossings for muddy conditions and monitor erosion controls. 2/22-3/9/06.</li> <li>- A stronger crossing is planed between poles#10-11 for access to bring in the poles. 3/2-3/9/06</li> <li>-There was no sediment tracking at the various road/ROW intersections. 3/9/06.</li> </ul>	<ul style="list-style-type: none"> <li>- The damage should be repaired at the 3<sup>rd</sup> wetland. See erosion control section for more details. 2/16- 3/9/06.</li> <li>- Continue to maintain as needed. 2/2-3/2/06 Monitor the conditions along the road near the wetland edge

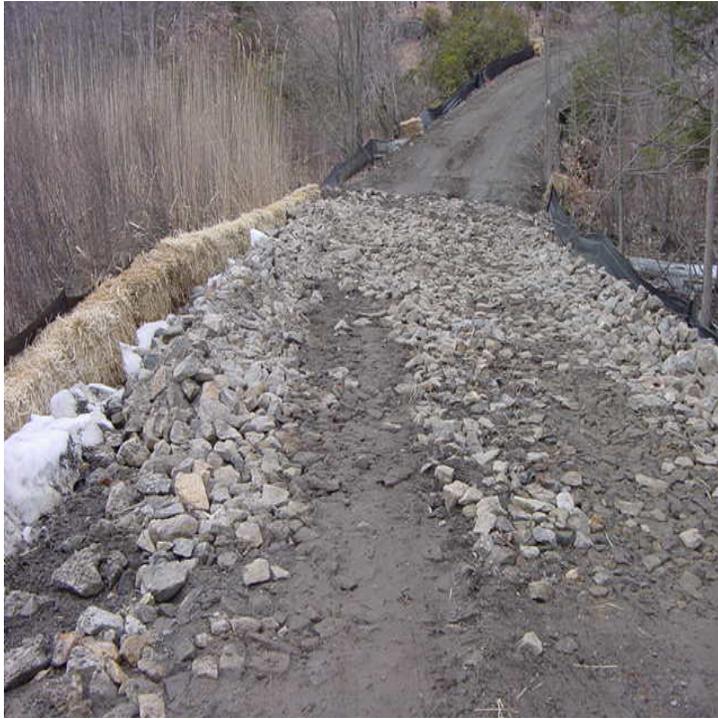
Erosion and Sediment Controls	<ul style="list-style-type: none"> <li>- Water levels appear to remain constant at the 2<sup>nd</sup> wetland crossing along the Archers Lane access road. Controls were repaired and sediment removed from the 2<sup>nd</sup></li> </ul>	<ul style="list-style-type: none"> <li>- None at this time. 3/9/06.</li> </ul>	<ul style="list-style-type: none"> <li>-N/A</li> </ul>

(Composite Section): Photo on the left shows a view of the 2<sup>nd</sup> crossing along the road from Archers Lane where controls were repaired. Photo on the right shows a spot where haybales were installed at the damaged silt fence at the 3<sup>rd</sup> crossing. 3/9/06

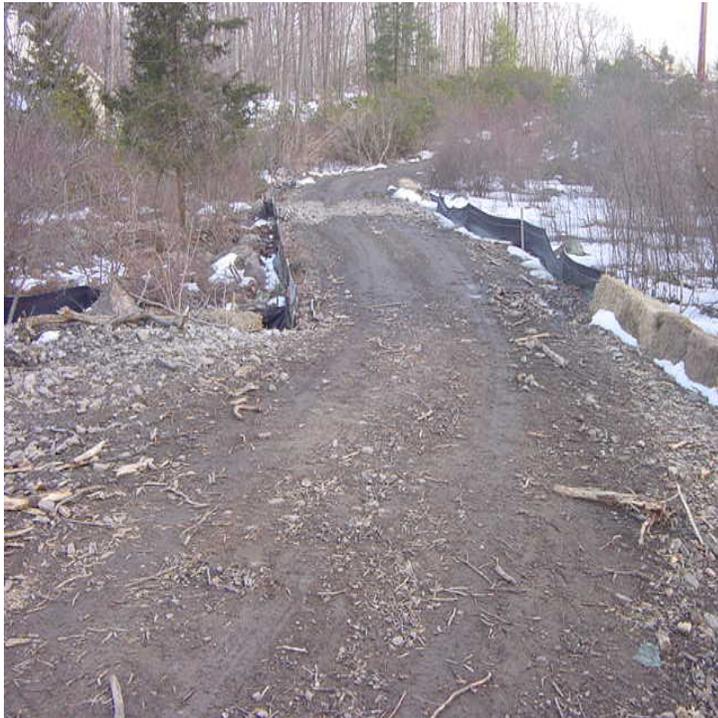
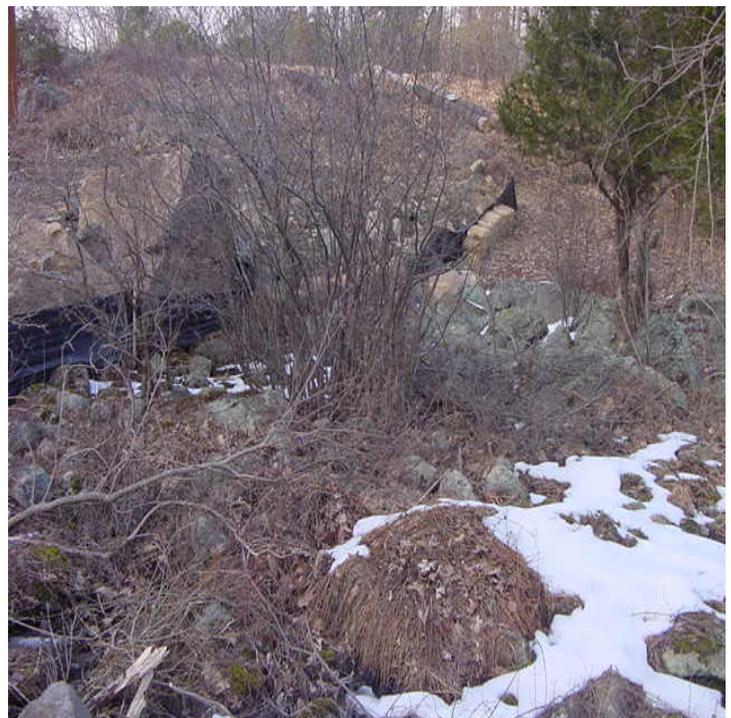
Photo on the left shows the wetland crossing near the 2<sup>nd</sup> structure within the Gallows Hill Section. Erosion controls have been repaired at the structure and along the access road. Photo on the left shows where soil had been pushed over the fence but controls were repaired. It appears that all soil has been removed from the wetland. 3/9/06.

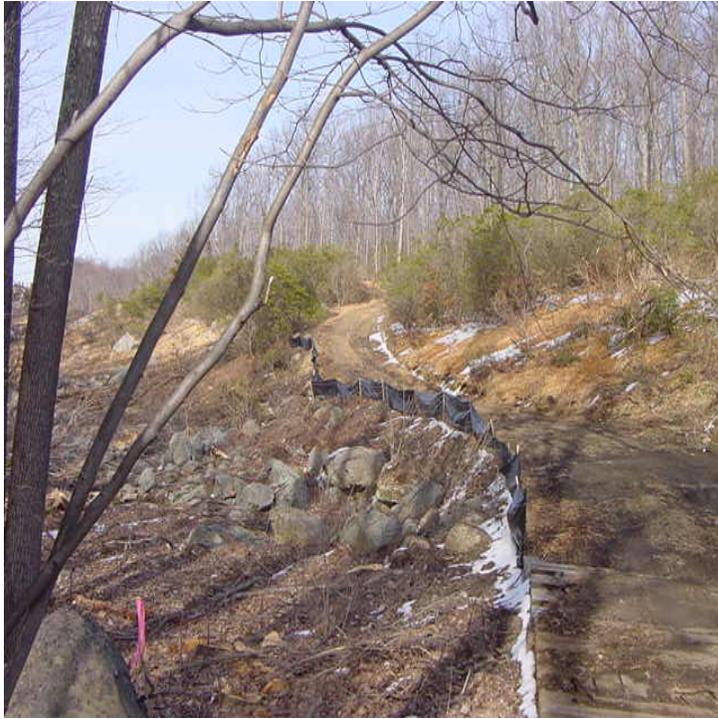
(345kV H-Frame): Photo on the left shows a view of the wetland crossing near structure #19 of the Bethel Reservoir section. Photo on the right shows a view of structure #10 which was recently installed of Nashville Road. 3/9/06.

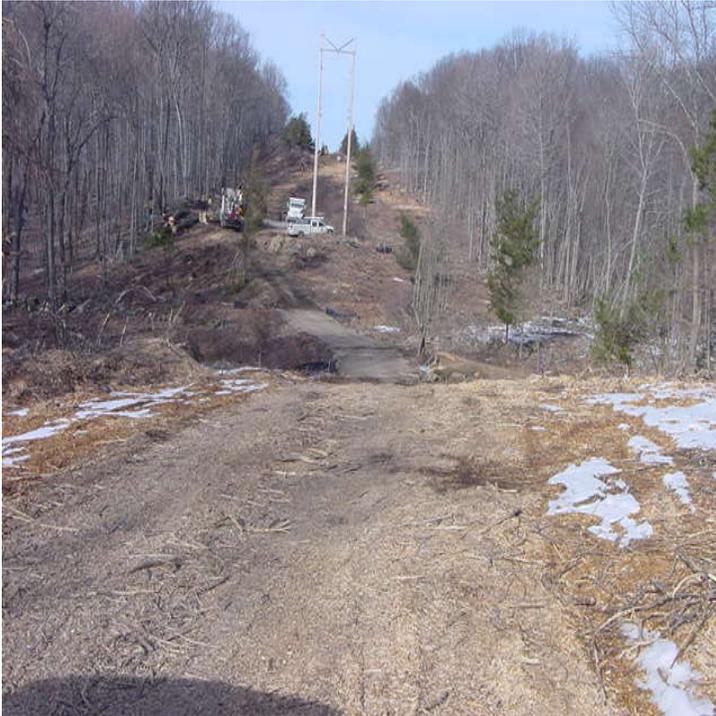
(345kV H-Frame): Photo on the left shows a view of the access drive along the Chestnut Hill Road ROW. Photo on the right shows a view of the dewatering controls adjacent to structure #6. Silt fence and haybales were in place and were functioning properly at the time of inspection. 3/9/06

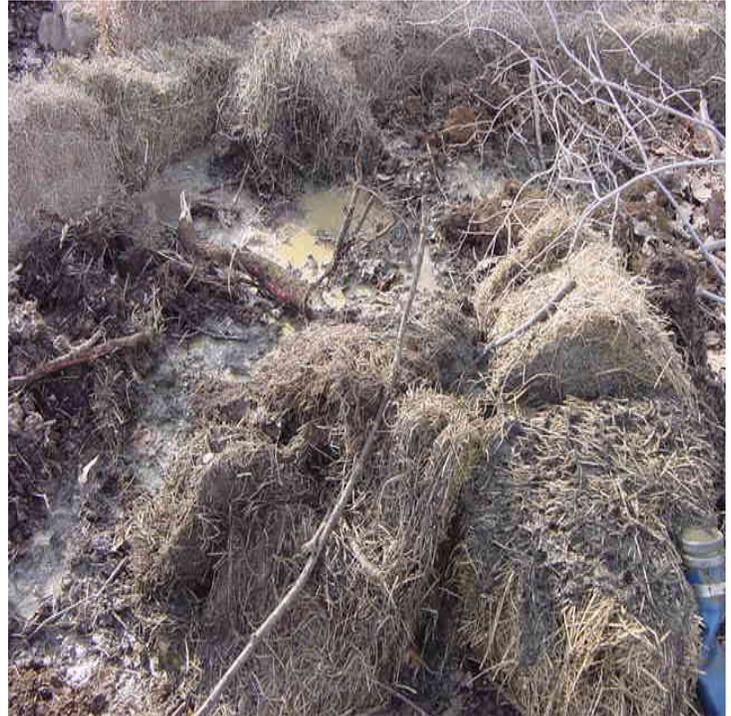
<p>Dewatering</p>	<p>- Dewatering was noted at one structure this week. Water appeared to be running clear beyond the controls installed. 3/9/06</p>	<p>- Release water to the ground only in well vegetated areas if it will not reach any resource areas. (Make sure to check downgradient for these areas- i.e. as in pole #6) Otherwise use a filter bag or adequate containment. 3/9/06.</p>	<p>-Controls were used for this dewatering.</p>
<p>Blasting</p>	<p>-No blasting has been necessary at this time on the ROW. 3/9/06.</p>	<p>-None at this time. 3/9/06.</p>	<p>-N/A</p>
<p>Spills and Material Storage</p>	<p>-None of the parked or active equipment had leaks noted at the time of</p>	<p>- Continue to keep all vehicles maintained well (i.e. no apparent fluid</p>	<p>-N/A.</p>

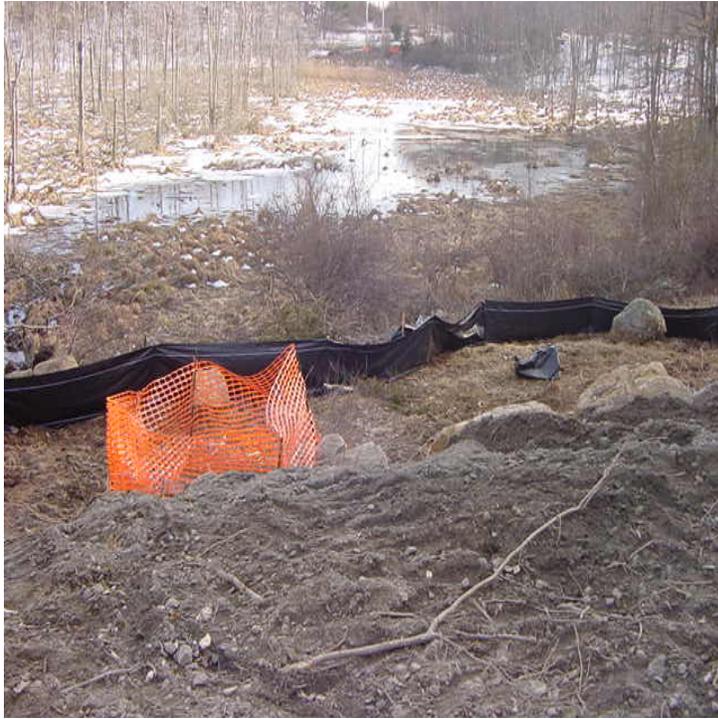
Areas of Inspection	Observation	Recommended Action	Corrected Action
	<p>the vicinity of pole #28. 3/2-3/9/06.</p> <p>-Structure #24 off John Todd way is adjacent to a large wetland system. Silt fence was in place in this area but was not properly toed in. No sediment had migrated toward the wetland at the time of inspection. 3/9/06.</p>	<p>crossing for increasing muddy conditions. 3/2-3/9/06.</p> <p>- This silt fence needs to be installed properly ASAP. Continue to monitor and maintain the erosion controls in this area due to its proximity to the wetland. 3/9/06</p>	<p>as recommended. 3/2/06.</p> <p>-The silt fence was repaired before the end of the day. 3/9/06.</p>
<p>Inland Wetland and Watercourse encroachment and mitigation</p> <p><b>Composite</b></p>	<p>-The D&amp;M plan approved stone on geotextile fabric at the wetland crossings had worked well, but at three areas near Archers Lane, turbidity issues have been present. Run-off from the road, the drainage pipe, and snow plow issues had led to sedimentation. 1/4-3/9/06.</p> <p>- Direct damage was noted to the wetland at the 3<sup>rd</sup> crossing as a result of equipment slipping. 2/16-3/9/06.</p> <p>- The rocks at the 1<sup>st</sup> crossing remain clogged with sediment and noticeable deposits were in the wetland. 1/4-3/9/06.</p> <p>- Use caution in removing trees from wetland areas. Avoid creating ruts when skidding them out. Clearing was noted along the wetland near Gallows Hill. Adjacent homeowners reported machinery in the wetland</p>	<p>- As the access is considered temporary, the stone will be removed when final work ends so the wetlands can be restored. 1/26-3/9/06.</p> <p>- The damage to the 3<sup>rd</sup> wetland should be repaired as well 3/9/06.</p> <p>- The 1<sup>st</sup> crossing could also use some clean stone. Sediment will have to be carefully removed. 1/4-3/9/06.</p> <p>- Retain shrubs and low growth as much as possible. 3/2-3/9/06.</p> <p>- If damage is noted during the spring, the previously created ruts should be repaired if possible.</p>	<p>-N/A until evaluated at the end of work.</p>

Photo on the left shows structure #24 off John Todd Way. Silt fence was not toed in properly at the time of inspection. Photo on the right shows a view of structure #22, off John Todd Way. 3/9/06.

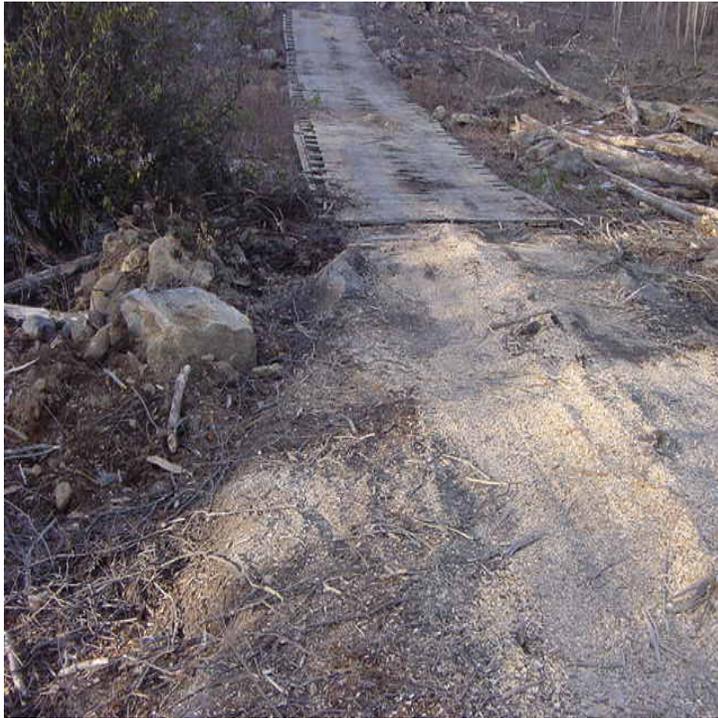
Photo on the left shows a view of the wetland crossing at the Costa Lane section of the ROW. Additional mats have been placed in this area. Photo on the right shows a view of the ROW at Gallows Hill from the Costa Lane. 3/9/06.
