Docket No. 217 – Development and Management Plan Inspection

Northeast Utilities Service Company Certificate of Environmental Compatibility and Public Need for the construction of a 345-kV electric transmission line and reconstruction of an existing 115-kV electric transmission line between Connecticut Light and Power Company's Plumtree Substation in Bethel, through the towns of Redding, Weston, and Wilton, and to the Norwalk Substation in Norwalk, Connecticut.

Date: April 26, 2006

Location: Overhead Line (Composite 345kV and 115kV Gallows Hill to Archers Lane, 345kV H-Frame Hoyts Hill to Gallows Hill, and Norwalk Section)

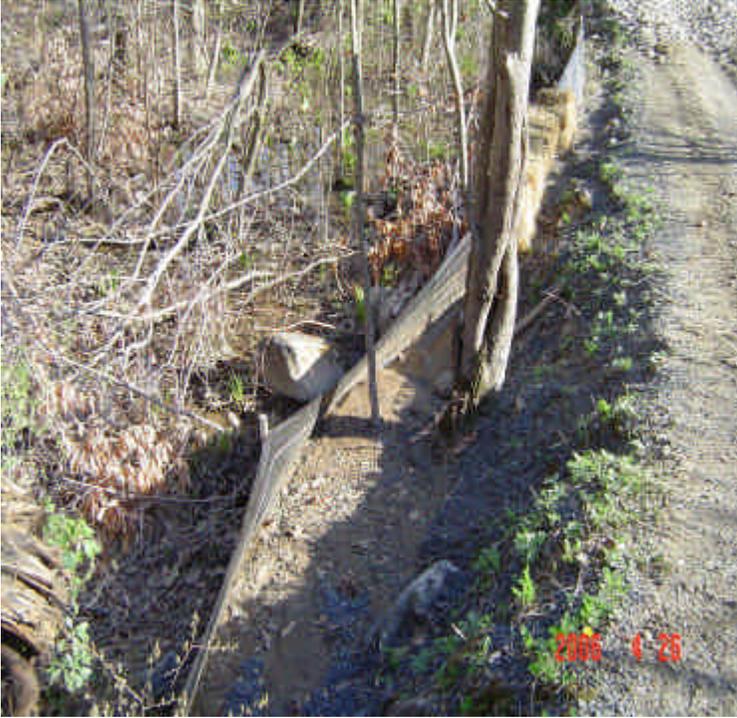
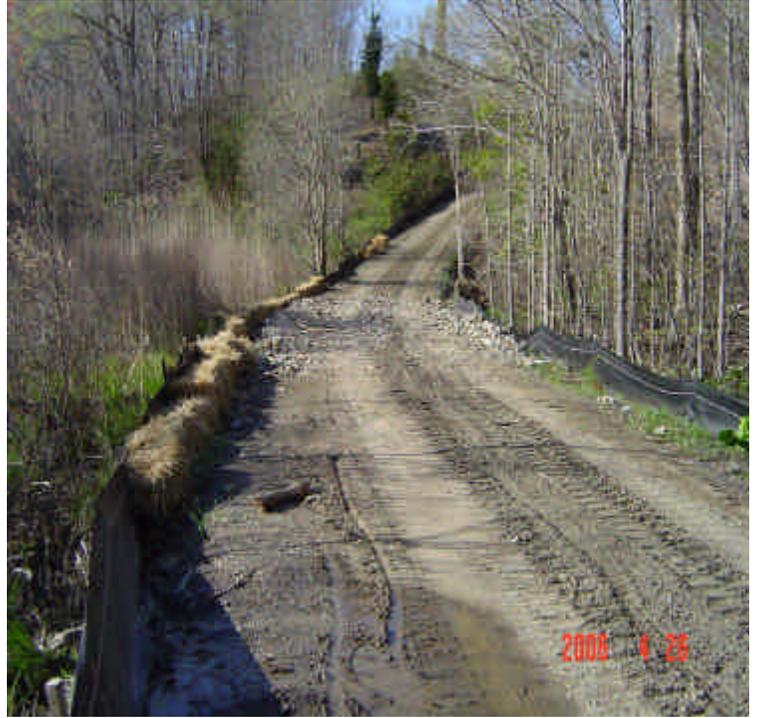
(Composite Section-Archers Lane): Photo on the left shows a view of silt fence holding back sediment from the wetland along the access road. Photo on the right shows a view of the crossing where water levels remain below problem levels, even following the recent rains. 4/26/06

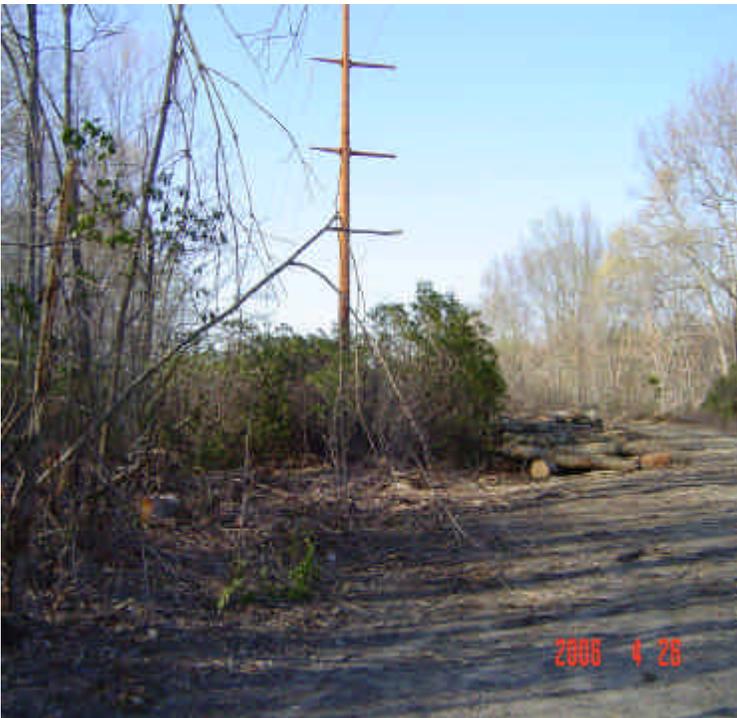
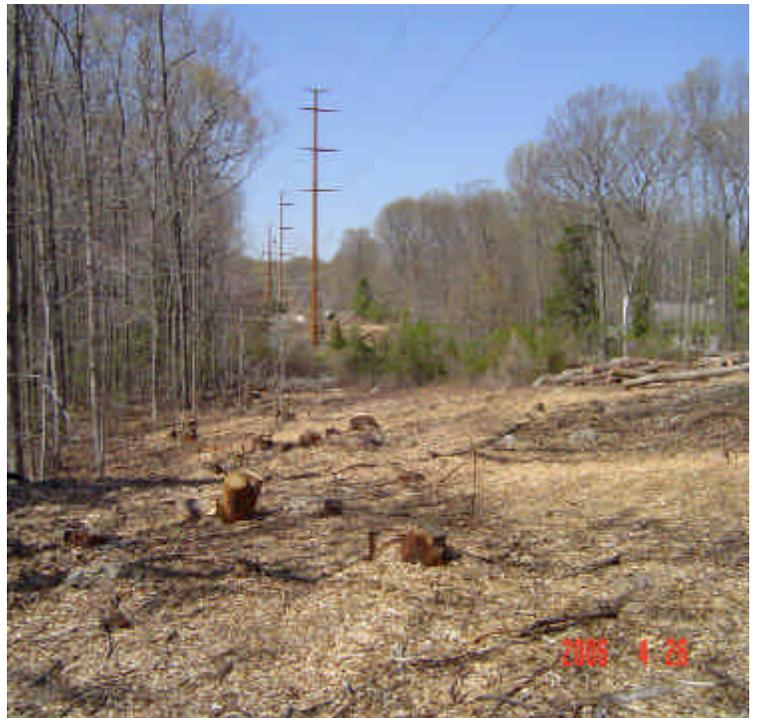
Photo on the left shows a view of some clearing in the ROW beyond Archers Lane. Photo on the right shows the ROW off Gallows Hill where some woody debris had been removed. 4/26/06.

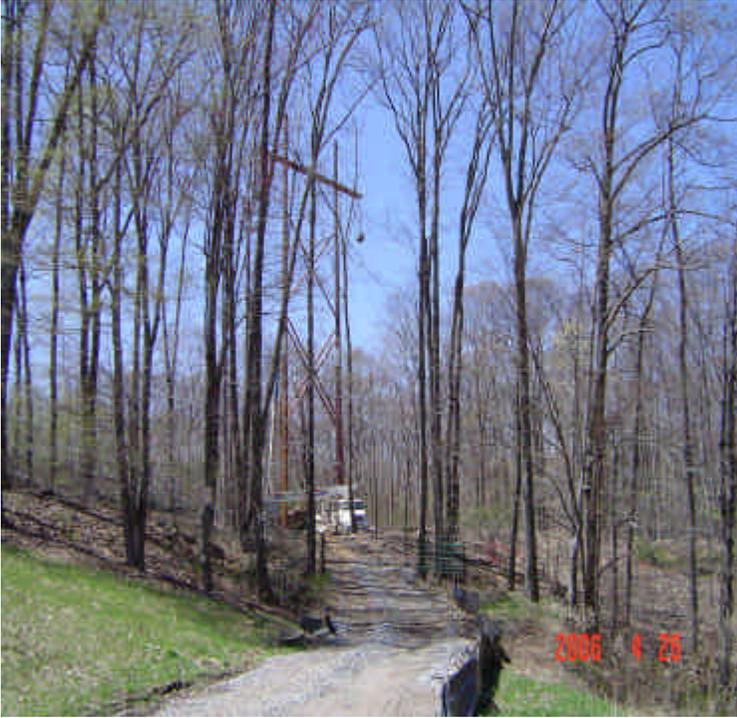
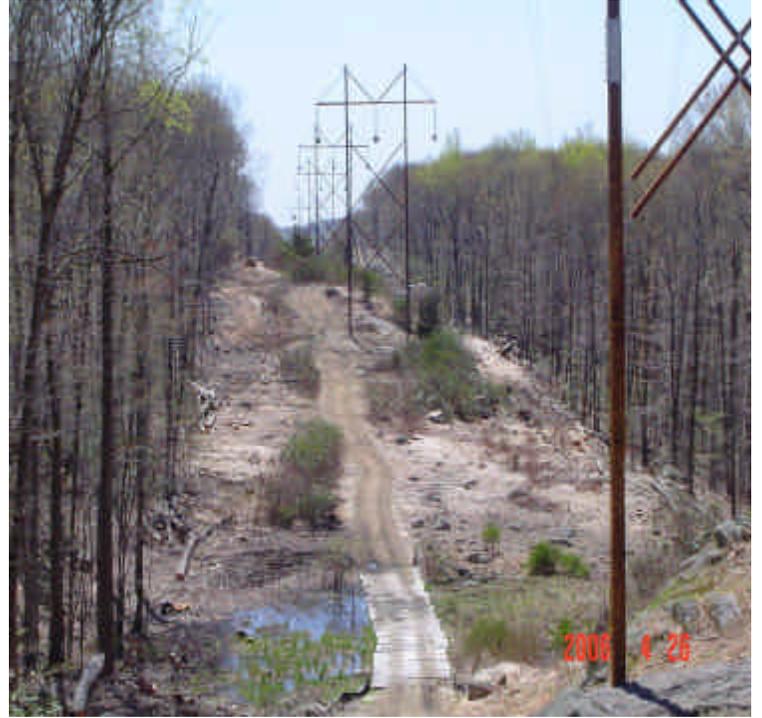
(345kV H-Frame): Photo on the left shows the last pole (#11) being set at the Bethel Res. section. Photo on the right shows a view along the ROW here where poles are in place. The blocks are also installed in preparation for pulling lines. 4/26/06.

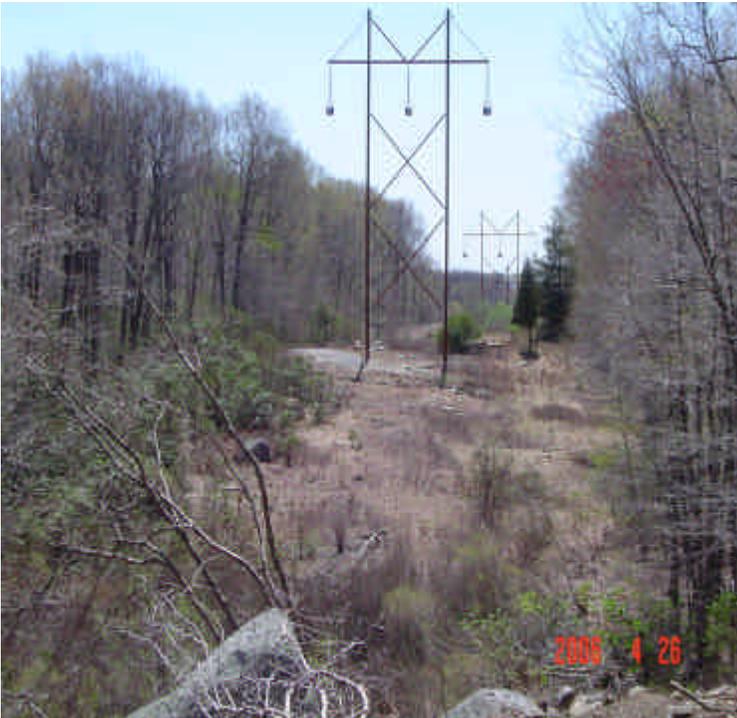
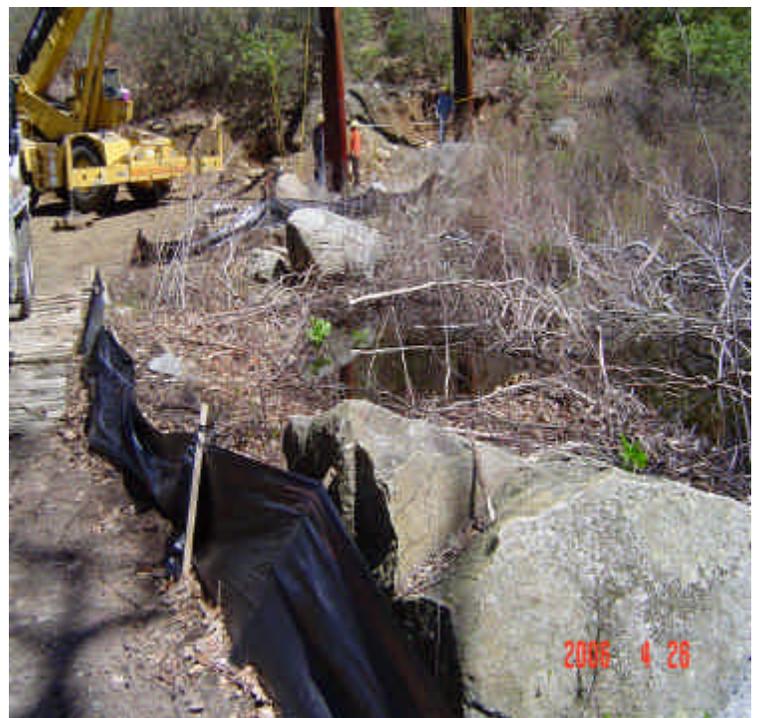
Photo on the left shows another view along the ROW. Photo on the right shows a view of the silt fence repaired near structure #19. 4/26/06.

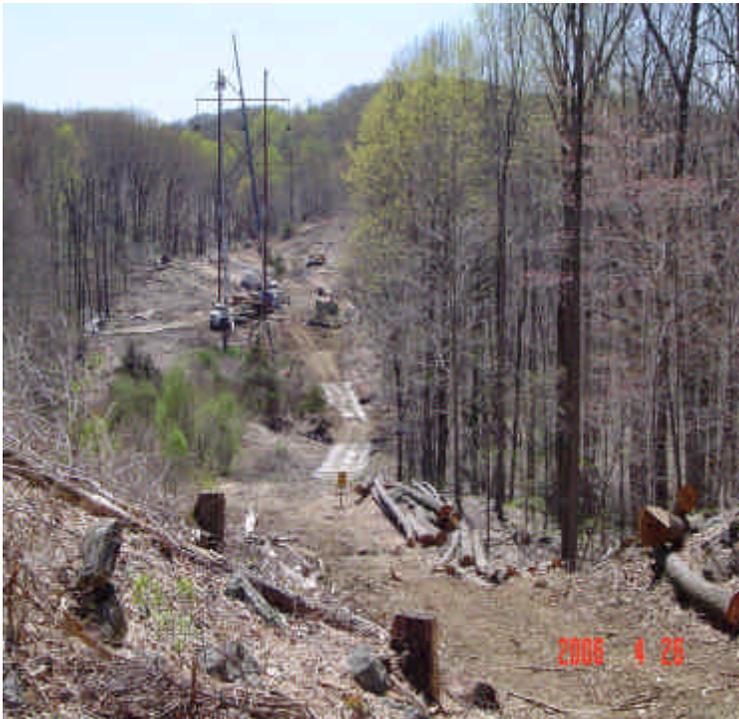
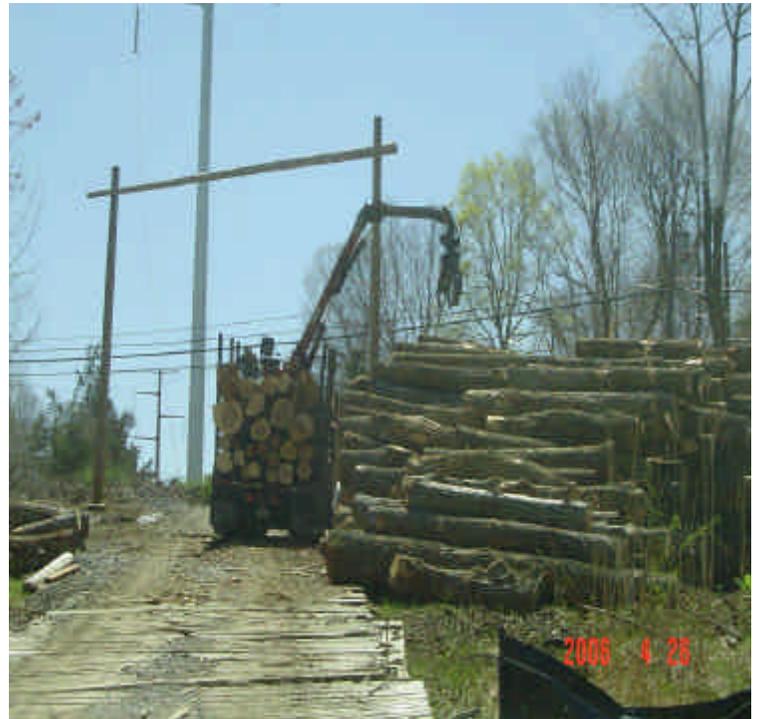
Photo on the left shows a view of the ROW where the mats were installed over the stream and water main. Work was occurring at structure #11 in the background. Photo on the right shows removal of cleared trees from the Chestnut Ridge section. Rider/guard poles are installed at the roadways. 4/26/06.

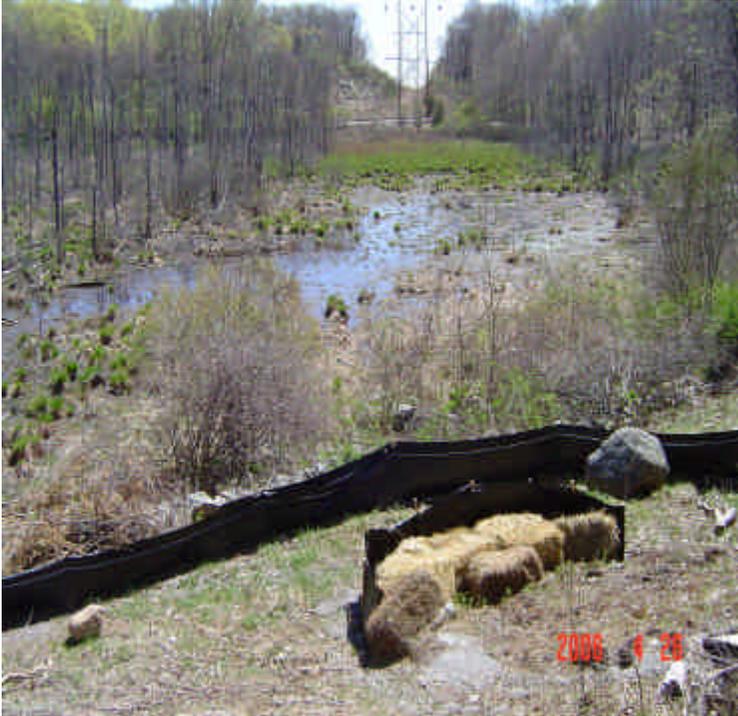
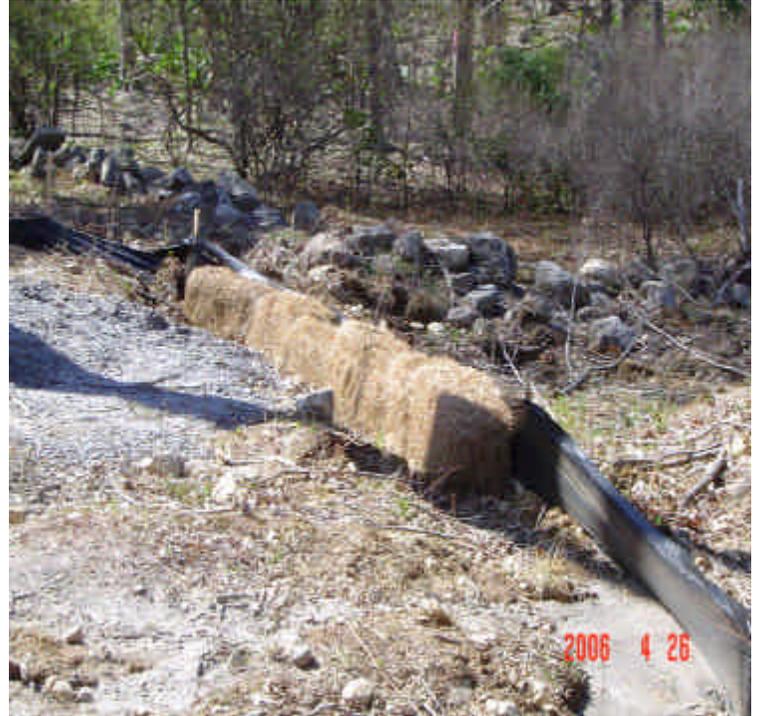
Photo on the left shows a view of the wetland between structures #24-25. Dewatering controls and the silt fence held up well through the recent rain. Photo on the right shows where silt fence was repaired and haybales were installed. 4/26/06

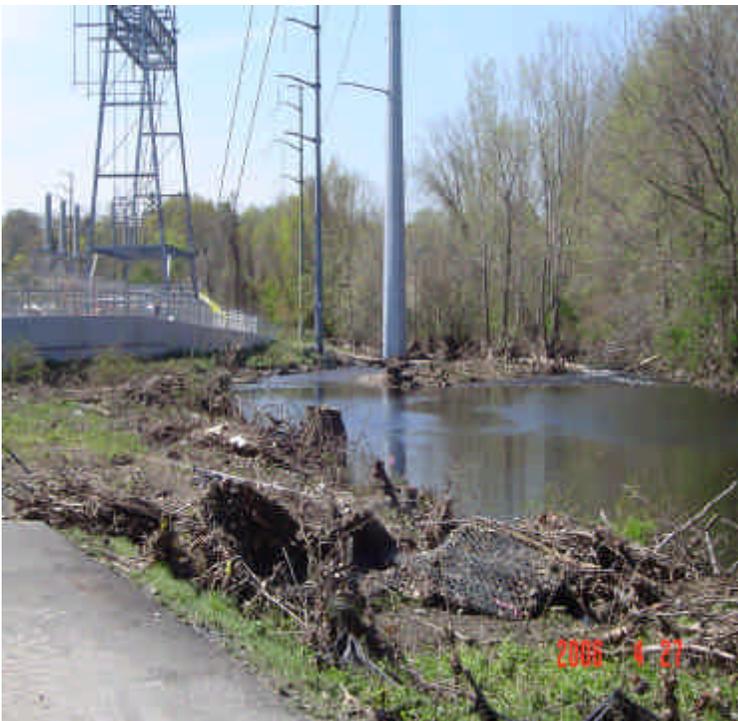
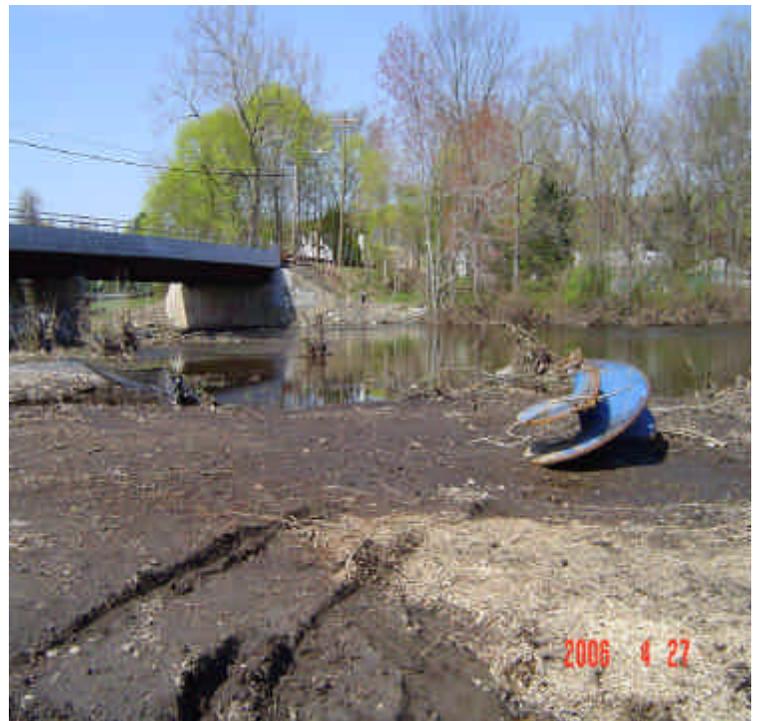
(Norwalk Section) Photo on the left shows where clearing had occurred from the ROW to Norwalk Substation. Photo on the right shows where the silt fence was pulled down by the flooded river it will be repaired when the area dries out. 4/26/06

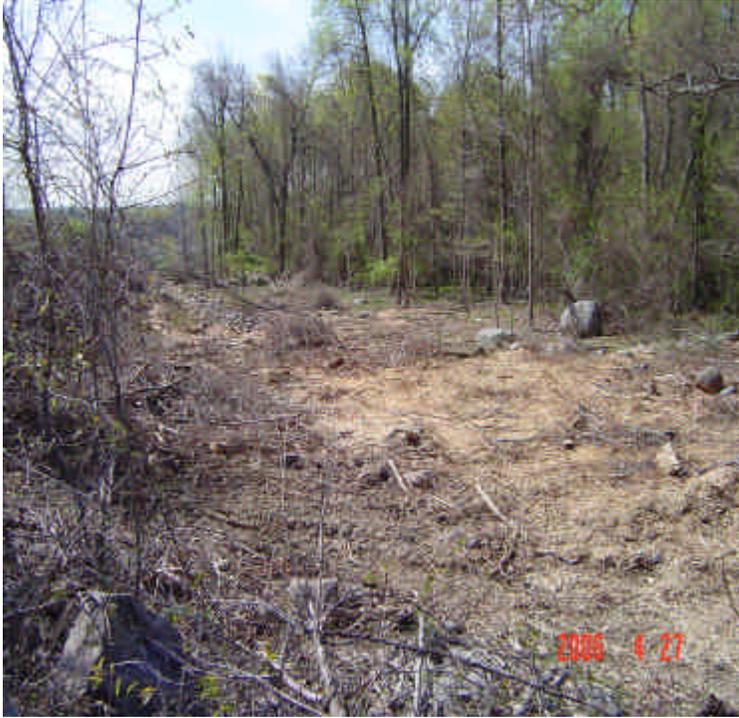
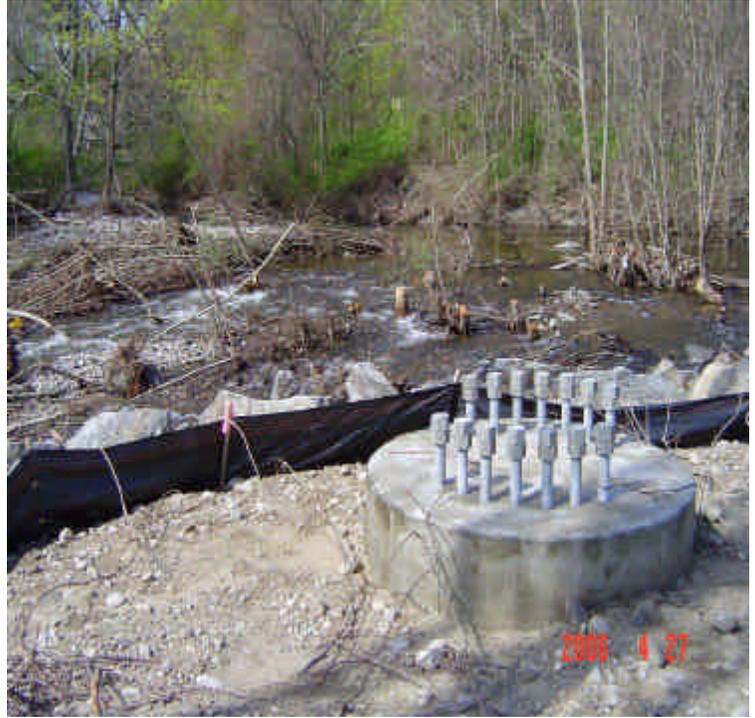
Perry Ave: Photo on the left shows where clearing had occurred along the ROW. Arrowhead Rd.: Photo on the right shows where the usually dry channel was flowing beyond the foundation. The silt fence held up well and was restored. 4/26/06
