Docket No. 217 – Development and Management Plan Inspection

Northeast Utilities Service Company Certificate of Environmental Compatibility and Public Need for the construction of a 345-kV electric transmission line and reconstruction of an existing 115-kV electric transmission line between Connecticut Light and Power Company's Plumtree Substation in Bethel, through the towns of Redding, Weston, and Wilton, and to the Norwalk Substation in Norwalk, Connecticut.

Date: May 10, 2006

Location: Overhead Line (Composite 345kV and 115kV Gallows Hill to Archers Lane,
345kV H-Frame Hoyts Hill to Gallows Hill, and Norwalk Section)

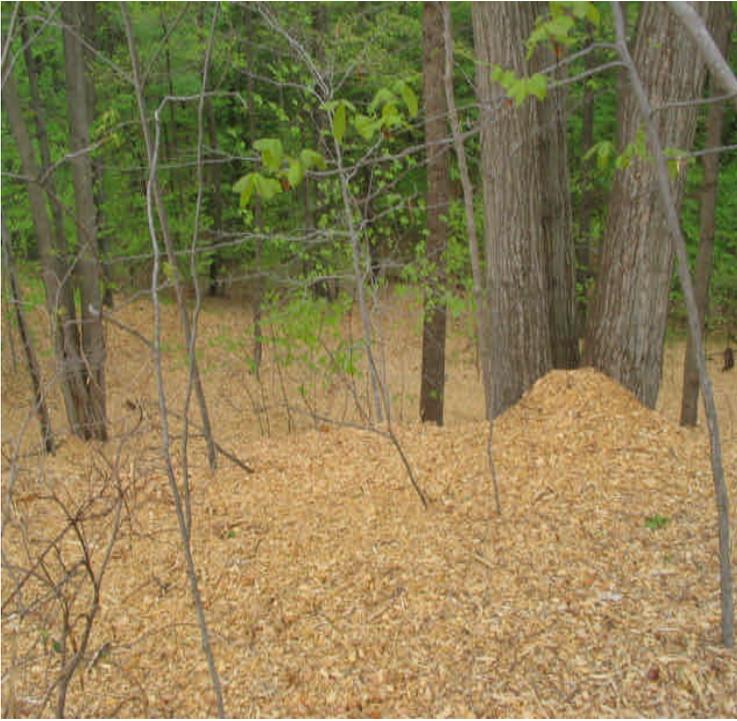
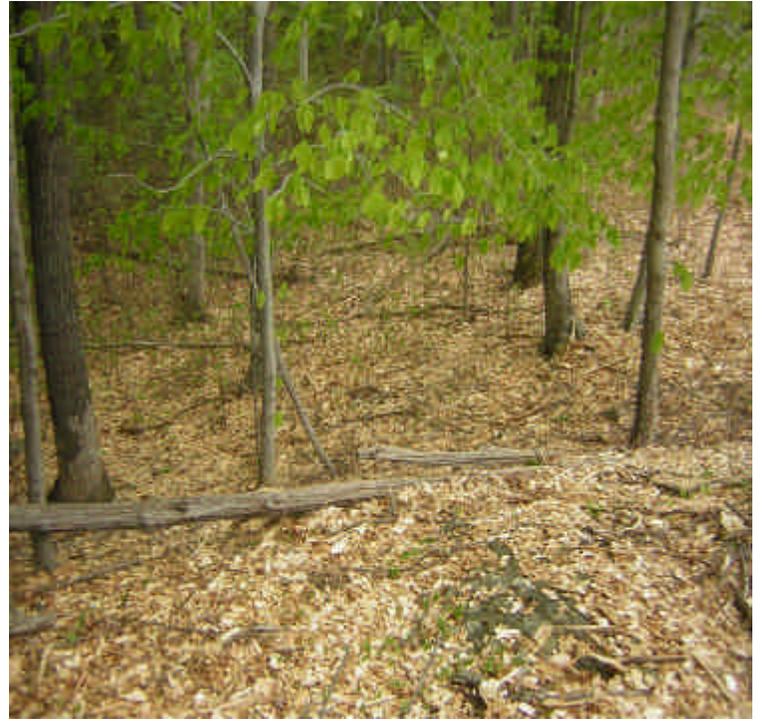
(Composite Section): Photo on the left shows the areas off the ROW past Archers Lane where wood chips have not been raked or removed. Photo on the right shows the area with the similar issue past Gallows Hill. CL&P has been looking into this. 5/10/06

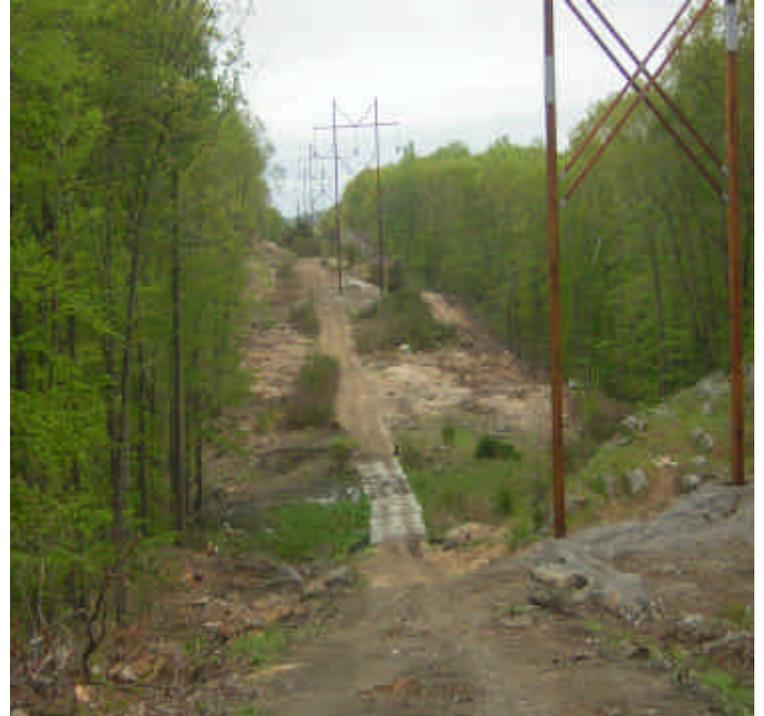
Photo on the left shows a view of the looking along the ROW towards Rt 53. **(H-Frame):** Photo on the right shows the wetland crossing south of structure #11 in the Bethel Res. Section in good shape. 5/10/06.

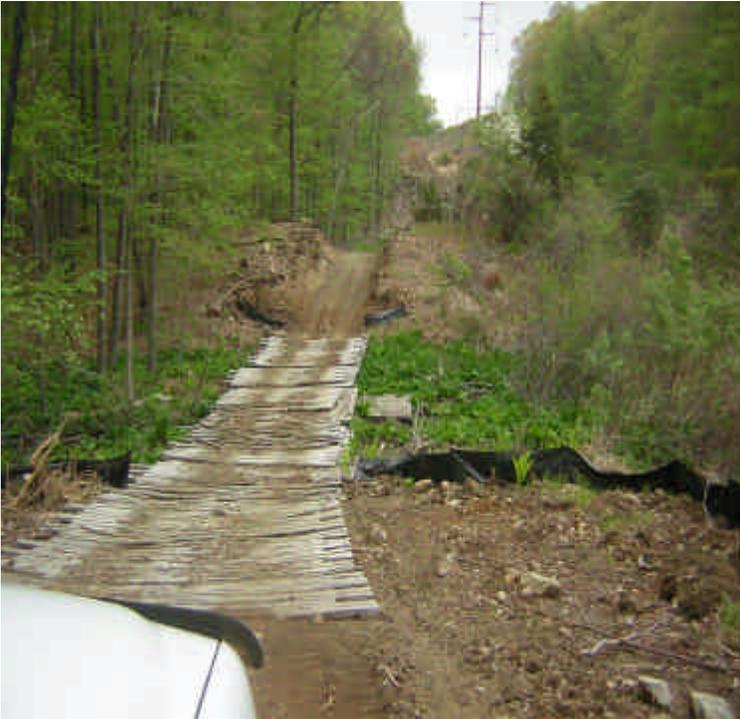
(345kV H-Frame): Photo on the left shows a view of the stream crossing between structures #10 and 11 with controls in good shape. Photo on the right shows silt fence near structure #9 which needs some repair, or the area should be restored with seed and mulch. 5/10/06.

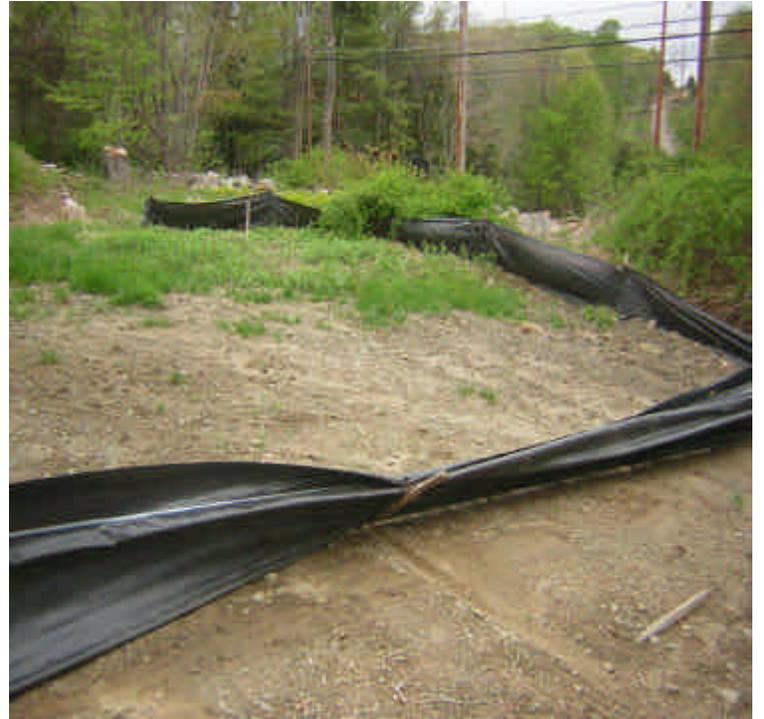
Bethel Reservoir Section to Chestnut Ridge Rd.	<p>- The silt fence by structure #9 requires some maintenance. The adjacent disturbed area should be restored if feasible. 5/10/06.</p> <p>- Silt fence and mats remain in place in a number of locations in this section. 4/6-5/10/06.</p>	<p>- Maintain silt fence here until the area is stabilized. (Or provide mulch and seed for stabilization). 5/10/06.</p> <p>- Continue to monitor for any muddy conditions or need for repairs. All observed controls remain in good condition. 4/6-5/10/06.</p>	<p>-Fence was going to be maintained following the inspection.</p> <p>-N/A</p>
Costa Lane, Whortleberry, Lime Kiln and John Todd Way	<p>- Mats remain well in place over the stream between poles #10-11. Erosion controls remain well installed at the "corners" and along the second wet area. 3/29-5/10/06.</p> <p>-Mats are in place at the wetland crossing in the vicinity of pole #29. 3/2-4/6-5/10/06.</p>	<p>- None at this time. Continue to monitor this area due to heavy use and maintain as needed. 4/6-5/10/06. Wetland vegetation is returning well with the growing season. 5/10/06</p> <p>-Continue to monitor the crossing for increasing muddy conditions and install silt fence as needed. 3/2-5/10/06.</p>	<p>- N/A.</p> <p>-N/A at this time</p>

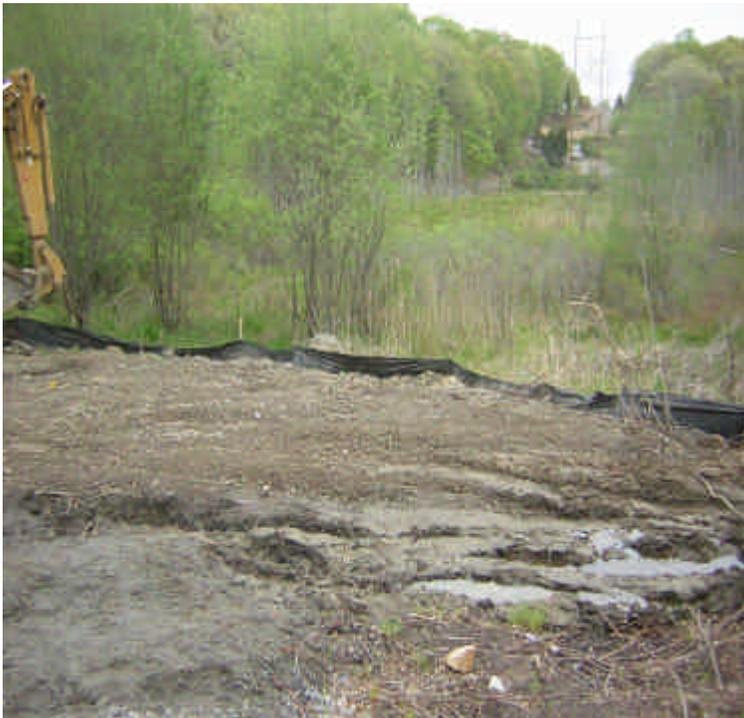
Photo on the left shows a view of the silt fence preventing sedimentation to the adjacent wetland at structure #25. Restore/stabilize this area when feasible. Photo on the right shows the silt fence in good shape near structure #24. 5/10/06.

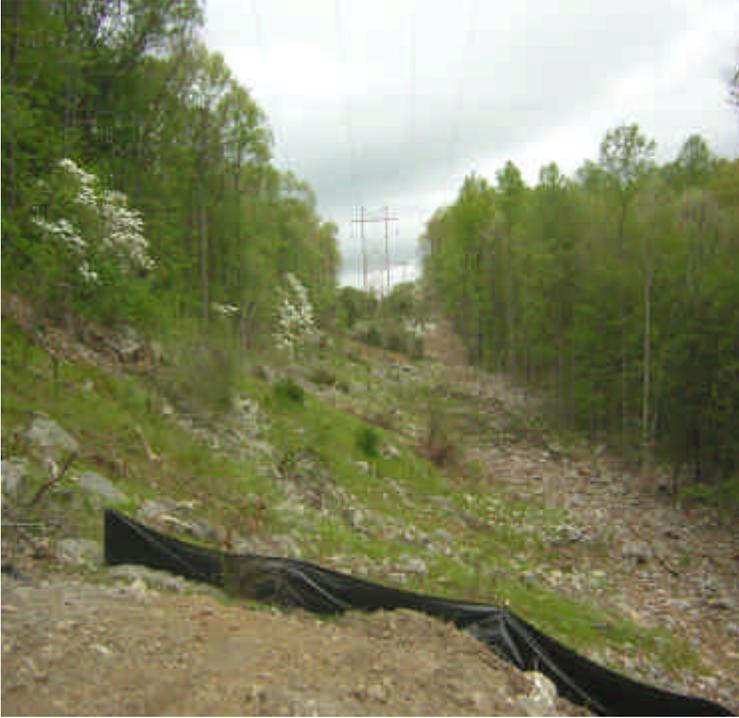
Photo on the left shows a view of the ROW in the area of Costa Lane. Silt fence on the side slope here should be monitored although wetlands are not immediately adjacent. (Norwalk Section)
Photo on the right shows the work area adjacent to the substation. 5/10/06.

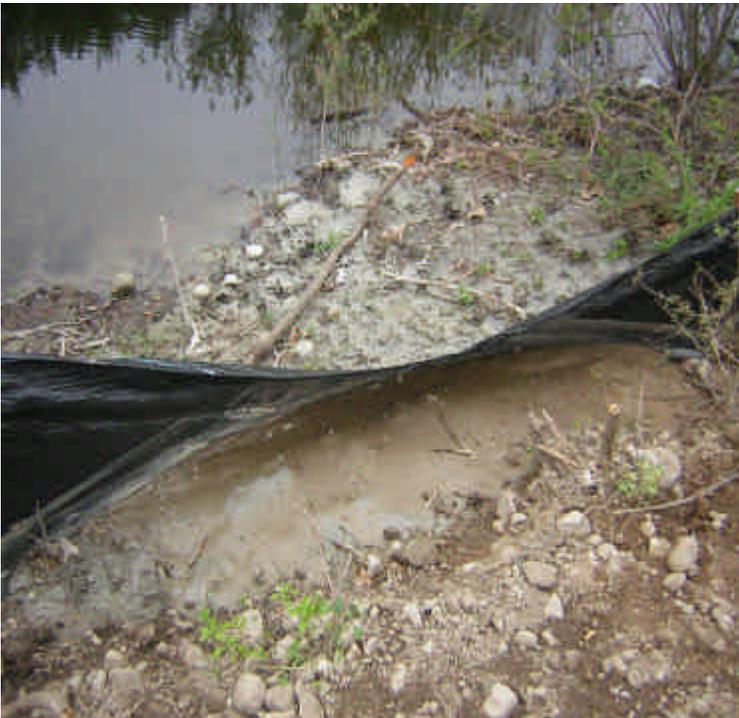
(Norwalk Section) Photo on the left shows an area of silt fence to clean up and a potential problem spot to continue monitoring. Additional controls should be considered here due to the proximity of the river. Photo on the right shows work north of Broad St. 5/10/06.

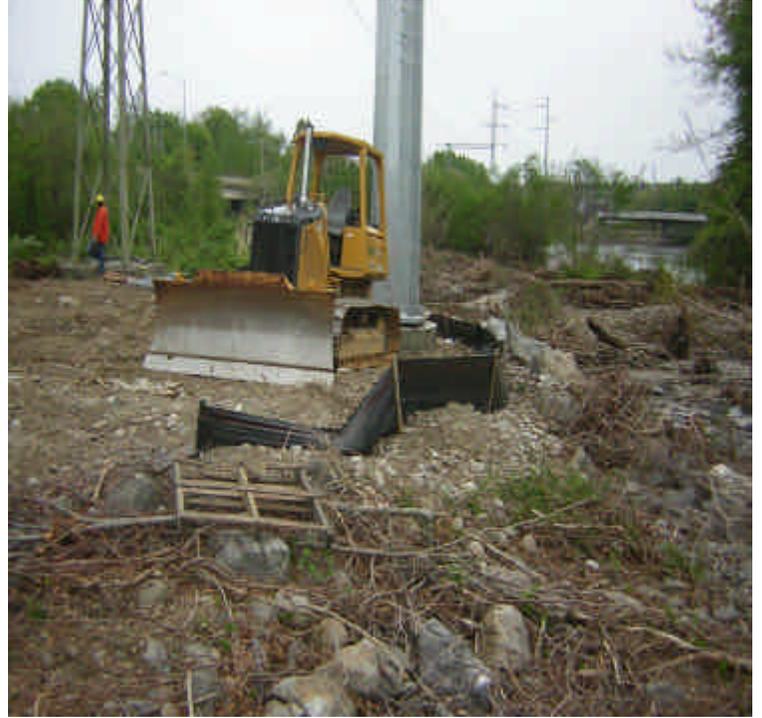
Perry Ave: Photo on the left shows structures being removed along the ROW to the south of Perry Ave. Photo on the right shows a work area adjacent to the recently flooded wetland channel. 5/10/06

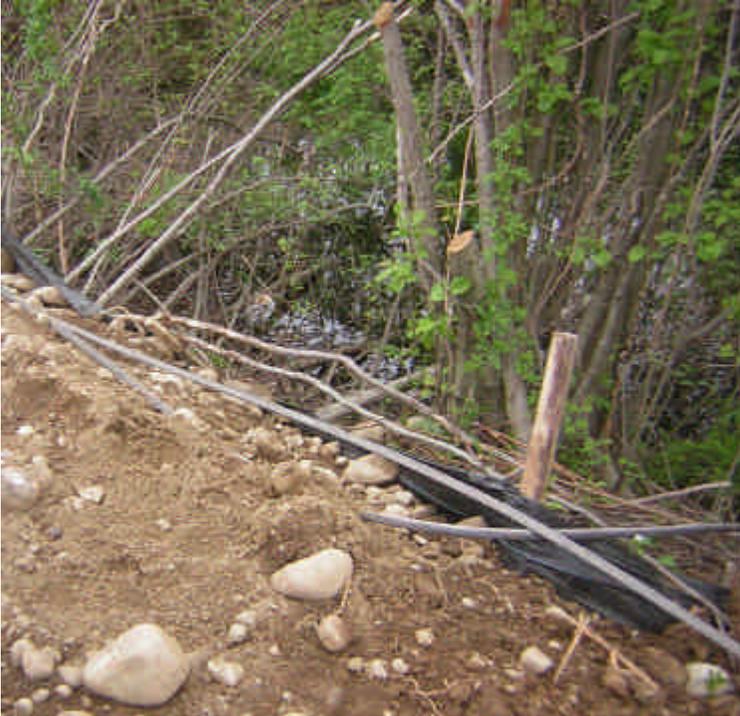
Photo on the left shows where soil was placed over the silt fence in a tight workspace in this area. The pile was being pulled back after the inspection. Fence should be repaired if necessary. Photo on the right shows the ROW to the north of Perry with spools set up. 5/10/06
