**Docket No. 217 – Development and Management Plan Inspection**

Northeast Utilities Service Company Certificate of Environmental Compatibility and Public Need for the construction of a 345-kV electric transmission line and reconstruction of an existing 115-kV electric transmission line between Connecticut Light and Power Company's Plumtree Substation in Bethel, through the towns of Redding, Weston, and Wilton, and to the Norwalk Substation in Norwalk, Connecticut.

**Date:** May 17, 2006

**Location:** Overhead Line (Composite 345kV and 115kV Gallows Hill to Archers Lane, 345kV H-Frame Hoyts Hill to Gallows Hill, and Norwalk Section)

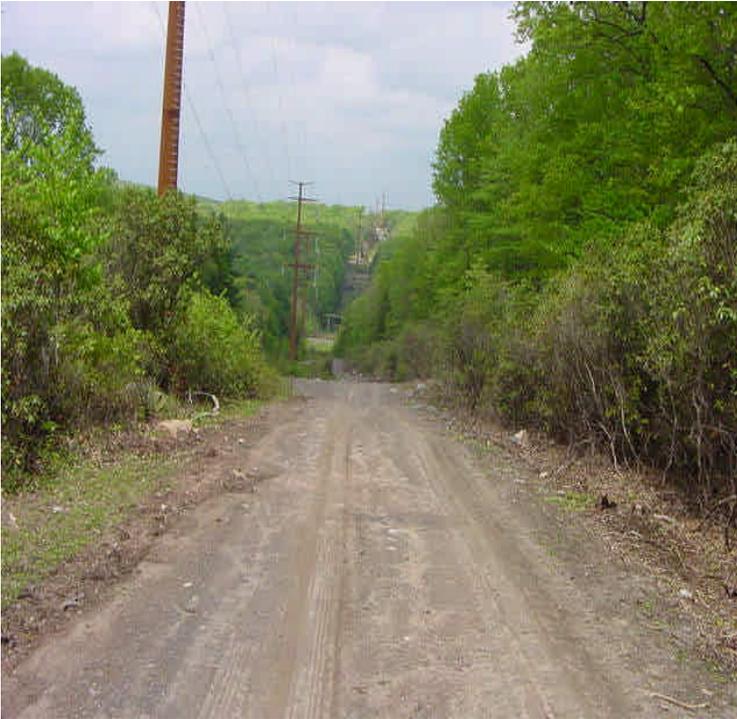
**(Composite Section):** Photo on the left shows the ROW past Archers Lane looking towards Rt 53. Photo on the right shows the wetland crossing off Gallows Hill where controls are still in good shape. 5/17/06

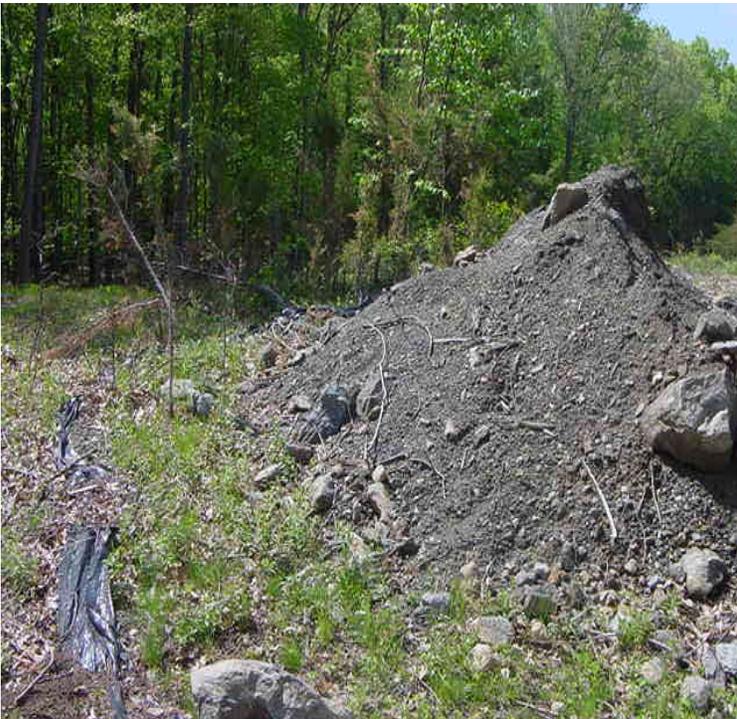
Photo on the left shows a stockpile remaining at a pole location. Make sure that proper restoration and material removal occurs before work is complete. (H-Frame): Photo on the right shows the ROW in the Bethel Res. Section. Conditions were very muddy at this time. 5/17/06.

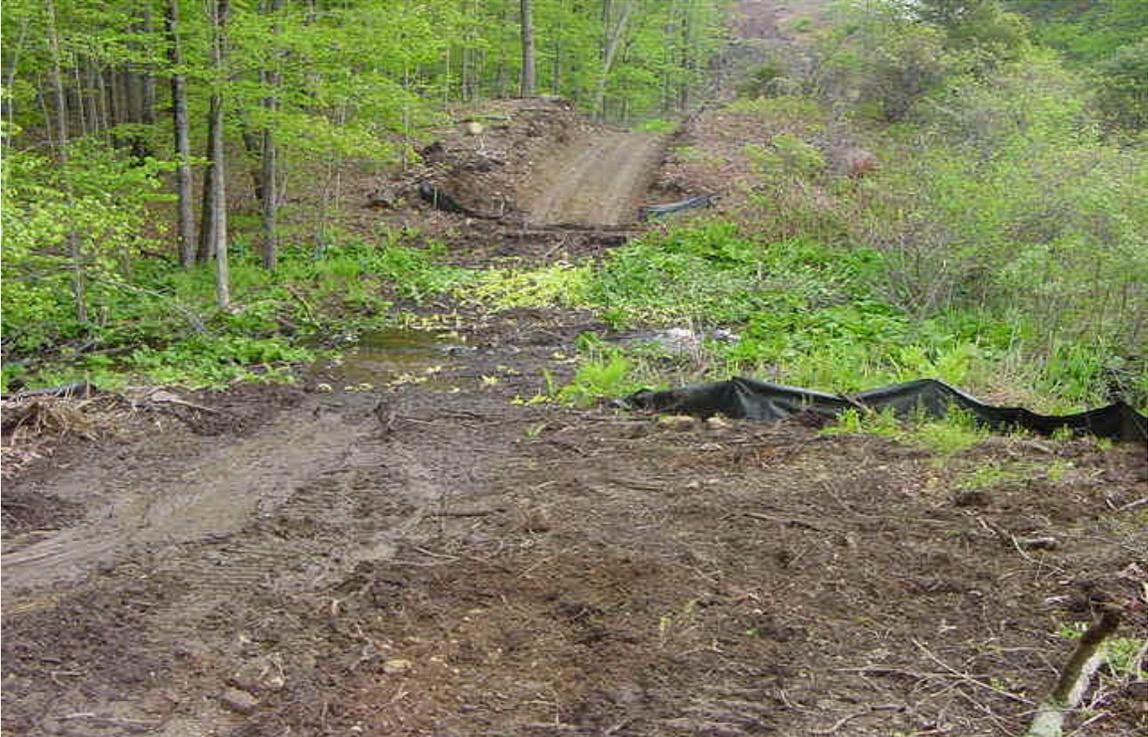
**(345kV H-Frame):** Photo on the left shows a view of the stream between structures #10 and 11 with the mats/crossing removed. The adjacent area is disturbed and additional controls or stabilization measures may be needed across the ROW. 5/17/06.

Areas of Inspection	Observation	Recommended Action	Corrective Action
<b>345kV H-Frame</b>	<p>Hill, Chestnut Ridge Rd, the Bethel Res. water plant road, Lime Kiln Rd, Whortleberry Rd, John Todd Way and Costa Lane. Wood chips were placed along a majority of the access roads. 3/29-5/17/06.</p> <p>-Stone dust is used on the access roads at Costa Lane and John Todd Way. 3/2-5/17/06.</p> <p>-Mats are in place in the wetland locations in all of the H-frame sections. Watch the crossings for muddy conditions and monitor erosion controls. 2/22-5/17/06.</p> <p>- The mat bridge between poles #10-11 was removed. The wetland is in good shape but the adjacent areas are disturbed where the bridge was located. 5/17/06.</p>	<p>roads. If muddy conditions re-occur, place more wood chips or consider installing silt fence as needed. 5/17/06.</p> <p>- The Bethel Res. section was fairly muddy due to rain. Watch ruts and repair if necessary. 5/17/06</p> <p>-The Chestnut Ridge sect. remains in good shape</p> <p>- Continue to monitor for muddy conditions and repair controls when necessary. All wetland crossings look good with vegetation returning and high water. 5/10-5/17/06.</p> <p>- The streambed and water main were protected but additional erosion controls or stabilization will be needed on the disturbed soil to prevent sedimentation to the wetland. 5/17/06.</p>	<p>-Continue to evaluate</p> <p>-N/A at this time</p> <p>-Bridge was removed and soil surface here needs attention</p>

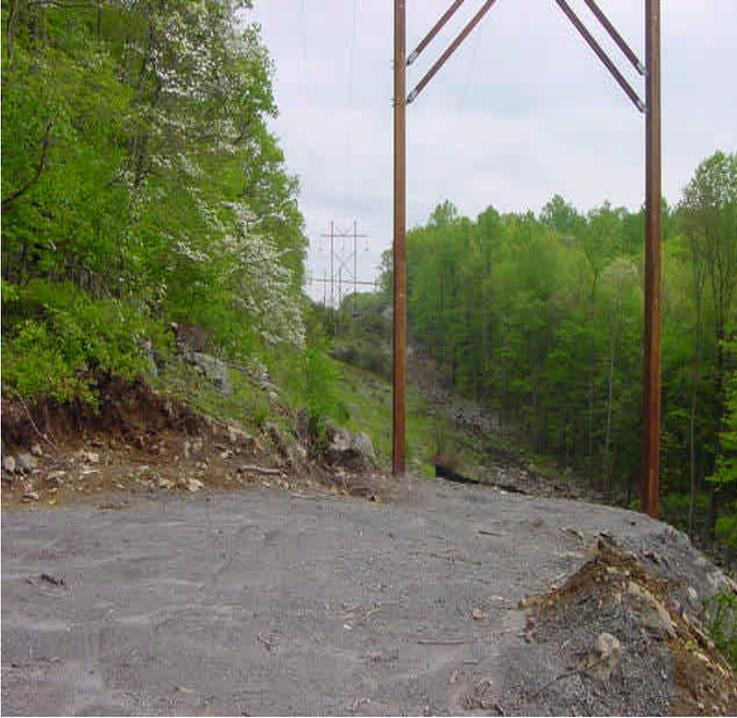
Areas of Inspection	Observation	Recommended Action	Corrective Action
<p><b>Norwalk Section</b></p>	<p>4/6-5/17/06.</p> <ul style="list-style-type: none"> <li>-Silt fence near structure #28 is being monitored and repaired as needed. 5/17/06.</li> <li>-Erosion controls remain intact at poles #24 and 25 and further washouts were not noted. 5/17/06.</li> <li>-One area of silt fence south of Perry Ave. continued to have soil piling against it. 5/17/06.</li> <li>- Silt fence was flooded at the river north of Broad St and will be repaired when the water recedes. 5/17/06.</li> <li>- Another area further north needs silt fence repair due to the tight workspace. 5/17/06</li> <li>- The foundation near the Norwalk substation has good silt fence coverage. 5/17/06.</li> <li>- Mats are installed at wetland crossings in the Rt 7 ext- Kent Rd section but controls are needed at the corners. 5/17/06</li> </ul>	<p>install silt fence as needed. 3/2-5/17/06.</p> <ul style="list-style-type: none"> <li>-Continue to monitor .Wetlands are not located immediately adjacent. 5/17/06.</li> <li>-Maintain controls until areas surrounding the foundation are stabilized. 5/17/06</li> <li>-The fence is being monitored and sediment is removed regularly. 5/17/06.</li> <li>- Continue to maintain all areas of fence due to proximity to resource areas. 5/17/06.</li> <li>- Sediment should be pulled back and fence repaired. 5/17/06</li> <li>-Continue to monitor due to proximity of the river. 5/17/06</li> <li>-Install haybales or silt fence at the corners of the mat crossings to prevent runoff from the access road. 5/17/06.</li> </ul>	<ul style="list-style-type: none"> <li>- Silt fence is being monitored</li> <li>-N/A</li> <li>-Silt fence is being monitored</li> <li>-Will be repaired when water recedes</li> <li>- Needs attention when feasible.</li> <li>-N/A</li> <li>-Needs attention when feasible.</li> </ul>

Photo on the left shows structure #28 in the vicinity of Costa Lane. Silt fence on the side slope here should be monitored although wetlands are not immediately adjacent. (Norwalk Section)  
Photo on the right shows an area north of Broad St. where silt fence could use some repair due to the tight workspace. 5/17/06.

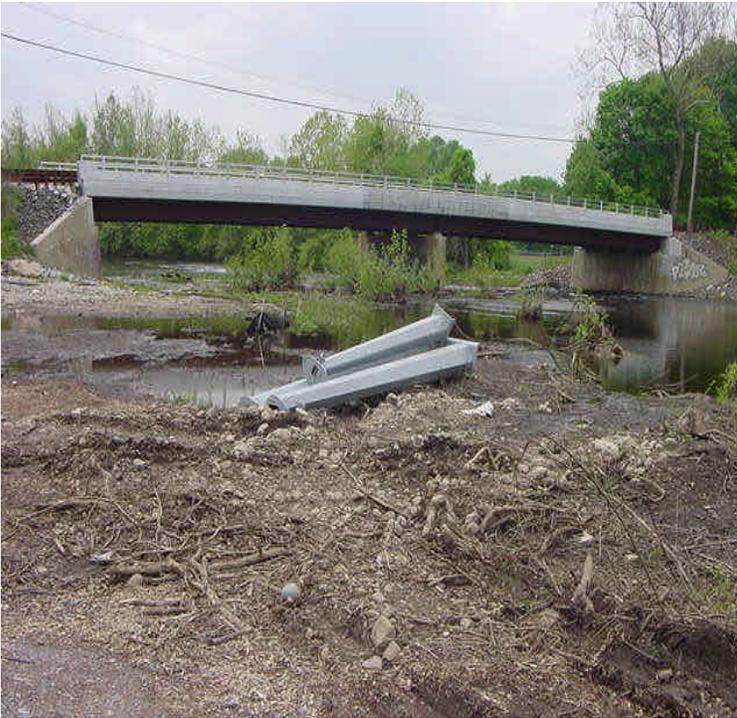
(Norwalk Section) Photo on the left shows where the river flooded over the silt fence in this location north of Broad St. Photo on the right shows the structure south of Perry Ave, adjacent to the river where sediment continues to pile against the silt fence but is regularly removed. 5/17/06.

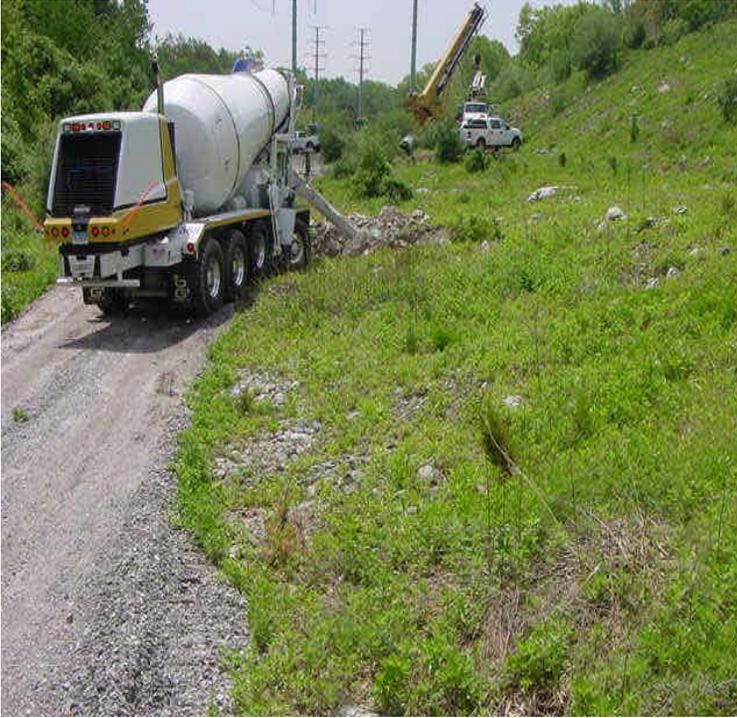
**Photo on the left shows foundation work on structure #11070 with concrete trucks following washout procedures. Photo on the right shows mats installed along a wetland crossing in the new Rt 7 extension to Kent Rd. section. Haybales check dam should be placed at the corners. 5/17/06**

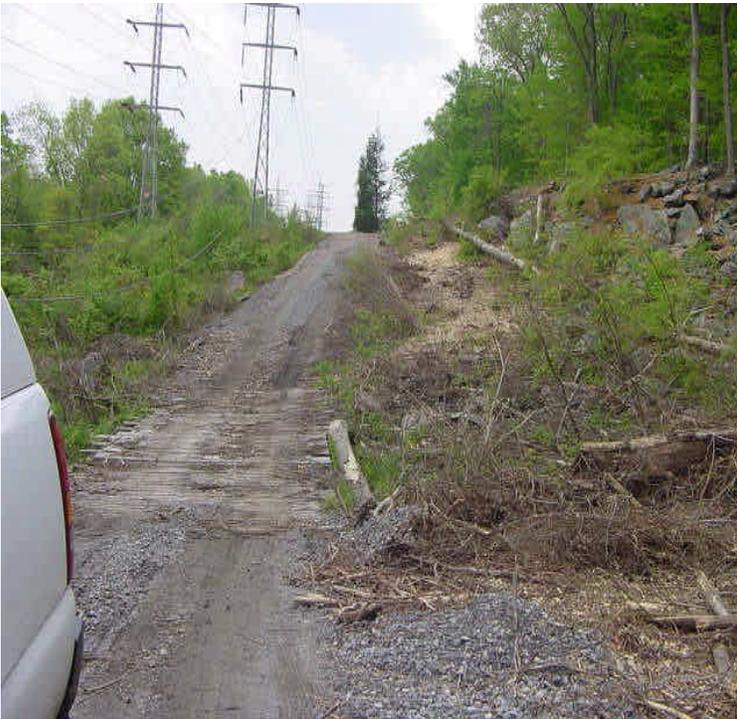
**Photo on the left shows another small wetland crossing in this area. Install haybales or silt fence as needed to prevent runoff from the roadway. Photo on the right shows an overview of the ROW in this area. 5/17/06**

<b>Norwalk Section</b>	<p>- Stone dust access roads are in place to the south of Perry Ave and north of Broad St. 4/6-5/17/06.</p> <p>- A gravel entrance pad was in place north of Broad St. 5/4-5/17/06.</p> <p>-Work to the north of Perry Ave is also accessed off the paved cul-de-sac at April Ln. 5/17/06</p> <p>- A new area of work is accessed from the Rt 7 extension and Kent Rd. Several wetlands are</p>	<p>- Controls are in place. 5/17/06.</p> <p>- The river is at high flow again but access roads are stable. None at this time. 5/17/06.</p> <p>- Install haybales (or silt fence) at the corners of the wetland crossings to prevent run-off from the</p>	<p>- N/A at this time</p> <p>- N/A</p> <p>-Needs attention when feasible</p>
