**Docket No. 217 – Development and Management Plan Inspection**

Northeast Utilities Service Company Certificate of Environmental Compatibility and Public Need for the construction of a 345-kV electric transmission line and reconstruction of an existing 115-kV electric transmission line between Connecticut Light and Power Company's Plumtree Substation in Bethel, through the towns of Redding, Weston, and Wilton, and to the Norwalk Substation in Norwalk, Connecticut.

**Date:** June 20, 2006

**Location:** Overhead Line (Composite 345kV and 115kV Gallows Hill to Archers Lane, 345kV H-Frame Hoyts Hill to Gallows Hill, and Norwalk Section)

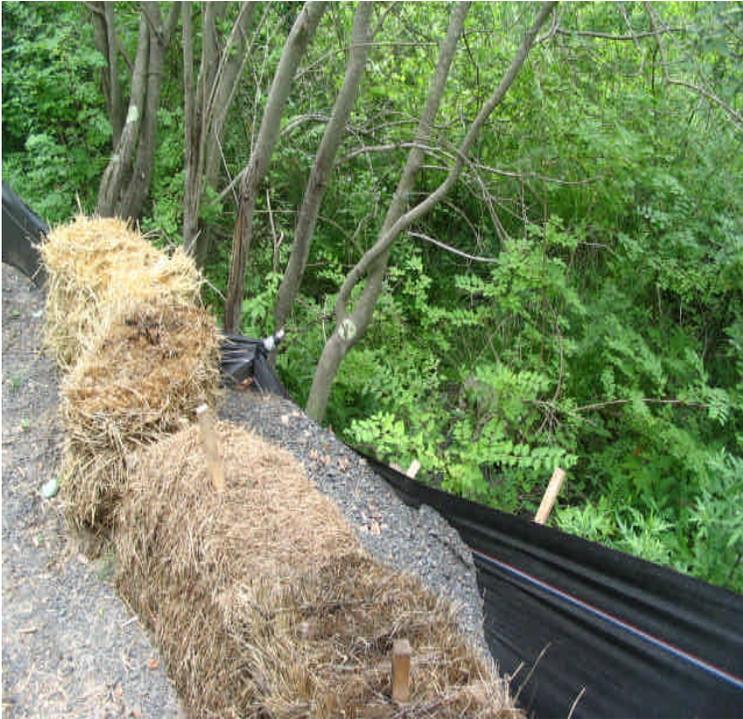
**(Composite Section):** Photo on the left shows the spot along the Archers Lane ROW where the access road stone overtopped the fence. It should be pulled back. **(345kV H-Frame):** Photo on the right shows the controls installed near structure #2 last week. 6/20/06

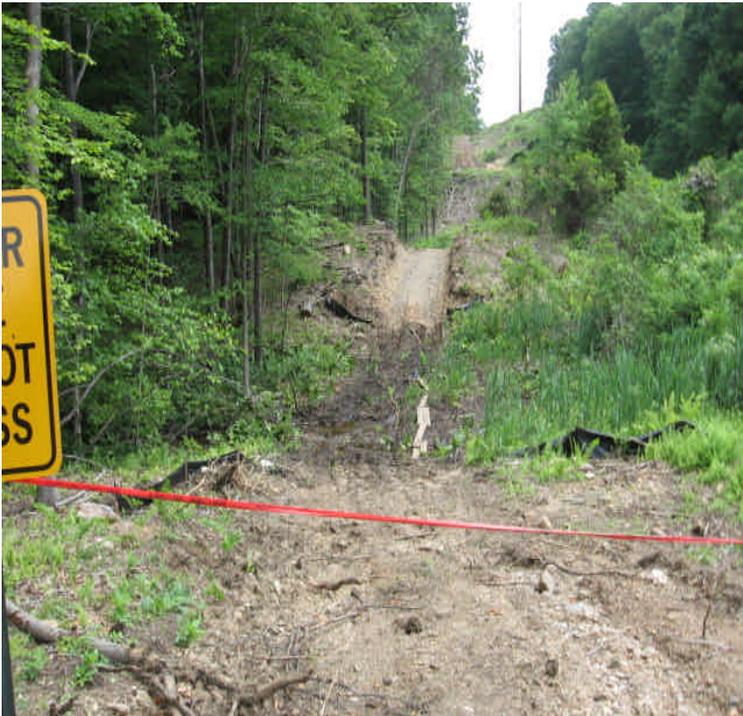
Areas of Inspection	Observation	Recommended Action	Corrective Action
Bethel Reservoir Section to Chestnut Ridge Rd.	<p>#6 on 6/14/06</p> <p>- Non project related vehicles were still reported in the stream &amp; wetland between poles #10-11. Ruts and disturbance worsened. 6/14-6/20/06.</p>	<p>- The ruts in the stream or wetland should be smoothed out and silt fence should be placed across the ROW to prevent sedimentation and help discourage access. 5/17-6/20/06</p>	<p>- Needs attention (even though the majority of the damage is not project related.)</p>
Costa Lane, Whortleberry, Lime Kiln and John Todd Way	<p>- Erosion controls at poles #24 and 25 are in good shape. 6/20/06.</p>	<p>-Continue to monitor. 6/20/06.</p>	<p>- N/A</p>
<b>Norwalk Section</b>	<p>- A contractor (unrelated to the project) remains in this area filling near the wetland for a driveway. 6/7/06-6/20/06. Silt fence has been installed near the work. 6/20/06.</p>	<p>- This is not project related but should be noted for the record in case there are issues here later. 6/7-6/20/06.</p>	<p>- Not project jurisdictional</p>

**(345kV H-Frame):** Photo on the left shows a view of the wetland between structures #10 and 11. Adjacent landowners have reported vehicles here which are not project related. Some silt fence across the access road may help to prevent this. Photo on the right shows vegetation growing well within the wetland. 6/20/06.

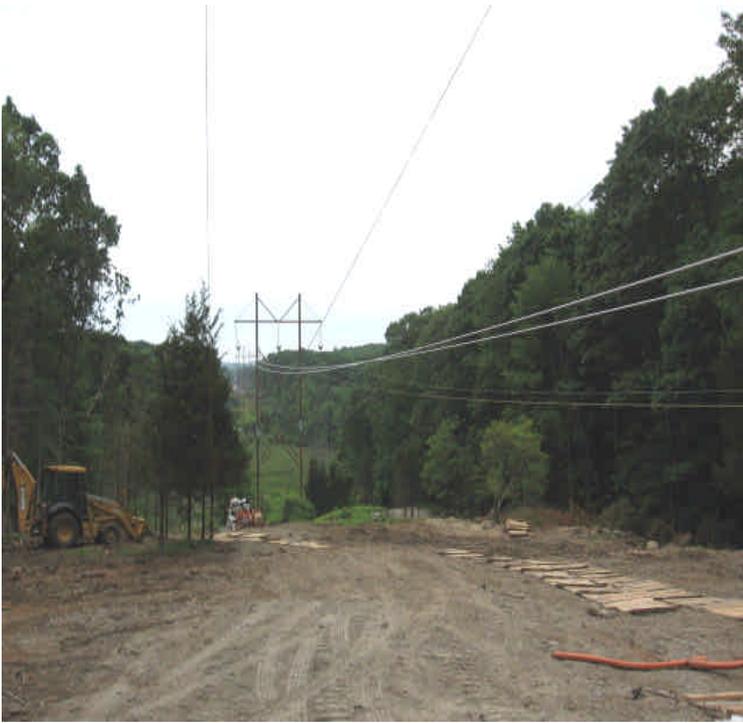
**Photo on the left shows the wire pulling in the vicinity of John Todd Way. Photo on the right shows the silt fence in place and the vegetative cover near structure #24. 6/20/06.**

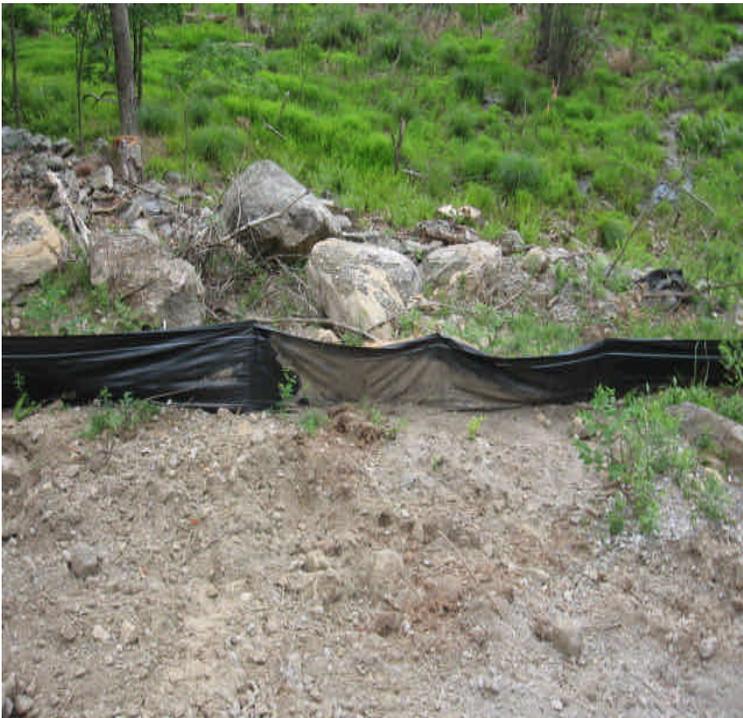
**Photo on the left shows the erosion controls in place near structure #25. (Norwalk Section): Photo on the right shows new foundations being installed along the new portion of the ROW, north of Kent Rd. 6/20/06.**

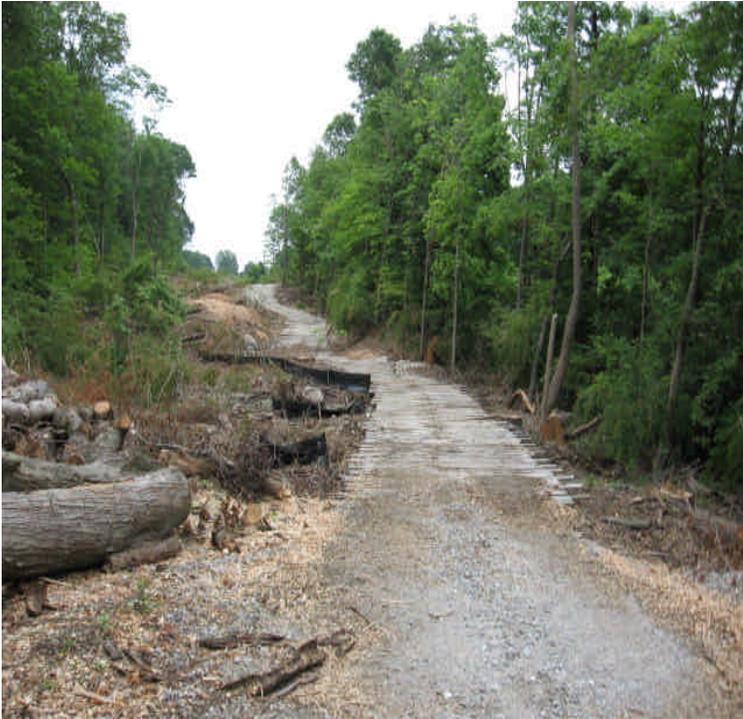
<p>-Although water in the stream was not turbid during the recent heavy</p>	<p>-Extend the silt fence along both banks of the stream to prevent run-off</p>	<p>- Needs attention</p>

**(Kent Rd):** Photo on the left shows the matted stream crossing. Silt fence should be extended along the banks here. Photo on the right shows the silt fence in good shape near the natural swale. 6/20/06.

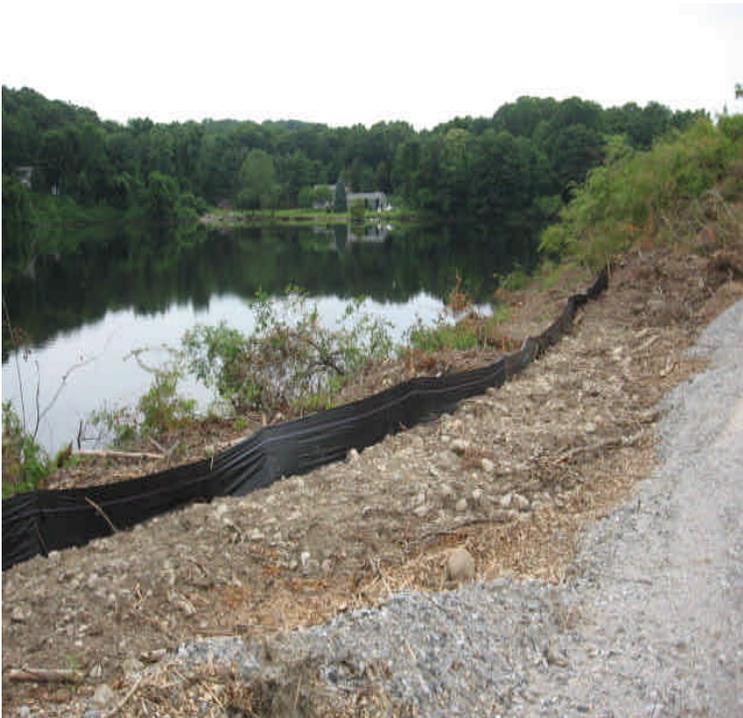
**Photo on the left shows a view of the pond with the silt fence in good shape. Photo on the right shows a view of mats placed in a wet area to access the structure. 6/20/06**

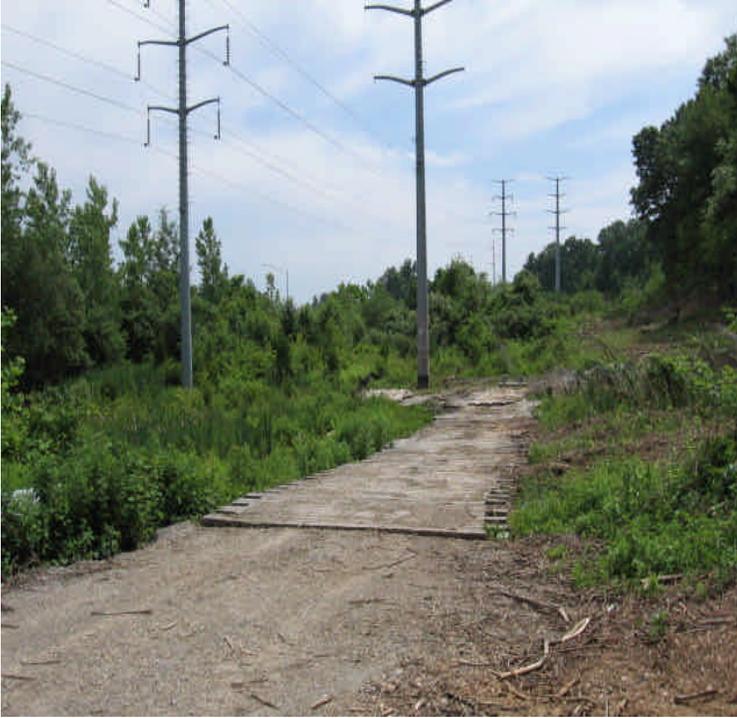
**Photo on the left shows another view of the ROW in the Kent Rd/North Seir Hill Rd. area. (Perry Ave): Photo on the right shows where the silt fence remains in place at the structure adjacent to the overflow portion of the river. The area surrounding the foundation should be revegetated. 6/20/06**

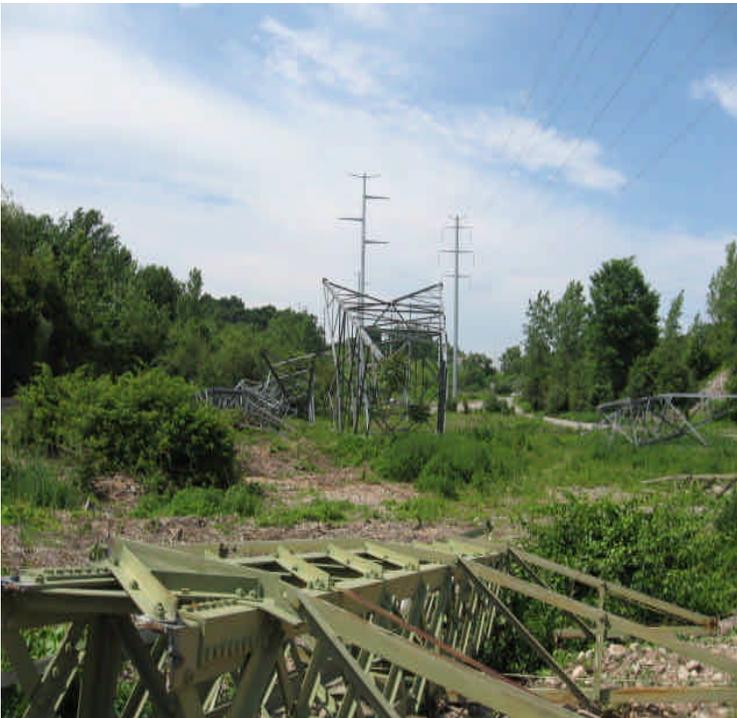
**Photo on the left shows a view of the ROW in the Perry Ave section. Towers will be removed eventually. Photo on the left shows the structure near Norwalk Substation. Erosion controls remain in place but the area should be re-vegetated to decrease potential run-off. 6/20/06**
