Docket No. 217 – Development and Management Plan Inspection

Northeast Utilities Service Company Certificate of Environmental Compatibility and Public Need for the construction of a 345-kV electric transmission line and reconstruction of an existing 115-kV electric transmission line between Connecticut Light and Power Company's Plumtree Substation in Bethel, through the towns of Redding, Weston, and Wilton, and to the Norwalk Substation in Norwalk, Connecticut.

Date: July 5, 2006

Location: Overhead Line (Composite 345kV and 115kV Gallows Hill to Archers Lane, 345kV H-Frame Hoyts Hill to Gallows Hill, and Norwalk Section)

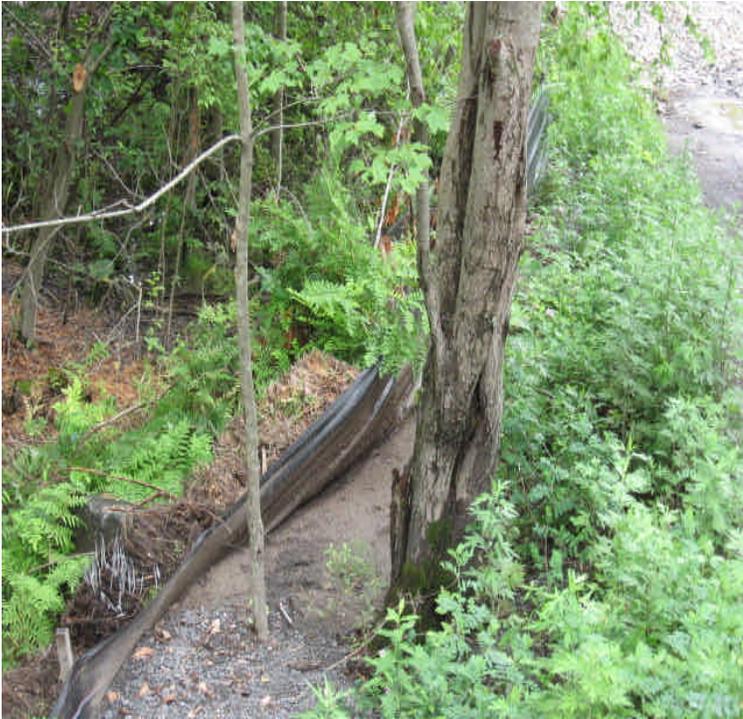
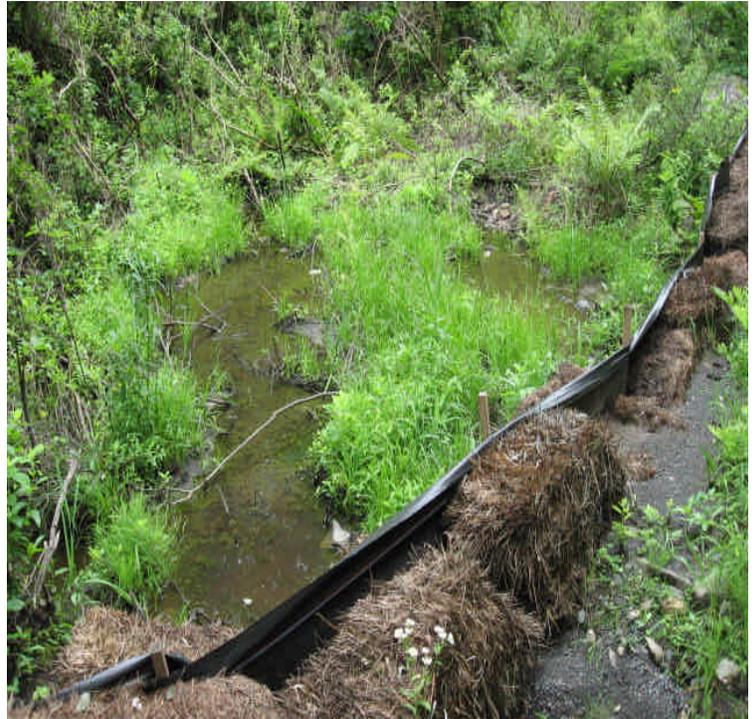
(Composite Section): Photo on the left shows the spot along the Archers Lane ROW where the access road stone was close to overtopping the fence near the 2nd wetland. Photo on the right shows where the wetland is recovering from the skidder damage this winter. 7/5/06

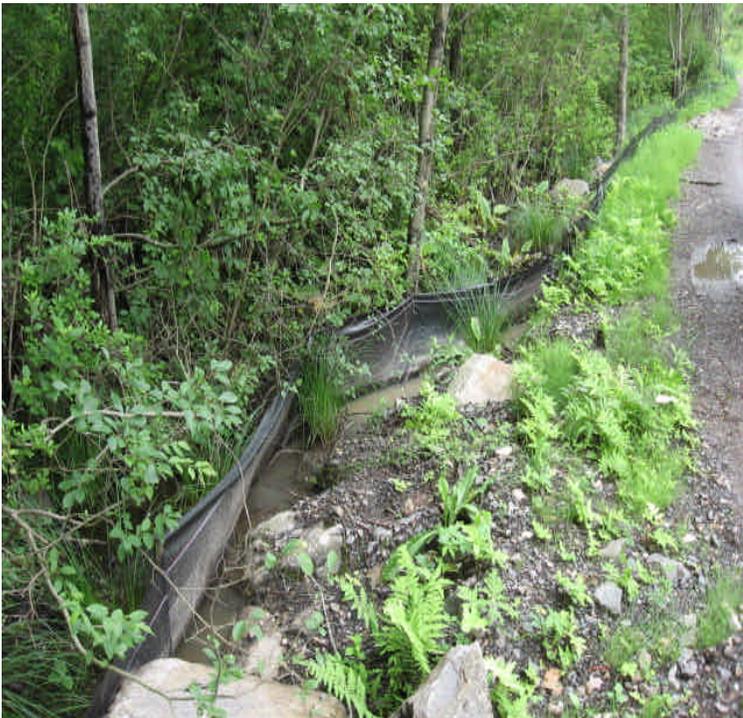
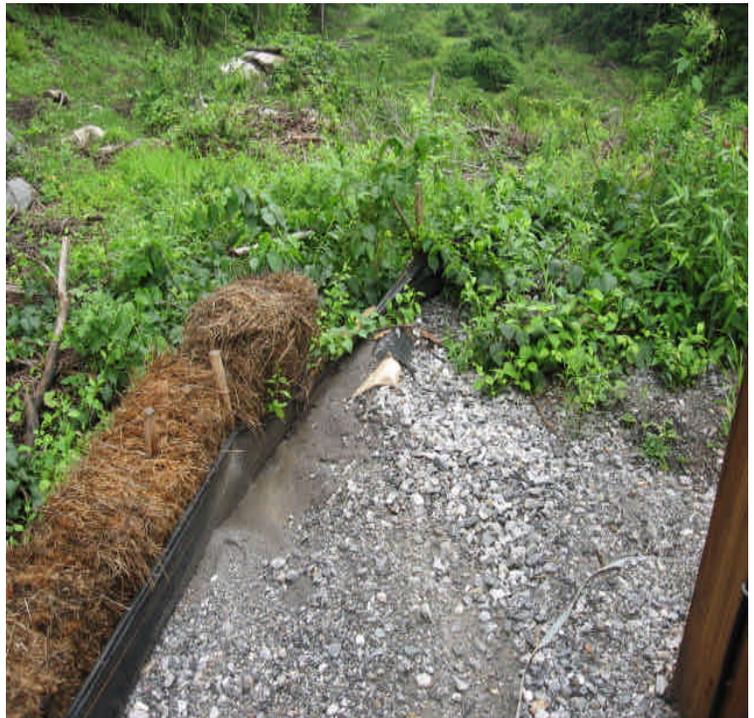
Photo on the left shows the 3rd wetland crossing past Archers Lane where turbid water from the access road was noted last week. Maintain controls where necessary. (345kV H-Frame): Photo on the right shows erosion controls holding near structure #2. 7/5/06.

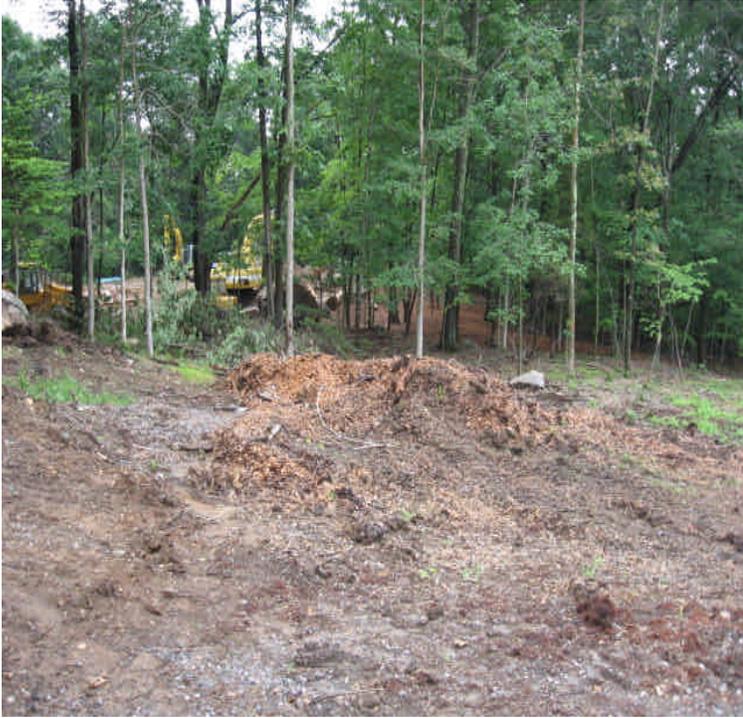
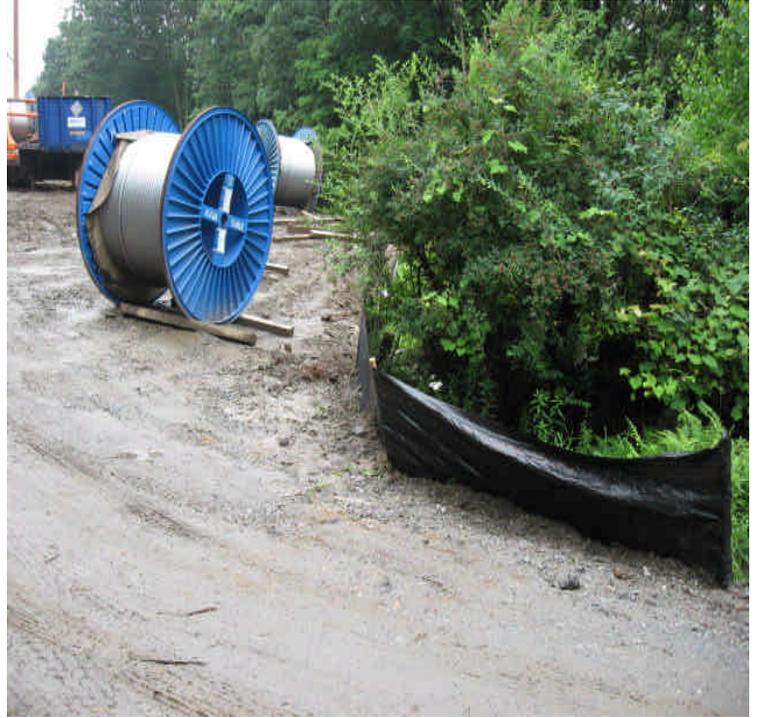
Photo on the left shows the residential contractor in the background and some wood chips in the ROW in the foreground near structure #24. The pile should be spread out to an appropriate depth. Photo on the right shows where the additional silt fence was installed as recommended.

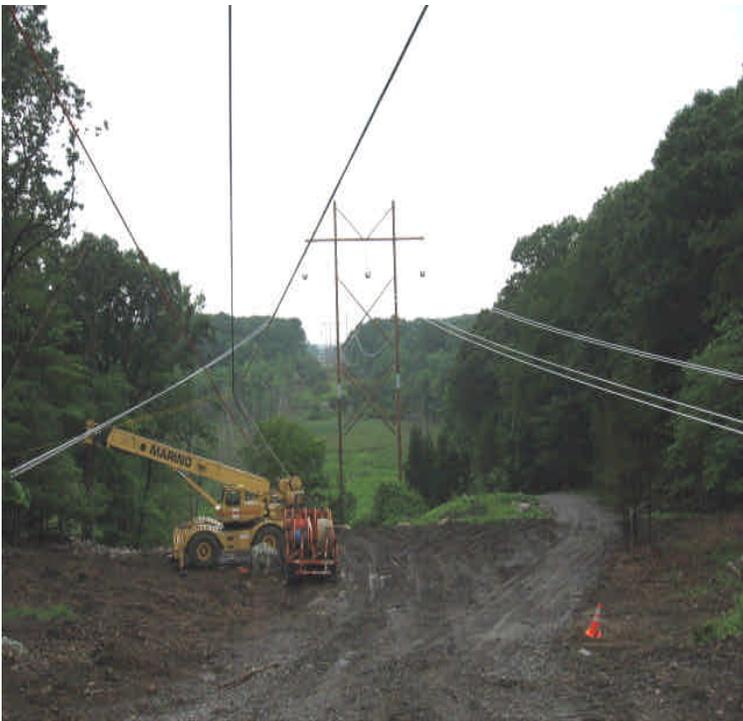
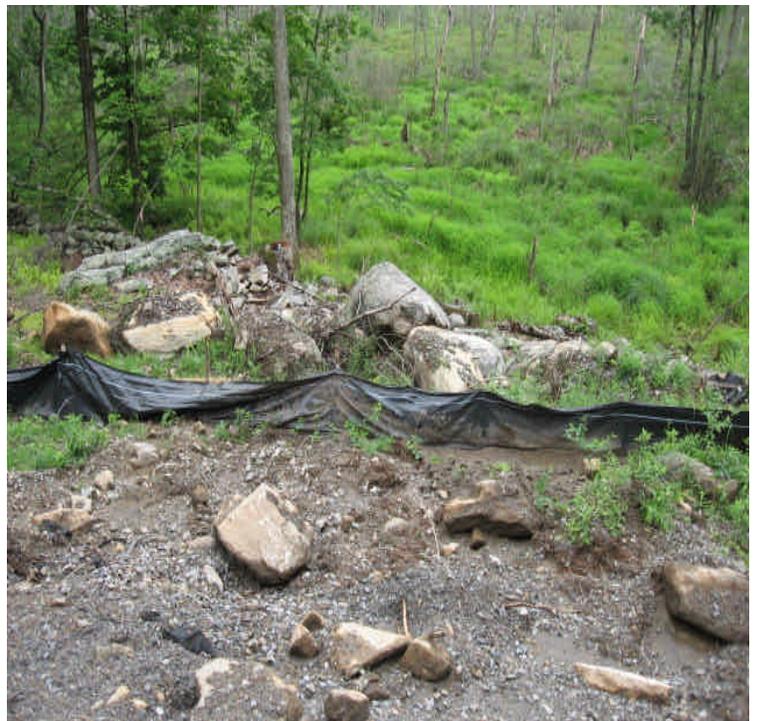
Photo on the left shows the wire pulling occurring near John Todd Way. Photo on the right shows where the silt fence was repaired in this area following a washout last week. 7/5/06.

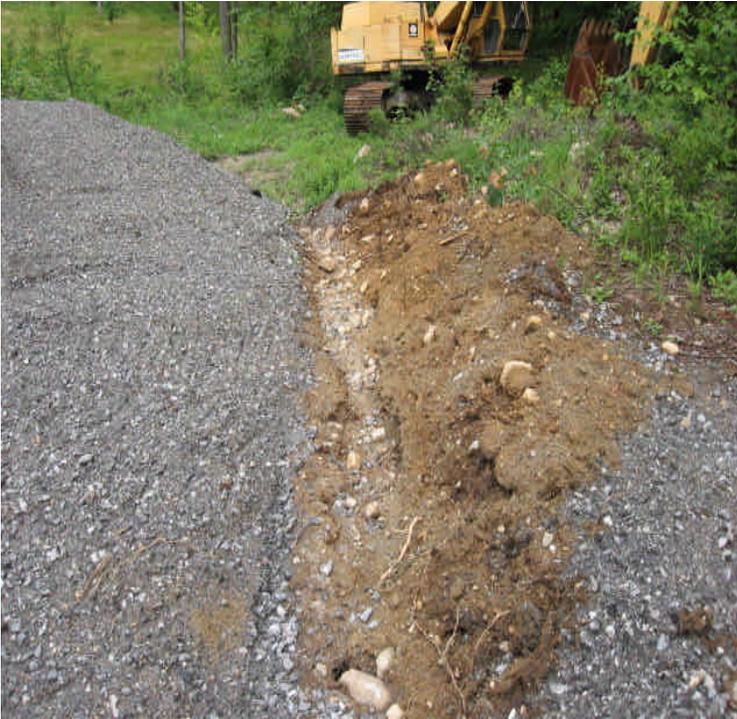
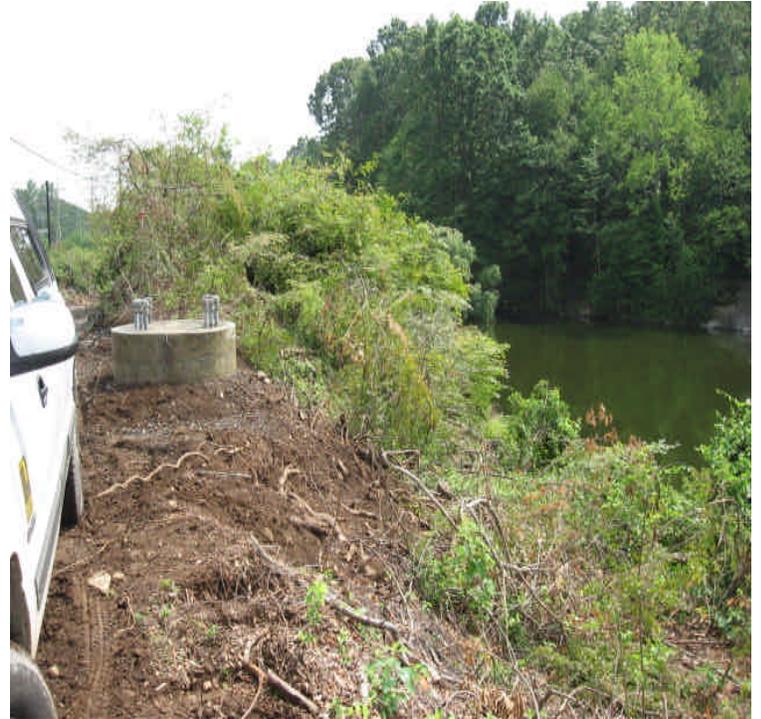
Photo on the left shows a swale cut in an attempt to direct erosive run-off flow in the area of structure #31 but in turn, it created new sedimentation issues. (Kent Rd) Photo on the right shows where controls (haybales, silt sock or silt fence) are needed near the new foundation installation. 7/5/06.

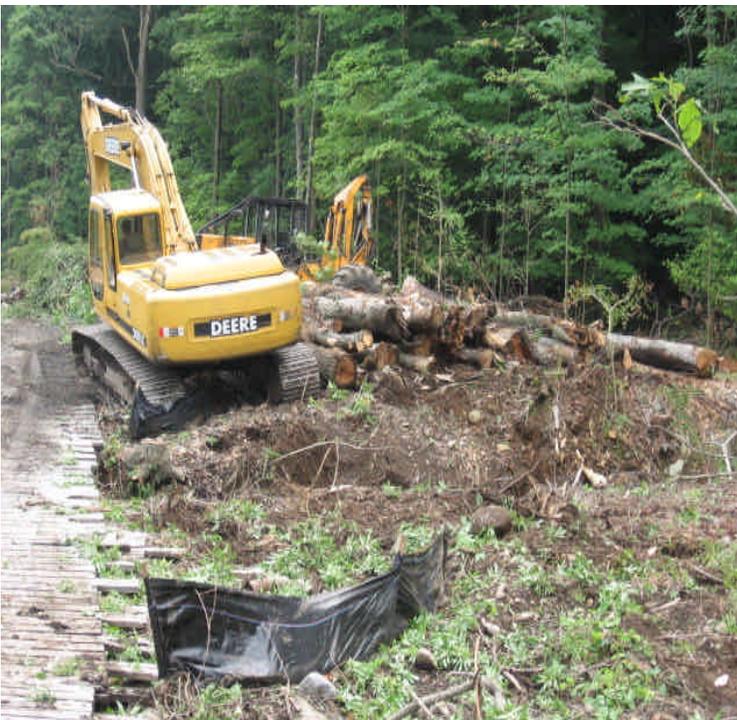
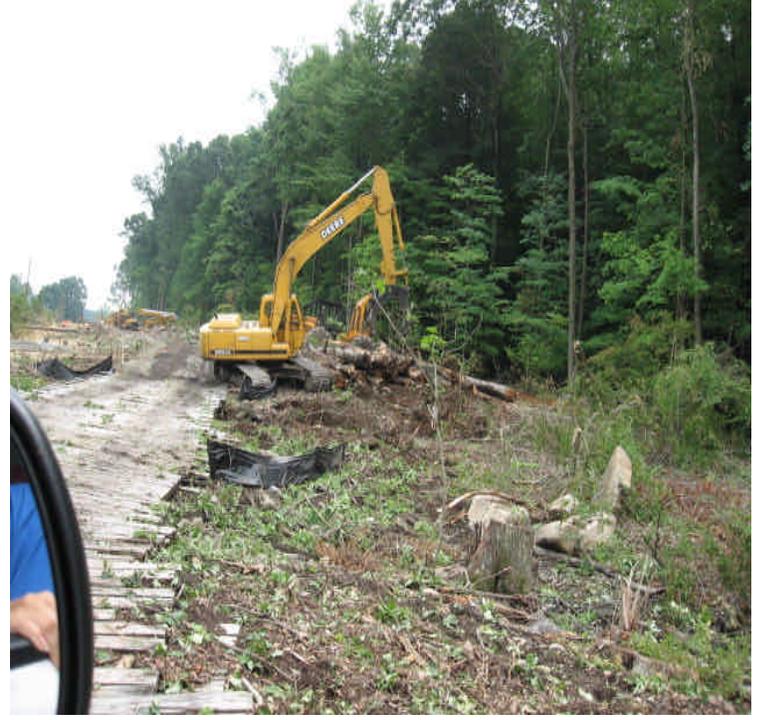
Both photos show additional clearing work near the stream crossing on the new ROW section. Controls need to be extended along both stream banks here since the soil is now exposed and disturbed. 7/5/06

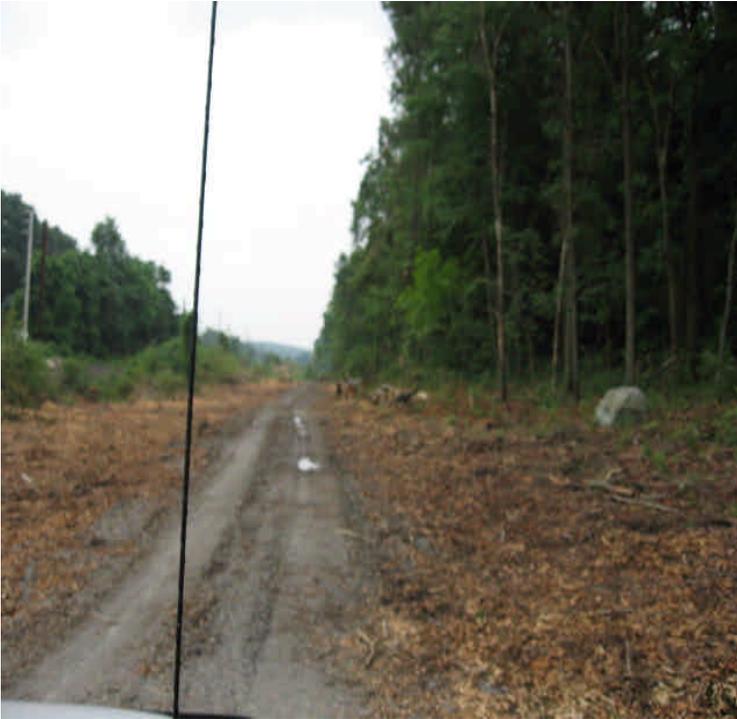
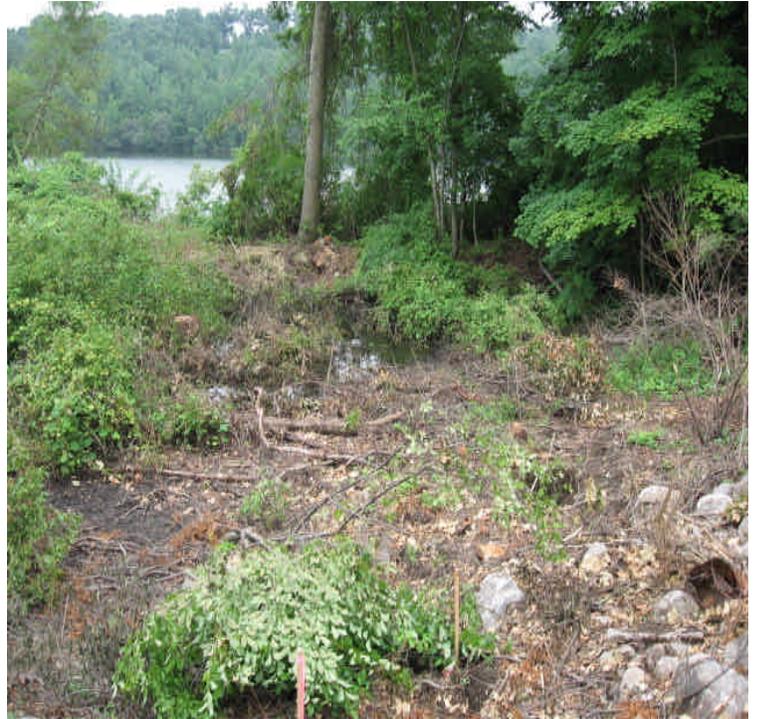
Photo on the left shows a view along the new ROW clearing north of Kent Rd off Wilton Terrace. Photo on the right shows the edge of a wetland area near a proposed foundation location adjacent to the pond. 6/28/06

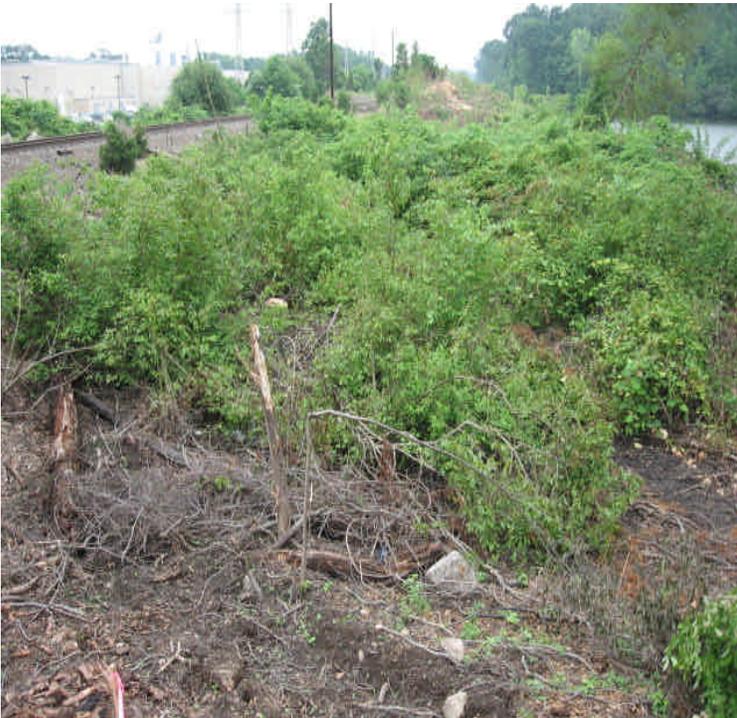
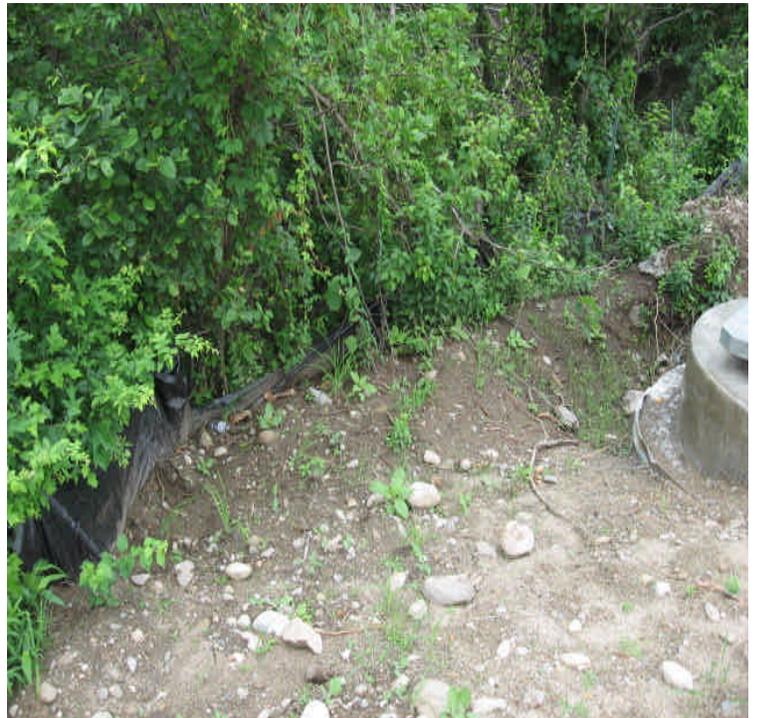
Photo on the left shows the view of the wetland swale where access would need to occur to reach the foundation. Mats and erosion control would be needed. Photo on the right shows a spot near structure #11078 where sediment was beginning to pile near the silt fence. Continue to monitor and remove if it becomes a problem. 7/5/06
