Docket No. 217 – Development and Management Plan Inspection

Northeast Utilities Service Company Certificate of Environmental Compatibility and Public Need for the construction of a 345-kV electric transmission line and reconstruction of an existing 115-kV electric transmission line between Connecticut Light and Power Company's Plumtree Substation in Bethel, through the towns of Redding, Weston, and Wilton, and to the Norwalk Substation in Norwalk, Connecticut.

Date: July 26, 2006

Location: Overhead Line (Composite 345kV and 115kV Gallows Hill to Archers Lane, 345kV H-Frame Hoyts Hill to Gallows Hill, and Norwalk Section)

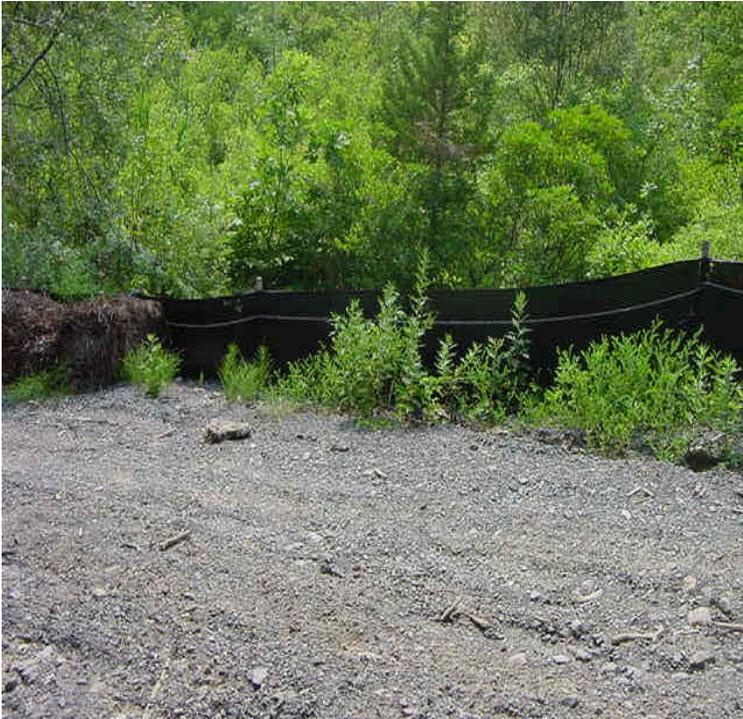
(Composite Section): Photo on the left shows repairs made to the silt fence along the access road on the Archers Lane ROW. Photo on the right shows erosion along the steeper slopes within the access road. 7/26/06

- Silt fence along the access road past Archers Lane was repaired at the second crossing. 7/26/06.	-Continue to address any other problem areas. Also, continue to remove any accumulated sediment in the wetlands 7/26/06	-Silt fence was repaired.
345kV H-Frame	- Work areas are accessed from Hoyts Hill, Chestnut Ridge Rd, Webb Rd, Lime Kiln Rd, Whortleberry Rd, John	-Continue to monitor the conditions of all access roads. If muddy conditions re-occur, place	- N/A at this time

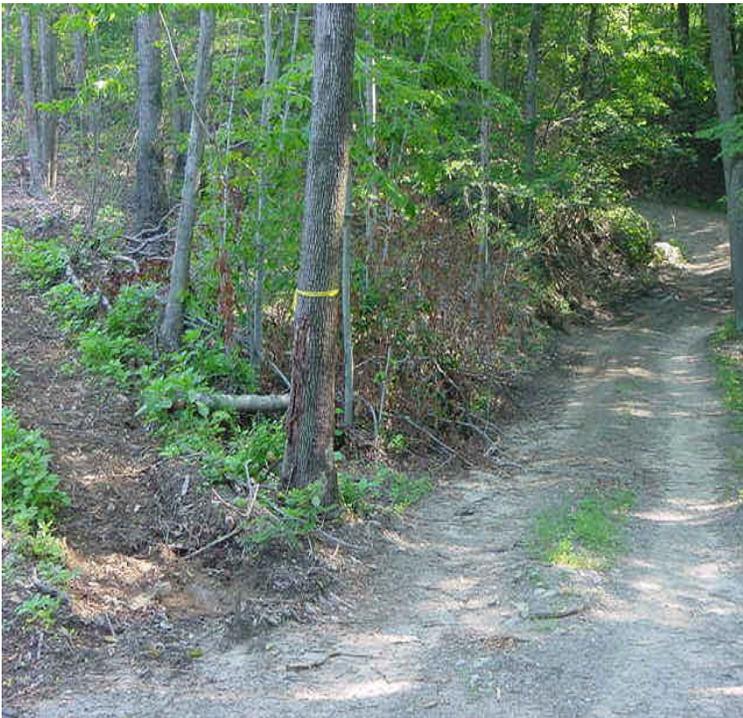
(345kV H-Frame): Photo on the left shows some danger trees marked out for clearing along this section. Photo on the right shows a view of the wetland between structures #10 and 11. Vegetation is returning where the mats had been but haybales could still be installed across the road. 7/26/06.

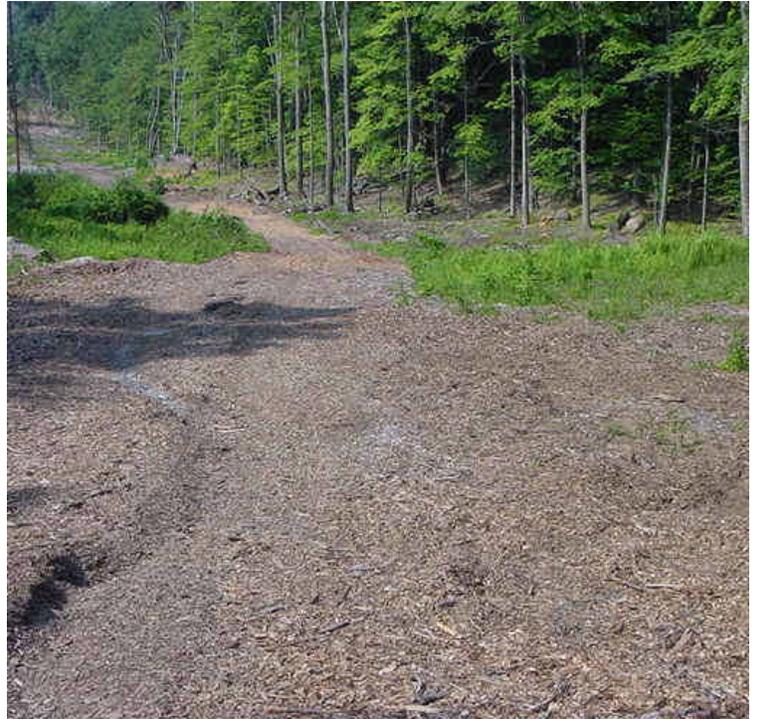
Photo on the left shows crews clipping in wire near structure #2. Photo on the right shows where some repairs were made to erosion in the access road. Wood chips were added. 7/26/06

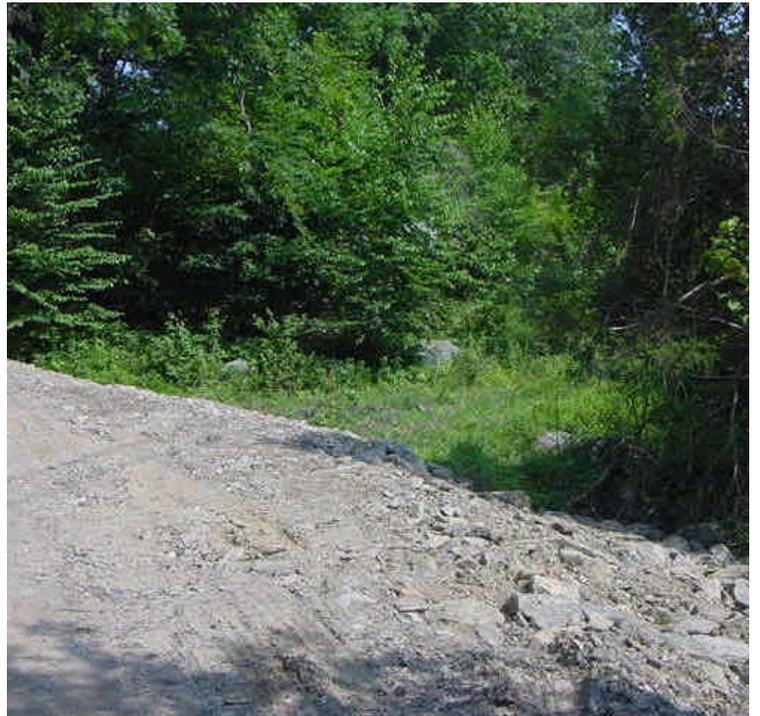
Photo on the left shows crews clipping in wire at structure #24 off John Todd Way. Photo on the right shows a view of the widened road resulting from the residential contractor's work. 7/26/06.

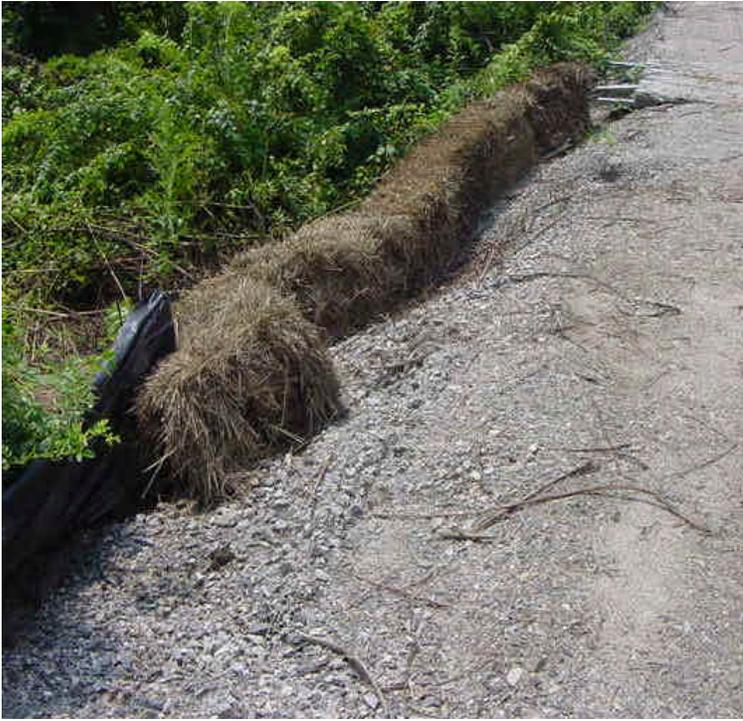
Photo on the left shows the haybales in place along the access road to the south of Kent Rd. Continue to monitor this spot. Photo on the right shows where silt fence needs repair between #11067 and 11068 off North Seir Hill Rd. 7/26/06
