Docket No. 217 – Development and Management Plan Inspection

Northeast Utilities Service Company Certificate of Environmental Compatibility and Public Need for the construction of a 345-kV electric transmission line and reconstruction of an existing 115-kV electric transmission line between Connecticut Light and Power Company's Plumtree Substation in Bethel, through the towns of Redding, Weston, and Wilton, and to the Norwalk Substation in Norwalk, Connecticut.

Date: August 3, 2006

Location: Overhead Line (Composite 345kV and 115kV Gallows Hill to Archers Lane,
345kV H-Frame Hoyts Hill to Gallows Hill, and Norwalk Section)

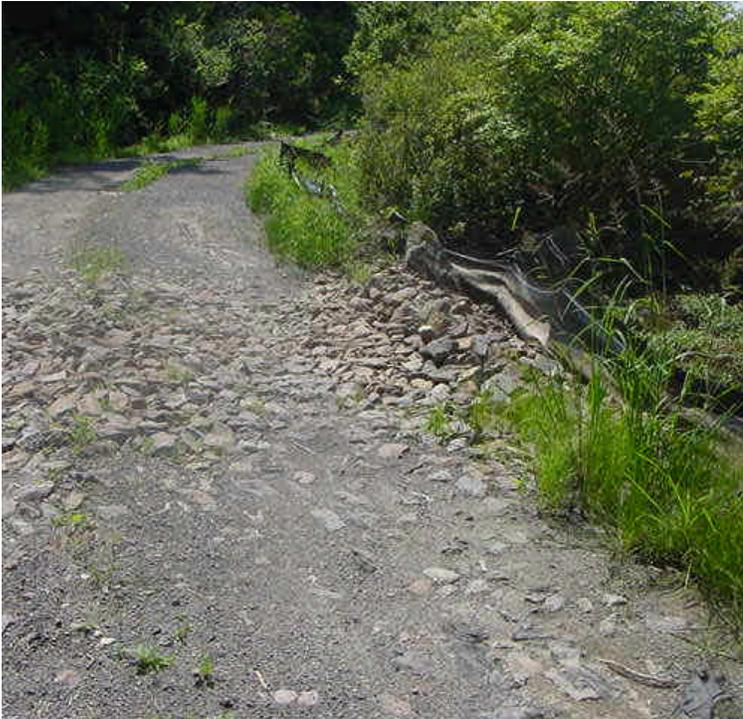
(Composite Section): Photo on the left shows the wetland crossing off Gallows Hill Rd. Wetland water levels are at seasonal low flow. Photo on the right shows crews clipping in wire along the Archers Lane ROW. 8/3/06

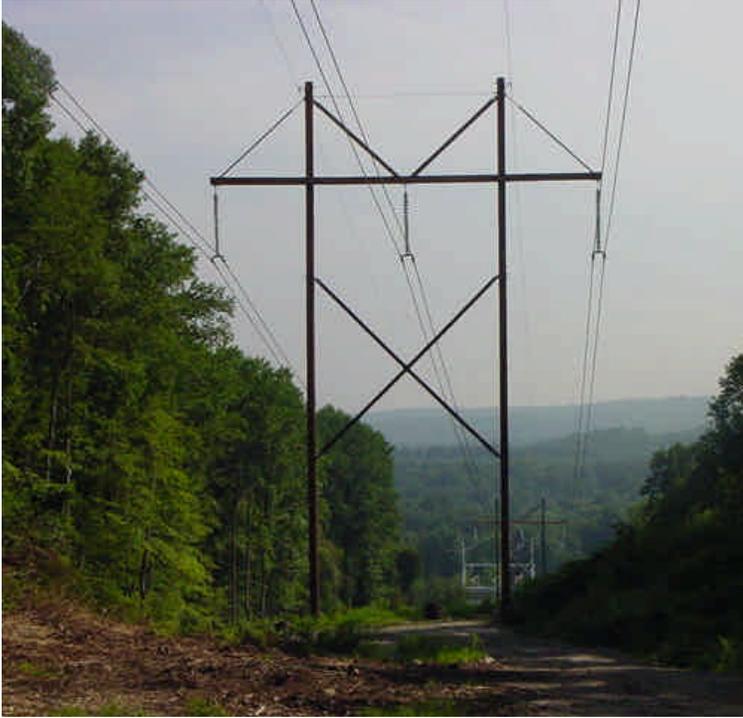
Photo on the left shows the wires clipped in at structure #2. Photo on the right shows silt fence coming down at the wetland edge off Lime Kiln Rd. 8/3/06

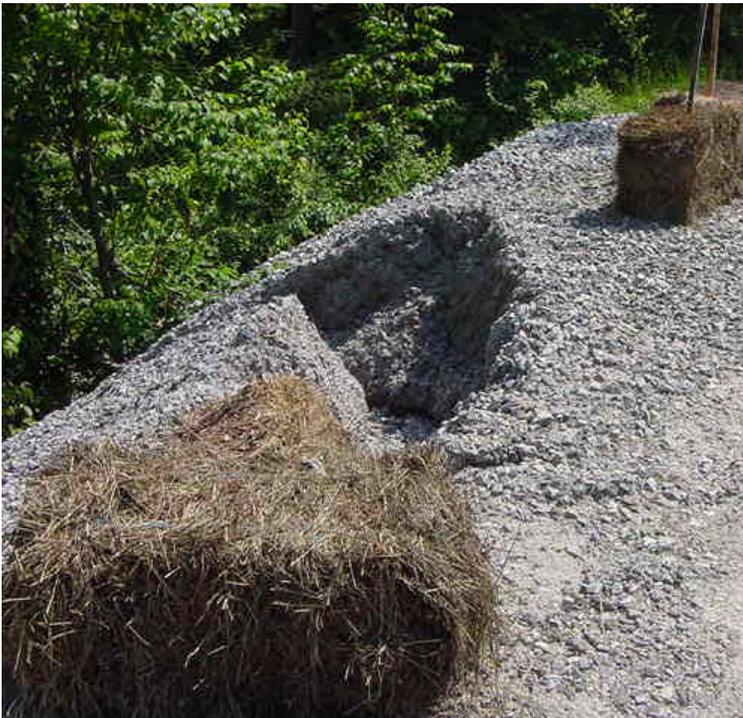
345kV H-Frame	- Work areas are accessed from Hoyts Hill, Chestnut Ridge Rd, Webb Rd, Lime Kiln Rd, Whortleberry Rd, John Todd Way and Costa Lane. 3/29-8/3/06. - The access road erosion near structure #31 was regraded but erosion	-Continue to monitor the conditions of all access roads. If muddy conditions re-occur, place more wood chips or consider installing silt fence as needed. 8/3/06. -Continue to monitor and keep stone out of any resource areas. Haybales	- N/A at this time -Look into more permanent solutions.

Photo on the left shows a view of the erosion continuing in the access road near structure #31 despite the haybales. (Norwalk Section): Photo on the right shows a view of the ROW moving south from Arrowhead Rd. Crews were preparing for brining in wire pulling equipment. 8/3/06.

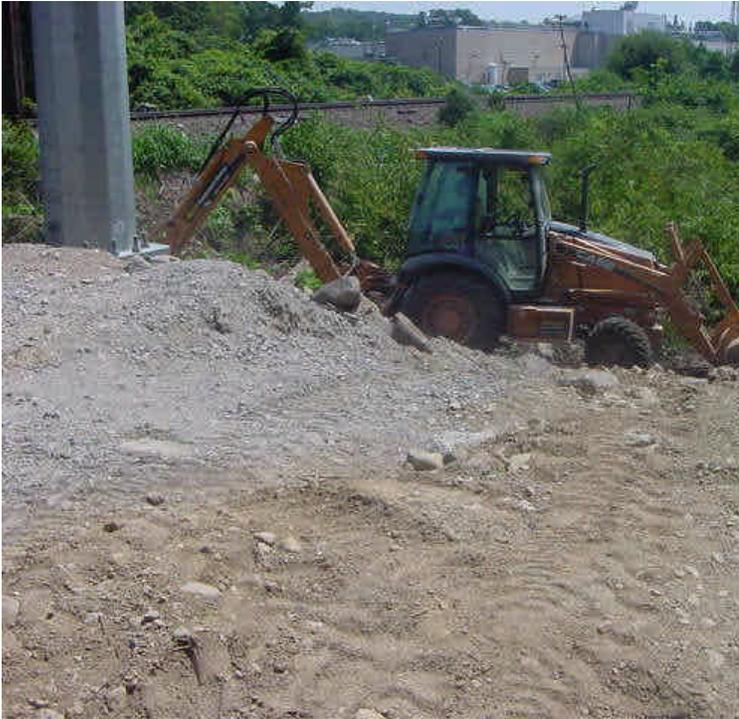
(Norwalk Section): Photo on the left shows grading work near structure #51. Silt fence will have to be repaired due to the adjacent wetland. Photo on the right shows a view along the ROW north of Kent Rd with structures in place. 8/3/06.

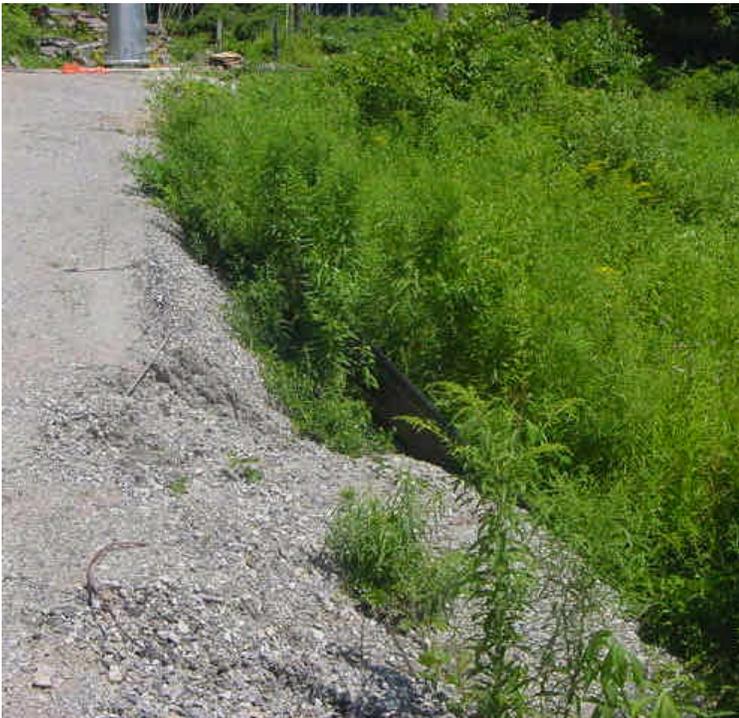
Photo on the left shows where stone from the access road has encroached on the silt fence and needs to be pulled back along the ROW south of Kent Rd. Photo on the right shows where a spill response kit was noted in this section. 8/3/06

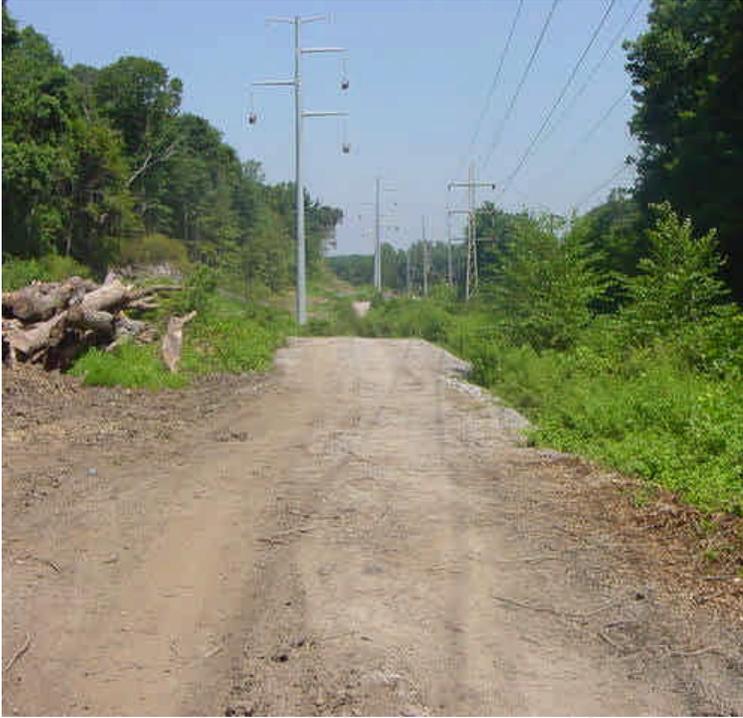
Photo on the left shows a view of the ROW south of Kent Rd with structures in place. Photo on the right shows some recently poured foundations in the North Seir Hill Rd section. 8/3/06

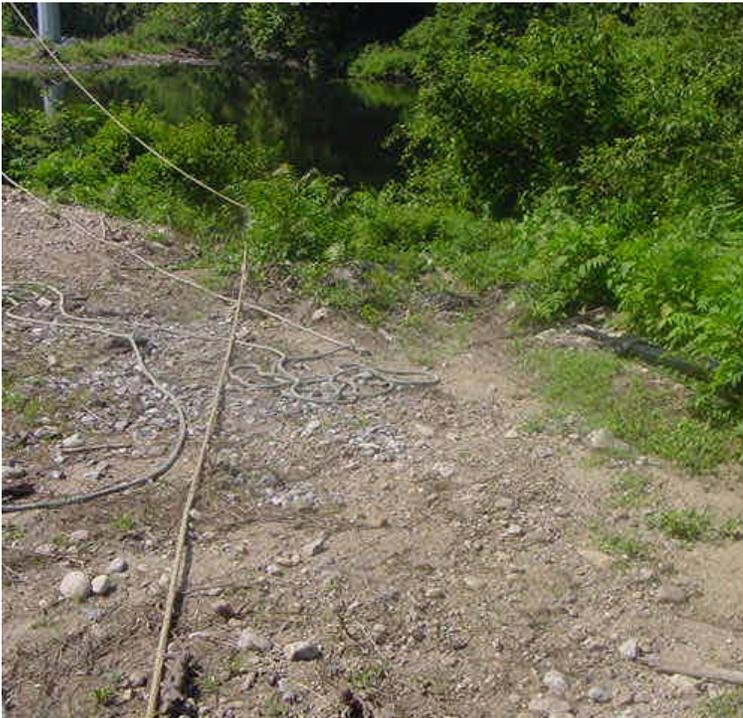
Photo on the left silt fence down near structure #11078, located north of Broad St. Repairs should be made. Photo on the right shows rope/wire pulling equipment in place just north of Norwalk Substation in the ROW. 8/3/06
