**Docket No. 217 – Development and Management Plan Inspection**

Northeast Utilities Service Company Certificate of Environmental Compatibility and Public Need for the construction of a 345-kV electric transmission line and reconstruction of an existing 115-kV electric transmission line between Connecticut Light and Power Company's Plumtree Substation in Bethel, through the towns of Redding, Weston, and Wilton, and to the Norwalk Substation in Norwalk, Connecticut.

**Date:** August 17, 2006

**Location:** Overhead Line (Composite 345kV and 115kV Gallows Hill to Archers Lane, 345kV H-Frame Hoyts Hill to Gallows Hill, and Norwalk Section)

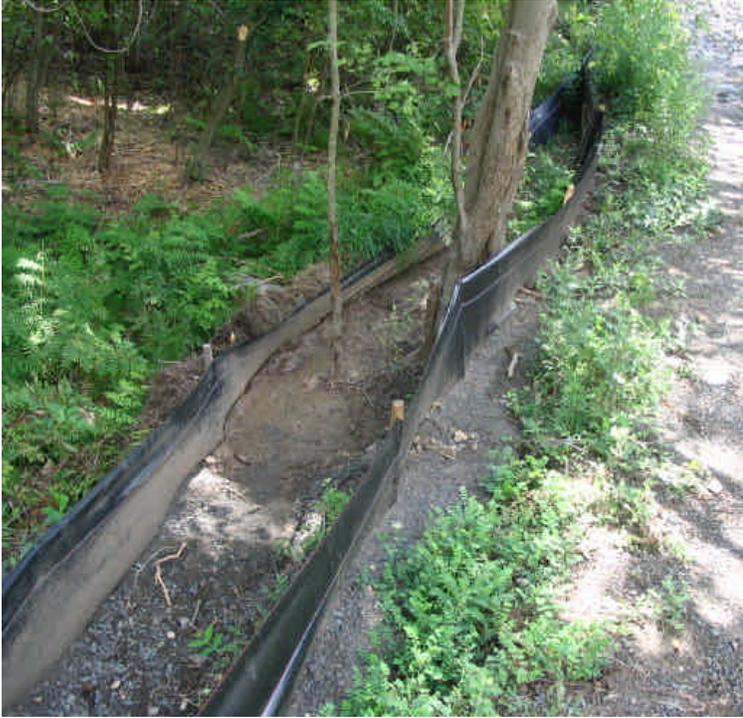
(Composite Section): Photo on the left shows a view of the repaired/reinforced silt fence along the access road in the ROW past Archers Lane. Photo on the right shows where stone continues to accumulate and spill over the fence even after repairs were recently made. 8/16/06

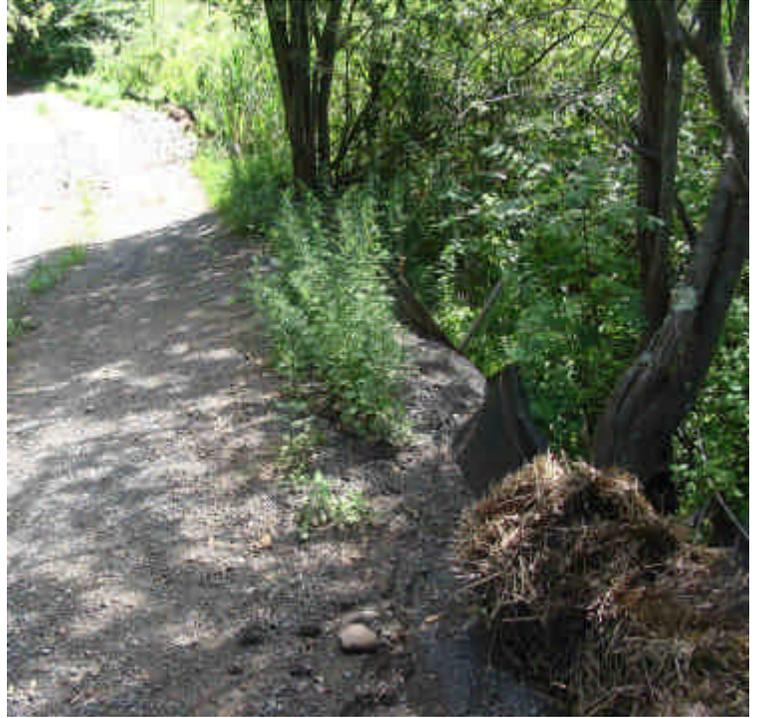
- Even with the recent repairs, erosion on the access road has caused stone to spill over the silt fence further down-gradient. 8/17/06	-This is adjacent to the 2 <sup>nd</sup> wetland crossing and will have to be pulled back and repaired again. 8/17/06	- Needs attention (even following recent repairs).
<b>345kV H-Frame</b>	- Work areas are accessed from Hoyts Hill, Chestnut Ridge Rd, Webb Rd, Lime Kiln Rd,	-Continue to monitor the conditions of all access roads. If muddy conditions re-occur, place	- N/A at this time

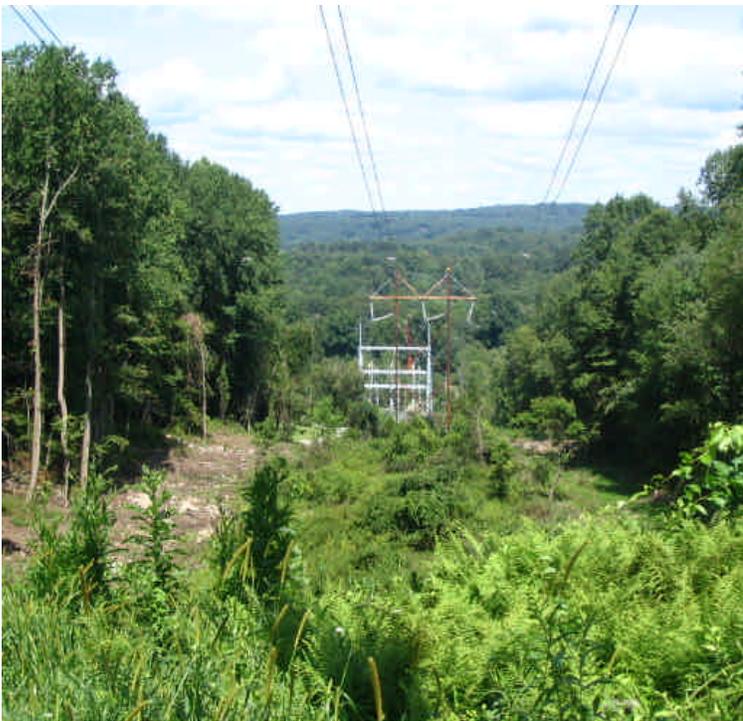
(345kV H-Frame): Photo on the left shows the view towards Hoys Hill in the Chestnut Ridge section of the ROW. Photo on the right shows a view towards structure #10 where the wetland crossing had been. Restore any bare soil areas when feasible. 8/16/06.

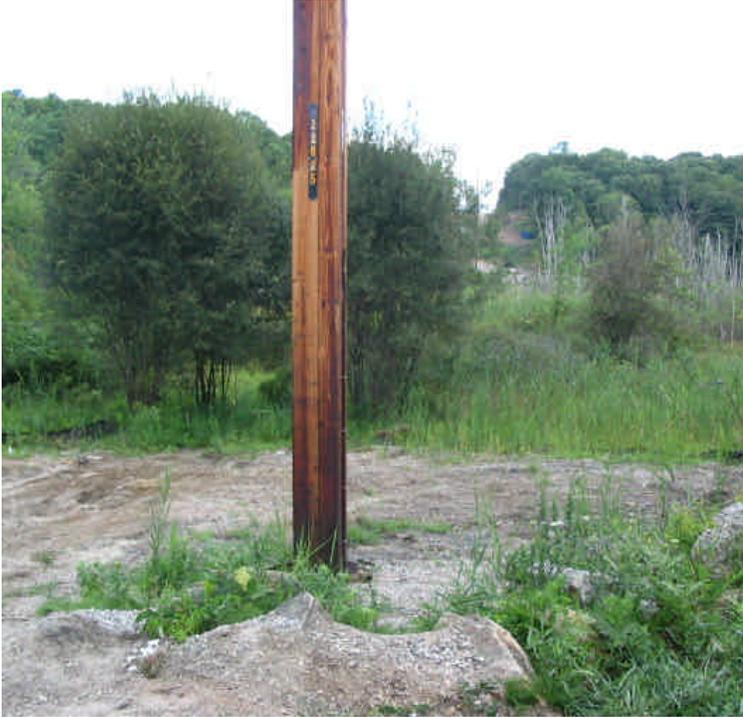
**Photo on the left shows a view towards the wetland and silt fence near structure #25 off Lime Kiln Rd. Restore vegetative cover where feasible. Photo on the right shows the continuing erosion of the access road near structure #31. 8/16/06**

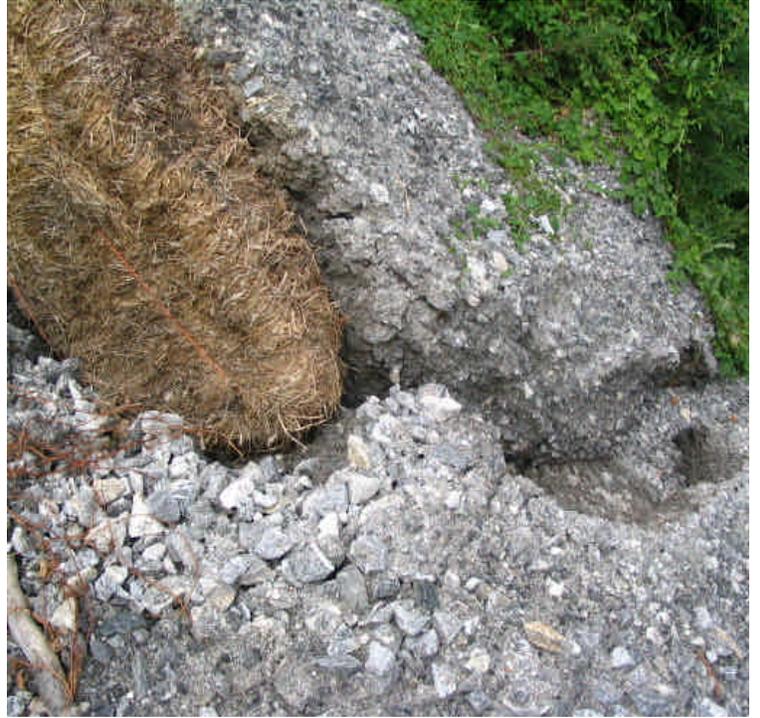
Areas of Inspection	Observation	Recommended Action	Corrective Action
<b>Norwalk Section</b>	<p>Whortleberry Rd, John Todd Way and Costa Lane. 3/29-8/17/06.</p> <p>- The access road erosion near structure #31 was regraded but erosion continues to the adjacent driveway even with the haybales in place. 7/19-8/17/06.</p> <p>- Controls at Bethel water building were in good shape. However, Webb Rd has received significant storm run-off from Nashville Rd ext. 7/12-8/17/06.</p> <p>- At Kent Rd (north) sediment tracking was not noted on the street. 7/19-8/17/06.</p> <p>-Mats remain in good shape over the wetlands in this section. 8/17/06</p> <p>-Several wetlands are matted to the south of Kent Rd. Silt fence appears to be in good shape along this section. 8/17/06.</p>	<p>more wood chips or consider installing silt fence as needed. 8/17/06.</p> <p>-Continue to monitor and keep stone out of any resource areas. Haybales currently contain the sediment. 7/26-8/17/06</p> <p>- Flow from Webb Rd during rain events is not project related but it is washing out the road with each storm 7/5-8/16/06</p> <p>- Continue to maintain this entrance and sweep street when necessary. Add more clean stone if needed 7/19-8/17/06</p> <p>- None at this time. 8/17/06</p> <p>- Continue to maintain and reinforce the spots that continuously wash out. 7/12-8/17/06</p>	<p>-Look into more permanent solutions.</p> <p>- Evaluate road condition</p> <p>-N/A at this time</p> <p>-N/A</p> <p>- Silt fence seems to be in good repair</p>

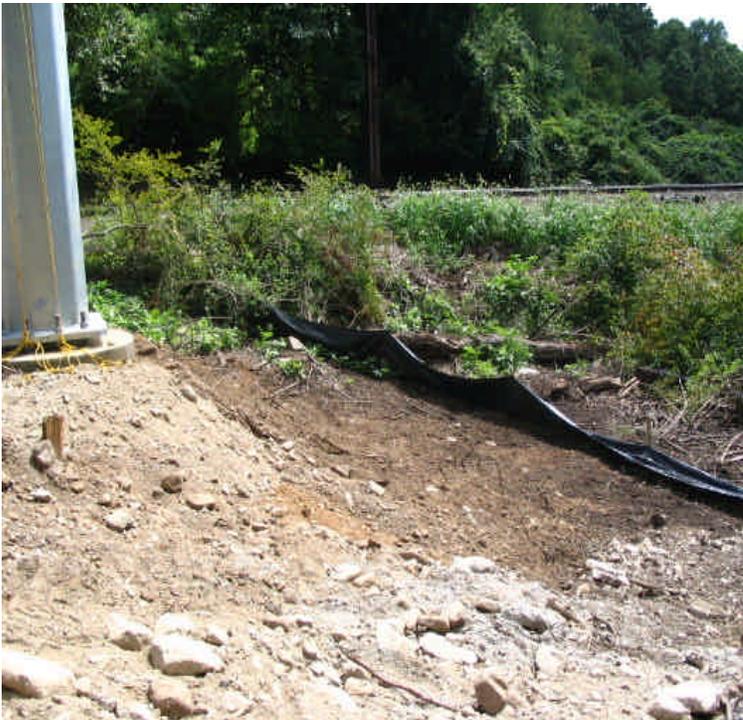
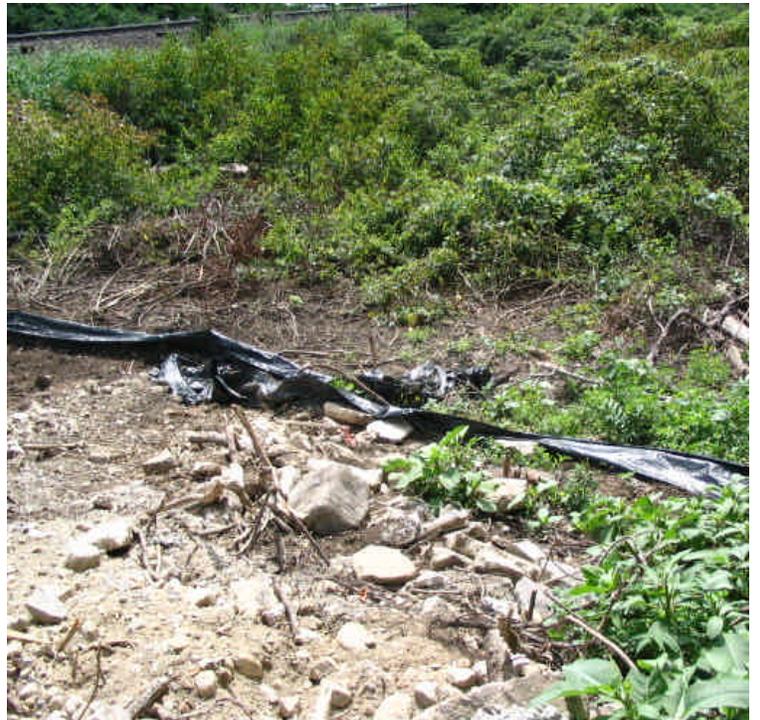
Areas of Inspection	Observation	Recommended Action	Corrective Action
<p>Arrowhead Rd (south)</p> <p>Kent Rd. (South)</p>	<p>-Silt fence was still down at pole #11051 at the time of inspection. 8/3-8/17/06</p> <p>- Fence was in good shape along the Kent Rd south ROW but stone remains on other side. 8/17/06.</p>	<p>- Silt fence was repaired immediately after the inspection. 8/17/06</p> <p>-Continue to repair and reinforce controls. These areas will be difficult to control during heavy rain due to the drainage patterns. 7/12-8/17/06</p>	<p>- Fence was repaired.</p> <p>- Remove stone when feasible.</p>
<p>Inland Wetland and Watercourse encroachment and mitigation <b>Composite</b></p> <p><b>345kV H-Frame</b></p> <p><b>Norwalk Section</b></p>	<p>-The D&amp;M plan approved stone on geotextile fabric at the wetland crossings have worked fairly well. 4/6-8/17/06.</p> <p>- Mats were removed from the wetland by Rt. 58. 8/17/06</p> <p>- At structure #6, most of the mud was removed from the wetland and they will continue to do so. 4/6-8/17/06.</p> <p>- Non project related vehicles had not returned to the wetland between #10-11 but damage remains. Vegetative growth has increased 8/17/06</p> <p>-Controls needed repair at #51 adjacent to the wetland near the pond at Kent Rd 8/17/06</p> <p>- Use caution in removing trees from wetland areas. Avoid creating ruts when skidding them out. 3/29-8/17/06.</p>	<p>- As the access is considered temporary, the stone will be removed when final work ends so the wetlands can be restored. 1/26-8/17/06.</p> <p>- 345kV XLPE crews restored the wetland. 8/17/06</p> <p>- Continue to remove entire pile. 2/16-8/17/06.</p> <p>- Haybales should be added across the access road on both side of the wetland to reduce sedimentation. 5/25-8/17/06</p> <p>-Silt fence was repaired immediately after the inspection. Adjacent wetlands were not impacted. 8/17/06</p> <p>- Retain shrubs and low growth as much as possible, especially at stream buffers. 3/2-8/17/06.</p>	<p>-N/A until the end of work.</p> <p>- N/A</p> <p>-Needs attention when feasible.</p> <p>-Needs attention (the majority of disturbance is from non project related vehicles)</p> <p>- NA</p> <p>- N/A</p>

**(Norwalk Section): Both photos show where silt fence remained partially down near structure #11051 adjacent to the wetland. (Fence was repaired after the inspection). 8/16/06.**

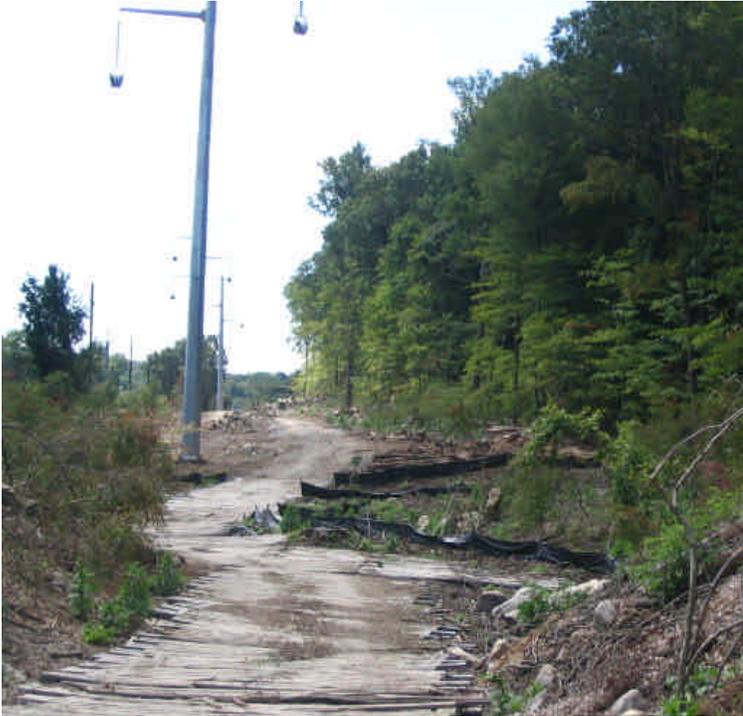
Photo on the left shows mats and silt fence in place along the section north of Kent Rd. Photo on the right shows a view of the structure in place along the bank of the pond. Ropes were in place for pulling wire. 8/16/06.

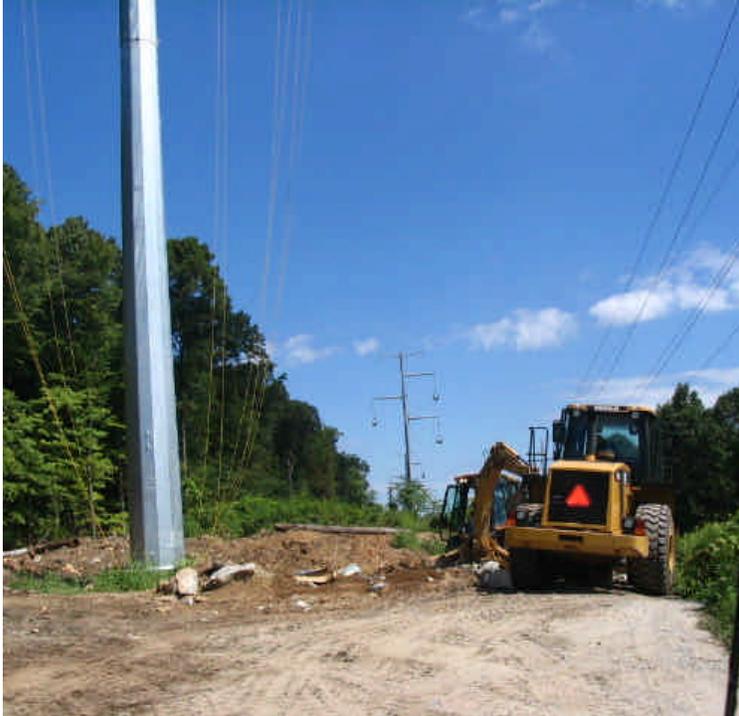
Photo on the left shows crews preparing to pull wire in the Kent Rd south area. Photo on the right shows work in the vicinity of North Seir Hill Rd. and Rt 7 extension. 8/16/06

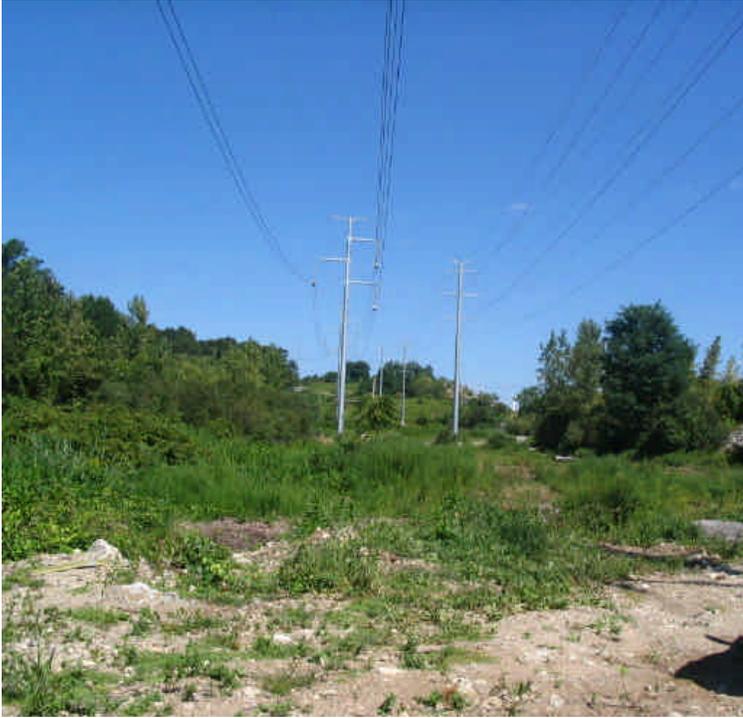
**Photo on the left shows a view along the ROW near Perry Ave with all old towers removed from the area. Photo on the right shows where the river has receded back to its main channel with the dry weather. 8/16/06**

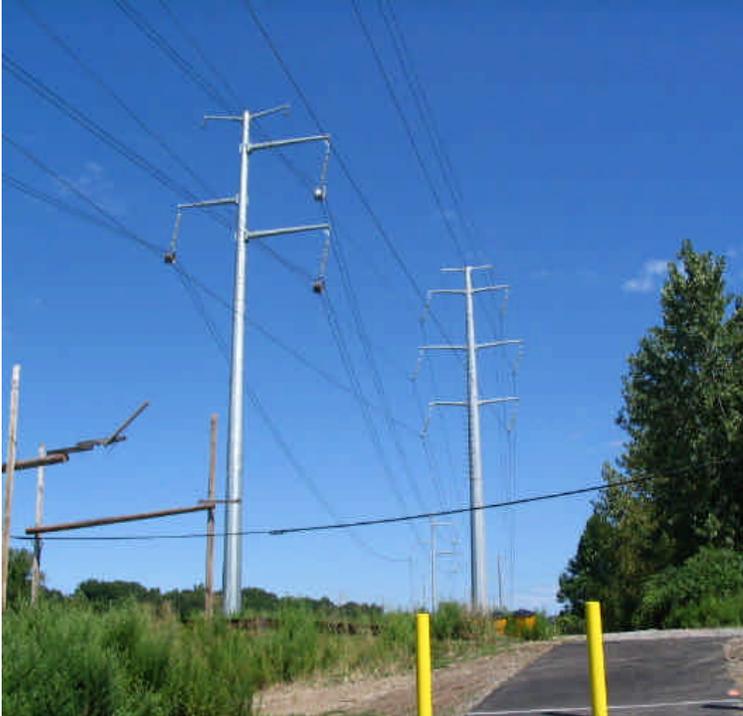
**Photo on the left shows the structures in place at the Broad St. crossing. Photo on the right shows structure #11080. Revegetate this area when feasible to reduce run-off to the silt fence and river. 8/16/06**
