Docket No. 217 – Development and Management Plan Inspection

Northeast Utilities Service Company Certificate of Environmental Compatibility and Public Need for the construction of a 345-kV electric transmission line and reconstruction of an existing 115-kV electric transmission line between Connecticut Light and Power Company's Plumtree Substation in Bethel, through the towns of Redding, Weston, and Wilton, and to the Norwalk Substation in Norwalk, Connecticut.

Date: August 22, 2006

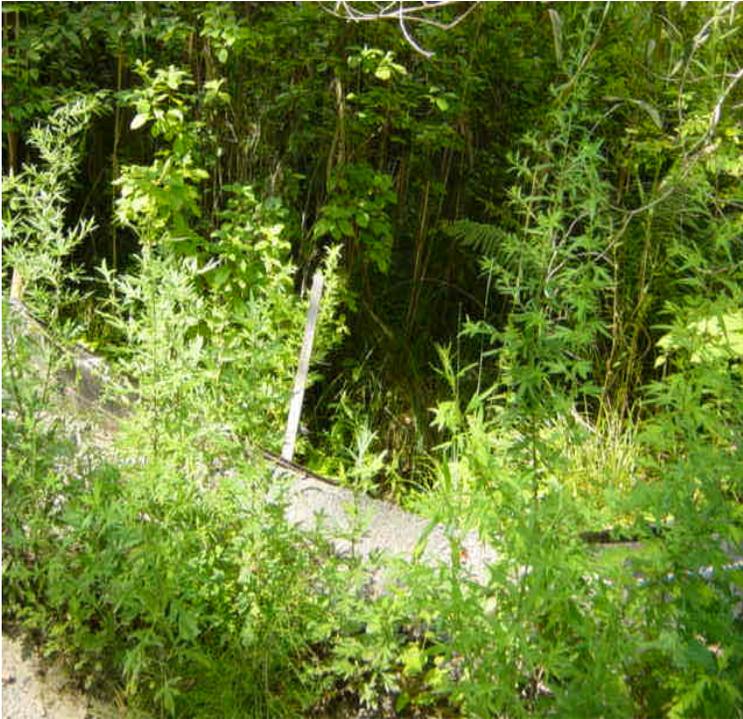
- Even with the recent repairs, erosion on the access road has caused stone to spill over the silt fence further down-gradient. 8/17-8/22/06.	-This is adjacent to the 2 nd wetland crossing and will have to be pulled back and repaired again. 8/17-8/22/06.	- Needs attention (even following recent repairs).
345kV H-Frame	- Work areas are accessed from Hoyts Hill, Chestnut Ridge Rd, Webb Rd, Lime Kiln Rd,	-Continue to monitor the conditions of all access roads. If muddy conditions re-occur, place	- N/A at this time

(Composite Section): Photo on the left shows a view of the silt fence in need of repair near the second wetland crossing along the access road past Archers Lane. Photo on the right shows where stone continues to erode and wash off the access road. 8/22/06

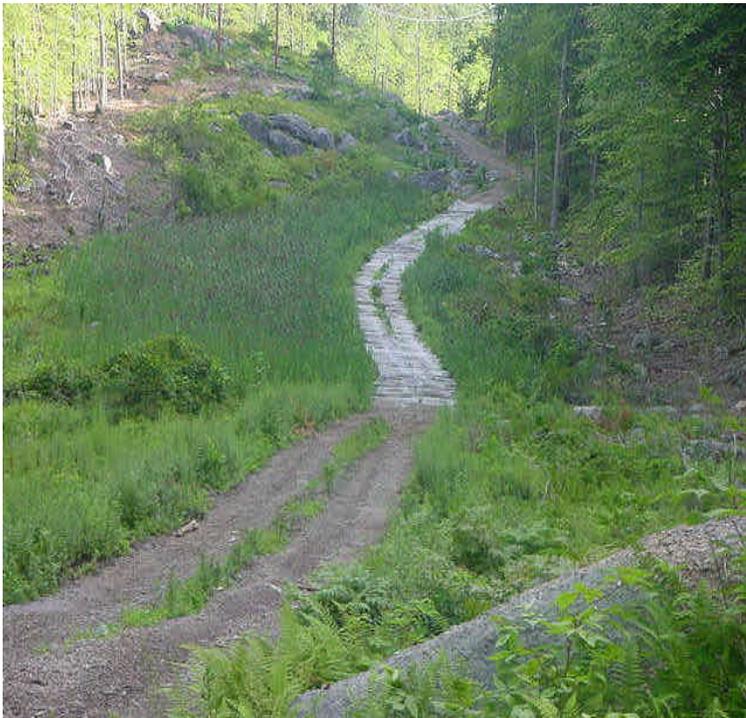
(345kV H-Frame): Photo on the left shows a view of the first wetland crossing in the Bethel Reservoir ROW Section. The majority of this area has re-vegetated and erosion controls remain intact. Photo on the right shows a view of the revegetated area at structure #11009. Silt fence could be removed 8/22/06.

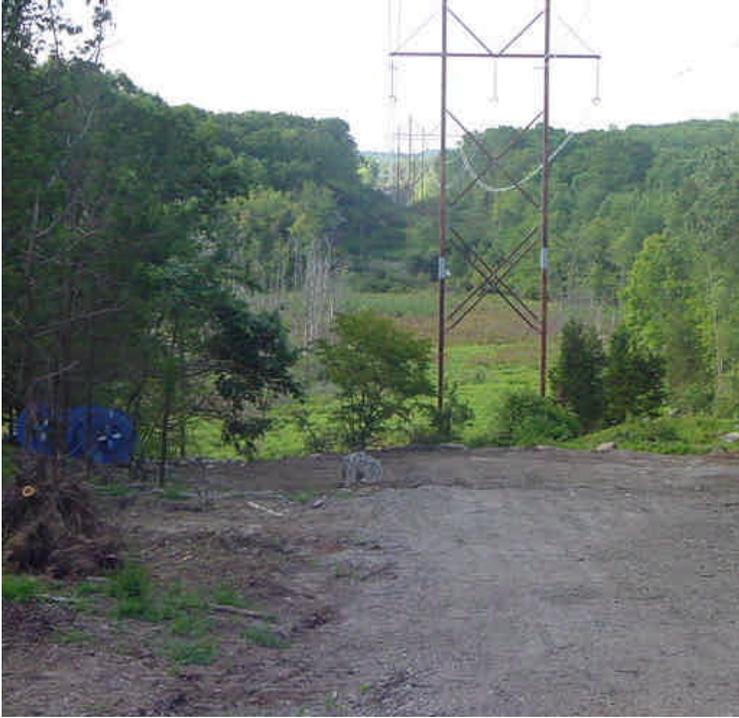
Photo on the left shows a view of structure #11024 off John Todd Way. The area adjacent to the silt fence has revegetated, but the majority of the area around the structure remains bare. Photo on the right shows a view of structure #11024 from Lime Kiln Road. 8/22/06.

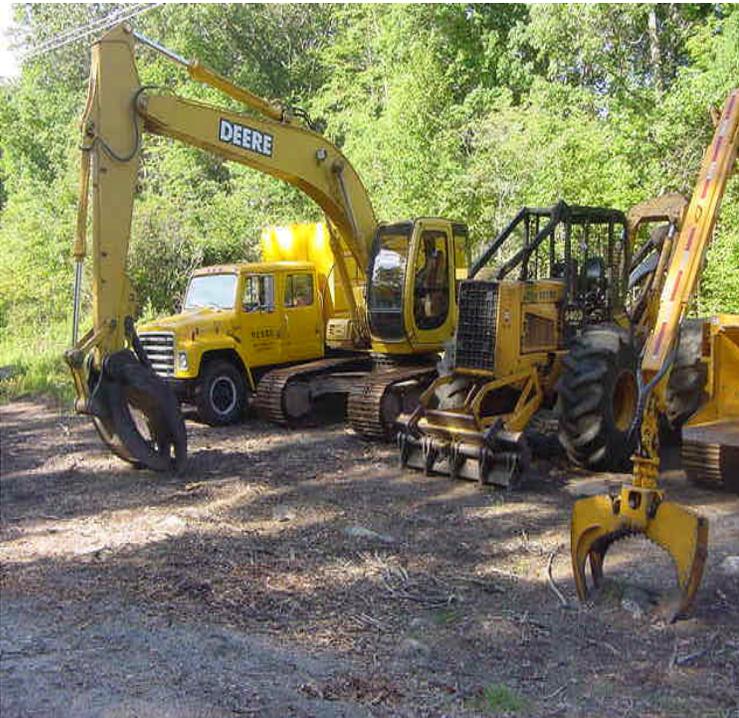
Photo on the left shows the area between structure #11030 and #11031 where Reese is storing equipment. Photo on the right shows repairs were made at the access drive near structure #11031 at Costa Lane. Erosion tends to be a problem here 8/22/06.

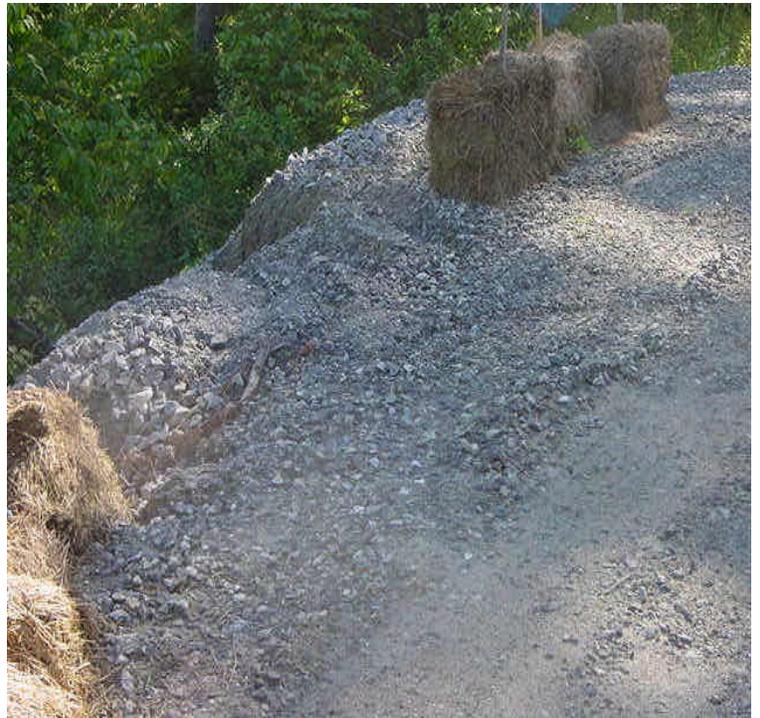
Areas of Inspection	Observation	Recommended Action	Corrective Action
<p>Norwalk Section</p>	<p>Whortleberry Rd, John Todd Way and Costa Lane. 3/29-8/22/06.</p> <p>- The access road erosion near structure #31 was regraded but erosion continues, even with the haybales in place. 7/19-8/22/06. Reese is storing equipment between structure #30 and #31. 8/22/06.</p> <p>- Controls at Bethel water building were in good shape. However, Webb Rd has received significant storm run-off from Nashville Rd ext. 7/12-8/22/06.</p> <p>- At Kent Rd (north) sediment tracking was not noted on the street. 7/19-8/22/06.</p> <p>-Mats remain in good shape over the wetlands in this section. 8/22/06</p> <p>-Several wetlands are matted to the south of Kent Rd. Haybales were placed at the wash out areas along the access road, where silt fence was difficult to maintain. 8/22/06.</p>	<p>more wood chips or consider installing silt fence as needed. 8/22/06.</p> <p>-Continue to monitor and keep stone out of any resource areas. Haybales currently contain the sediment. 7/26-8/22/06</p> <p>- Flow from Webb Rd during rain events is not project related but it is washing out the road with each storm 7/5-8/22/06</p> <p>- Continue to maintain this entrance and sweep street when necessary. Add more clean stone if needed 7/19-8/22/06</p> <p>- None at this time. 8/22/06</p> <p>- Continue to maintain the erosion controls at the areas that continuously wash out. 7/12-8/22/06</p>	<p>-Area was regraded but look into permanent solutions.</p> <p>- Evaluate road condition</p> <p>-N/A at this time</p> <p>-N/A</p> <p>- Hay bales were placed at the wash out areas. The remaining silt fence is in good condition.</p>

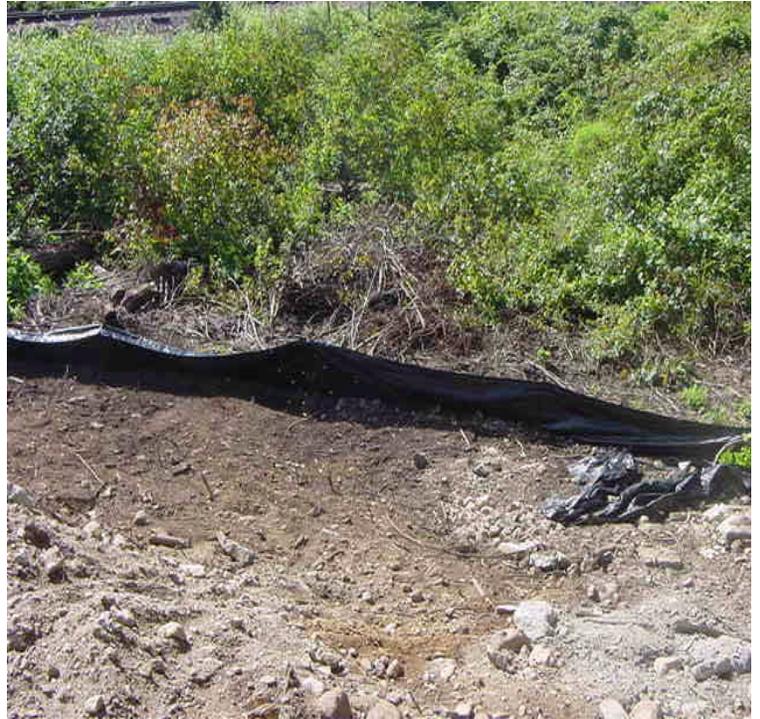
(Norwalk Section): The photo on the left shows a crew pulling wire at structure #11048. Photo on the right shows repairs were made to the silt fence at structure #11051. 8/22/06.

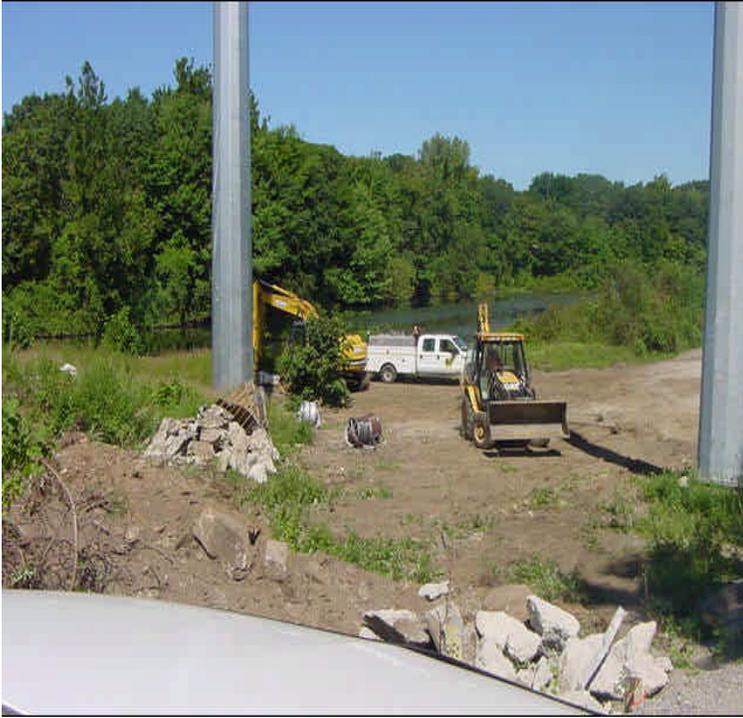
Areas of Inspection	Observation	Recommended Action	Corrective Action
<p>Norwalk Section</p> <p>Line Construction continued</p>	<p>appears to be complete in these areas. 8/22/06.</p> <p>-Old tower foundations were being removed from the ROW at Broad Street and Kent Road south. All old concrete is currently contained in dumpsters and will be removed from site when the work is complete. 8/22/06</p> <p>- Crews continue to pull wire in several locations in the Kent Rd to the north and south. Wire pulling also continues at North Seir Road 8/17-8/22/06.</p> <p>- Crews were also performing wire work in both sections near Perry Ave. 8/22/06.</p> <p>-Although wire pulling was complete near John Todd Way, reels were stored at #11024. 8/22/06.</p>	<p>-None at this time. 8/22/06.</p>	<p>-N/A</p> <p>- N/A</p> <p>-N/A</p> <p>-N/A</p>
<p>Erosion and Sediment Controls</p> <p>Composite</p>	<p>- Although controls upgradient of the 2nd wetland crossing along the Archers Lane access road were repaired, additional run-off caused stone to pile over the fence again. 8/17-8/22/06.</p> <p>- Wood chips had been blown into the uplands and wetland area at the third structure in from Gallows Hill Road. 2/22-8/22/06. Another area with deep wood chips off</p>	<p>- Controls should be maintained as necessary and the stone has to be pulled back from the wetland. More permanent measures will be needed. 8/17-822/06.</p> <p>-Make sure chips stay on the ROW. Contractors should remove the off ROW chips since this is not allowed in the D&M plan. 2/22-8/22/06.</p> <p>- Wood chips on the ROW can remain at a</p>	<p>-N/A</p> <p>-Still needs attention (CL&P is looking into a solution here)</p>

Photo on the left shows a crew removing old foundations at structure #11079. Photo on the right shows the dumpsters used to store the debris before it is removed from site during similar work near structure #11062. 8/22/06.

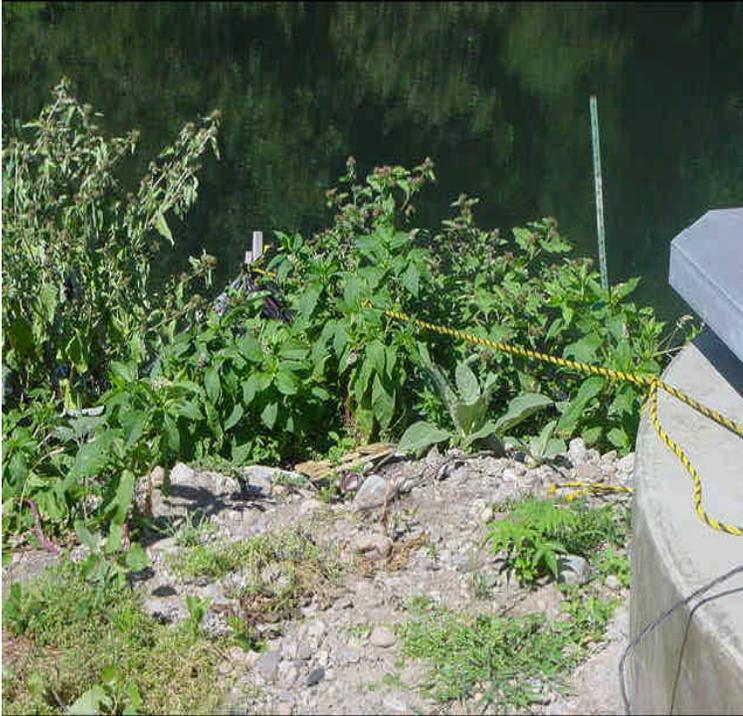
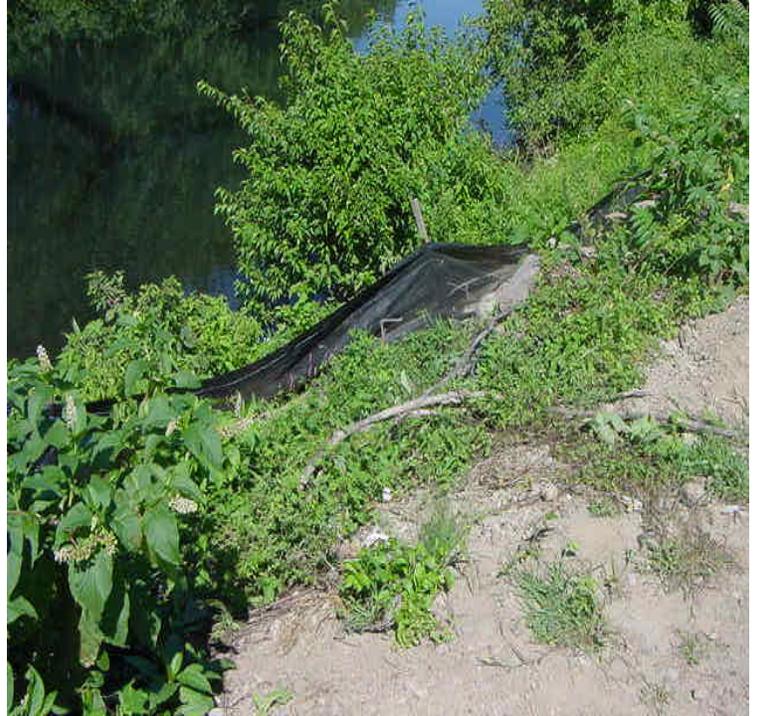
Both photos show silt fence repairs at structure #11080 near Norwalk substation. Photo on the left shows the rope used to help reinforce the silt fence on the bank of the Norwalk River. Restore this area with vegetation soon in order to reduce the reliance on the silt fence. 8/22/06.
