Docket No. 217 – Development and Management Plan Inspection

Northeast Utilities Service Company Certificate of Environmental Compatibility and Public Need for the construction of a 345-kV electric transmission line and reconstruction of an existing 115-kV electric transmission line between Connecticut Light and Power Company's Plumtree Substation in Bethel, through the towns of Redding, Weston, and Wilton, and to the Norwalk Substation in Norwalk, Connecticut.

Date: September 29, 2006

Location: Overhead Line (Composite 345kV and 115kV Gallows Hill to Archers Lane, 345kV H-Frame Hoyts Hill to Gallows Hill, and Norwalk Section)

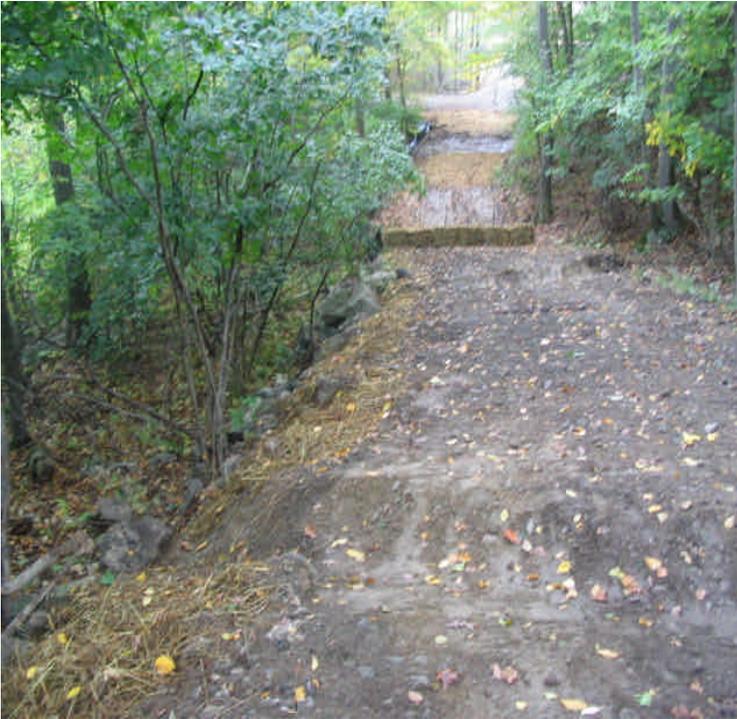
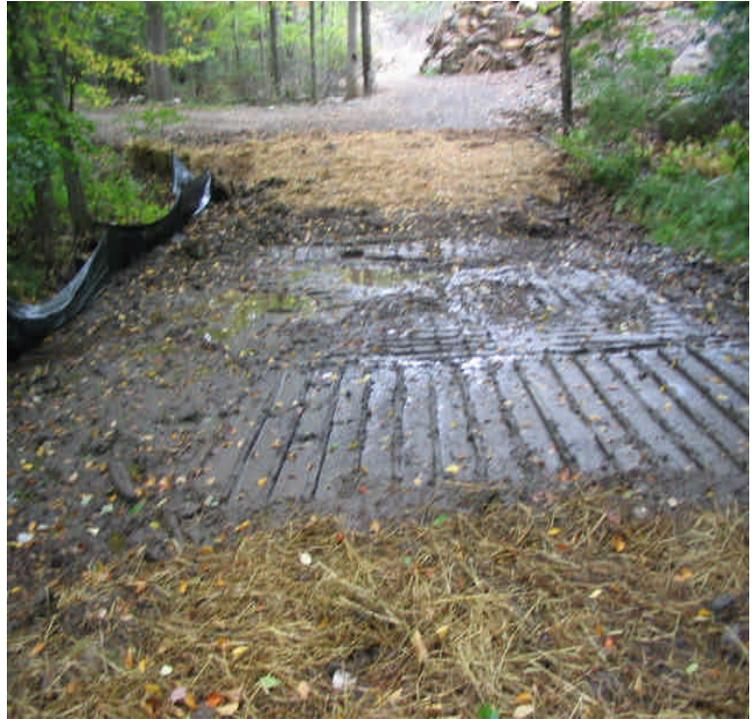
(Composite Section): Both photos show views of the 1st wetland crossing at Archers Lane. Stone, fabric and mats have been removed from the ROW and the wetland crossing restored. Photo on the left shows the water bars constructed within the road. Photo on the right shows the re-graded crossing with seed and mulch applied to adjacent areas. 9/29/06.

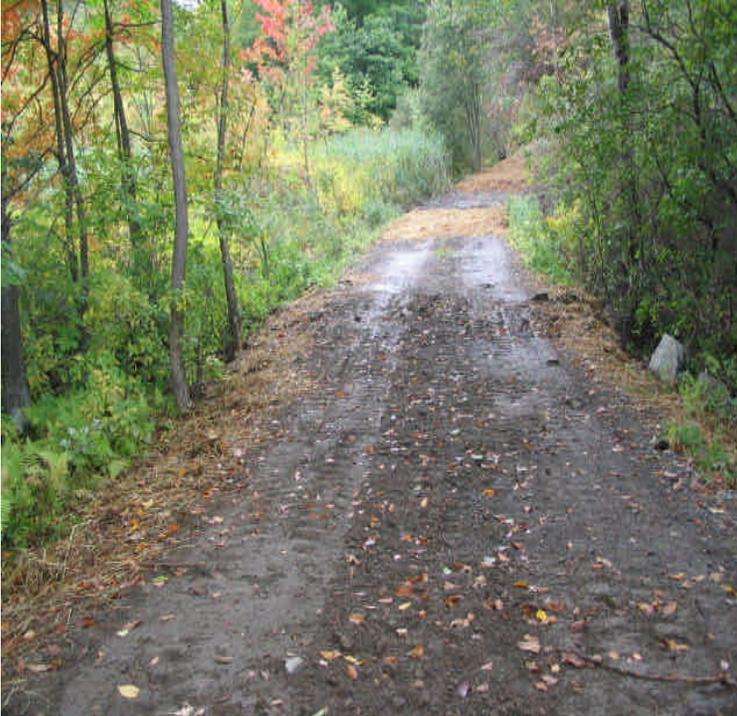
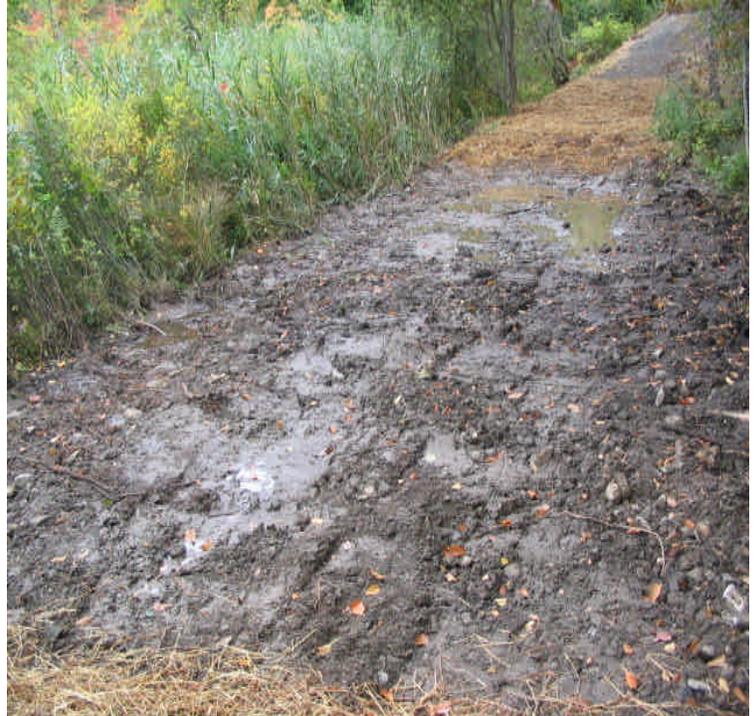
Both photos show views of the second wetland crossing at Archers Lane. Photo on the left shows an overview of seed and hay mulch applied to the adjacent access road. Photo on the right shows a close up of the restored crossing. 9/29/06.

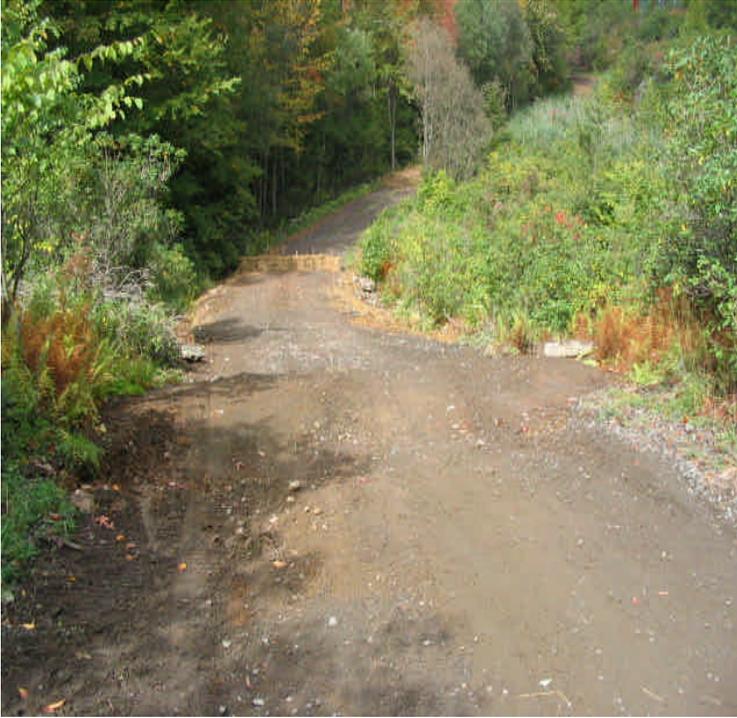
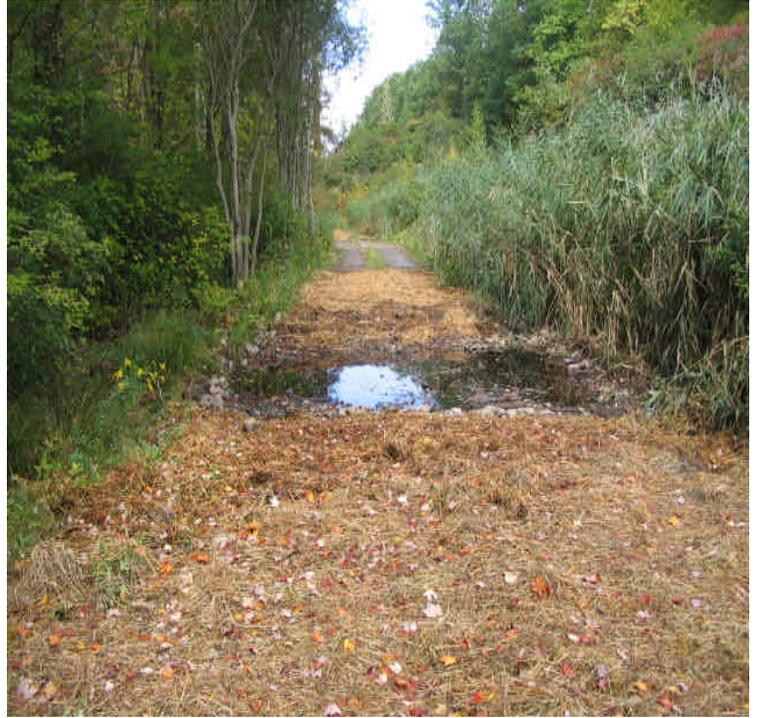
Both photos show the views of the third wetland crossing at Archers Lane. Photo on the left shows the water bars constructed within the ROW. Photo on the right shows a close up of the restored crossing. This area has been re-graded to original conditions. Seed and hay mulch were applied to adjacent areas. 9/29/06.

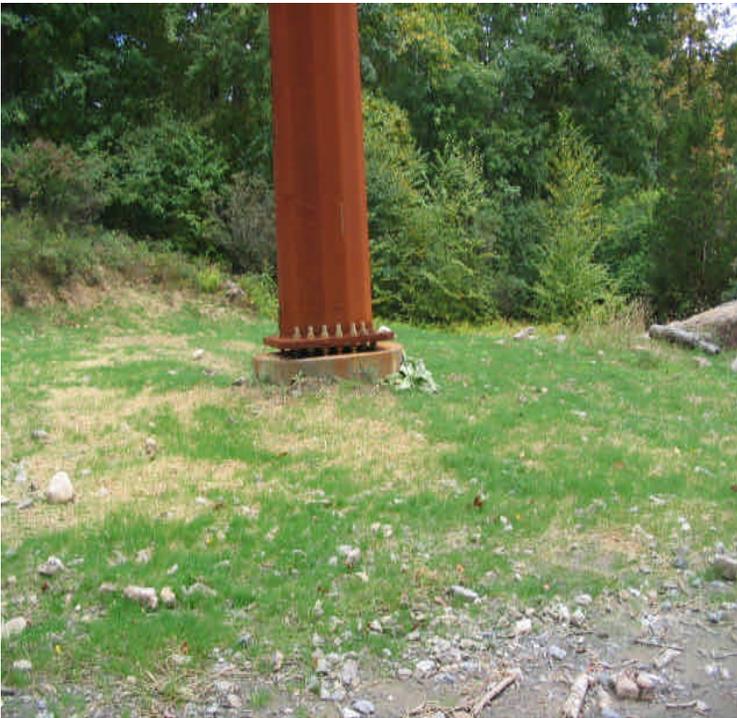
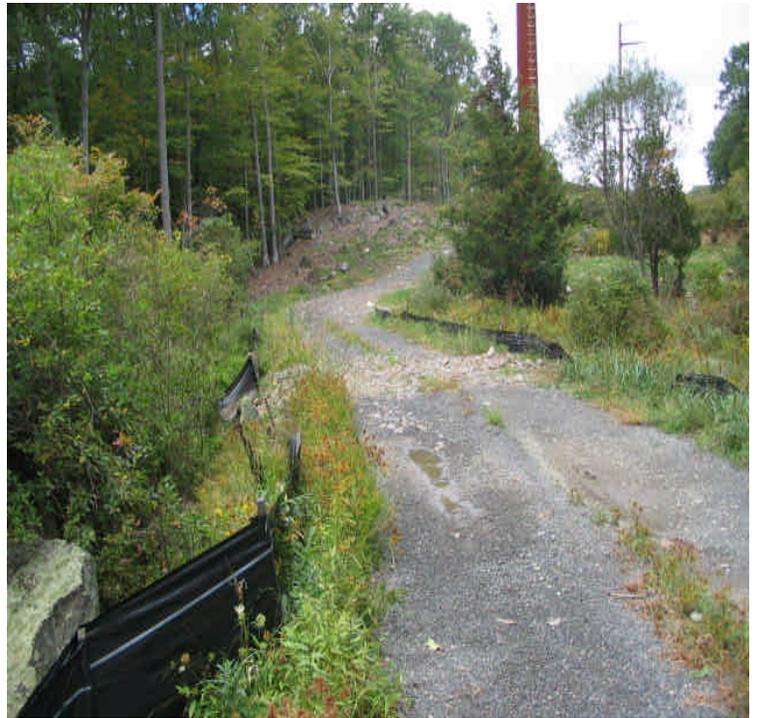
Photo on the left shows grass growth in the restored area at structure #34 off Gallows Hill Road. Photo on the right shows the stone crossing remaining in the wetland within the ROW here.

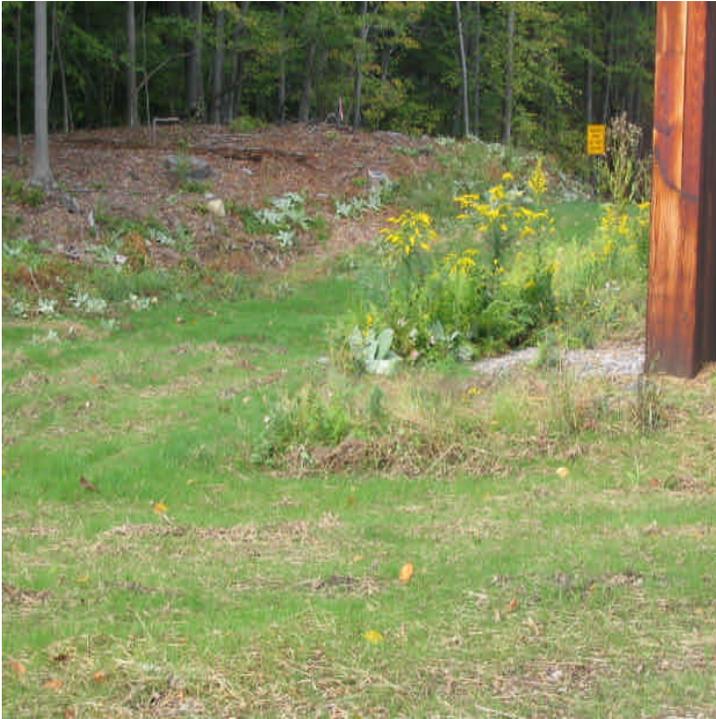
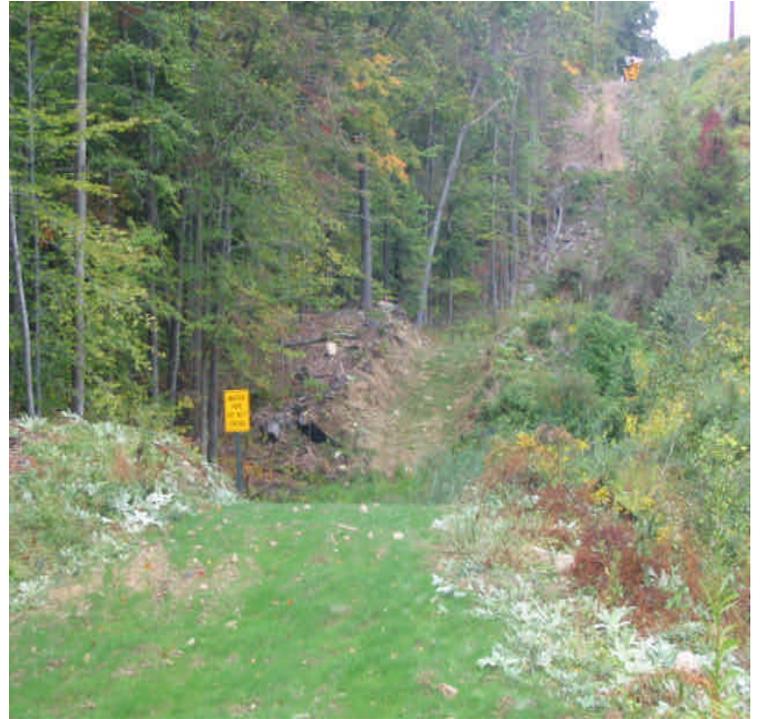
(345kV H-Frame): Both photos show grass growth in the restored areas in the ROW near Bethel Reservoir. Photo on the left shows a close up of the area at structure #11. Photo on the right shows the wetland crossing between structures #10 and 11.

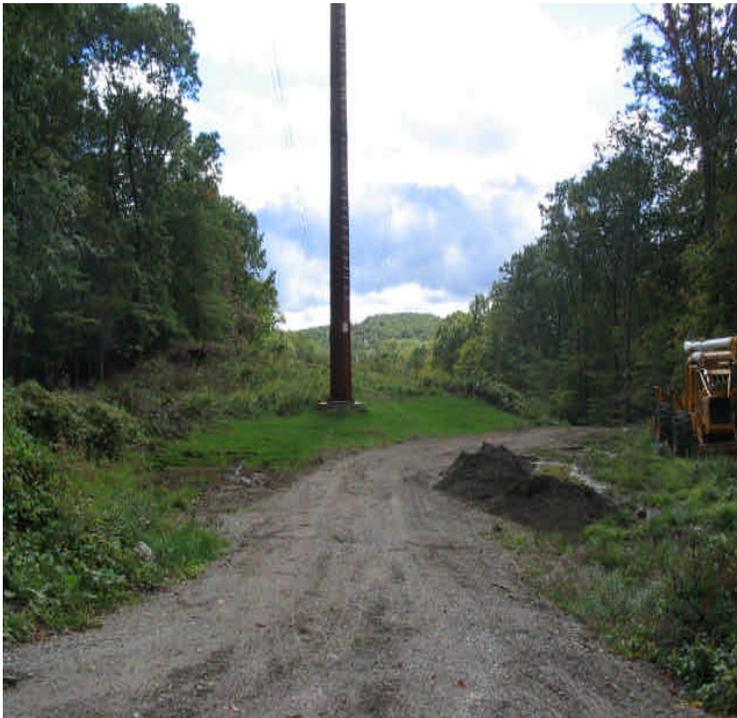
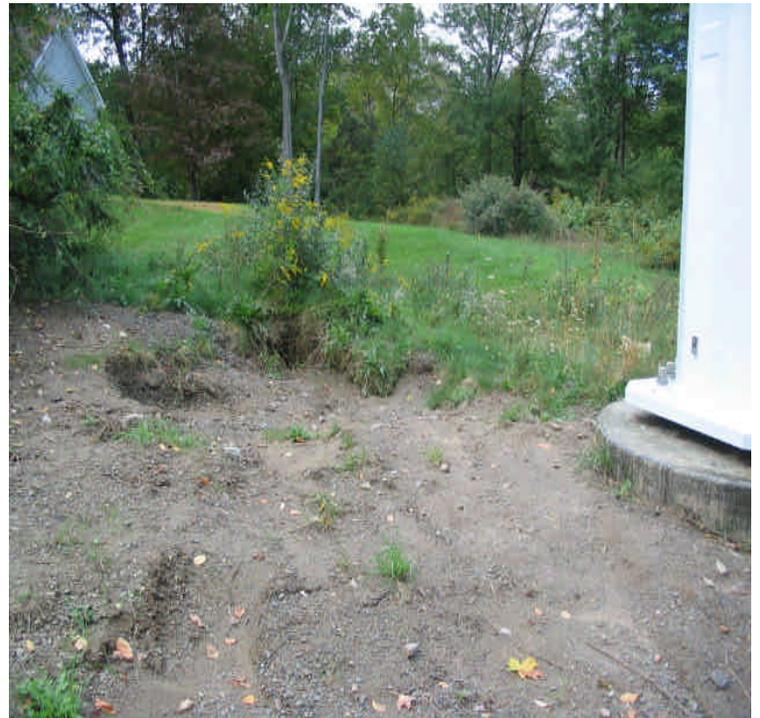
Photo on the left shows the restored area at structure #10 where tire tracks still remain. Photo on the right shows the disturbed area at structure #9 which has not been graded or seeded. 9/29/06.

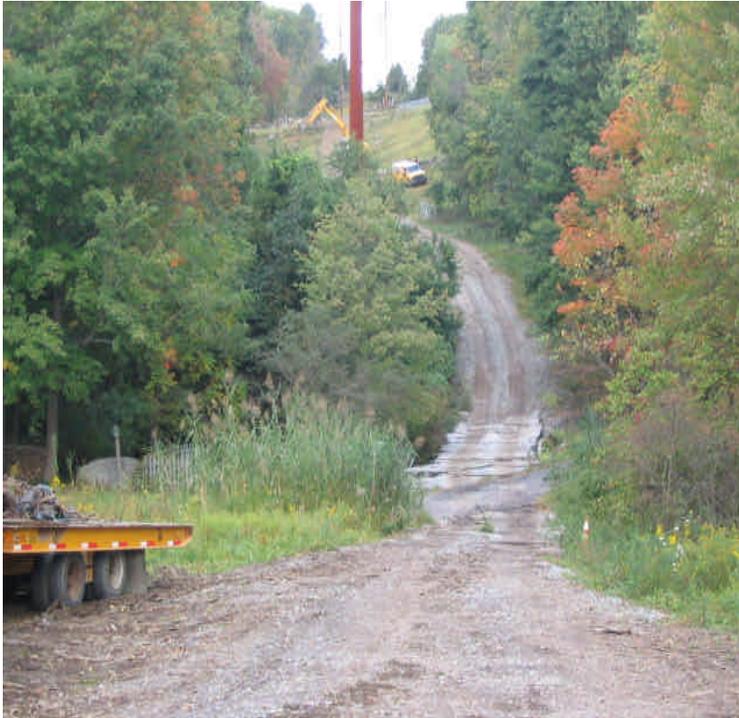
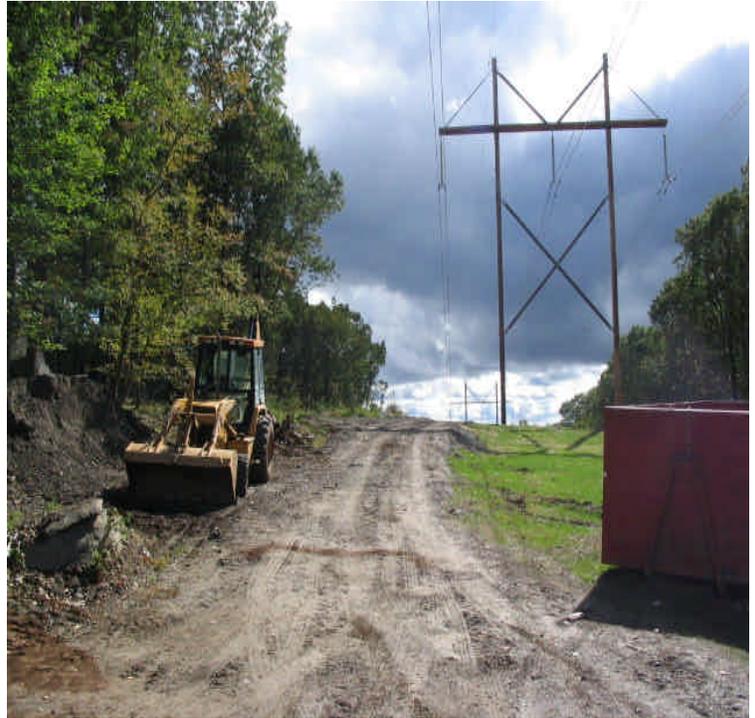
Photo on the left shows a view of the ROW off Chestnut Ridge Road. Crews were removing/restoring the road near the pasture at the time of inspection. Photo on the right shows the private contractor operating machinery in the recently restored area near structure #23.

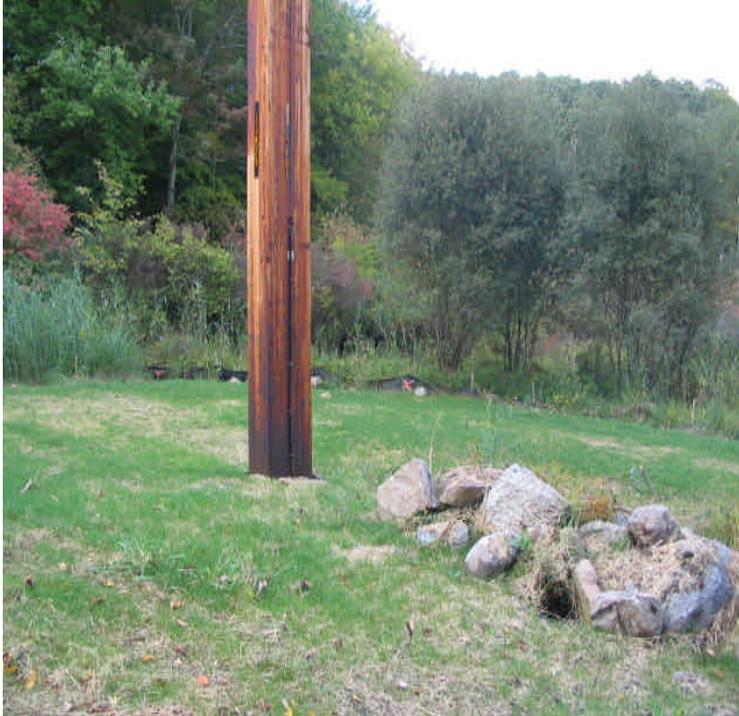
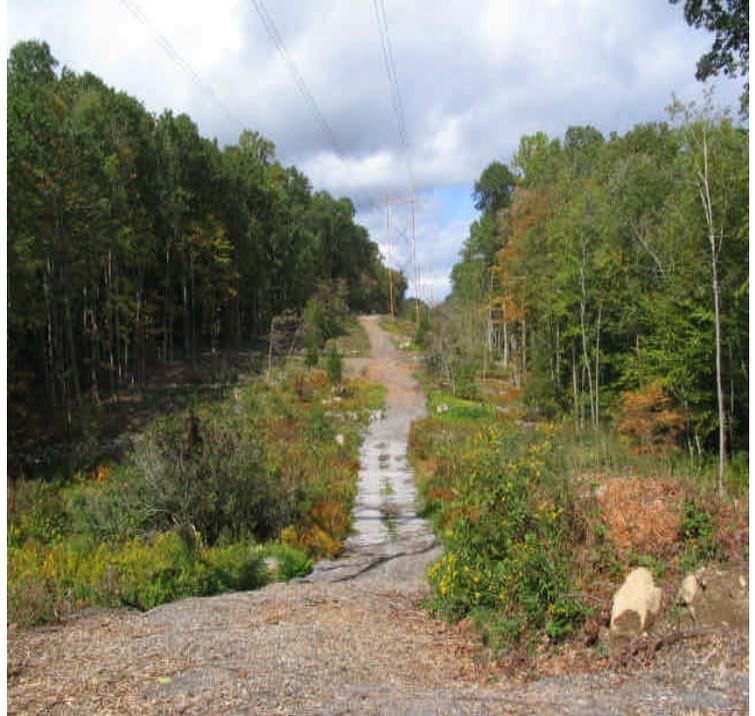
Photo on the left shows grass growth in the restored area off Lime Kiln Road. Photo on the right shows a view of the ROW off Costa Lane. Seed and hay mulch have been applied to most areas but mats still remain at the wetland crossing. 9/29/06.

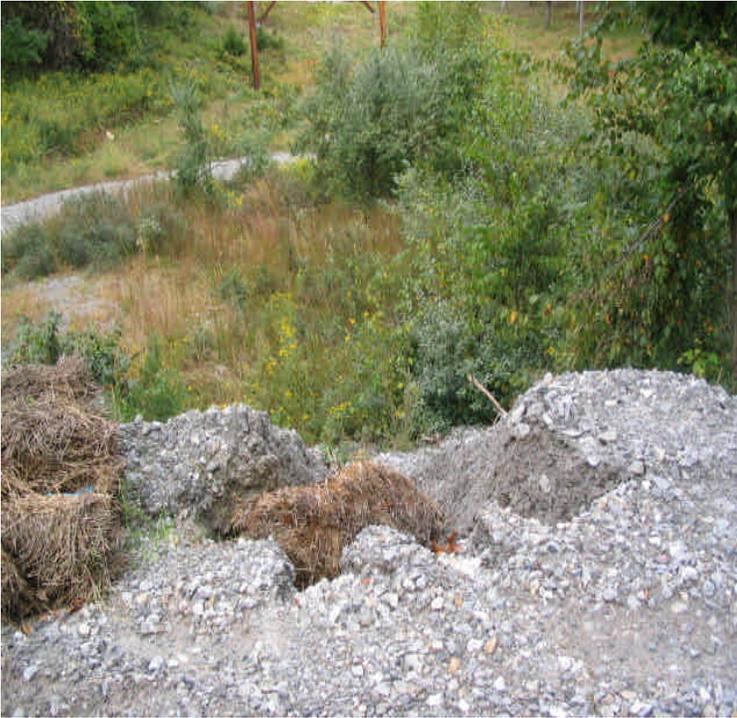
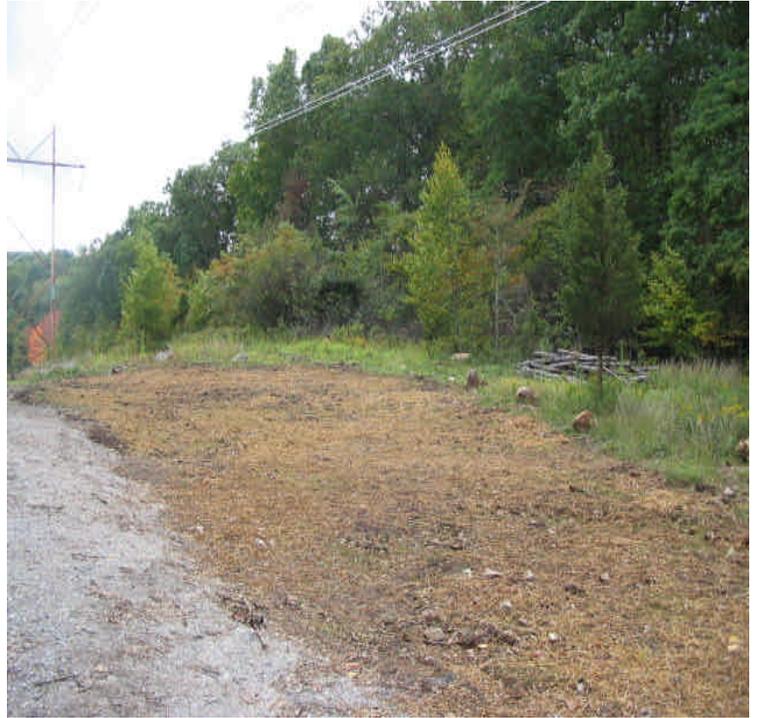
Norwalk Section	<ul style="list-style-type: none"> - Erosion continues along the access road near structure #31 but haybales seem to be containing sediment. 7/19-9/29/06. - No sediment tracking was noted in Kent Road from the ROW access to the north this week. There was no active work here at the time of inspection. 9/29/06. -It appears that restoration activities have not yet begun in the Kent Road north section of 	<ul style="list-style-type: none"> -Continue to monitor and keep stone out of any resource areas. Haybales currently contain the sediment. 7/26-9/29/06. - Continue to maintain this entrance and sweep street when necessary. Add more clean stone if needed. 7/19-9/29/06. - Continue restoration and clean up in previously disturbed areas. Restore as near as possible to 	<ul style="list-style-type: none"> -Needs evaluation. -NA - Needs attention

Photo on the left shows a view of the continued erosion in the access road near structure #31. Photo on the right shows the restored area between structures #31 and #32. 9/29/06.

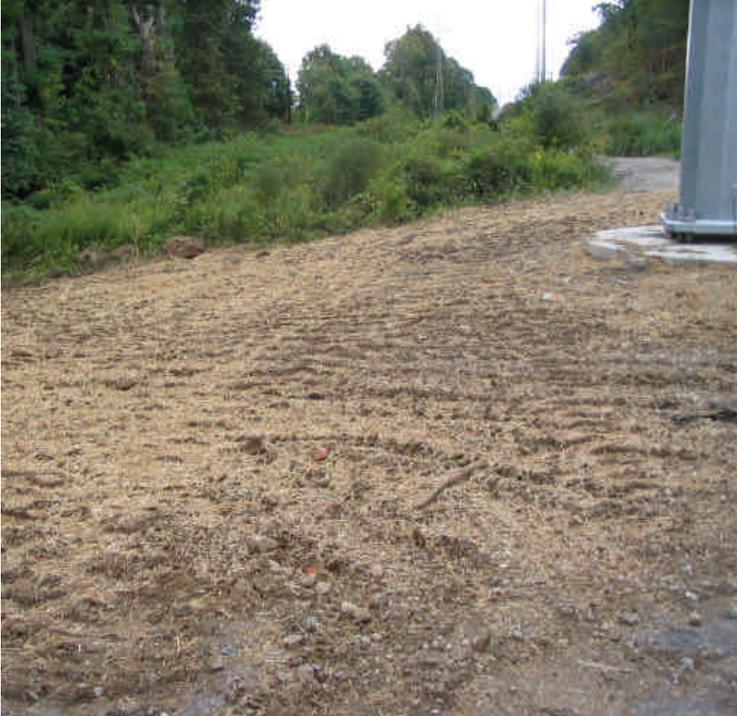
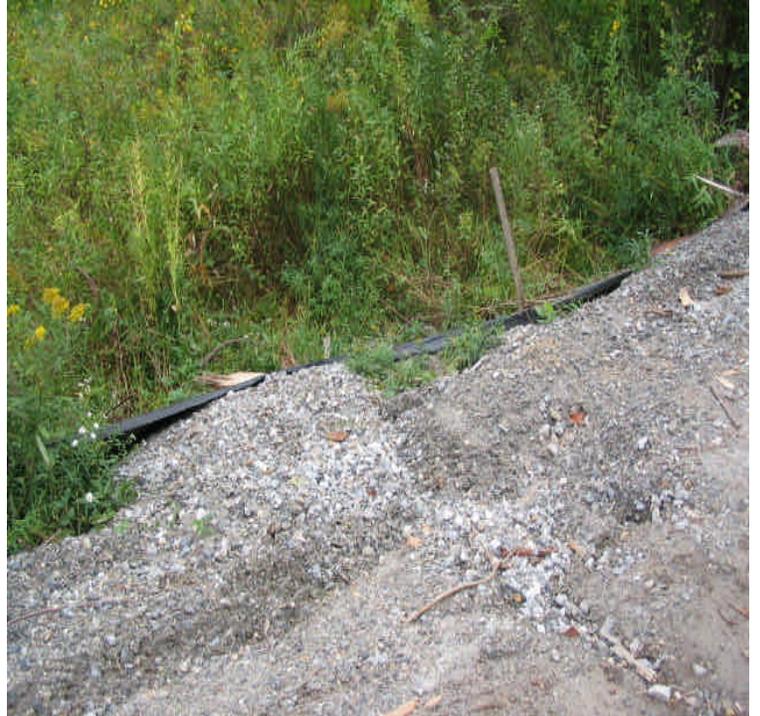
Areas of Inspection	Observation	Recommended Action	Corrective Action
Kent Rd. (South)	road continues to washout beyond the erosion controls into the wetland. Silt fence/ haybales here are deteriorating. 9/29/06.	the stone access road should be evaluated. 9/29/06. These areas will be difficult to control during heavy rain due to the drainage patterns. 7/12-9/29/06.	
<p>Inland Wetland and Watercourse encroachment and mitigation Composite</p> <p>345kV H-Frame</p> <p>Norwalk</p>	<p>-The stone and mats have been removed from the wetland crossings along the Archers Lane ROW and the road has been re-graded to original condition. 9/29/06.</p> <p>- The wetland crossing at Gallows Hill needs to be removed. 9/29/06</p> <p>-Mats remain at all wetland crossings. All restored areas are re-vegetating rapidly 9/29/06.</p> <p>-Mats remain at wetland crossings. Some areas have not yet been restored. 9/29/06.</p> <p>-The disturbed slopes adjacent to structure #11064 have not yet been seeded or mulched and the stream channel is not protected by erosion controls. 9/29/06.</p>	<p>Silt fence will be removed when vegetation has established (or replaced with haybales in appropriate locations). 9/29/06.</p> <p>-Restore in a similar manner to wetlands at Archers Lane. 9/29/06</p> <p>- Continue to monitor until stabilized. Silt fence should be replaced with haybales in appropriate locations. Remove mats from wetland crossings when restoration activities are nearing completion. 9/29/06.</p> <p>-Continue restoration activities. 9/29/06.</p> <p>-Install hay bales along both sides of the stream to prevent sediment from entering the stream channel. 9/29/06.</p>	<p>-Stone and mats have been removed from wetland crossings.</p> <p>-Needs attention.</p> <p>- Vegetative growth noted within restored areas.</p> <p>-Some restoration efforts noted.</p> <p>-Needs attention</p>

(Norwalk Section): Photo on the left shows a view of the restored area within the ROW at Kent Road (south). Most disturbed areas have been re-graded to original conditions and seed and hay mulch applied. Photo on the right shows stone from the access road overwhelming the silt fence along the edge of the wetland. 9/29/06.

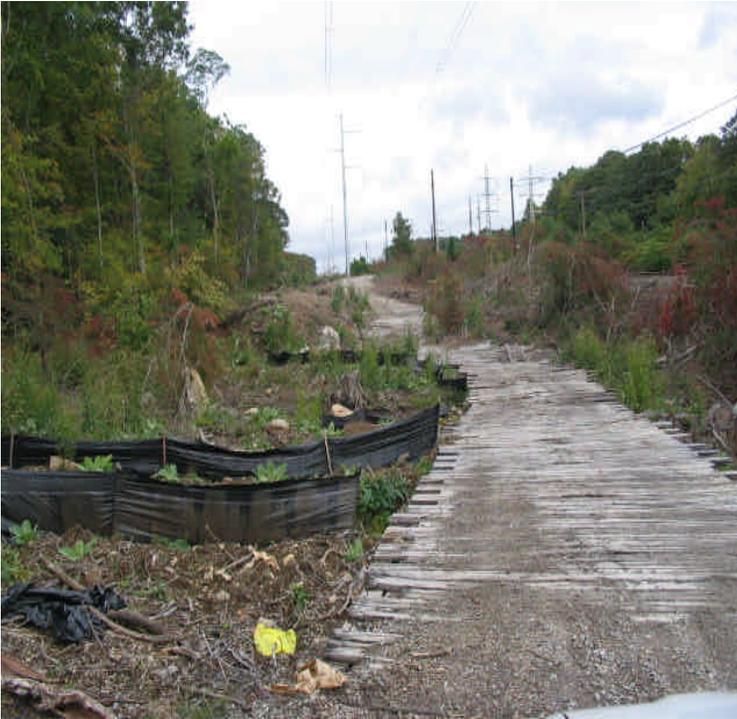
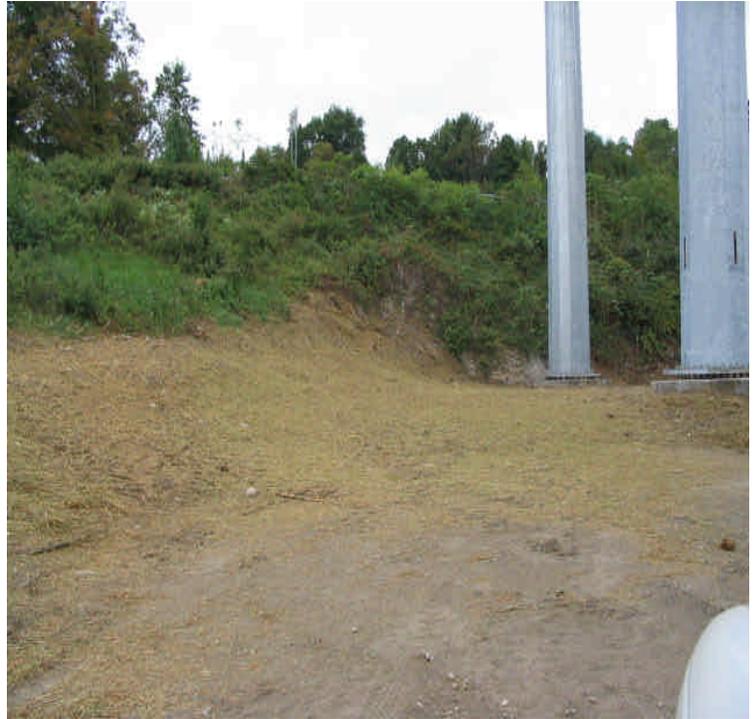
Kent Rd. (North)	<p>- The disturbed areas at Kent Road (north) have not been seeded or mulched. Some areas don't appear to have been graded back to original conditions. 9/29/06.</p> <p>- Silt fence remains along both banks of the stream and near the foundation at the pond in the Kent Rd north section. 7/19-9/29/06.</p> <p>- The work areas at Kent Road (south) have been re-graded to original conditions and seed and hay mulch applied. Mats still need to be removed. 9/29/06.</p> <p>- Stone from the access</p>	<p>-These areas should be restored/seeded as soon as possible. Generally, the end of fall seeding is Oct 15th. 9/29/06.</p> <p>-Continue to monitor and maintain as needed. Restore areas and replace silt fence with haybales. 9/29/06.</p> <p>-Monitor until stabilized with vegetation.</p> <p>- Stabilization options for</p>	<p>-Needs attention</p> <p>-NA</p> <p>-NA</p> <p>-Needs attention</p>

Photo on the left shows a view of the ROW off Kent Road (north). This section has not been seeded yet and mats still remain at wetland crossings. Photo on the right shows the restored area at structure #11063. 9/29/06.

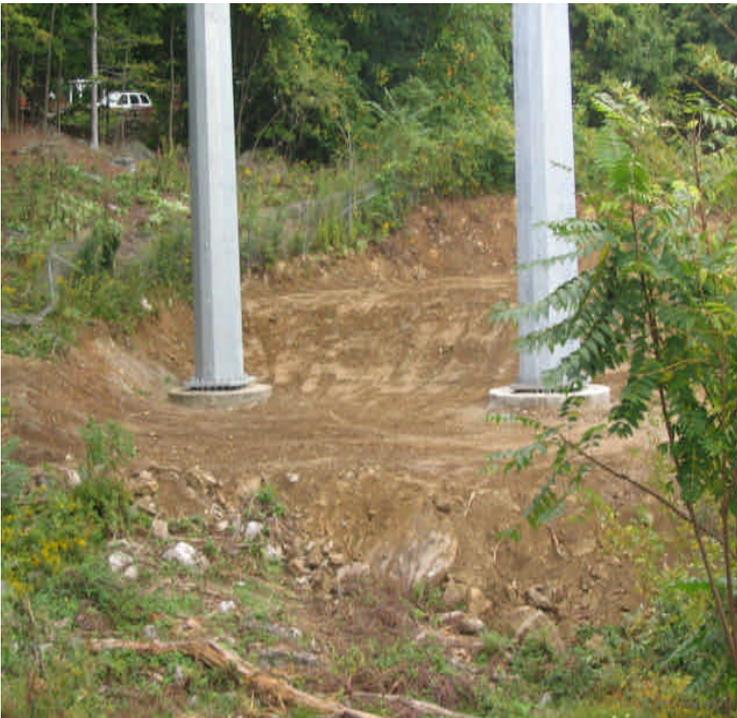
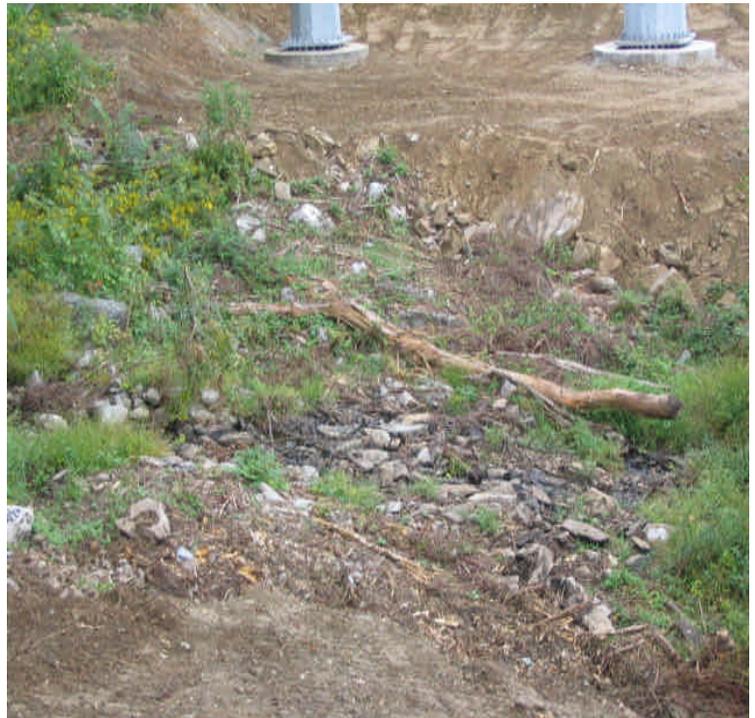
Both photos show the area at structure #11064 in the ROW off North Seir Hill Road. Photo on the left shows a close up of the disturbed slope which has not been seeded. Photo on the right shows a close up of the stream channel at the base of the slope which is not protected by erosion controls. Erosion control mats may be necessary here on the slopes. 9/29/06.

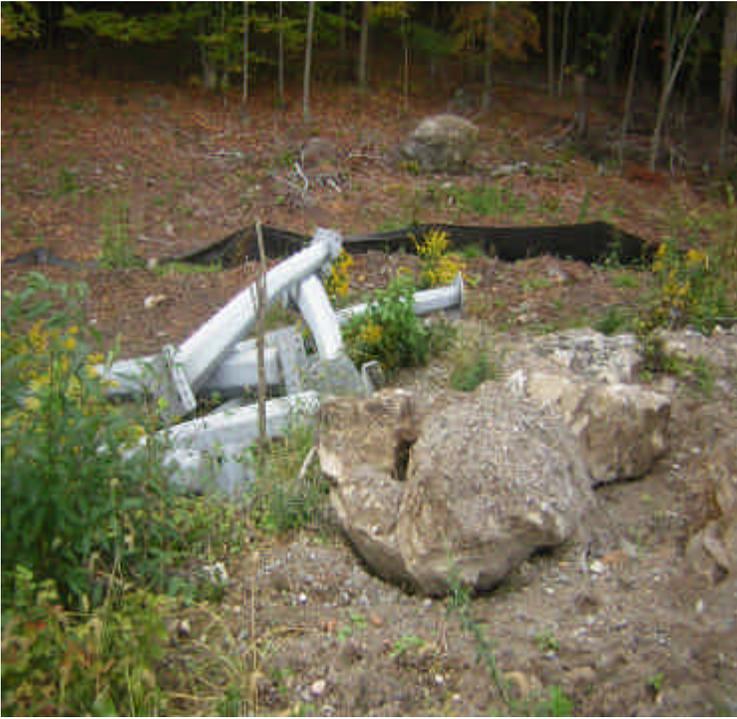
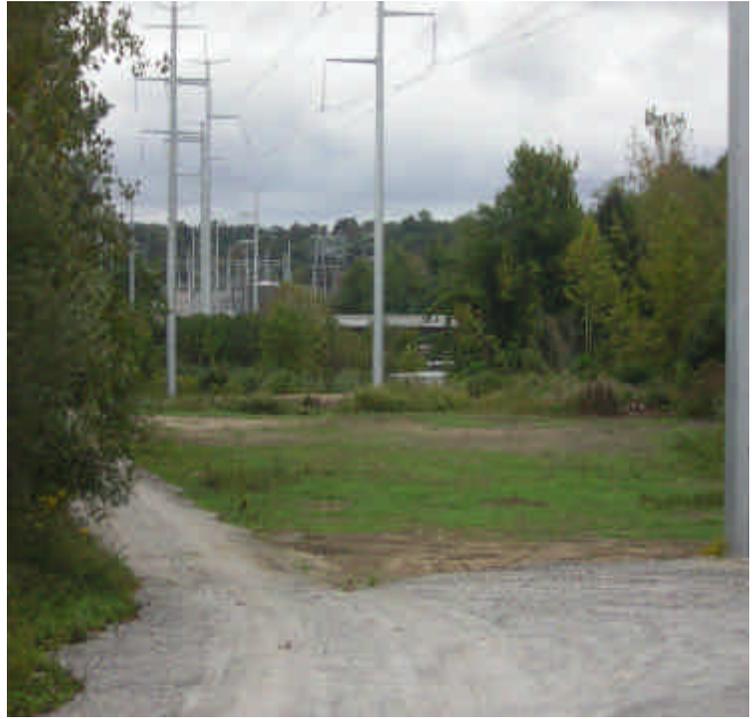
Photo on the left shows spare structure arms being stored near structure #11074 off Perry Ave. All old materials should be removed. Photo on the right shows the restored area at Perry Ave (south) with significant grass growth. 9/29/06.

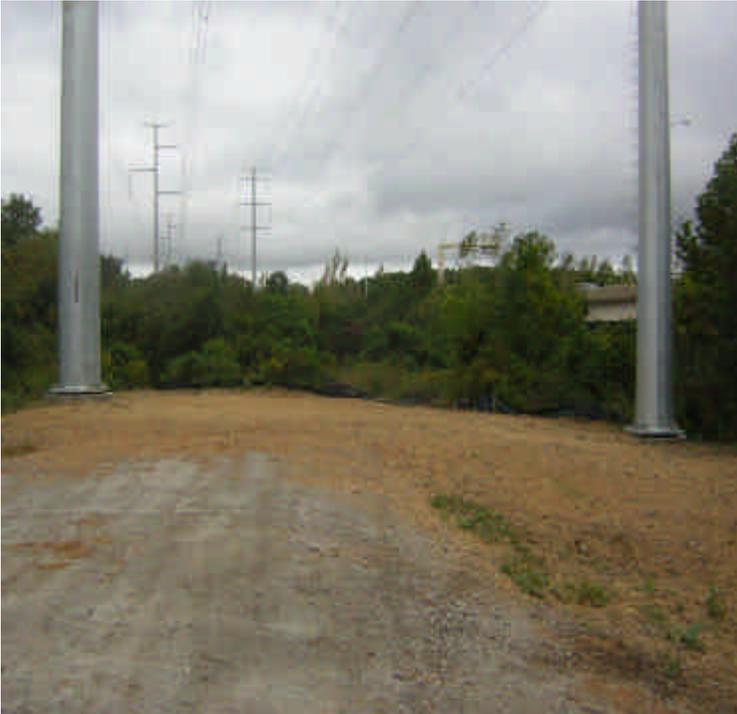
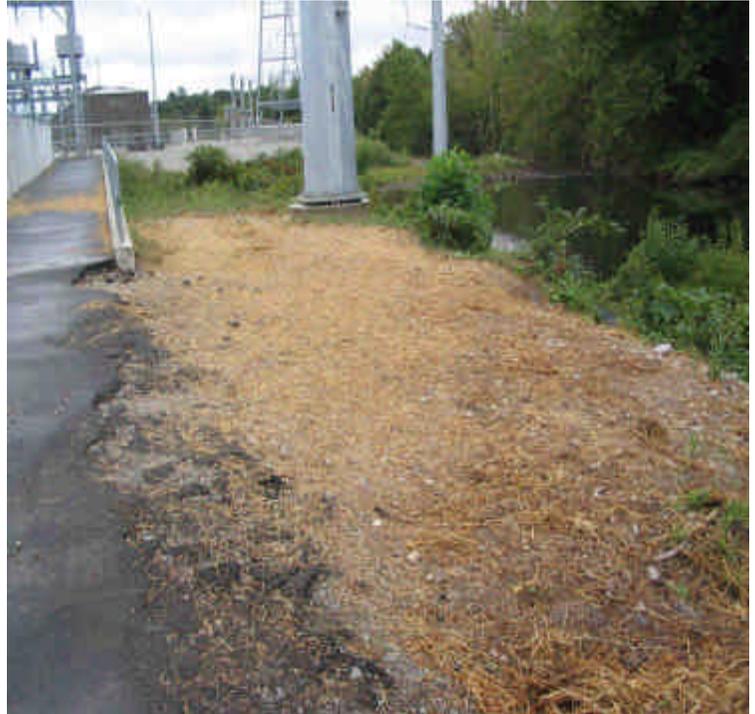
Photo on the left shows a view of the restoration in the ROW off Broad Street (north). Photo on the right shows where seed and hay mulch have been applied to structure #11080. Soil is stony here and may not revegetate easily. 9/29/06.
