**Docket No. 217 – Development and Management Plan Inspection**

Northeast Utilities Service Company Certificate of Environmental Compatibility and Public Need for the construction of a 345-kV electric transmission line and reconstruction of an existing 115-kV electric transmission line between Connecticut Light and Power Company's Plumtree Substation in Bethel, through the towns of Redding, Weston, and Wilton, and to the Norwalk Substation in Norwalk, Connecticut.

**Date:** December 14, 2005

**Location:** Overhead Line (Composite 345kV and 115kV Gallows Hill to Archers Lane)

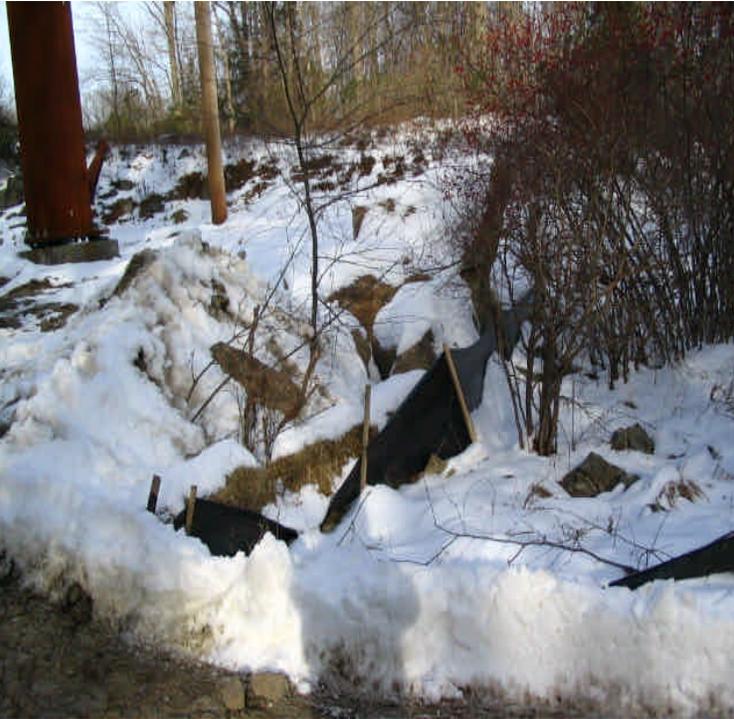
Photo on the left shows the erosion controls in place near the 2<sup>nd</sup> structure off Gallows Hill. This area will need restoration when snow cover is gone. Photo on the right shows the silt fence at the wetland crossing which should be extended during a thaw period. 12/14/05

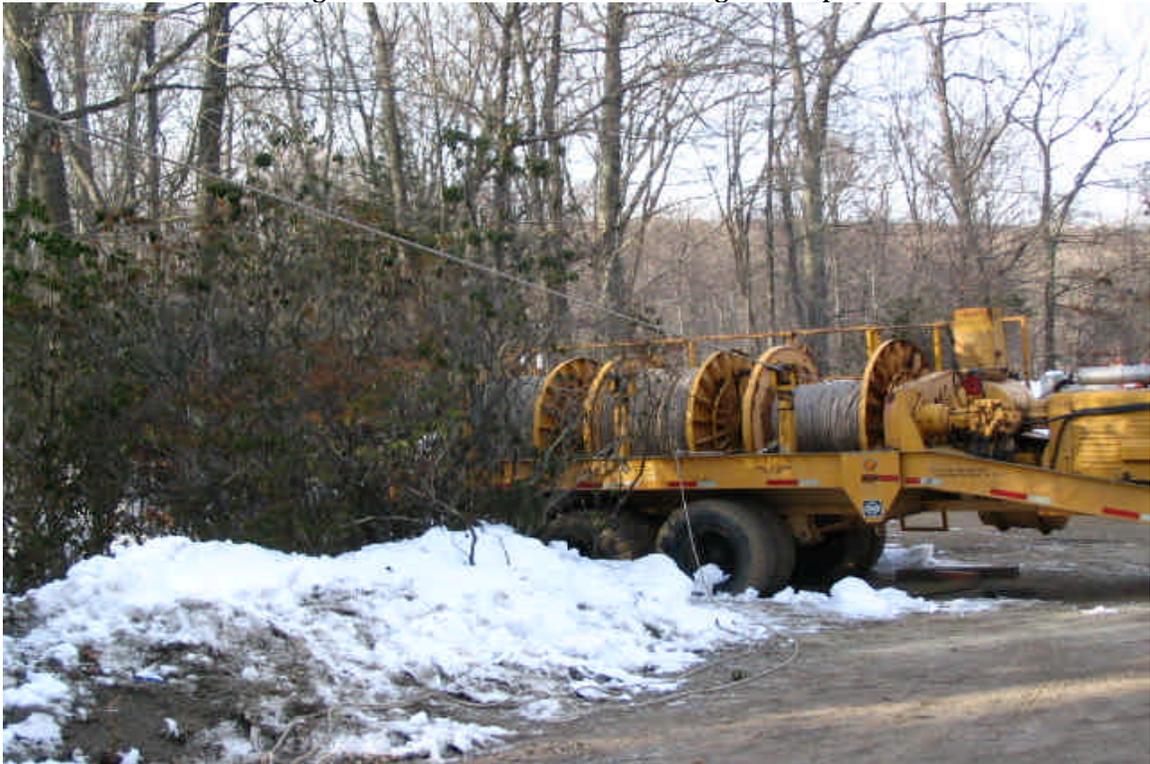
View of the equipment actively pulling rope through the structures. 12/14/05

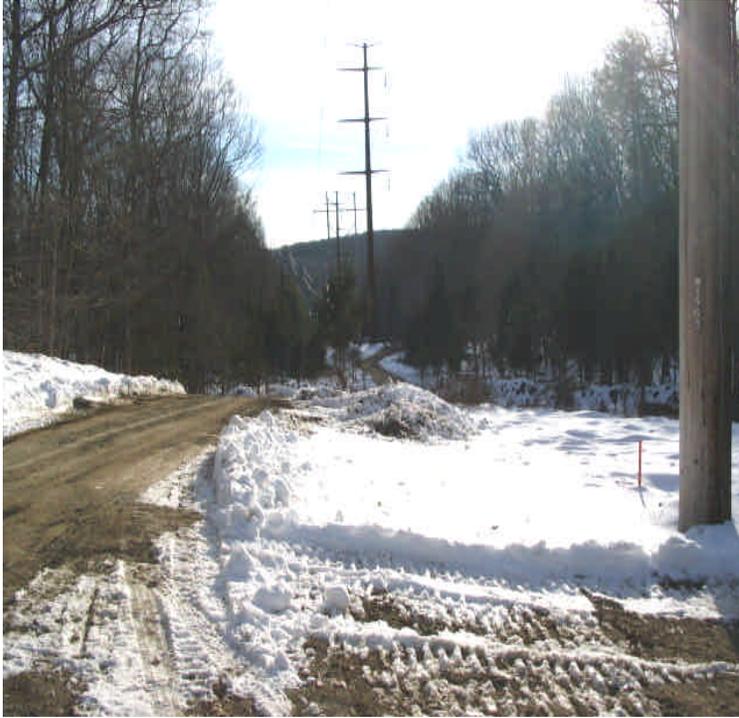
Photo on the left is a view along the ROW looking towards the Archers Lane side. Photo on the right is looking at some of the completed work on the first structure near Gallows Hill. 12/14/05

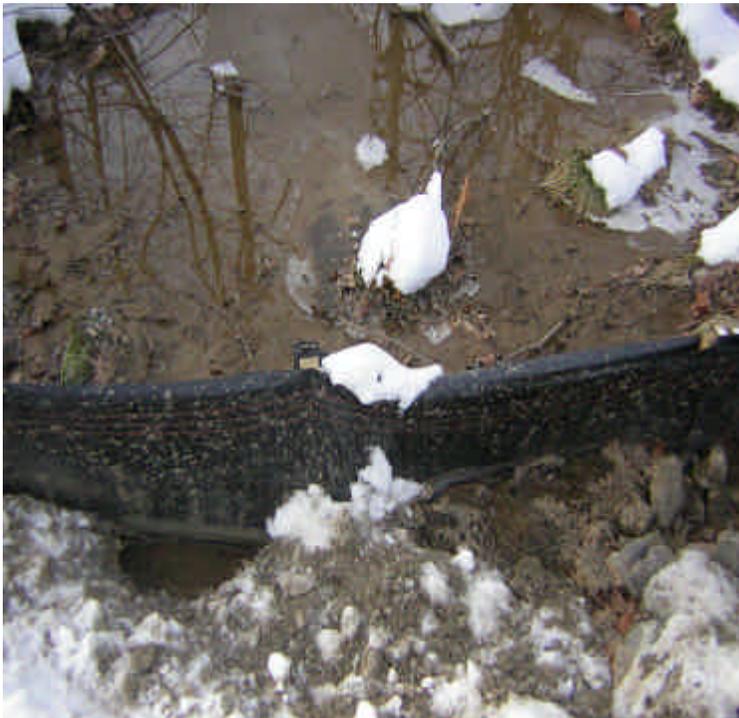
Photo on the left shows the low spot/wetland crossing near Archers Lane where water is apparently pooling through the fence to the wetland. This area will need to be secured to provide filtration to run-off. Photo on the right shows the access with snow piled along the road. 12/14/05

Areas of Inspection	Observation	Recommended Action
<p>Inland Wetland and Watercourse encroachment and mitigation</p>	<p>-The D&amp;M plan approved stone on geotextile fabric at the wetland crossings has worked well, but a few area came untoed and turbid water mixed in before the area froze over. Continue to toe in and/or extend the fence as necessary. 12/8-12/14/05</p> <p>-There was what appears to be excavation-dewatering discharge that drained to a wetland area off the left fork access road near Archers Lane. 11/17-12/14/05</p> <p>- Snow plow piles adjacent to wetland areas can distribute sediment when the snow melts. 12/14/05</p>	<p>-The crossings have been used consistently. As the access is considered temporary, the stone will be removed when final work ends so the wetlands can be restored. 12/14/05. Extend and/or toe in areas of silt fence where necessary to prevent additional turbidity during thaw periods. 12/8-12/14/05</p> <p>-The solid sediment was not contained and removed prior to snow cover. 11/17-12/14/05</p> <p>- Pull the snow piles back and fix the silt fence. 12/14/05</p>

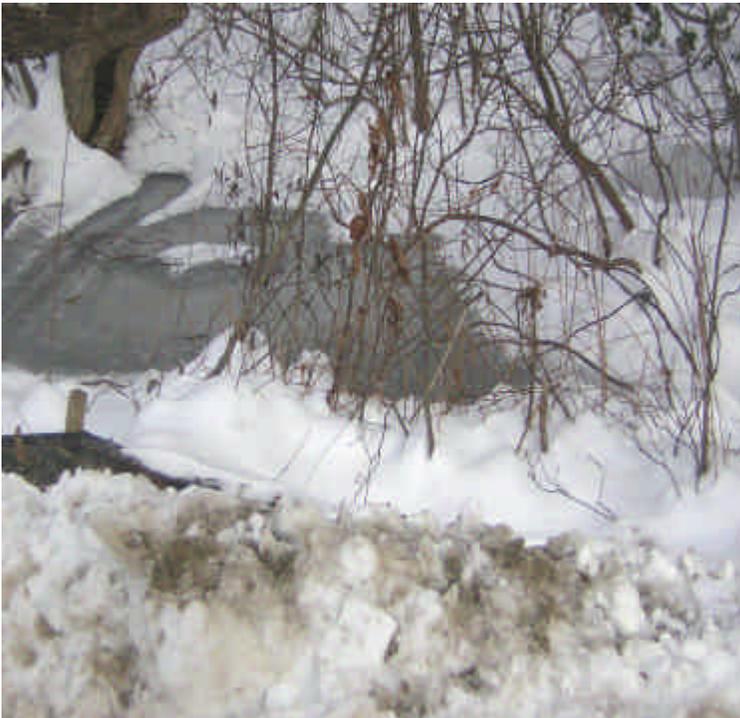
**Photo on the left shows another wetland area with snow piling up to and over the silt fence. This allows sediment to cross the barrier when the snow. Photo on the right is an overview of the ROW from the Archers Lane side. 12/14/05**

Areas of Inspection	Observation	Recommended Action
	<p>- Crews were working on pulling rope between the pole structures in preparation for line/cable pulling. 12/14/05</p>	<p>- None at this time. 12/14/05.</p>
<p>Erosion and Sediment Controls (includes inspection within 24 hours of a storm event) Erosion and Sediment Controls</p>	<p>-Water had been flowing around and/or underneath the silt fence although areas are now frozen over. Silt fence should be extended in areas where pooled water is reaching beyond the limits of the fence. All silt fence should be checked to be sure it is still toed in properly. 12/01-12/14/05.</p> <p>- The ROW and roads had been very muddy but are now frozen. 12/14/05</p> <p>- The 2<sup>nd</sup> structure in from Gallows Hill has had a bare soil stockpile/slope adjacent to the wetland with controls still well in place. 11/23-12/14/05.</p> <p>-On the Archers Lane side of the ROW, a vehicle had disturbed the soil and vegetation on the edge of the access road. 12/1-12/14/05.</p> <p>- Sediment, which is likely turbid dewatering from an excavation, had been placed at the top of slope but had drained to a wetland area. This is located off the left fork of the access path to the ROW coming from the Archers Lane station. 11/17-12/14/05</p> <p>- Snow plowing for access created some potential issues where snow was pushed over the controls in some places adjacent to wetlands. 12/14/05.</p>	<p>- The silt fence should be extended, towed in, and/or repaired as necessary. When maintained, the silt fence does a very good job of keeping turbid water out of the wetlands. These areas are frozen at this point but the controls should be prepared for thaw periods. 12/8-12/14/05.</p> <p>- Mats may be necessary to stabilize the access road for equipment movement during thaw periods. 12/8-12/14/05</p> <p>- The area should be regraded, pulled back from the fence, and restored when feasible due to weather. 12/1-12/14/05</p> <p>-The ruts should be repaired and silt fence may be needed along the edge of disturbance. Snow cover makes it difficult to see or repair this area. 12/14/05.</p> <p>- The sediment was not scraped up and removed prior to snow cover and is now difficult to see. Control all dewatering discharge especially near wetlands. 12/8-12/14/05</p> <p>- The snow needs to be pulled back from these areas and silt fence righted. 12/14/05</p>

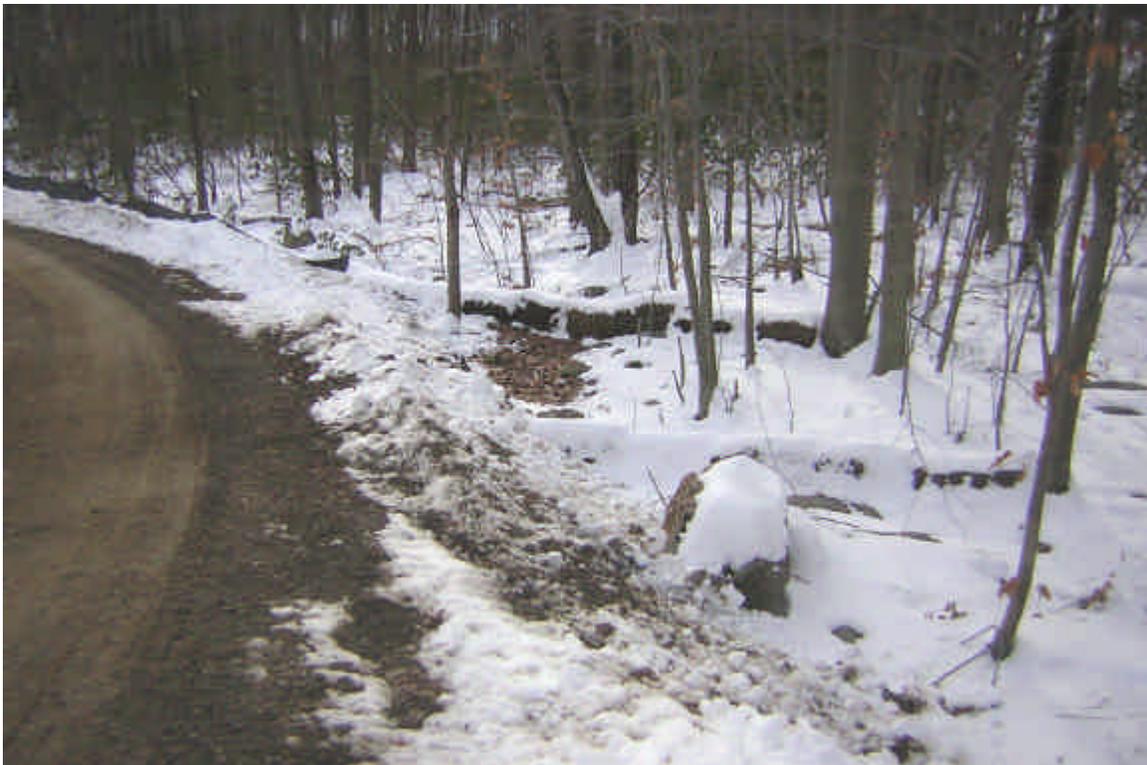
**The check dams that were previously installed are a good addition as they appear to be preventing some run-off from the access road from reaching adjacent wetlands. 12/14/05**
