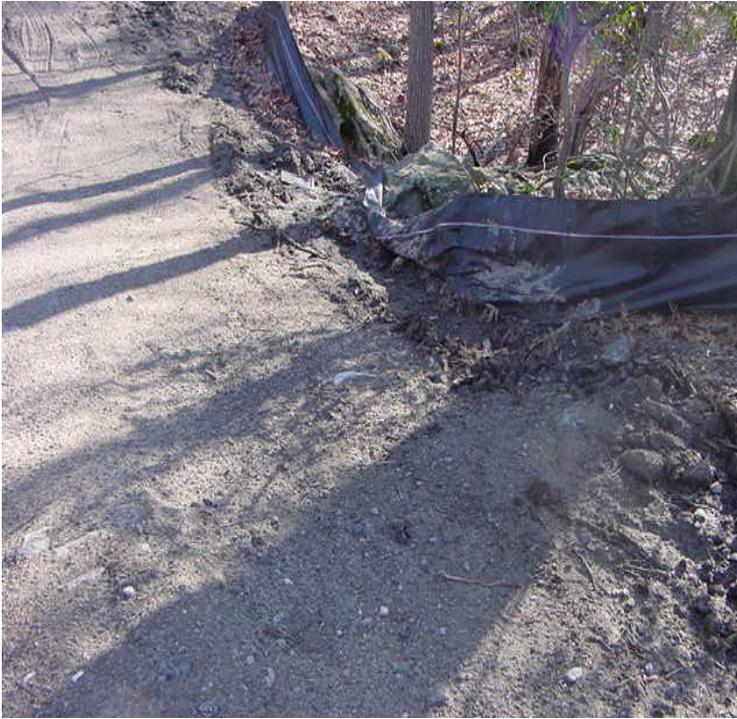
(Composite Section): Photo on the left shows silt fence in need of repair at the 1<sup>st</sup> tower in from Archers Lane. This may be where snow was piled over. Photo on the right shows a general view of the ROW and access road in the area. 12/30/05

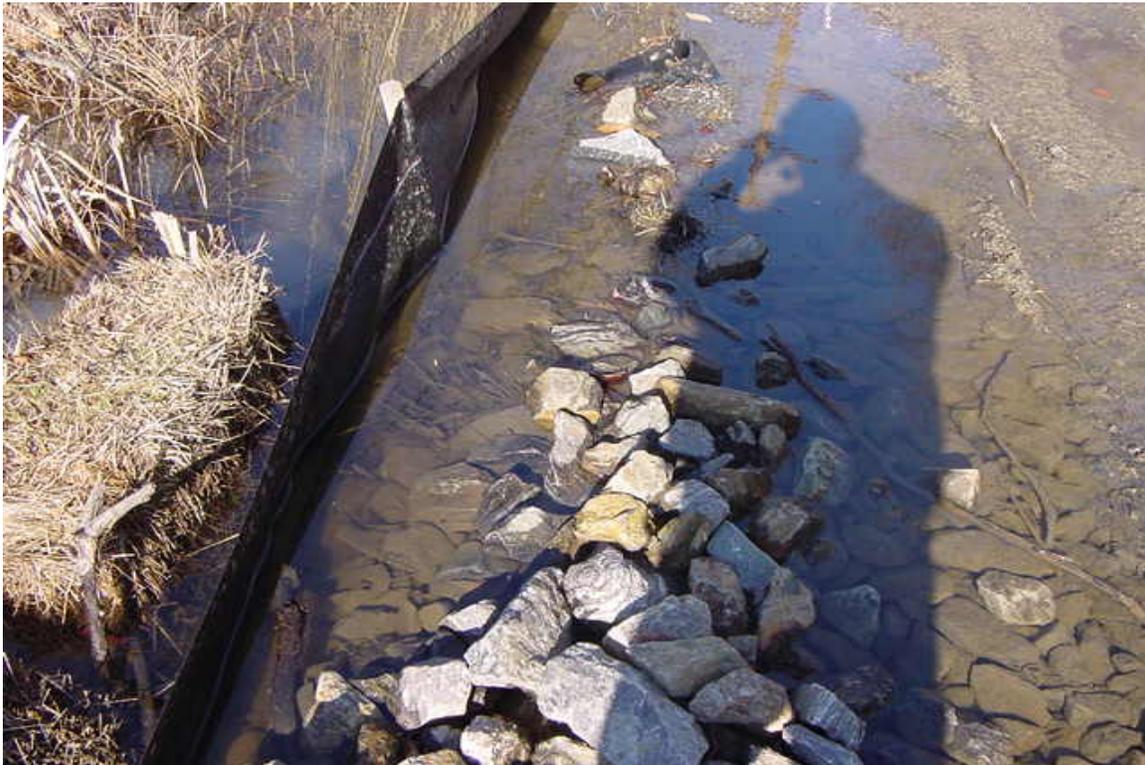
View of the access road near a low wetland area on the Archers Lane side. This area has had turbid water passing through to the wetland but conditions look a little better. Haybales were installed and should be continued in a line here if silt fence cannot be toed-in. 12/30/05

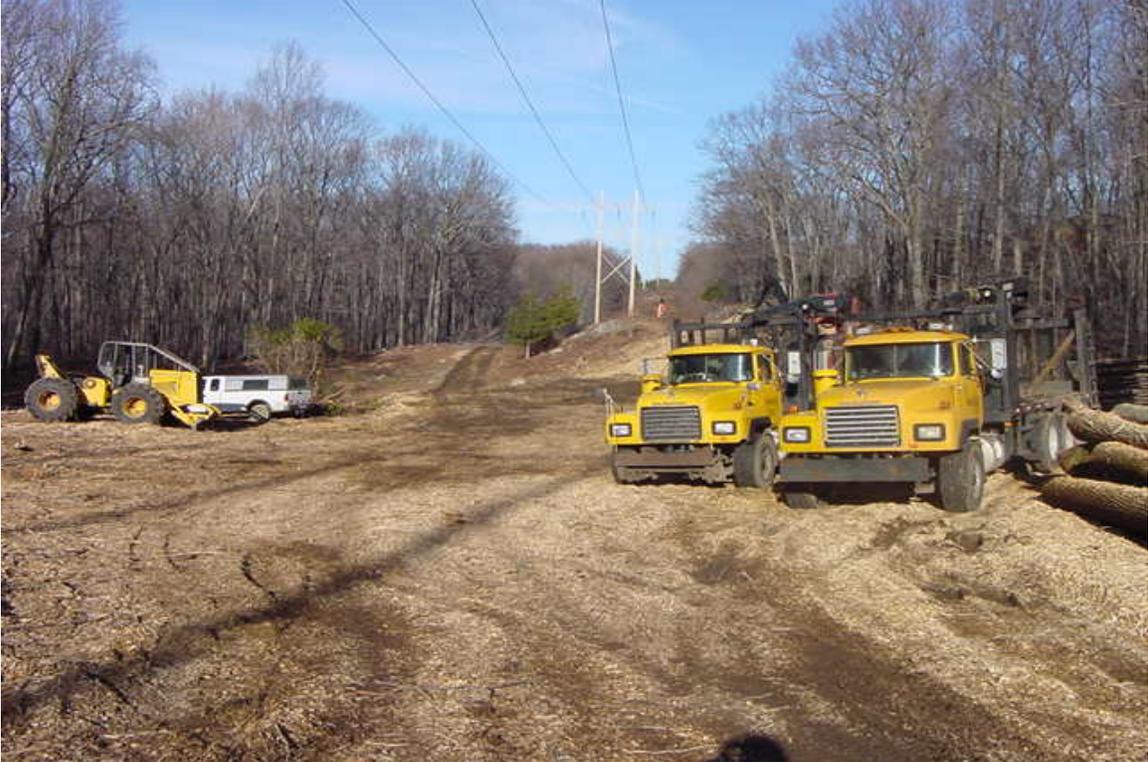
345kV (H-Frame Section): View of the clearing and chipping activities near the Bethel Reservoir section of the ROW. We need to confirm that chips spread on the ROW are no more than 3-inches deep. 12/30/05

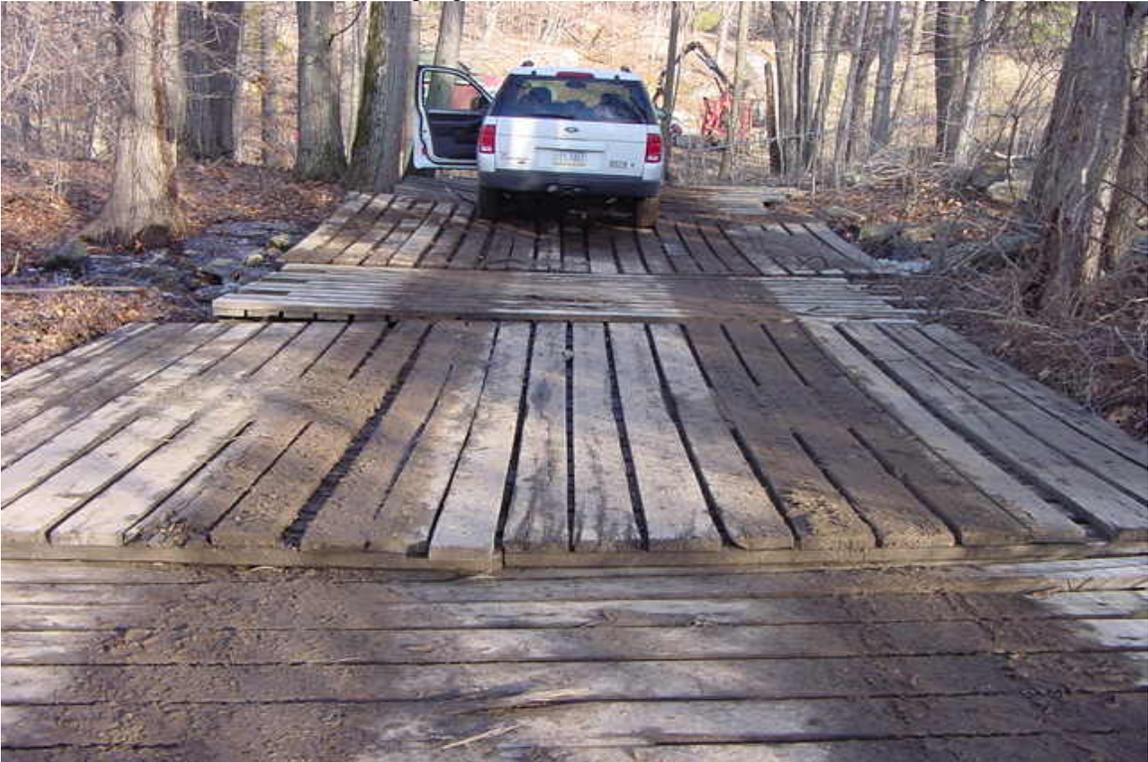
View of the mats installed over the stream crossing along the access road in from the Bethel Reservoir. The stream was running high but remained clear. 12/30/05

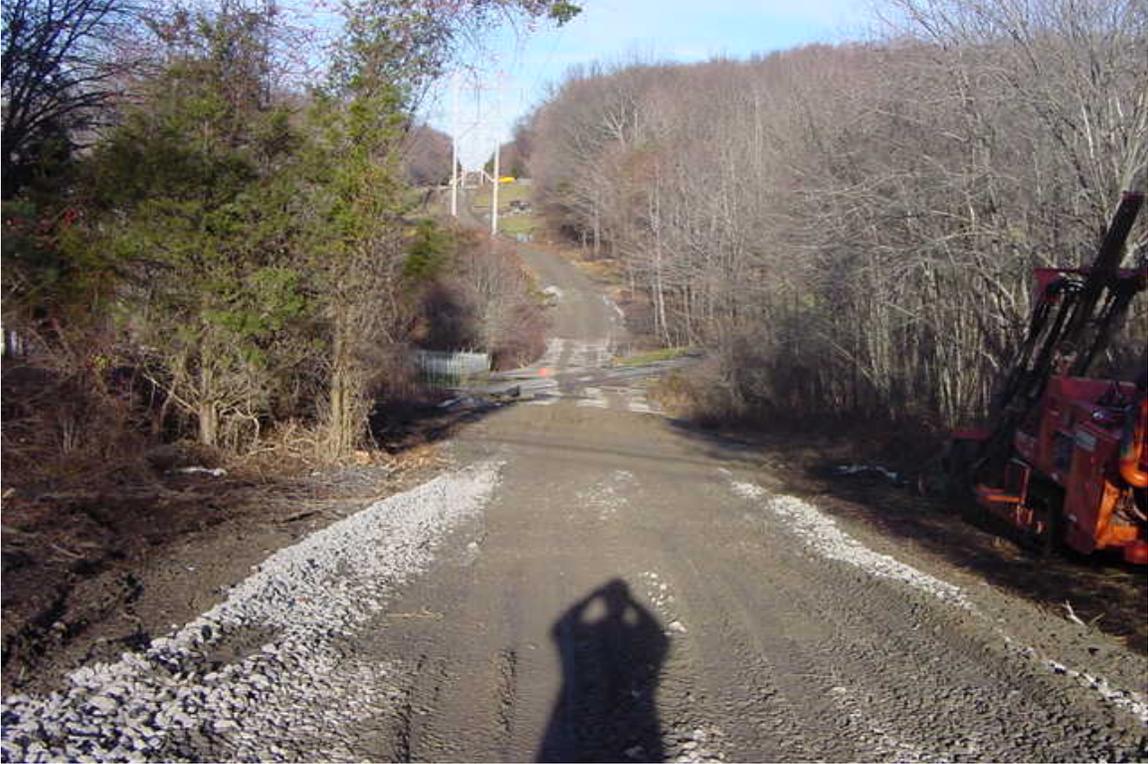
(345kV H-Frame Section): View of the ROW from Chestnut Ridge Rd. looking northerly towards Hoyts Hill. 12/30/05

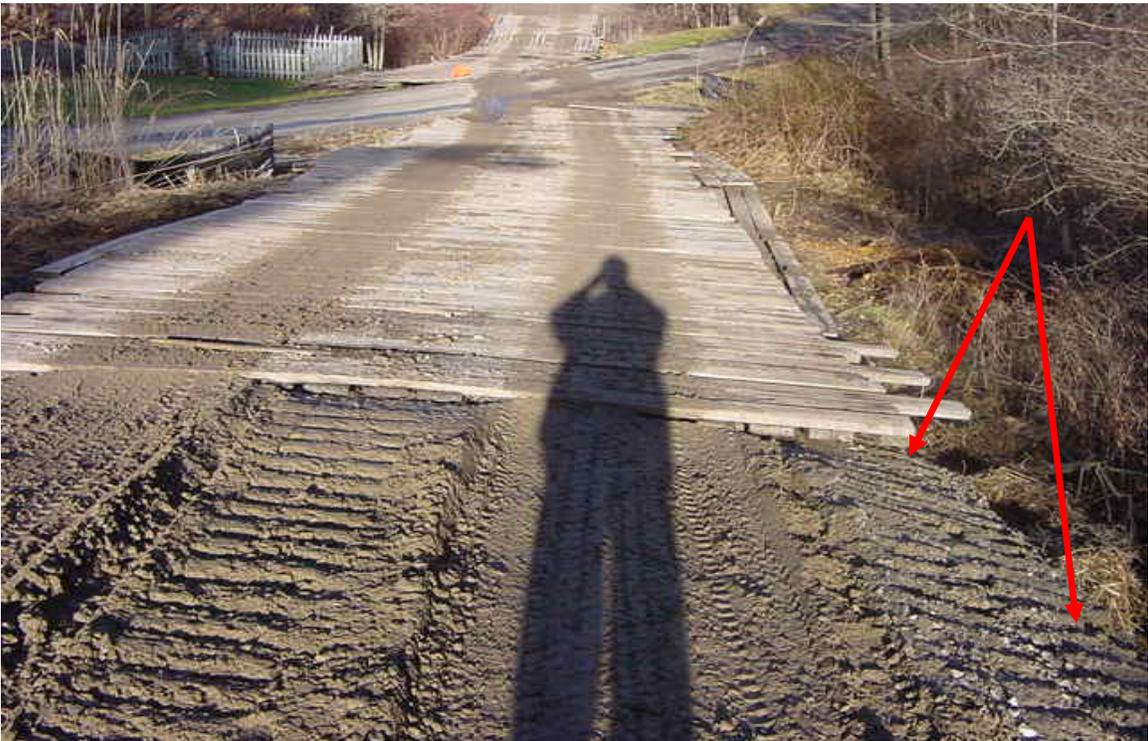
Close up view of the mats installed over the wetland crossing on the ROW off Chestnut Ridge Rd. Mats are working well but some erosion controls may be necessary on the approach to the mat. 12/30/05
