**Docket No. 217 – Development and Management Plan Inspection**

**Date:** January 4, 2006

**Location:** Norwalk Substation Expansion

**Location:** Plumtree Substation Expansion, Bethel

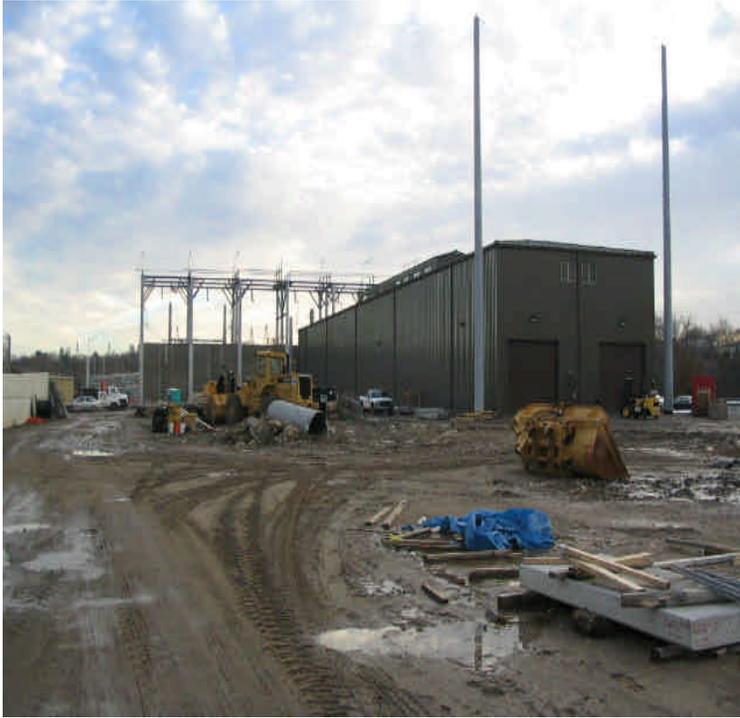
**Norwalk Substation: Photo on the left is an overview of the yard looking towards the GIS building. Photo on the right shows a view of the recently installed structures and the 345kV turning structure. 1/4/06.**

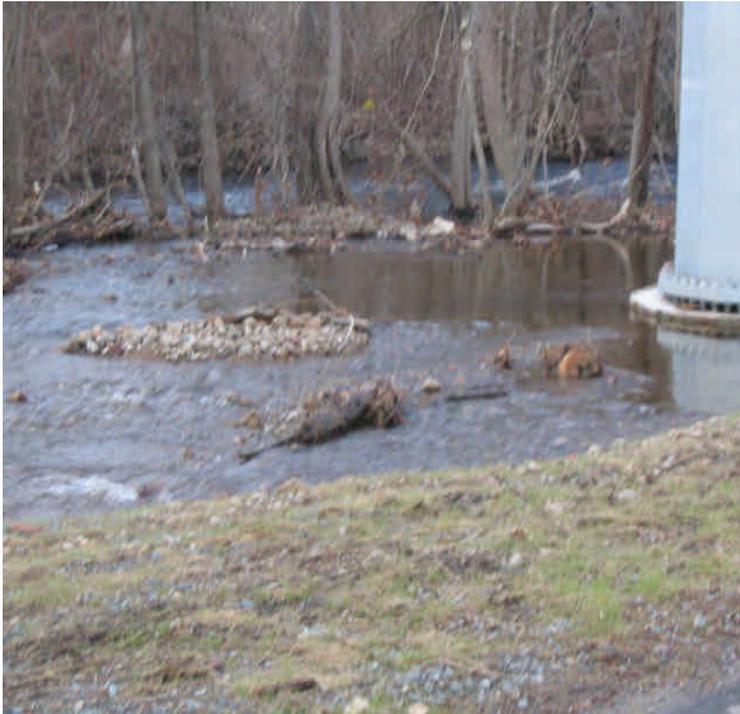
Erosion and Sediment Controls	<p>- Stone is in place between the paved access and unpaved areas of the GIS yard to prevent sediment tracking. 12/22-1/4/06.</p> <p>- The overflow channel and natural overflow area are flooded once again due to the rain and high level of the Norwalk River. 1/4/06.</p> <p>- The topsoil stockpile remains well contained on site. 1/4/06.</p>	<p>- The site remains contained- none at this time. 1/4/06</p> <p>- Sediment previously noted here is most likely a result of natural deposition by the river. 1/4/06.</p> <p>- None at this time. 1/4/06</p>

**Photo on the left shows the flooded natural overflow channel near the 345kV turning structure. Photo on the right shows a view of the structures at the southwest corner of the GIS building. 1/4/06.**

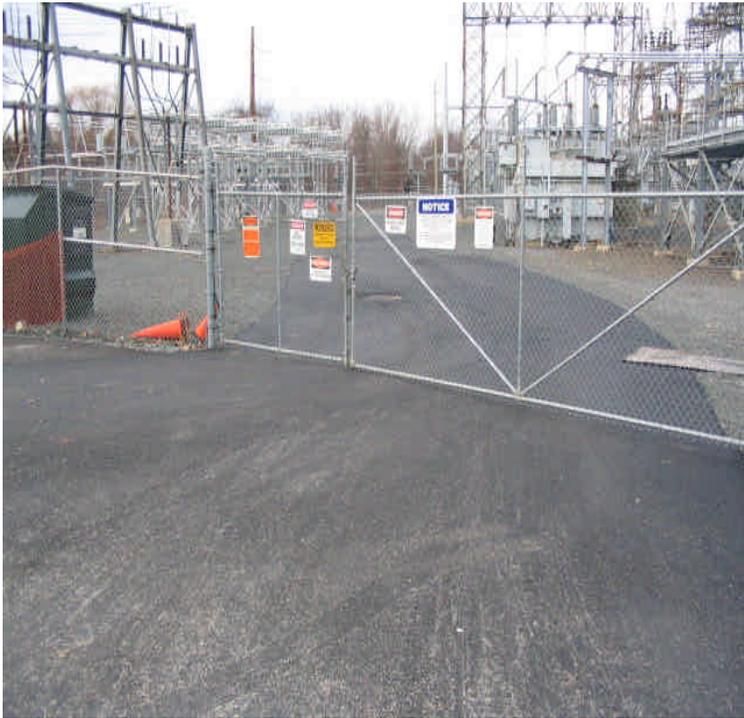
Photo on the left shows the paved access way off New Canaan Ave. Photo on the right shows sediment deposits within the stone at the perimeter fence along Rt. 7. Although the majority of the sediment remained in the stone, some appears to have washed off site. 1/4/06.

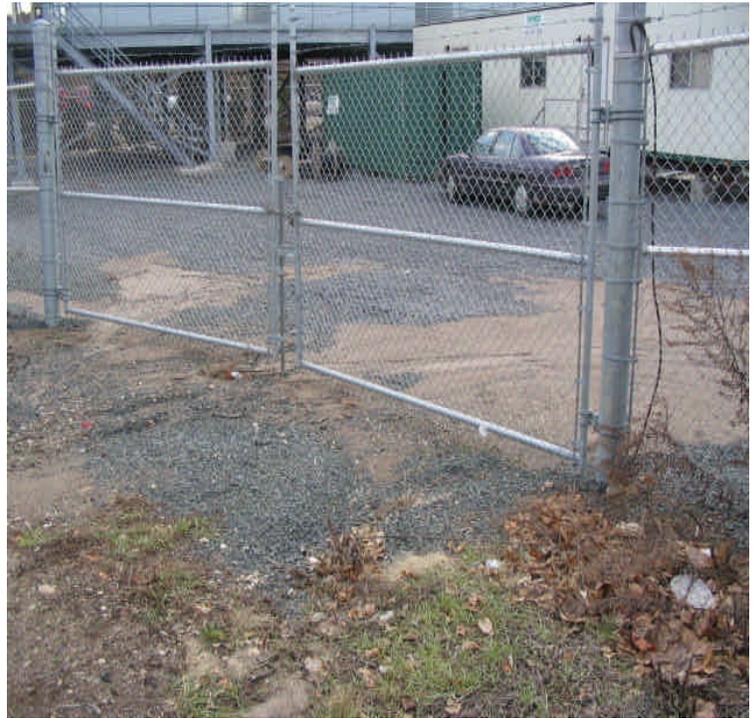
Areas of Inspection	Observation	Recommended Action
Erosion and Sediment Controls continued (includes inspection within 24 hours of a storm event)	- Some sediment was noted collecting in the stone onsite at one of the access gates. This is a result of offsite stormwater 1/4/06.	- Monitor stormwater flow and drainage patterns when possible. Watch for any erosive flows off site. 1/4/06.
Inland Wetland and Watercourse encroachment and mitigation	-Water was flowing fairly clear once again in both the natural and constructed overflow channel. 1/4/06.	- The piles of loose sand sediment noted is most likely a result of natural deposition by the river during these flood periods. None at this time. 1/4/06
State species of concern, threatened and endangered species	- No species of concern are located in this area of construction.	- N/A
Vegetative clearing limits (including trees to save or danger trees noted)	-No additional clearing is needed at this time. 1/4/06.	- Clearing was limited to what is necessary and it will continue to be monitored. 1/4/06.

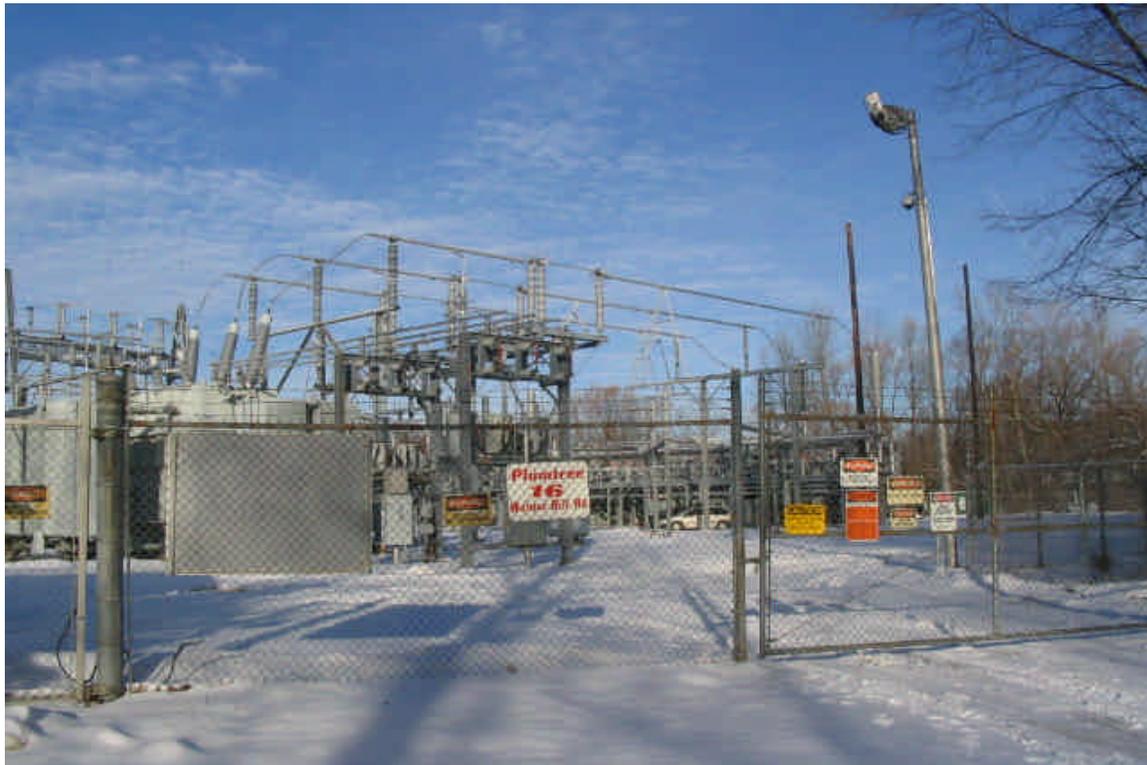
Plumtree Substation: View of the yard where external work has not occurred for some time. 1/4/06.
