**Docket No. 217 – Development and Management Plan Inspection**

Northeast Utilities Service Company Certificate of Environmental Compatibility and Public Need for the construction of a 345-kV electric transmission line and reconstruction of an existing 115-kV electric transmission line between Connecticut Light and Power Company's Plumtree Substation in Bethel, through the towns of Redding, Weston, and Wilton, and to the Norwalk Substation in Norwalk, Connecticut.

**Date:** January 15, 2004

**Location:** Norwalk Substation Expansion

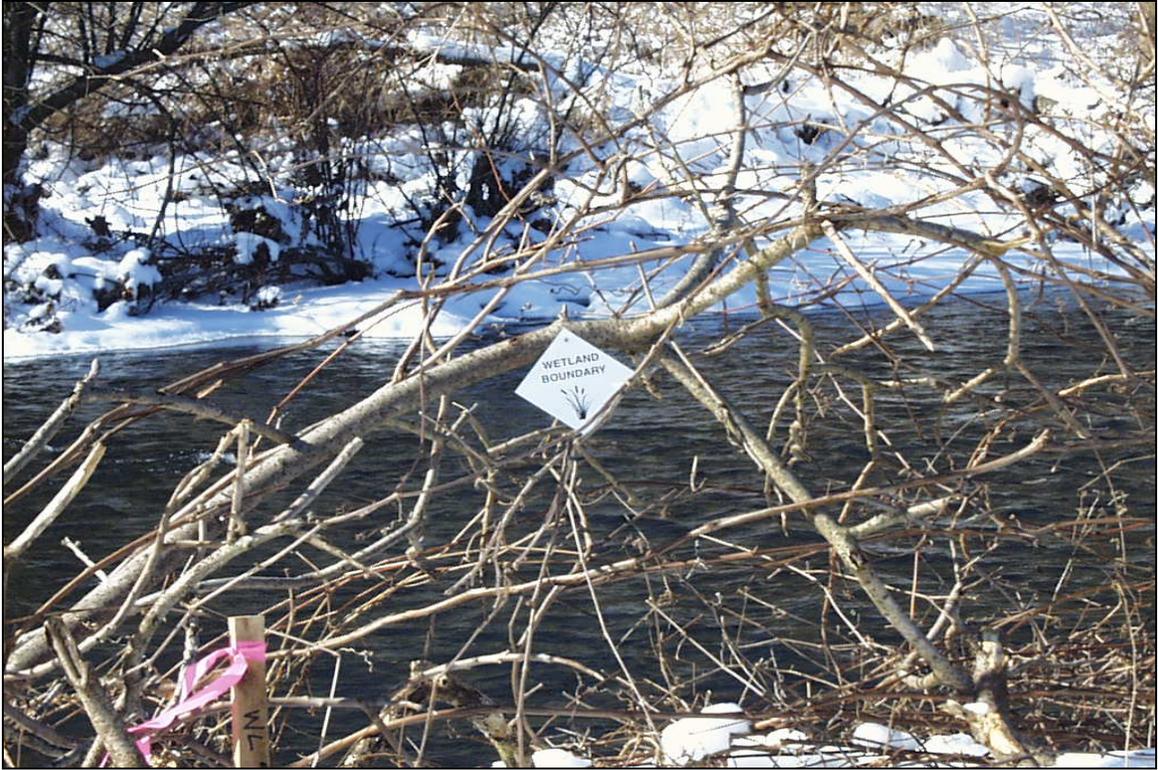
WETLAND BOUNDARY SIGNS WERE PLACED ALONG THE FLAGGED EDGE  
OF THE WETLAND RESOURCE AREA. NOTED 1/15/04

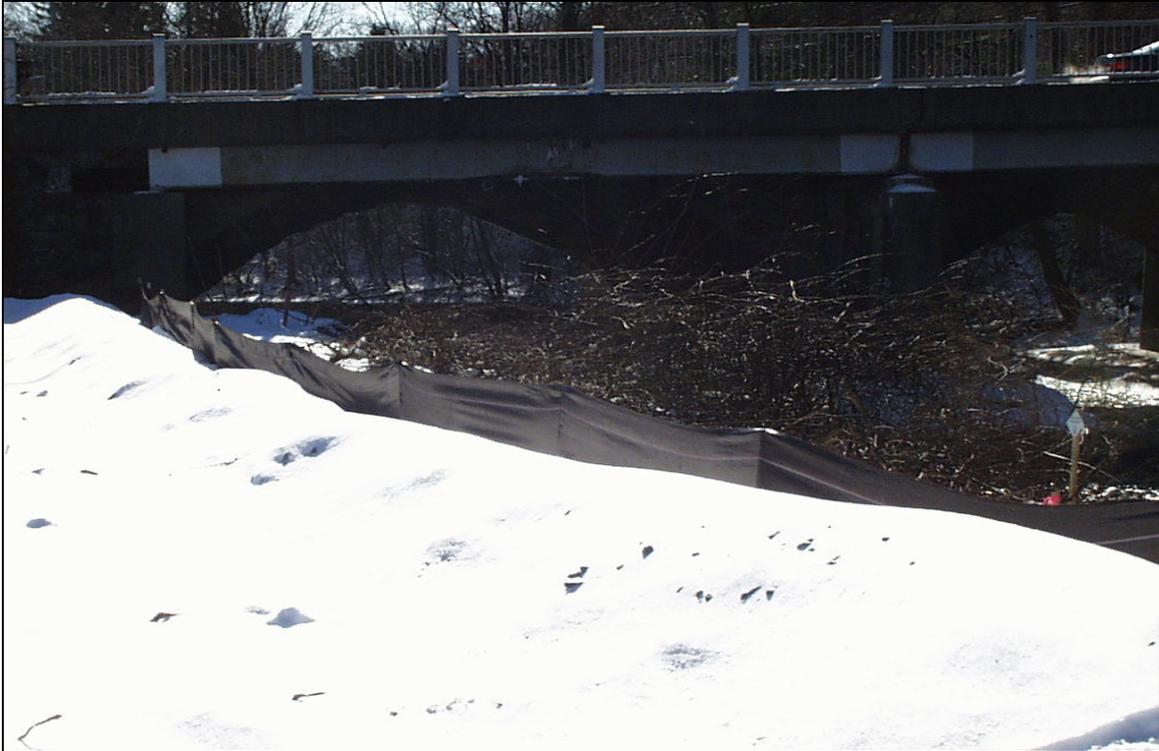
VIEW OF A NEWLY INSTALLED (SNOW COVERED) STONE BERM NEAR THE NORWALK RIVER. THE BERM WILL HELP TO STABILIZE AREAS NEAR THE BANK UNTIL SITE COMPLETION. 1/15/04

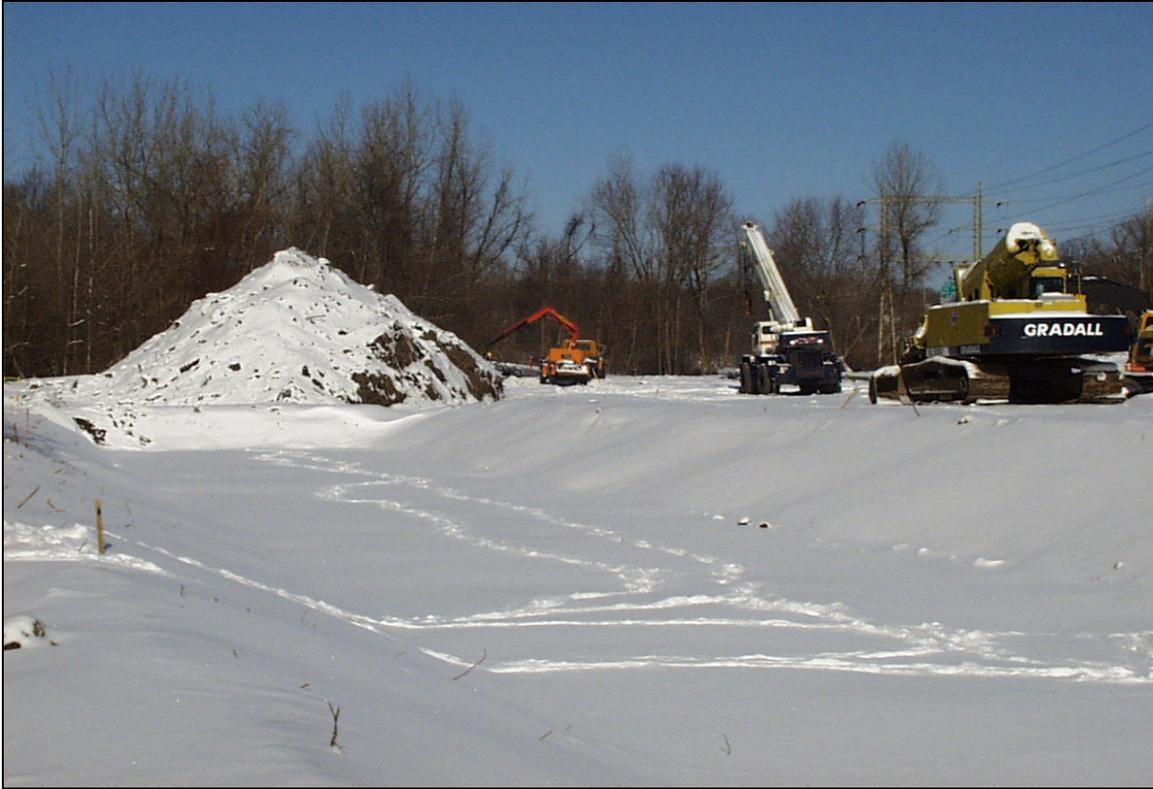
VIEW OF THE CONTINUING EXCAVATION FOR THE TEMPORARY SEDIMENT BASIN. THE BASIN IS ANTICIPATED FOR COMPLETION EARLY NEXT WEEK.

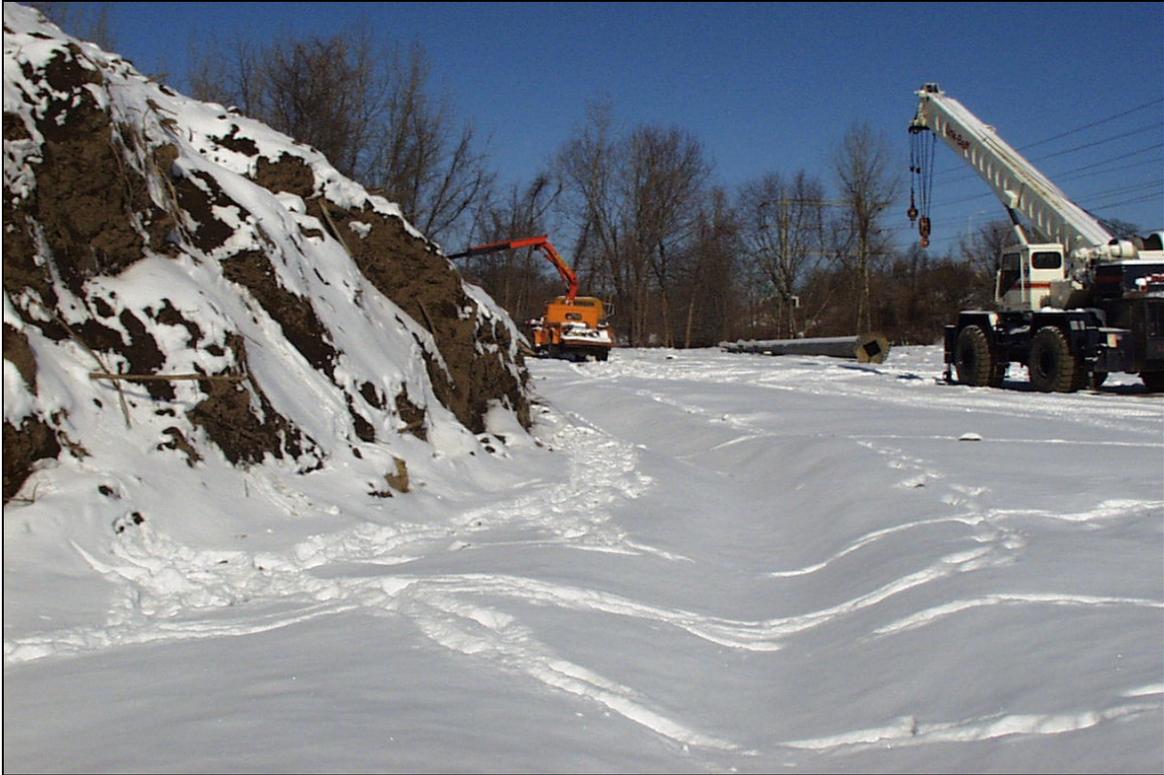
VIEW OF STONE SWALE WHICH WILL DIRECT DRAINAGE TO THE  
SEDIMENT BASIN. THE SWALE IS LOCATED NEAR THE BASE OF THE  
TOPSOIL STOCKPILE. 1/15/04

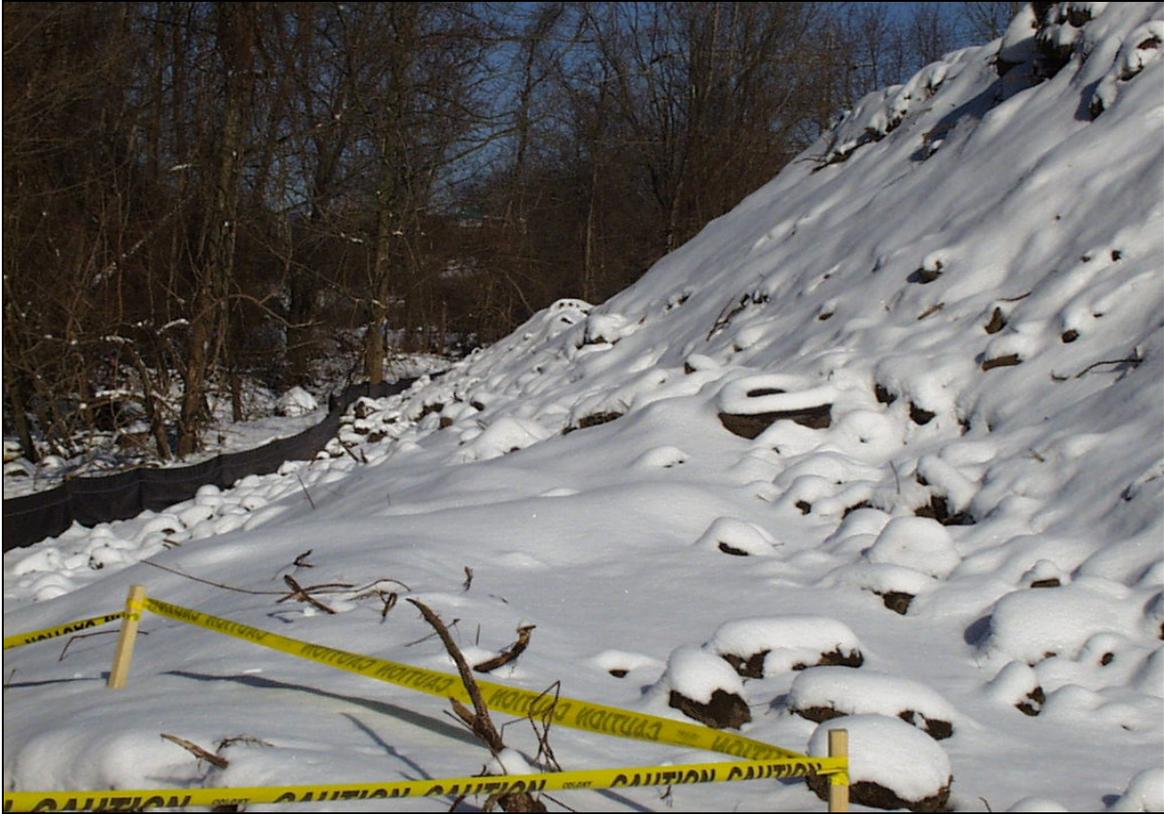
VIEW OF THE BACK OF THE TOPSOIL STOCKPILE ADJACENT TO THE PERIMETER SILT FENCE. A SECOND SILT FENCE IS RECOMMENDED FOR INSTALLATION AT THE BASE OF THE STOCKPILE PRIOR TO ANY THAWING TRENDS OR RAIN EVENTS. 1/15/04
