Docket No. 217 – Development and Management Plan Inspection

Date: January 19, 2006

Location: Norwalk Substation Expansion

Location: Plumtree Substation Expansion, Bethel

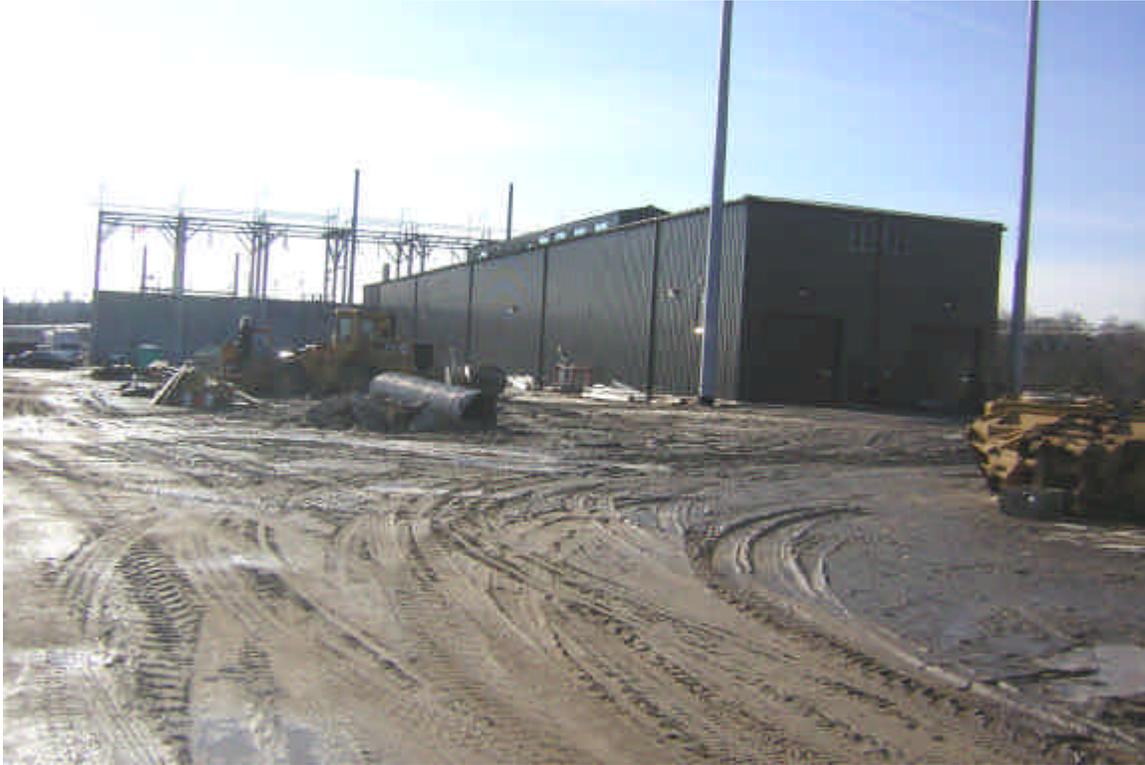
Norwalk Substation: View of the yard looking towards the GIS building. 1/19/06.

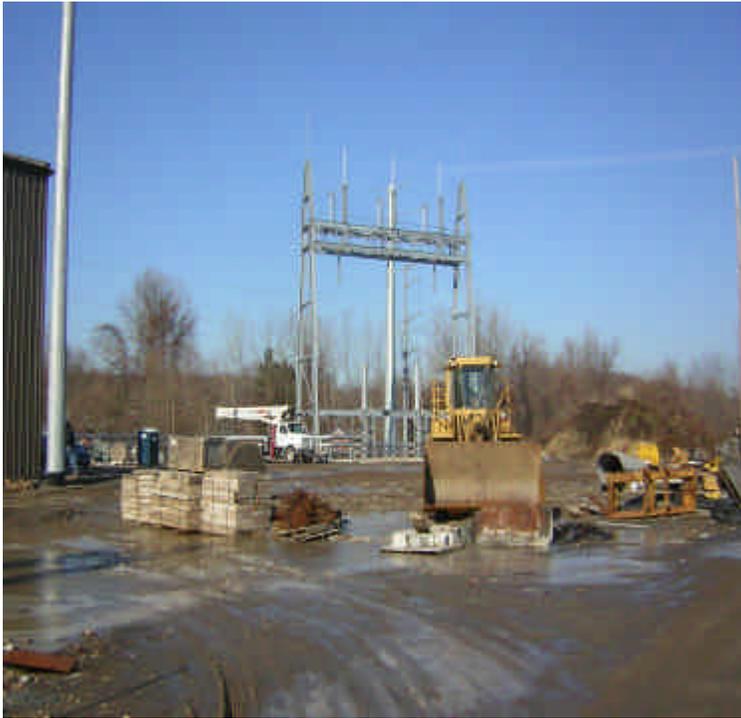
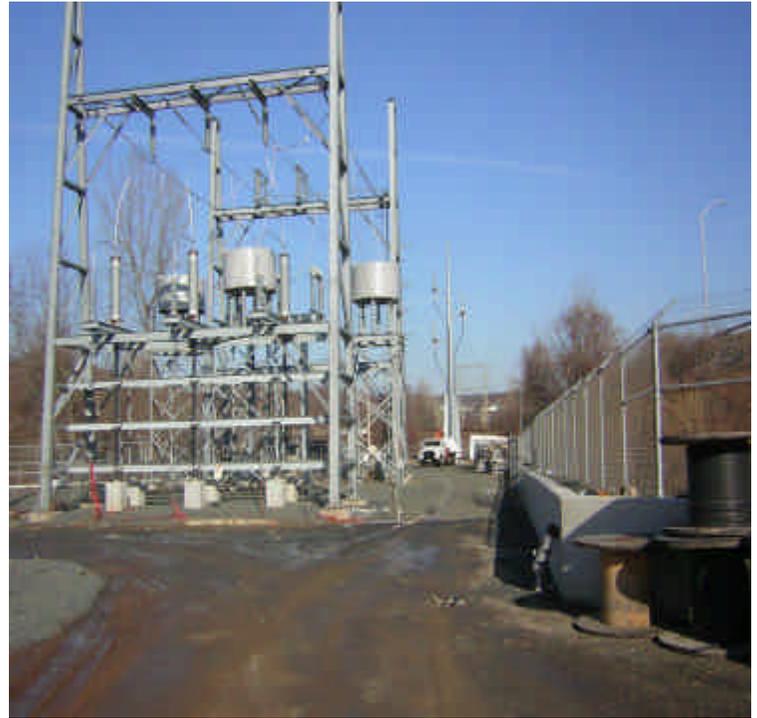
Photo on the left shows the structures recently installed to the north of the GIS building near the retaining wall. Photo on the right is a view of the ongoing work near the tower near the ROW 1/19/06.

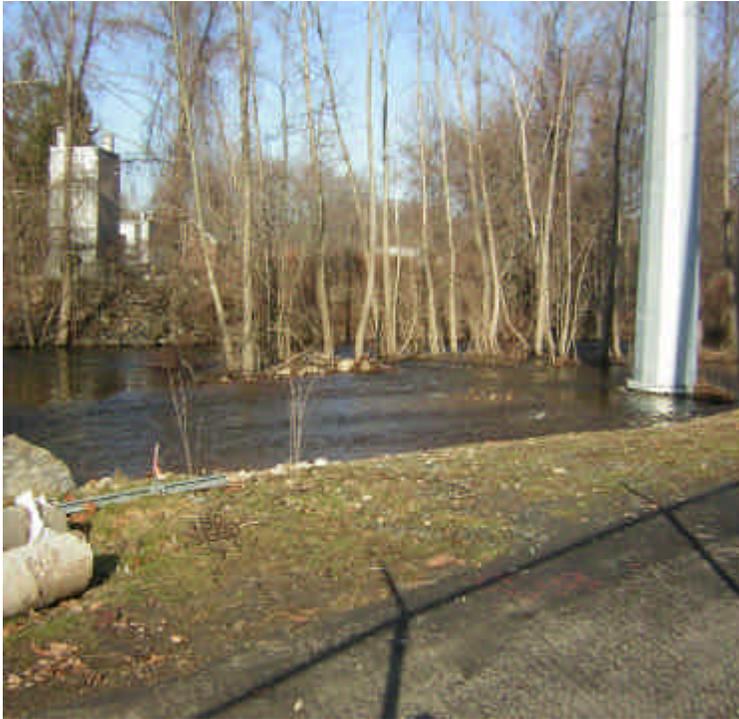
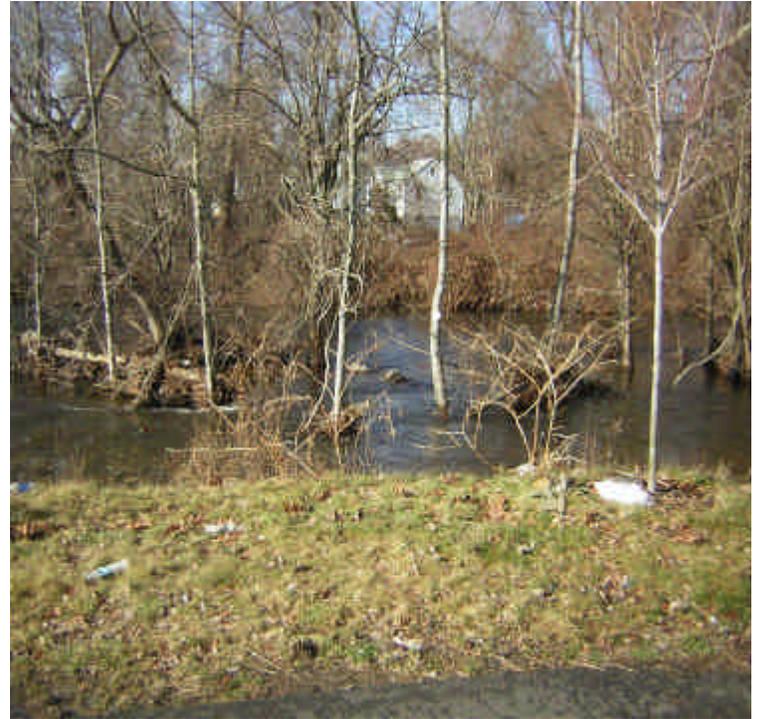
Areas of Inspection	Observation	Recommended Action
Continued	<p>1/19/06.</p> <ul style="list-style-type: none"> - The overflow channel and natural overflow area were still flooded at this time due to high levels of the Norwalk River. 1/19/06. - The topsoil stockpile remains well contained on site. 1/19/06. 	<ul style="list-style-type: none"> - None at this time. 1/19/06
	<ul style="list-style-type: none"> - Some sediment was noted collecting in the stone onsite at one of the access gates. This is a result of offsite stormwater 1/4-1/19/06. 	<ul style="list-style-type: none"> - Monitor stormwater flow and drainage patterns when possible. Watch for any erosive flows off site.1/4-1/19/06.
Inland Wetland and Watercourse encroachment and mitigation	<ul style="list-style-type: none"> -Water was flowing fairly clear once again in both the natural and constructed overflow channel. Some minor erosion was noted along the top of slope 1/19/06. 	<ul style="list-style-type: none"> - Sediment does deposit naturally along the channel. None at this time. 1/19/06

Both photos show views in the area of the natural and constructed overflow channels where the river had flooded. 1/19/06.

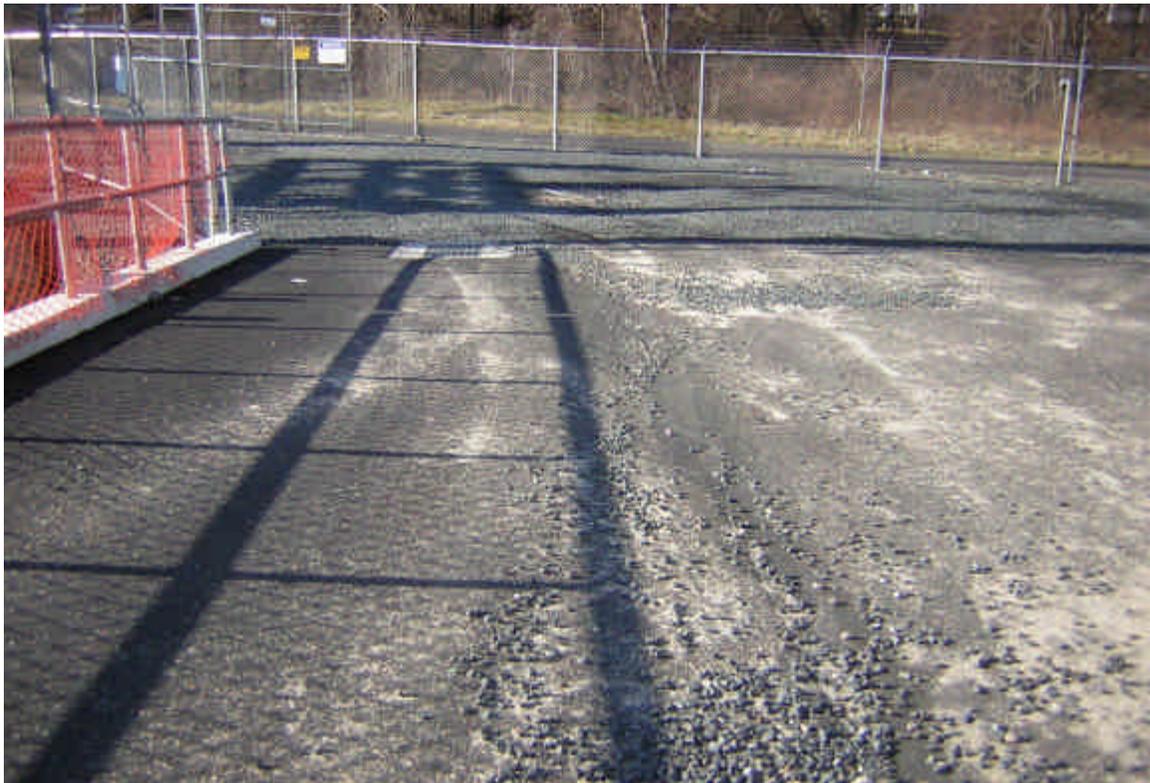
Areas of Inspection	Observation	Recommended Action
Access Roads and Adjacent Roadways	- The catch basin near the Route 7 ramp receives a lot of off-site stormwater, and erosion and sedimentation is occurring here. 12/22-1/19/06.	-The area should no longer be affected by any onsite sediment. The access road is paved and the swale is vegetated The silt fence could be removed. 12/1-1/19/06.
Foundation construction	- Little “soil-disturbing” work was occurring on site. Some structural and electrical work was ongoing in and near the GIS building, including above the front bays and at the recently installed structures to the northwest. 1/19/06. - Work was complete on the tower near the ROW with scaffolding removed. 1/19/06.	-None at this time. The site remains largely contained. 1/19/06. - None at this time. 1/19/06. (115kV Contractors)
Erosion and Sediment Controls	- Stone is in place between the paved access and unpaved areas of the yard to prevent sediment tracking but the site was fairly muddy overall. 1/19/06. -Some sand and sediment has accumulated at the paved area south of the GIS building and is migrating toward the catch basin. The catch basin is not protected with filter fabric.	- The site remains contained- none at this time. 1/19/06 -Monitor sediment tracking from the disturbed areas to the pavement. Install filter fabric in catch basin if tracking continues. 1/19/06.

View of the paved area to the south of the GIS building where sand and sediment is migrating toward the catch basin. 1/19/06.
