**Docket No. 217 – Development and Management Plan Inspection**

Northeast Utilities Service Company Certificate of Environmental Compatibility and Public Need for the construction of a 345-kV electric transmission line and reconstruction of an existing 115-kV electric transmission line between Connecticut Light and Power Company’s Plumtree Substation in Bethel, through the towns of Redding, Weston, and Wilton, and to the Norwalk Substation in Norwalk, Connecticut.

**Date:** January 27, 2005

**Location:** Norwalk Substation Expansion

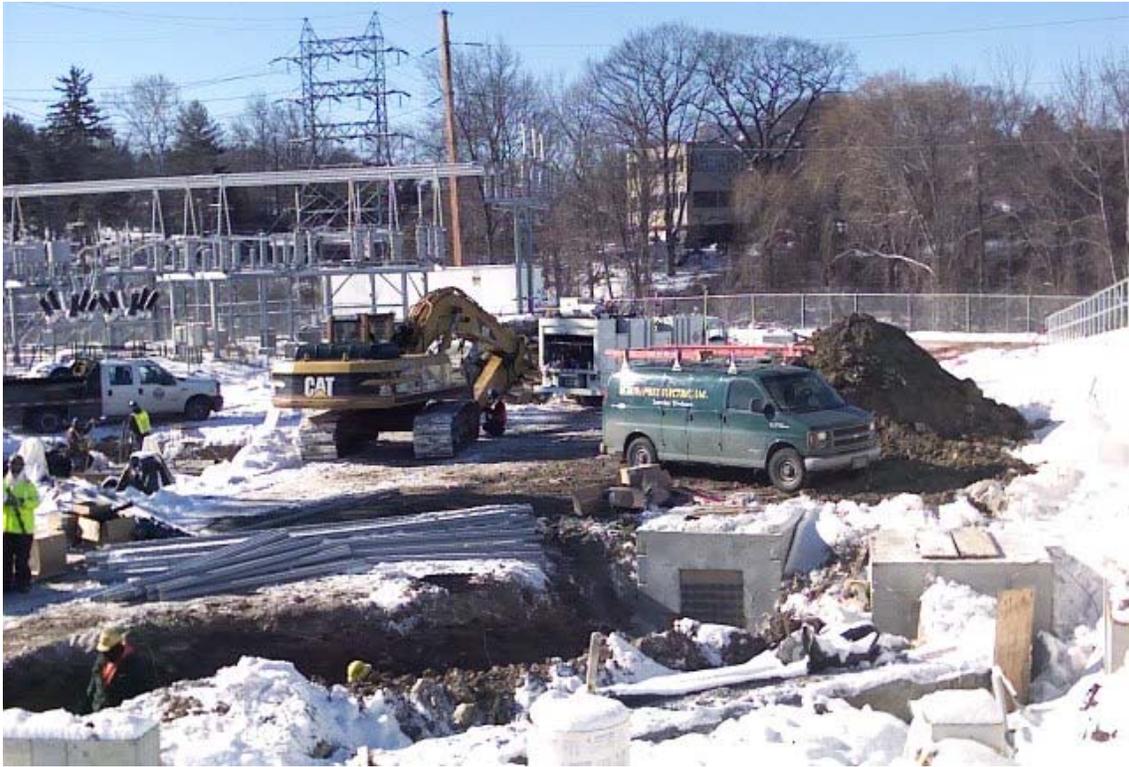
View of the excavation and trench work south of wall #3 for the continued expansion of equipment. All areas are well contained at this time. 1/27/05

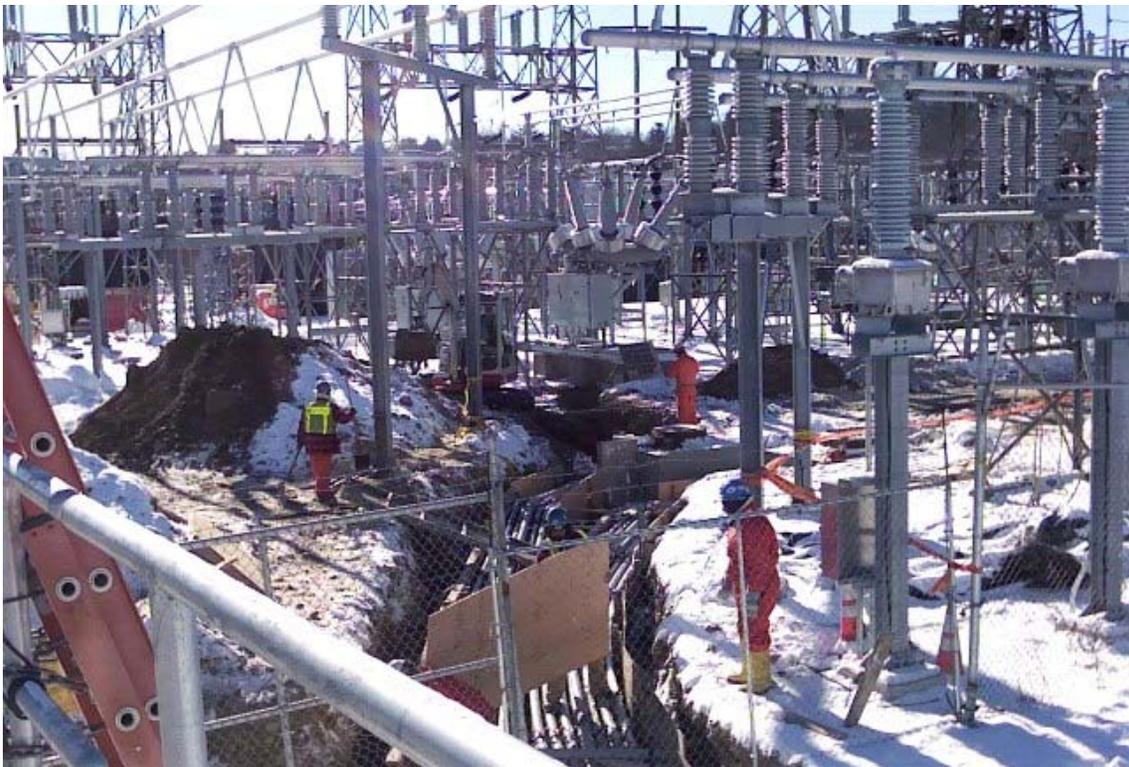
The excavation and trench work is expanding into the active, charged yard. Again all areas are contained and well within the site. 1/27/05

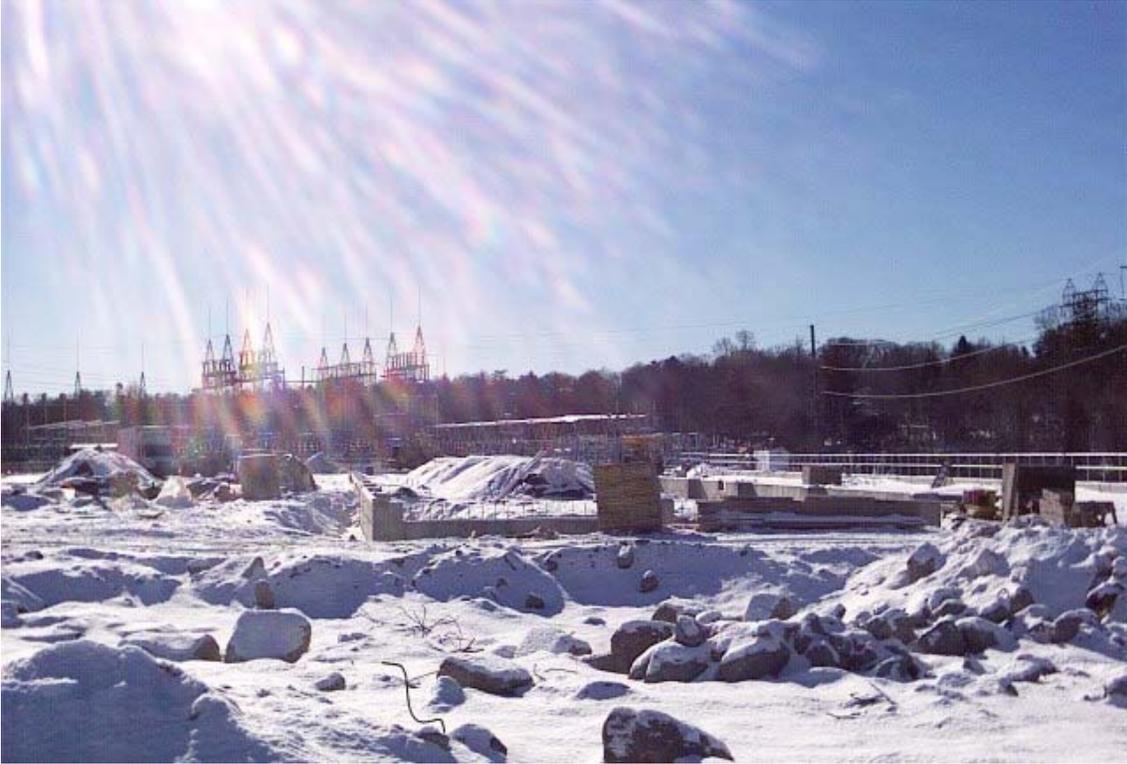
The GIS building forms have been poured and carpentry work on the building will begin. soon 1/27/05

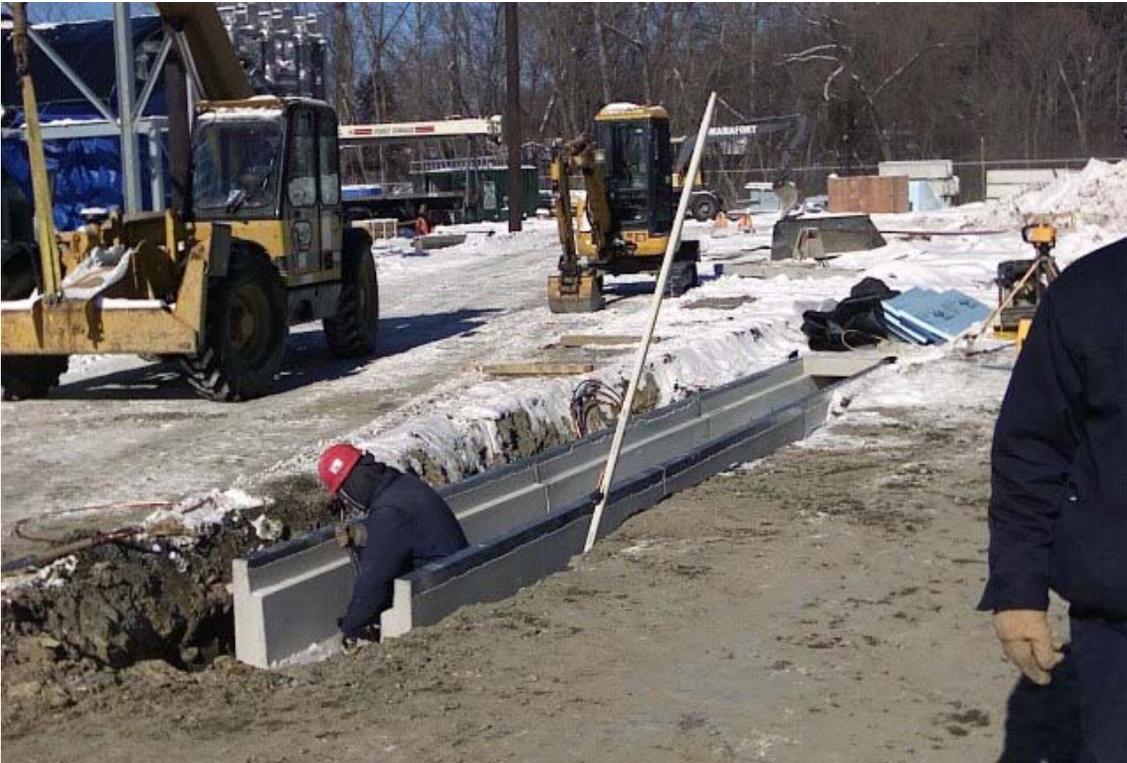
Plumtree Substation: Work continues on the cable trenches near the trailer however it may be put on hold due to a deep frost layer. 1/27/05

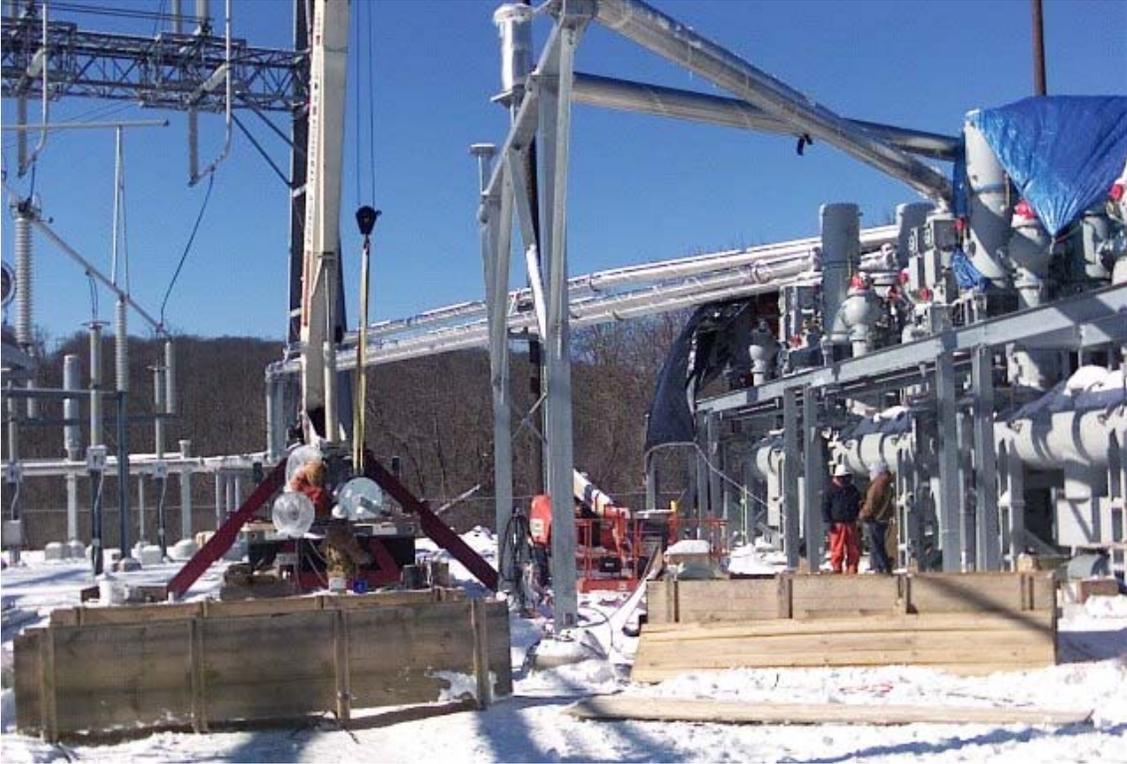
Work continues on the slab connecting the new equipment to the active yard. 1/27/05

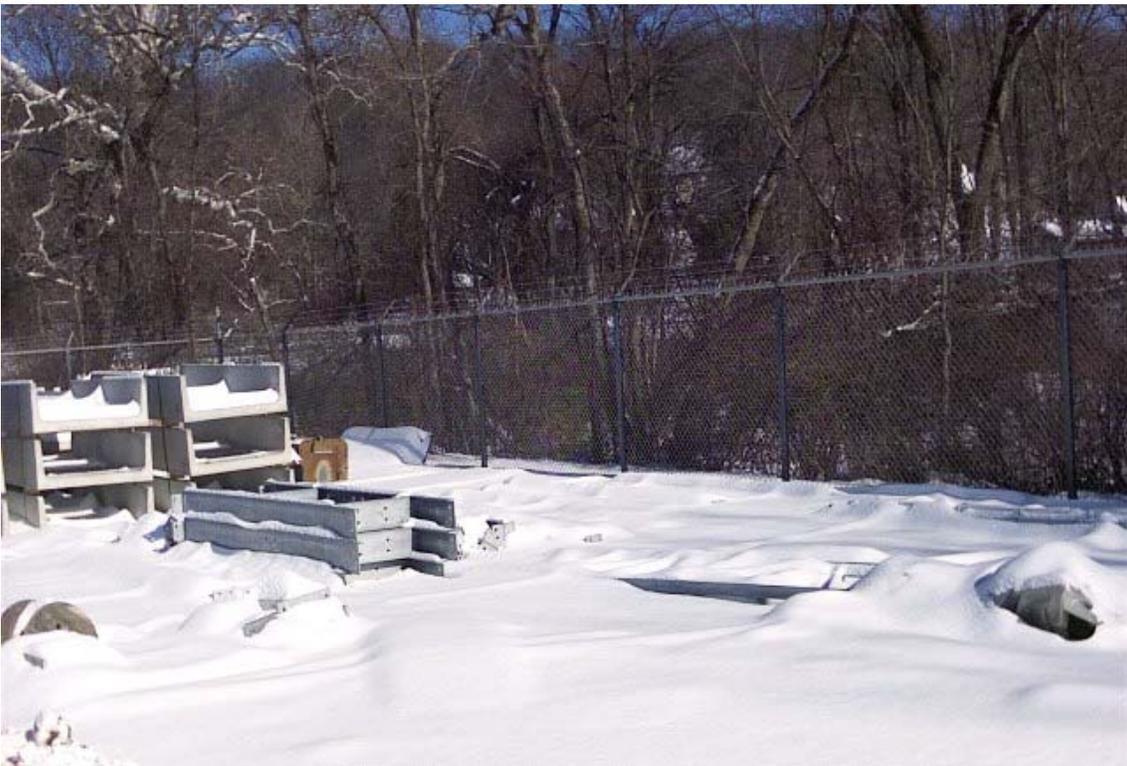
The site is largely snow covered and surfaces are frozen at this time. Sediment is not highly mobile. 1/27/05
