Docket No. 217 – Development and Management Plan Inspection

Northeast Utilities Service Company Certificate of Environmental Compatibility and Public Need for the construction of a 345-kV electric transmission line and reconstruction of an existing 115-kV electric transmission line between Connecticut Light and Power Company’s Plumtree Substation in Bethel, through the towns of Redding, Weston, and Wilton, and to the Norwalk Substation in Norwalk, Connecticut.

Norwalk Substation

Date: February 16, 2006

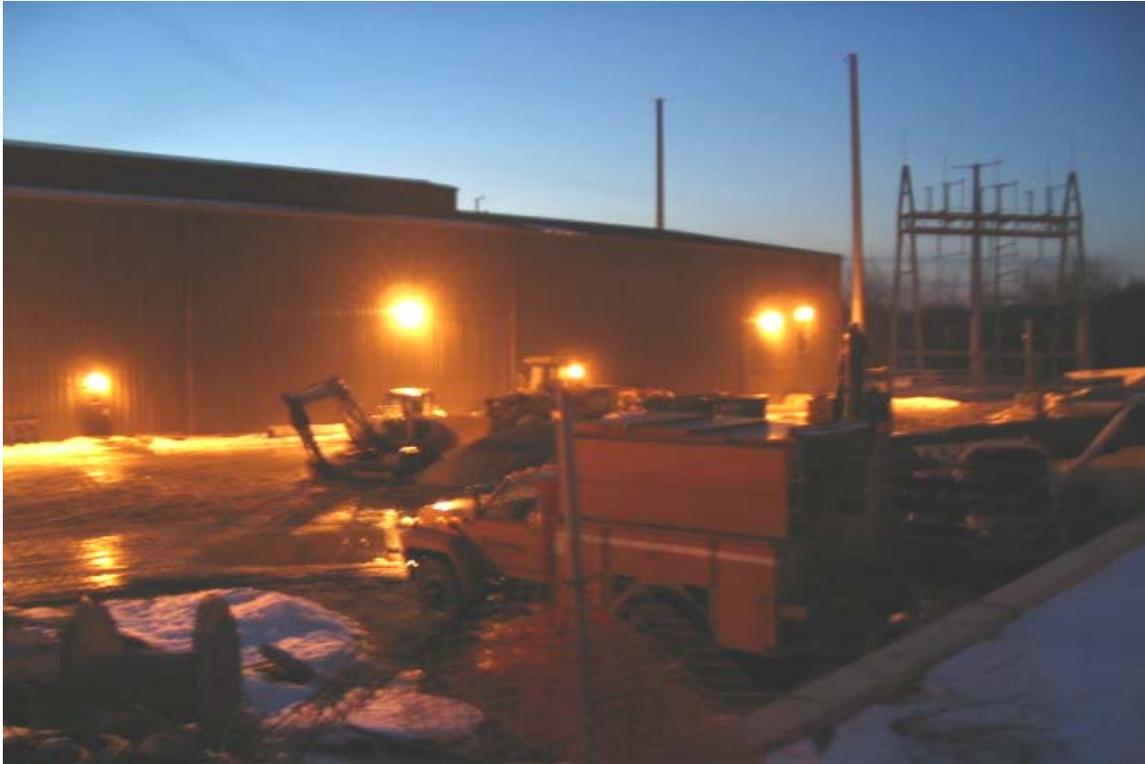
Norwalk Substation: Work continues on structures and within the GIS building. A quick inspection was made late in the day from the perimeter. 2/16/06.

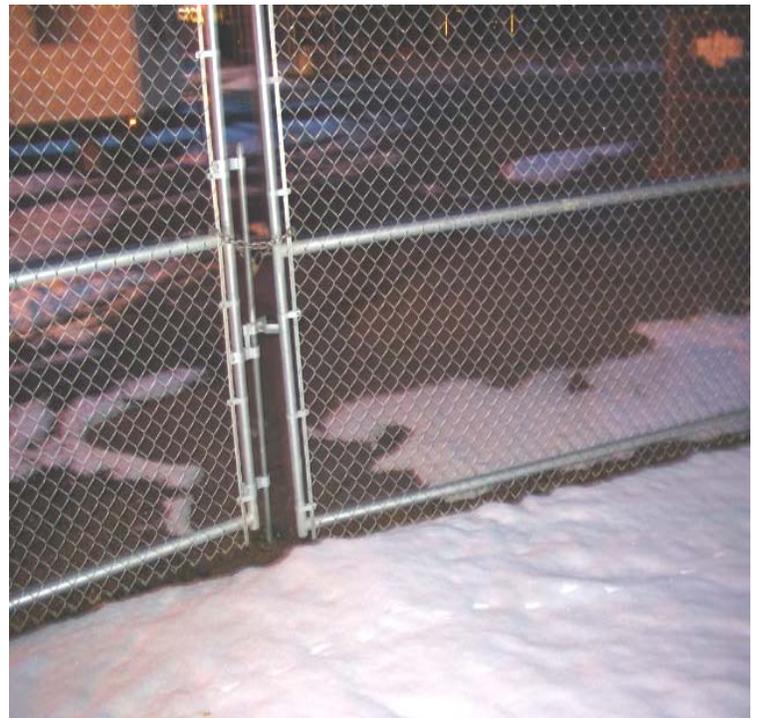
Photo on the left shows some sedimentation to the perimeter swale near the Rt. 7 ramp. Photo on the right shows where road sand

from the ramp has washed on site and accumulated in the stone. It all remains contained and these are mostly a result of off-site issues.
2/16/06
