Docket No. 217 – Development and Management Plan Inspection

Northeast Utilities Service Company Certificate of Environmental Compatibility and Public Need for the construction of a 345-kV electric transmission line and reconstruction of an existing 115-kV electric transmission line between Connecticut Light and Power Company’s Plumtree Substation in Bethel, through the towns of Redding, Weston, and Wilton, and to the Norwalk Substation in Norwalk, Connecticut.

Norwalk Substation

Date: February 22, 2006

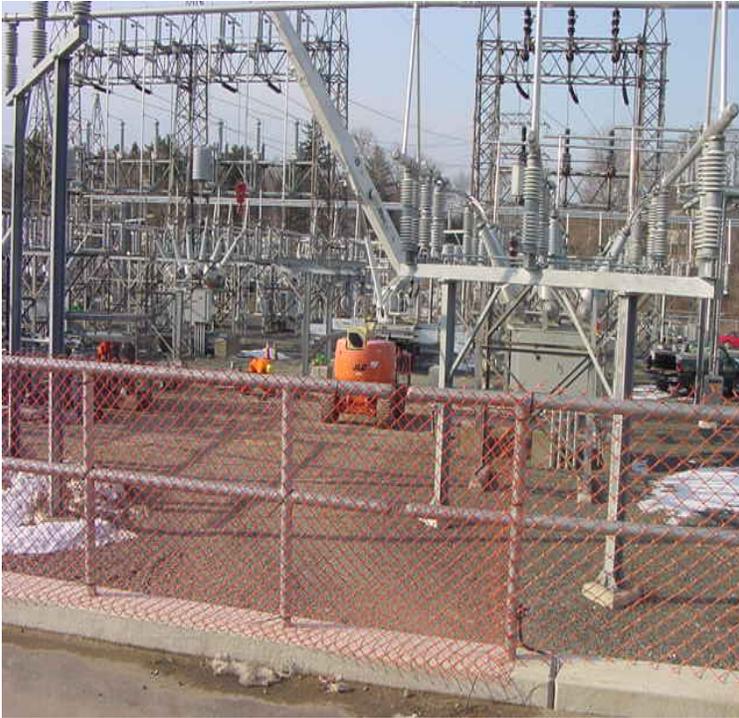
Norwalk Substation: Photo on the left shows work continuing within the live yard. Photo on the right shows work continuing on the structure to the northwest of the yard. 2/22/06.

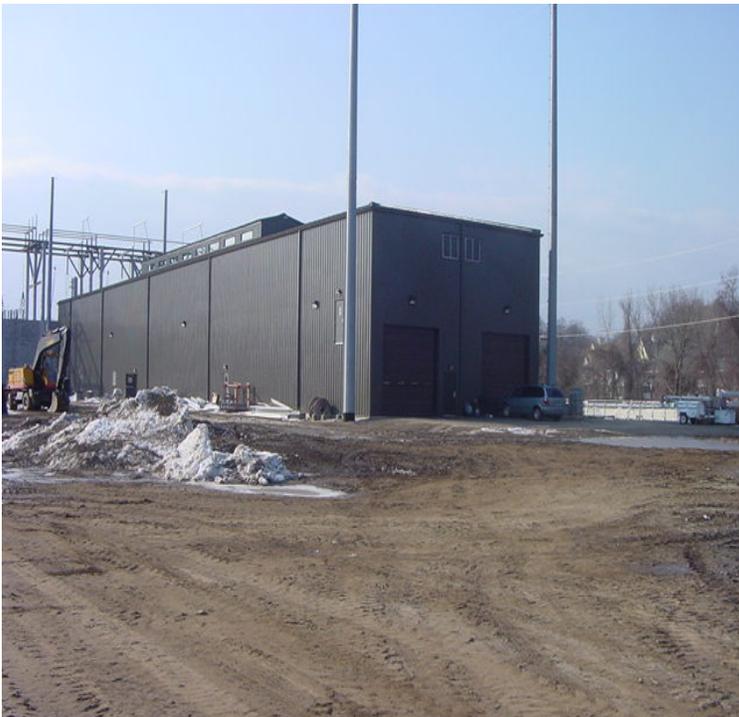
Photo on the left shows an overview of the GIS building and yard. Photo on the right shows the Plumtree Substation where work has resumed in the access drive for the 345kV XLPE portion of the project. Make sure silt fence is in place at the wetland swales here. 2/22/06
