Docket No. 217 – Development and Management Plan Inspection

Northeast Utilities Service Company Certificate of Environmental Compatibility and Public Need for the construction of a 345-kV electric transmission line and reconstruction of an existing 115-kV electric transmission line between Connecticut Light and Power Company’s Plumtree Substation in Bethel, through the towns of Redding, Weston, and Wilton, and to the Norwalk Substation in Norwalk, Connecticut.

Date: March 2, 2005

Location: Norwalk Substation Expansion

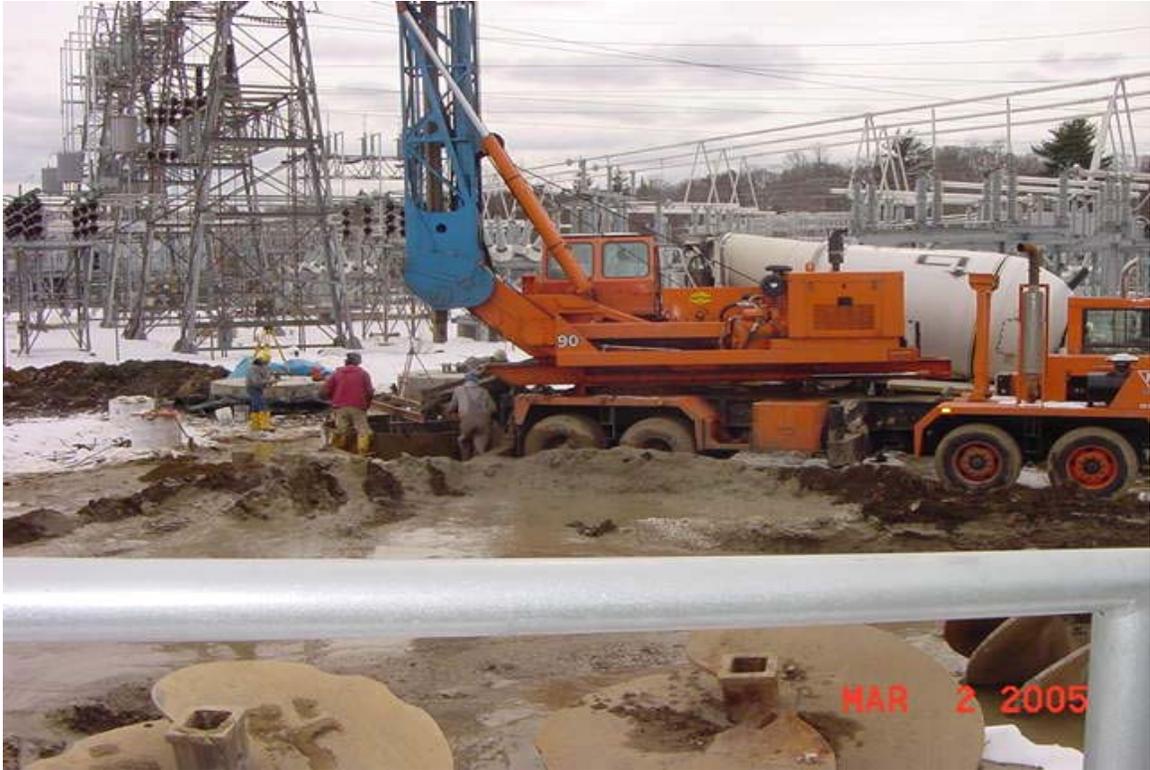
View of construction of caissons near retaining wall #3. 3/2/05

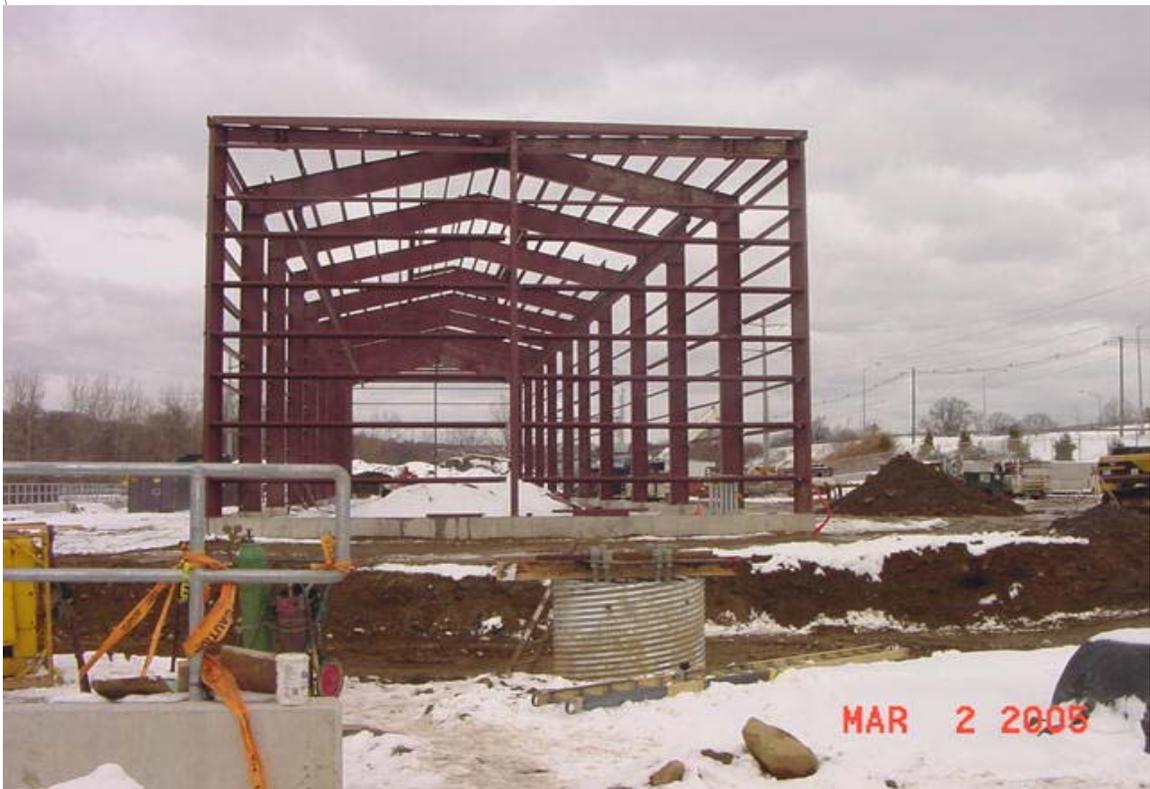
View of steel frame of GIS building, under ongoing construction at this time. 3/2/05

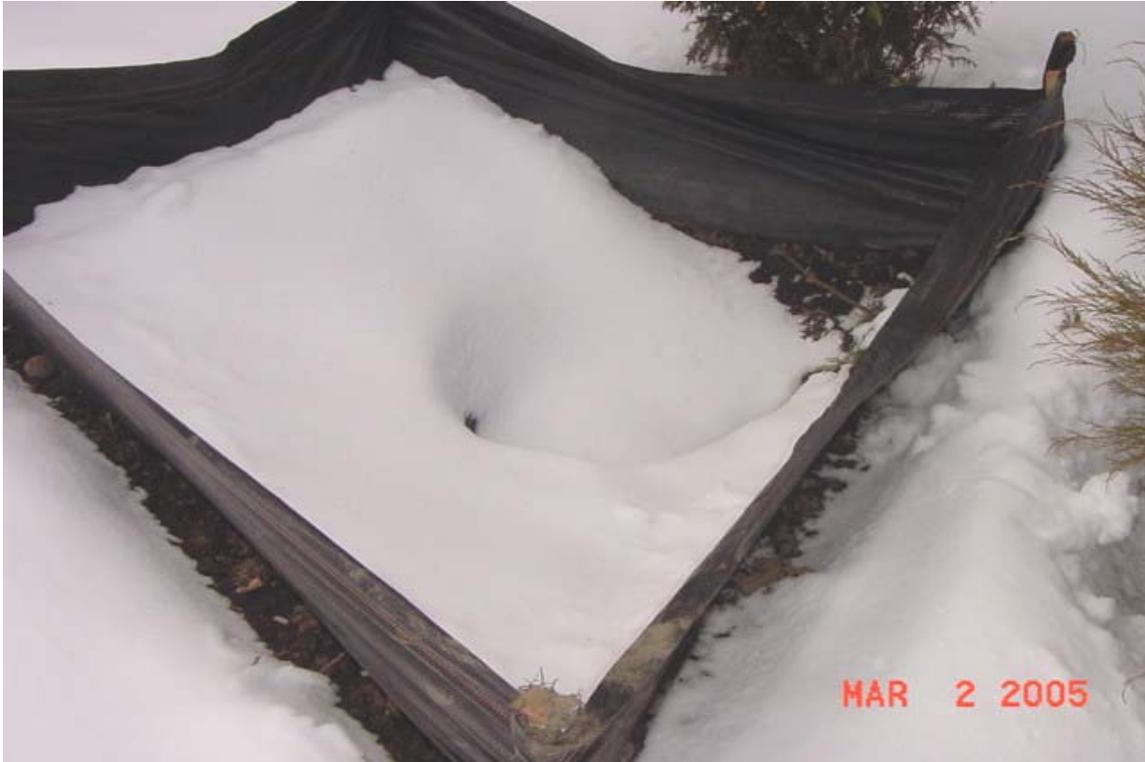
- The flared inlet near the Rt 7 ramp is receiving obvious stormwater flows from off site roadway and on site sources, but it is well protected at this time. A haybale should be placed as an additional precaution when snow cover is gone. 2/23-3/2/05	- Continue to monitor until stabilized as the surrounding area is still bare soil. Until vegetative cover establishes, the potential for sedimentation in this area remains. 1/27-3/2/05

View of Route 7 ramp inlet free of sediment and with silt fence in good repair with several inches of snow cover. 3/2/05

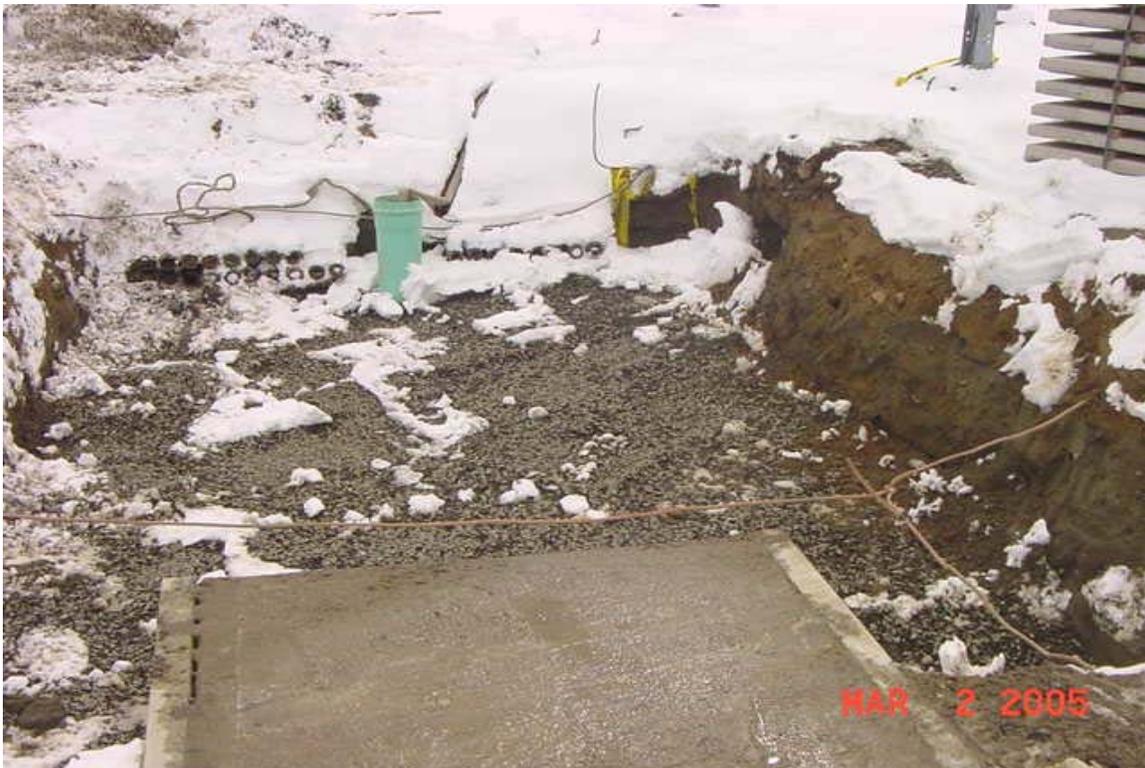
Areas of Inspection	Observation	Recommended Action
	excavations adjacent to the slab. Water is being directed appropriately to the trap rock in the center of the yard. 2/16-3/2/05	
Blasting	- No blasting is occurring on site at this time.	- None at this time.
Spills and Material Storage	<ul style="list-style-type: none"> - No drips or spills were reported for the week. 3/2/05 - No spills or equipment drips were noted during the inspection. 3/2/05 	<ul style="list-style-type: none"> - The contractors should remain vigilant about securing and handling fuel containers. - Keep all vehicles maintained well (i.e. no apparent fluid leaks) if they will be used or stored on site. Check equipment status on a regular basis. - Report spills to the office immediately, even if they are being controlled.
Additional Observations

Plumtree Substation: View of one of two small excavations for duct banks adjacent to the concrete slab. 3/2/05

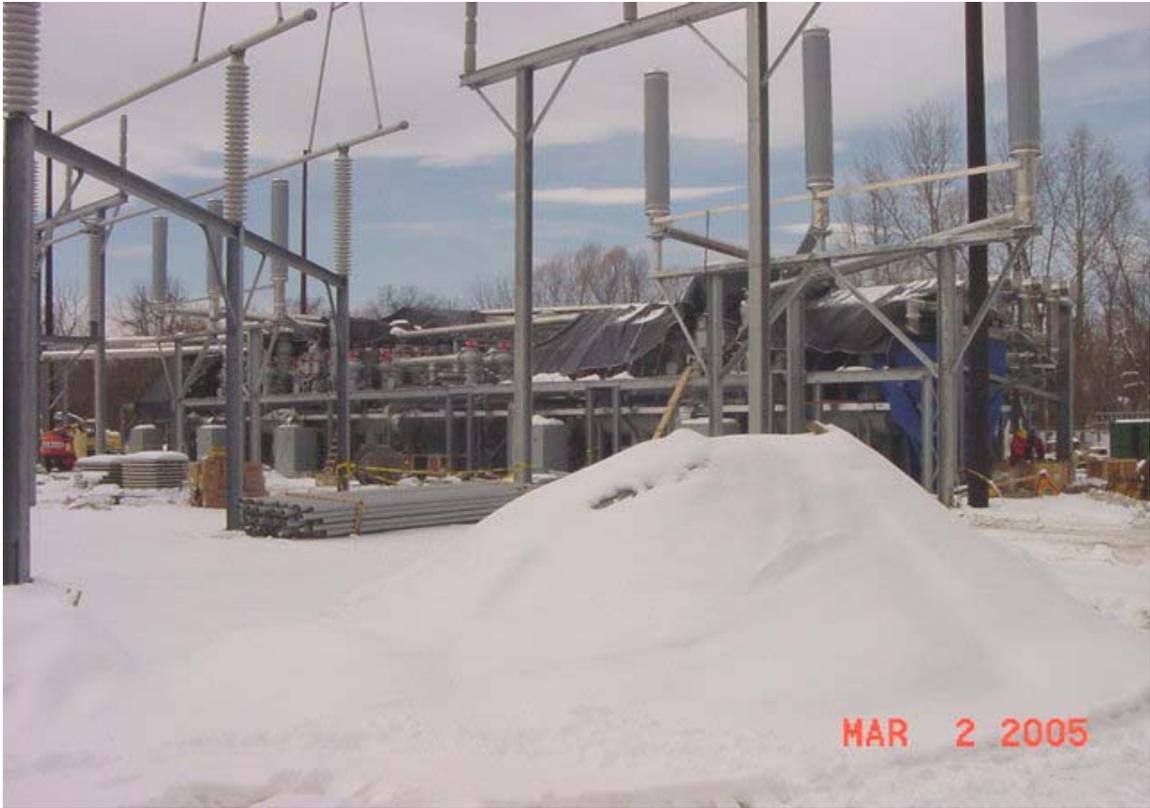
View of snow covered yard and ongoing work on the equipment on and adjacent to the slab.
3/2/05
