Docket No. 217 – Development and Management Plan Inspection

Northeast Utilities Service Company Certificate of Environmental Compatibility and Public Need for the construction of a 345-kV electric transmission line and reconstruction of an existing 115-kV electric transmission line between Connecticut Light and Power Company’s Plumtree Substation in Bethel, through the towns of Redding, Weston, and Wilton, and to the Norwalk Substation in Norwalk, Connecticut.

Date: March 3, 2004

Location: Norwalk Substation Expansion

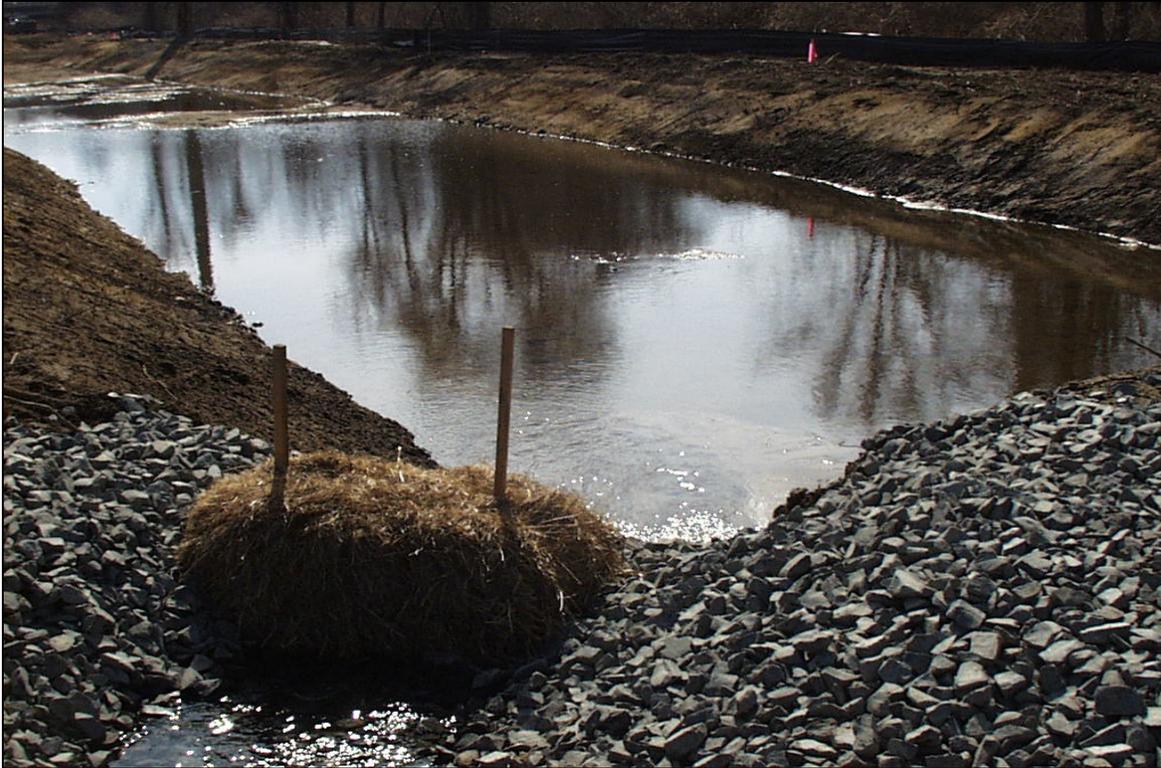
A VIEW OF THE SEDIMENT BASIN. THE DEWATERING DISCHARGE REMAINS CLEAR AND IS DIRECTED TO THE BASIN. A SMALL AMOUNT OF EROSION OCCURRED AT THE INLET INTO THE BASIN. 3/3/04

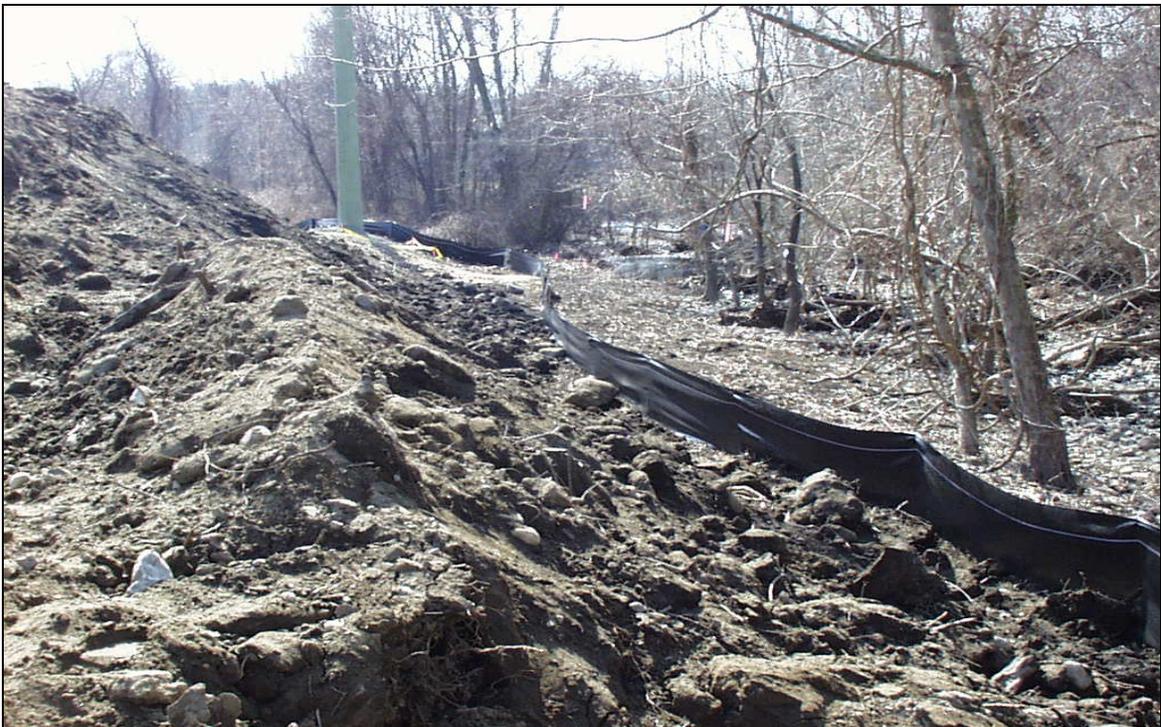
ALTHOUGH THE STOCKPILE REMAINS CLOSE TO THE SILT FENCE, THE RIVERBANK AND UNDISTURBED AREA HAS NOT RECEIVED SEDIMENT. 3/3/04

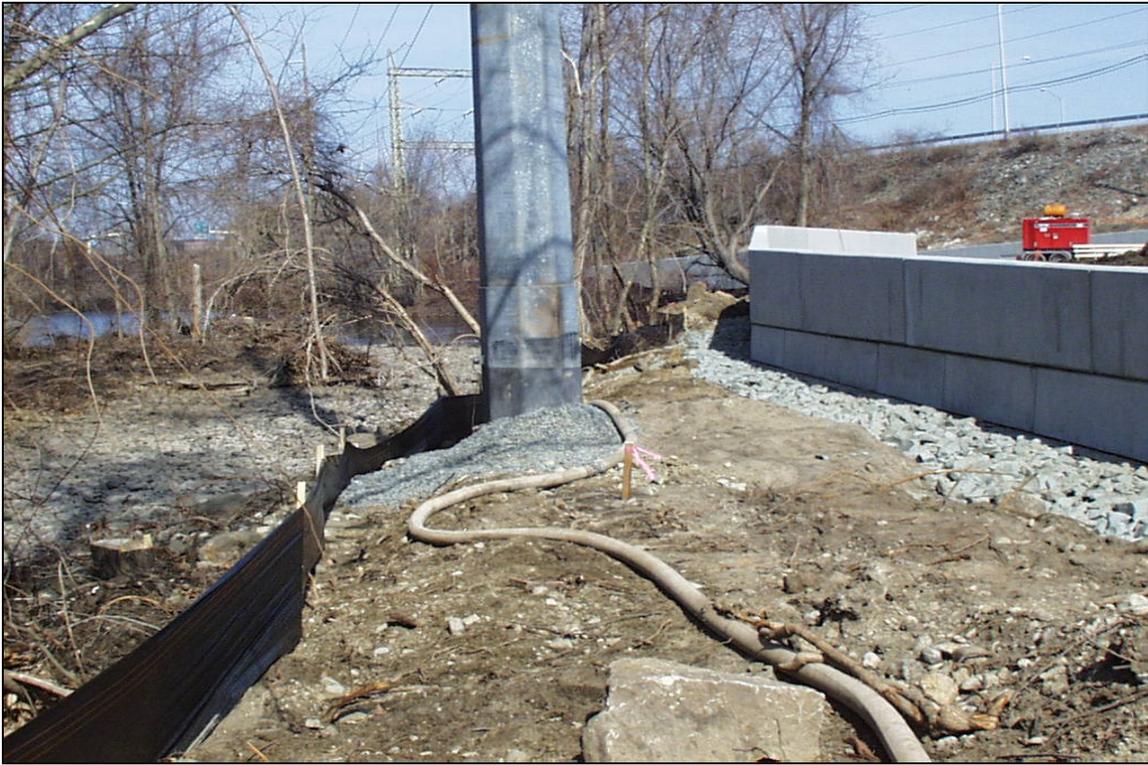
WORK WILL NOT OCCUR ANY CLOSER TO THE BANK THAN IT IS CURRENTLY. THE RIPRAP HAS BEEN PLACED AT THE BASE OF THE WALL TO STABILIZE THE AREA.
3/3/04

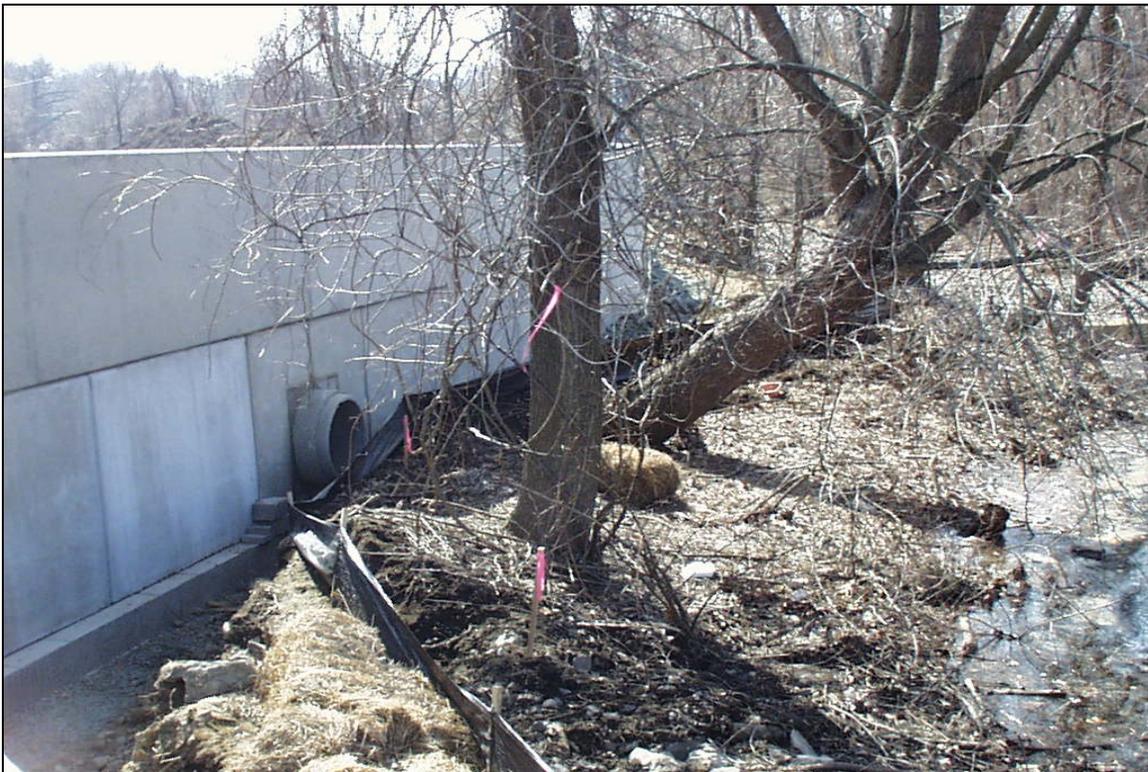
VIEW OF THE BACK PORTION OF THE WALL, ADJACENT TO THE RIVERBANK.
3/3/04

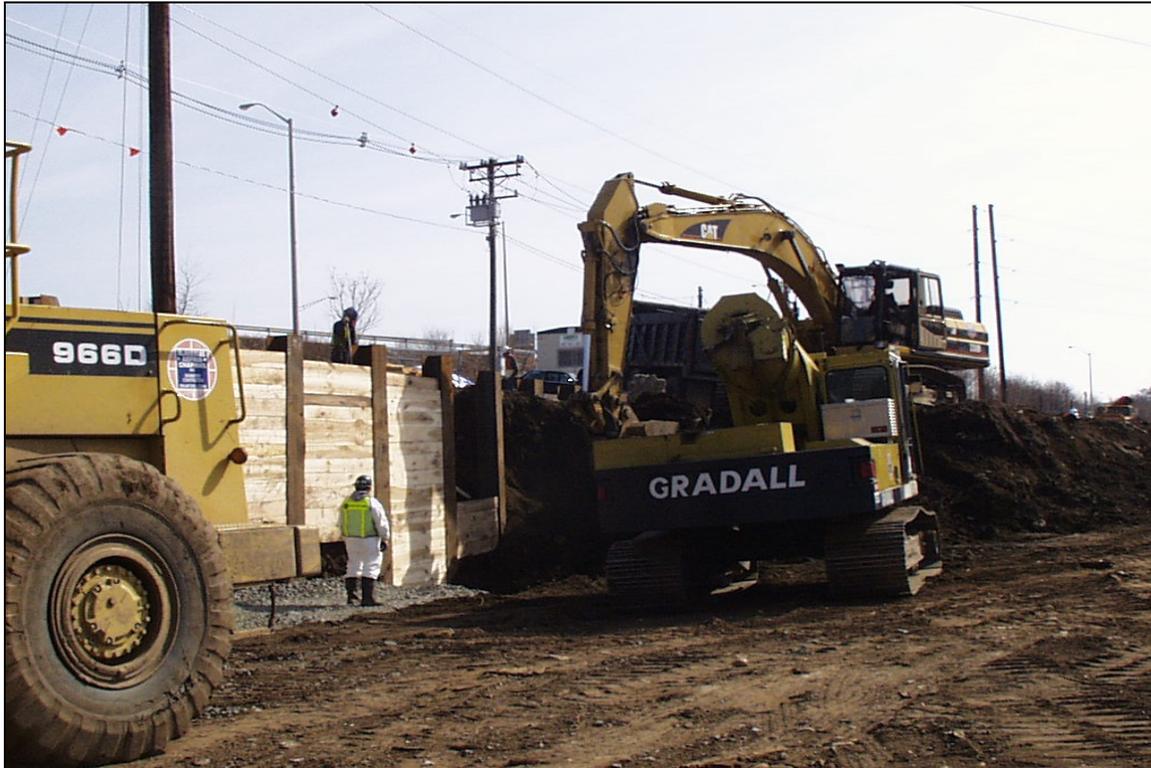
REMOVAL OF THE PORTIONS OF THE CONTAMINATED FILL WHERE LEAD COUNTS WERE 2000 PPM OR GREATER HAVE RESUMED. PREVENTATIVE CLOTHING IS BEING WORN. 3/3/04

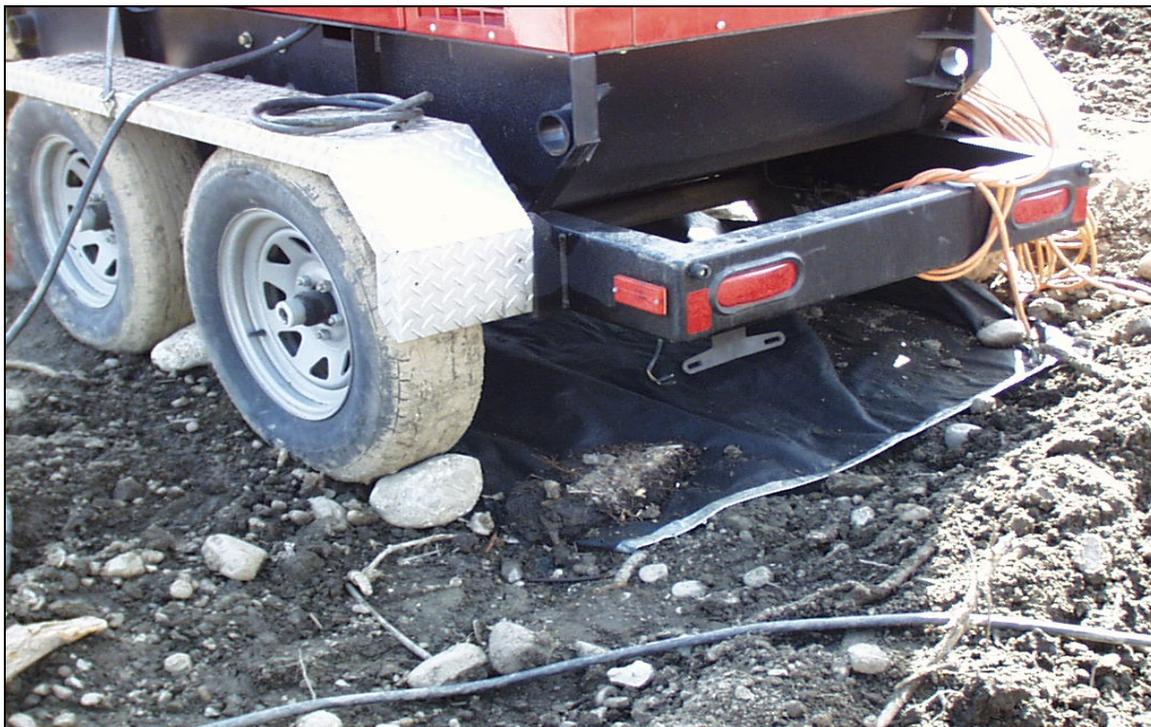
VIEW OF EFFORTS TO KEEP DIAPERS UNDER ANY STATIONARY MACHINERY
WITH THE POTENTIAL TO DRIP. 3/3/04
