Docket No. 217 – Development and Management Plan Inspection

Northeast Utilities Service Company Certificate of Environmental Compatibility and Public Need for the construction of a 345-kV electric transmission line and reconstruction of an existing 115-kV electric transmission line between Connecticut Light and Power Company’s Plumtree Substation in Bethel, through the towns of Redding, Weston, and Wilton, and to the Norwalk Substation in Norwalk, Connecticut.

Date: March 9, 2005

Location: Norwalk Substation Expansion

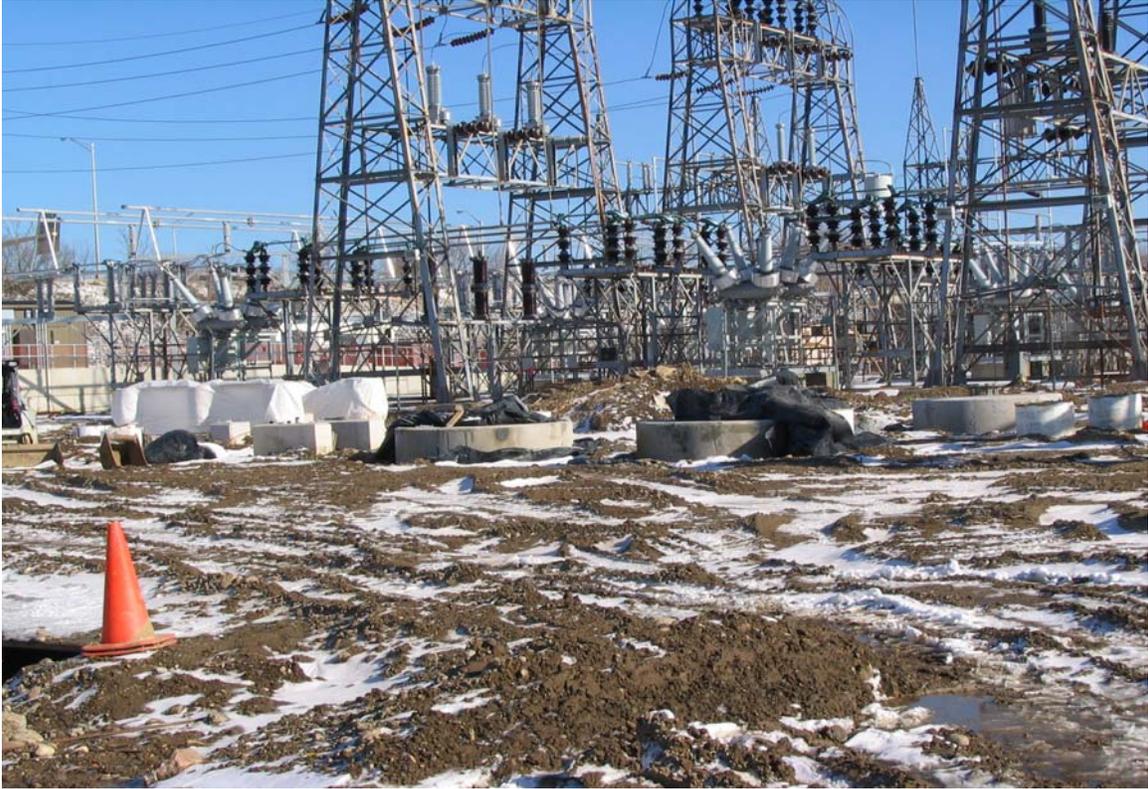
View of some of the completed work on the caissons and footings near retaining wall #3. 3/9/05

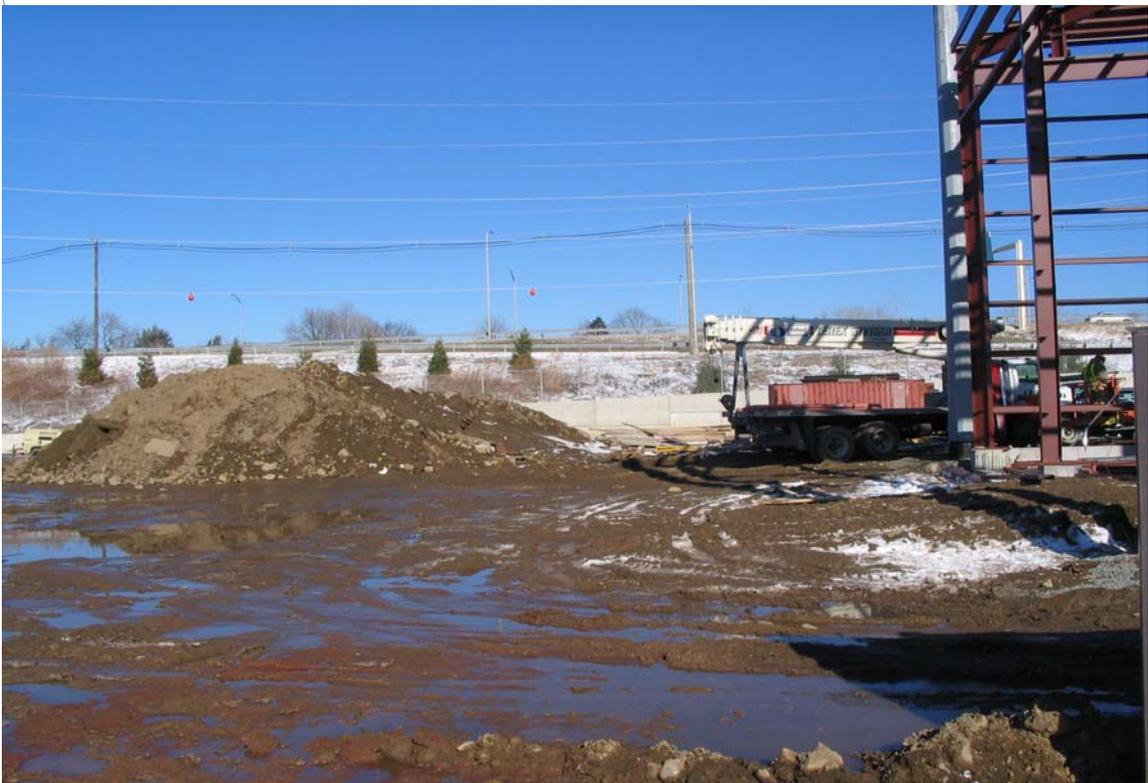
Partial view of steel frame of GIS building and newer small stockpile in the vicinity of the old pit area. 3/9/05

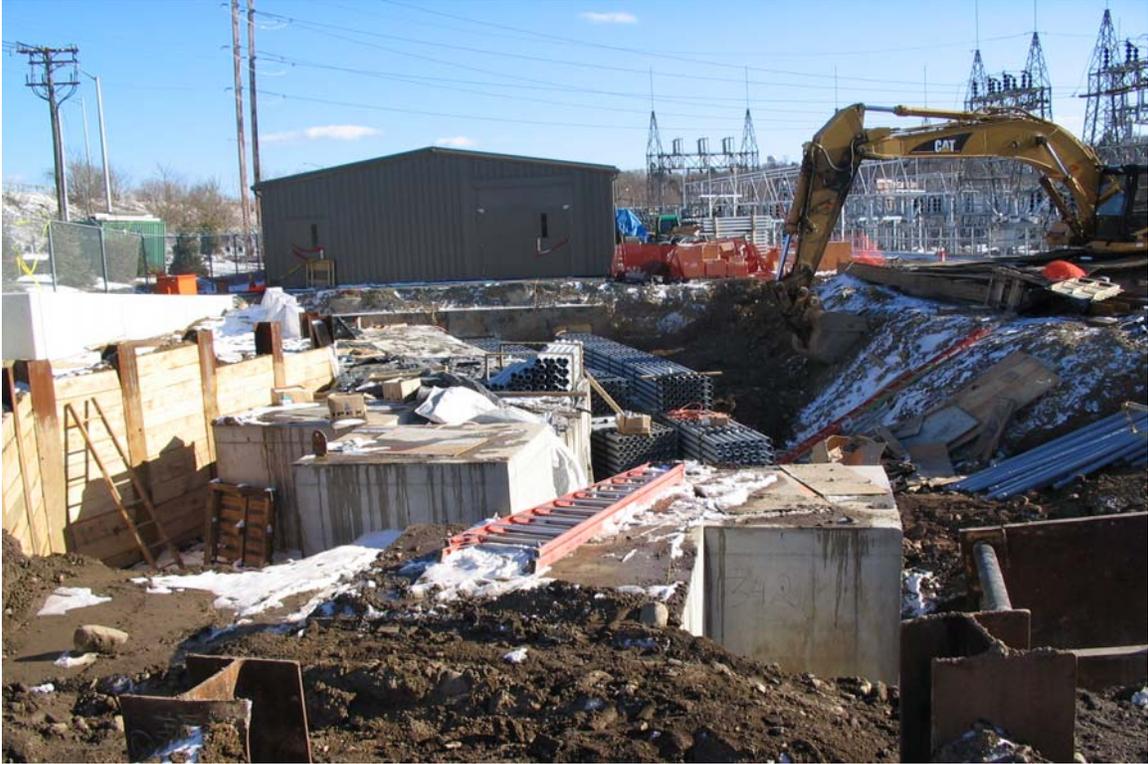
View of the excavation near the control house for manhole installation and conduit bank work. All work is well within the site. 3/9/05

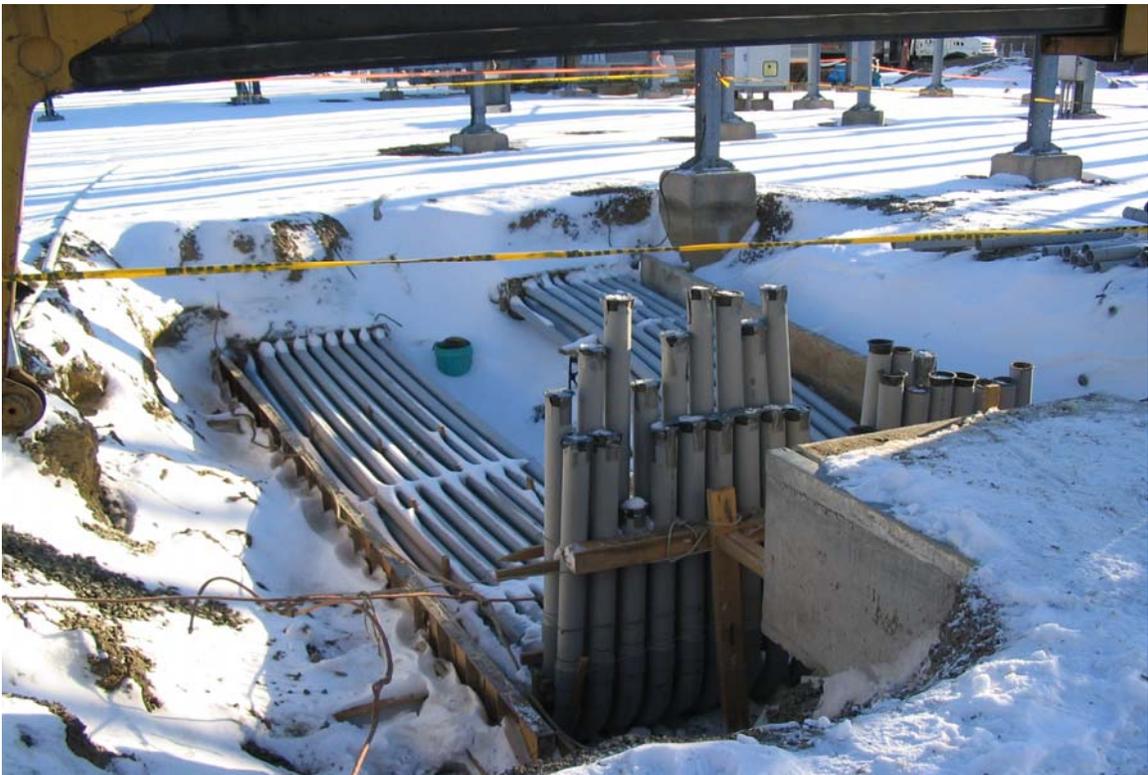
Plumtree Substation: View of small excavation for duct banks/conduit work adjacent to the concrete slab. 3/9/05

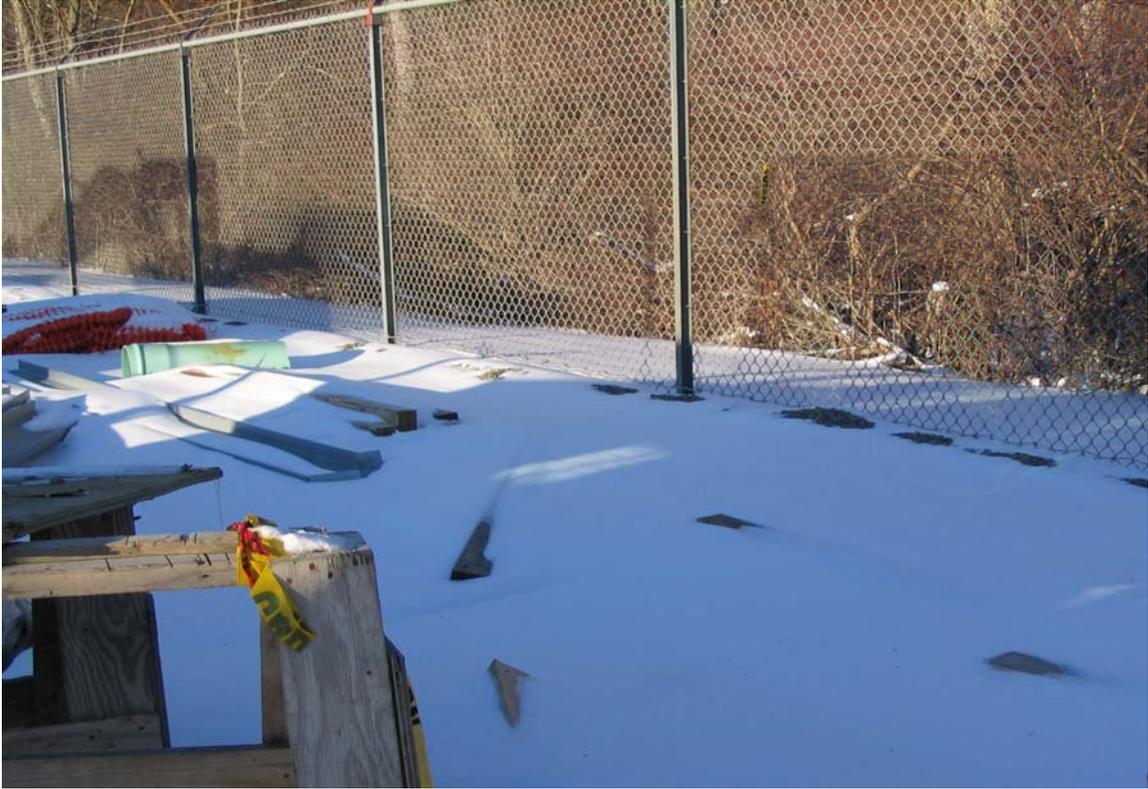
Additional stone was placed along the eastern perimeter fence in the area where the berm was noticeable lower. One area may still require improvement to the berm and will be completed when access is available. 3/9/05
