Docket No. 217 – Development and Management Plan Inspection

Northeast Utilities Service Company Certificate of Environmental Compatibility and Public Need for the construction of a 345-kV electric transmission line and reconstruction of an existing 115-kV electric transmission line between Connecticut Light and Power Company’s Plumtree Substation in Bethel, through the towns of Redding, Weston, and Wilton, and to the Norwalk Substation in Norwalk, Connecticut.

Date: March 18, 2004

Location: Norwalk Substation Expansion

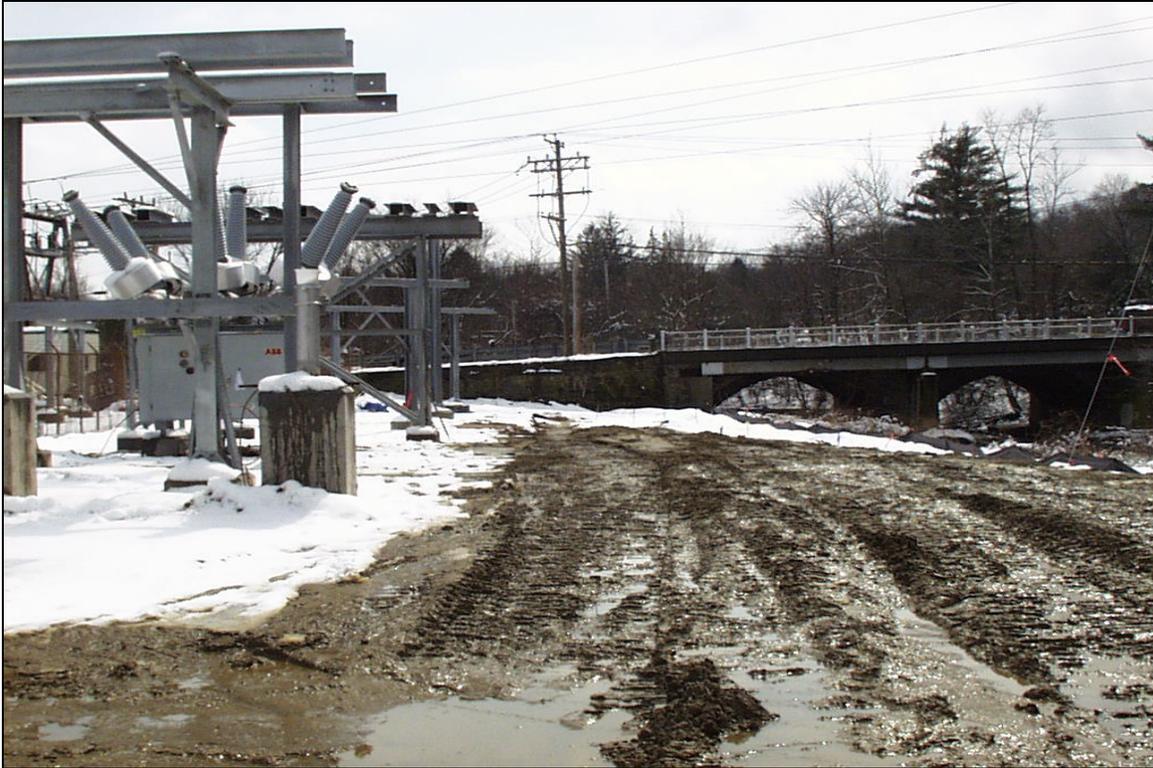
THE FOUNDATION CONSTRUCTION AREAS NEAR THE EDGE OF THE FENCED YARD HAVE BEEN GRADED AND FILLED. 3/18/04

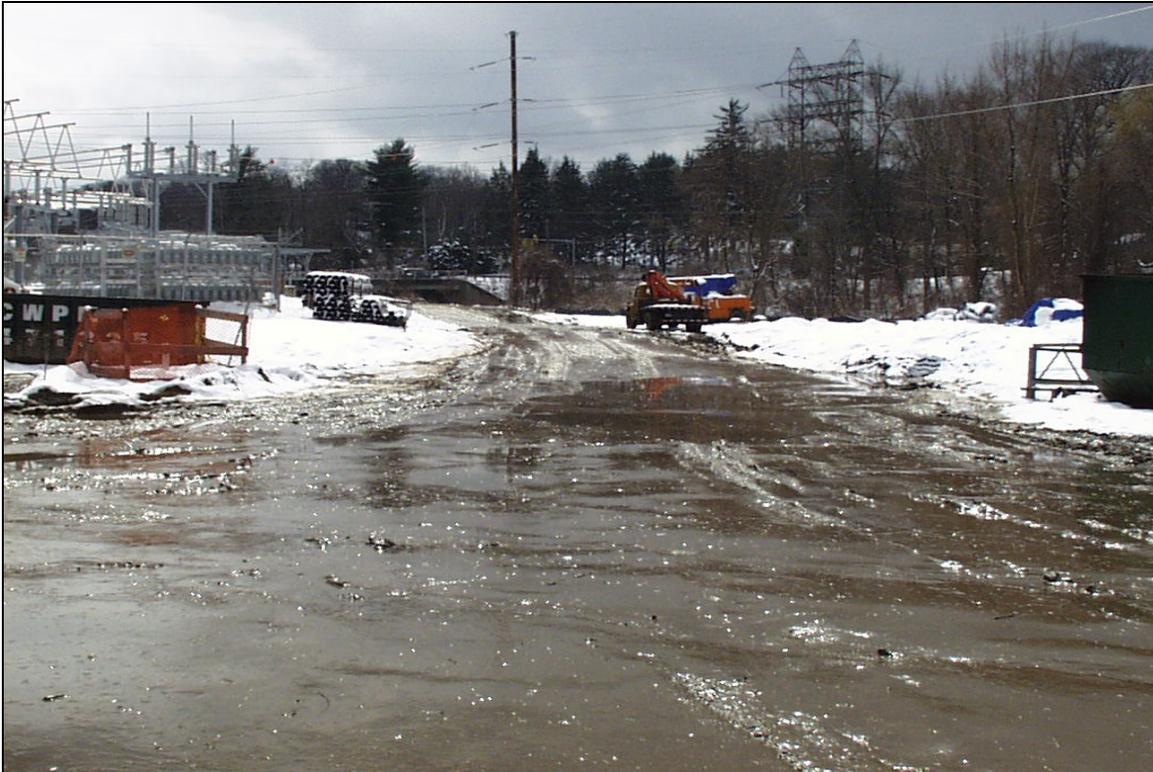
Areas of Inspection	Observation	Recommended Action
Access Roads	<p>-Work areas and access roads were once again extremely muddy following the snow. Discussions are ongoing regarding where to place the mud which does not provide a suitable base. 3/18/04</p> <p>- Although the area is muddy, there is a support base not too far below the soil surface. If necessary, mats should be used. 3/18/04</p> <p>-The roadways continue to look maintained although the mud is catching within the gravel. New Canaan Avenue is free of sediment 3/18/04</p>	<p>- None at this time. Continue to monitor. 1/15-3/18/04</p> <p>- None at this time. Continue to monitor. 3/18/04</p>
Foundation construction	<p>- Construction of the concrete retaining walls continues at this time. 3/3-3/18/04</p> <p>- Grading and fill had occurred at the foundation construction at the edge of the fenced yard. The area is well controlled and within the silt fence but is</p>	<p>- Continue to monitor any potential impacts to the silt fence during work. 1/22-3/18/04</p>

VIEWS AT THE ACCESS ROAD IN ITS PRESENT MUDDY CONDITION. MUD IS ONLY ONE TO THREE INCHES DEEP WITH A SOLID SOIL BASE BENEATH IN MOST PLACES. 3/18/04

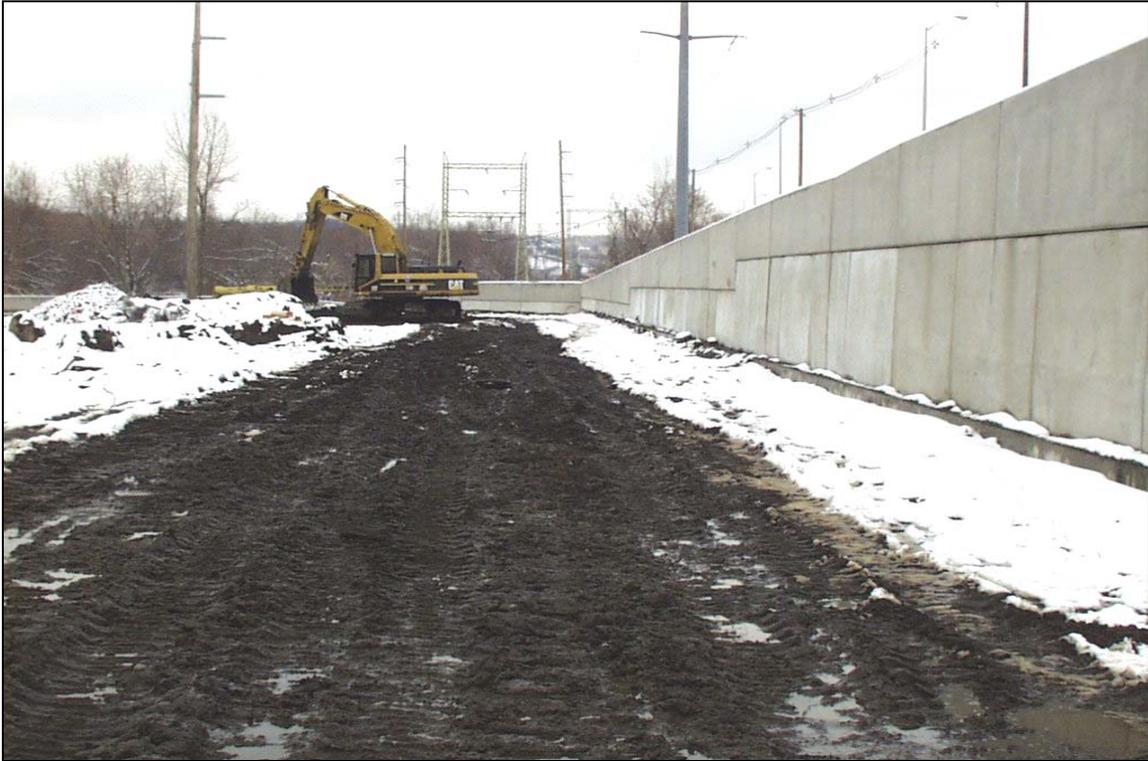
Areas of Inspection	Observation	Recommended Action
	<p>should be piled over the silt fence.</p> <p>-Discussions regarding appropriate base fill for future construction are ongoing. This includes what to do with the muddy soil which does not provide stable base construction material.</p> <p>- The topography of the slope near the Route 7 ramp is noticeably different. The contaminated soil is gone and an access-way is being created past the retaining wall.</p>

VIEWS OF ACCESSWAY NEAR RETAINING WALL. THE AREA OF CONTAMINATED SOIL HAS BEEN REMOVED AND THE TOPOGRAPHY HERE IS NOTICEABLY DIFFERENT. 3/18/04

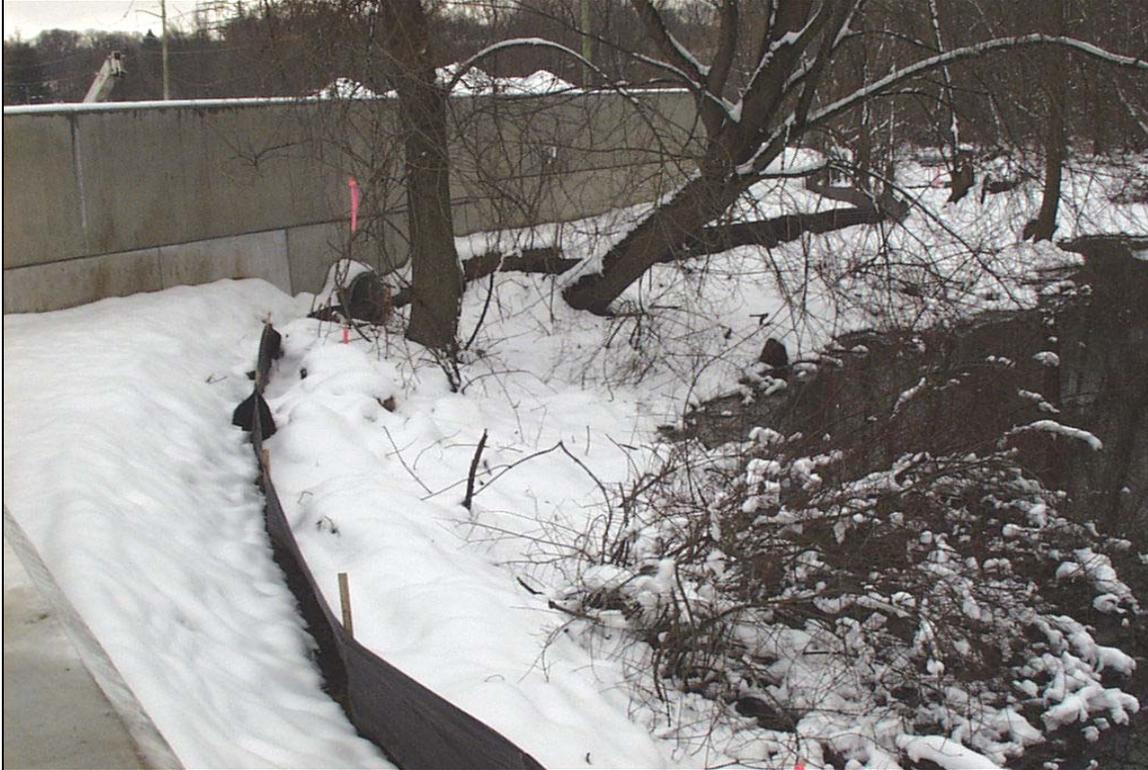
Vegetative clearing limits (including trees to save or danger trees noted)	<ul style="list-style-type: none"> - The area on the riverbank side of the silt fence near the retaining wall has not been touched during the finalization of the contours but revegetation may be necessary 3/12-3/18/04 - Roots and stumps are left in 	<ul style="list-style-type: none"> - The areas near the river still appear stable. There are no serious erosion issues. 1/15-3/18/04 - The more vegetation left in place at the river, the more stable the bank will be.

VIEW BEHIND THE RETAINING WALL CLOSEST TO THE RIVER. BACKFILLING AND CONTOURING HERE IS COMPLETED. 3/18/04

Areas of Inspection	Observation	Recommended Action
	place here.	- Temporary vegetative stabilization measures for the bank should be considered if it becomes apparent in the spring that there will be any bare spots. 3/3-3/18/04
Dewatering	- Dewatering activities are complete at this time. 3/18/04	-No actions required at this time. 3/18/04
Blasting	- No blasting is occurring on site at this time and it is not anticipated to be necessary.	- None at this time.
Spills	<p>- No spills were reported this week and no spills were observed during inspection however small spots from dripping machinery were noted as sheens in the mud and runoff. 3/18/04</p> <p>- Tracking pads/diapers have been placed under some of the equipment parked on site in an effort to reduce any drips. 2/20-3/18/04</p>	<p>- The contractors should remain vigilant about securing and handling fuel containers due to the sensitivity of the area</p> <p>- Continue to keep all vehicles maintained well (i.e. no apparent fluid leaks) if they will be used or stored on site. There may be new procedures implemented for this- i.e. walk around checks on equipment on a regular basis.</p> <p>- The practice of using “diapers” is highly encouraged for any vehicle or equipment with a known leak.</p> <p>- Report spills to the office immediately, even if they are being controlled.</p>

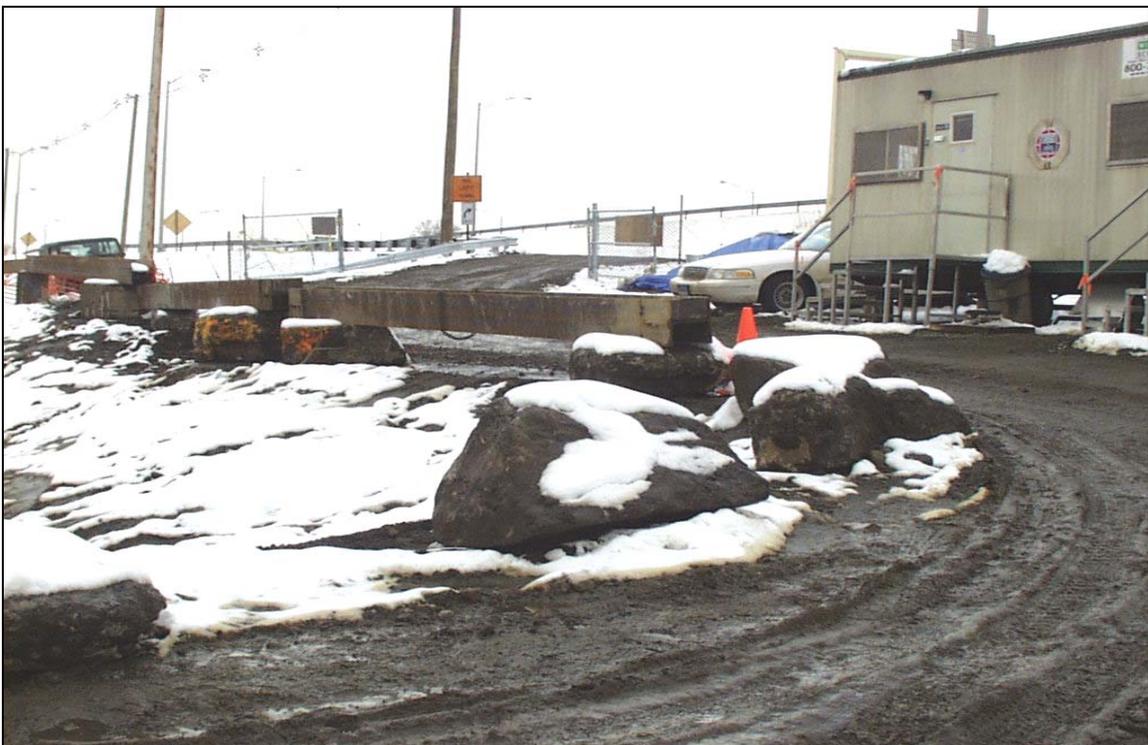
Areas of Inspection	Observation	Recommended Action
	<p>muddy. 3/18/04</p> <p>-The smaller excavation adjacent to the roadway continues. This stockpile will not be here long. 3/12-3/18/04</p> <p>- The access road near the Route 7 ramp has been reshaped and redirected. A railing has been placed and the contaminated soil area is excavated. 3/18/04</p>	<p>- The stockpile was covered with plastic tarp to prevent any sedimentation to the roadway. 3/18/04</p>
<p>Erosion and Sediment Controls (includes inspection within 24 hours of a storm event)</p>	<p>- The snow fall has created some muddy conditions. Discussions are ongoing regarding where to place the mud. It will be tested and may be sent off site. 3/18/04</p>	<p>- Overall the site continues to do well with no significant sedimentation or erosion issues. 1/22-3/18/04</p>
	<p>- Silt fence remains in place and is effectively preventing sediment from entering the river. 1/15-3/18/04</p> <p>-A few areas of the fence show some wear in the fabric or a broken post and should be repaired when possible. 3/3-3/18/04</p>	<p>- Continue to monitor and maintain as needed. Some spots are very close to the river and will require the most monitoring. 1/15-3/18/04</p> <p>- Some areas were lightly repaired since last inspection. Keep up with silt fence repair as needed, and continue to be proactive 3/18/04</p>

THE ACCESS ROAD AT THE ROUTE 7 RAMP HAS BEEN RECONFIGURED. 3/18/04

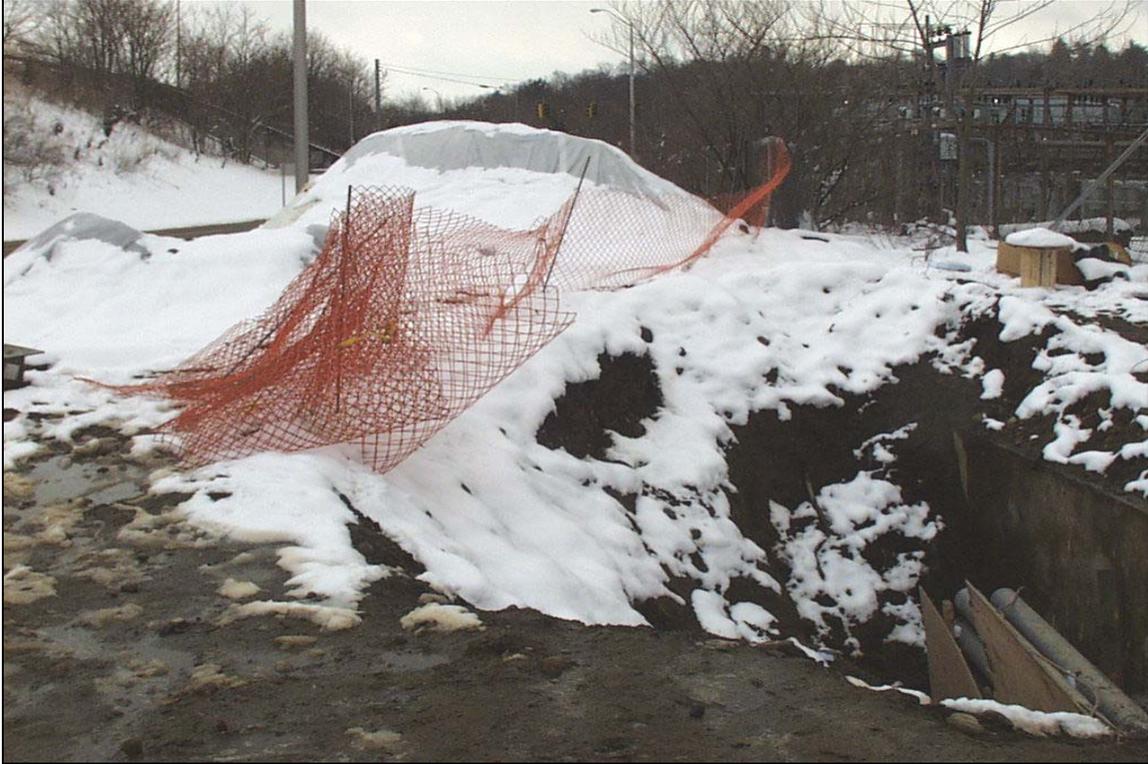
THE STOCKPILE FOR THE EXCAVATION NEAR THE ROUTE 7 RAMP ROADWAY HAS BEEN CONTAINED WITH PLASTIC SHEETING TO PREVENT SEDIMENTATION.
3/18/04
