Docket No. 217 – Development and Management Plan Inspection

Date: March 18, 2005

Location: Norwalk Substation Expansion

Location: Plumtree Substation Expansion , Bethel

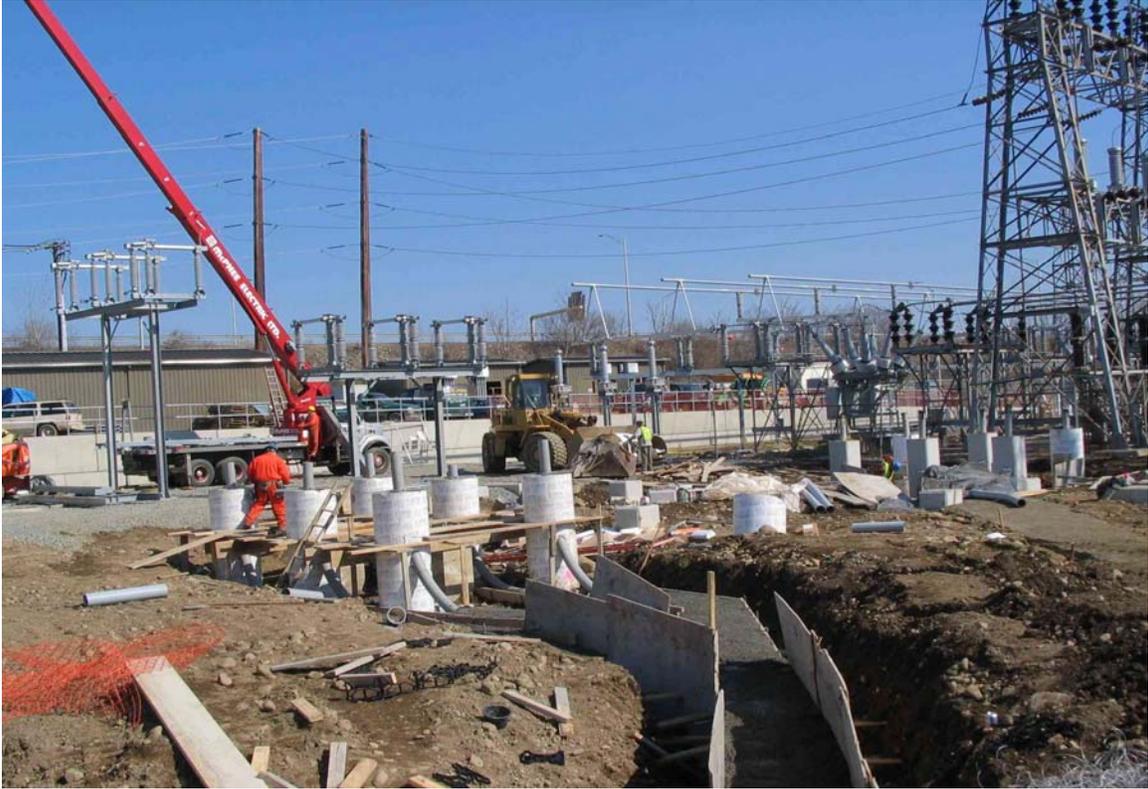
Excavation, backfill and work on the conduit bank continues near retaining wall #3. 3/18/05

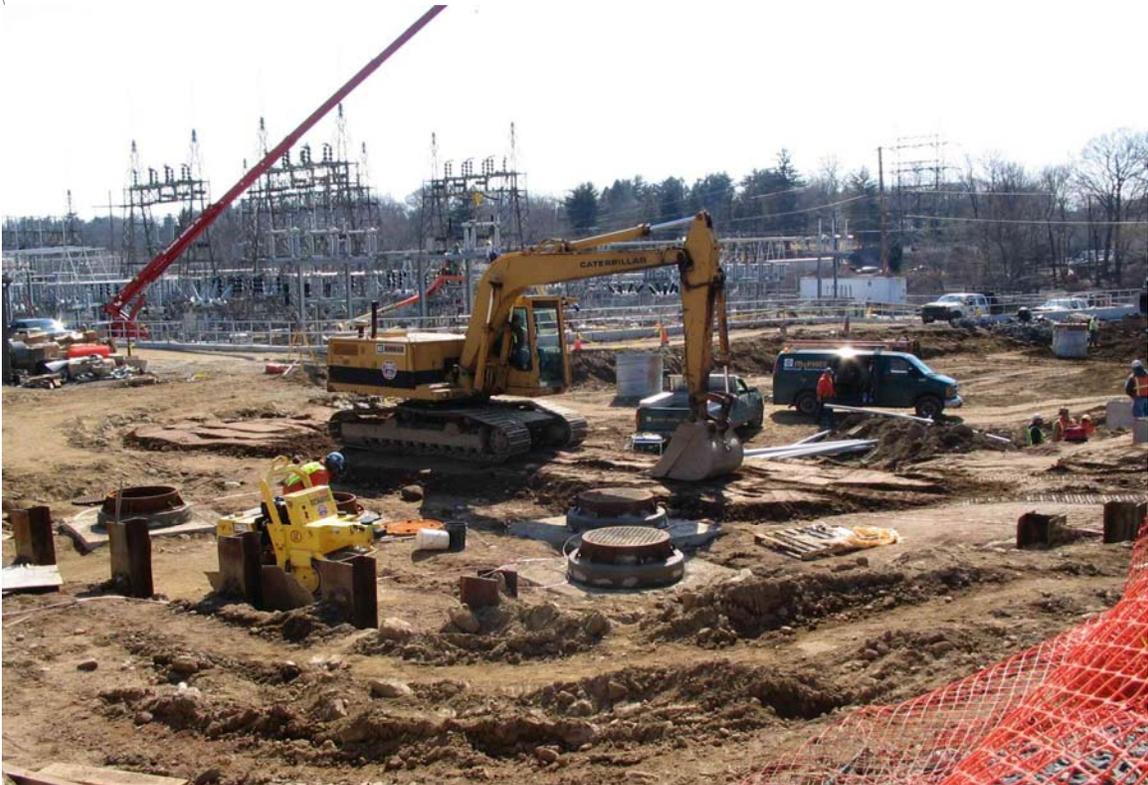
The recent excavation area near the control house is being backfilled and brought up to grade.
3/18/05

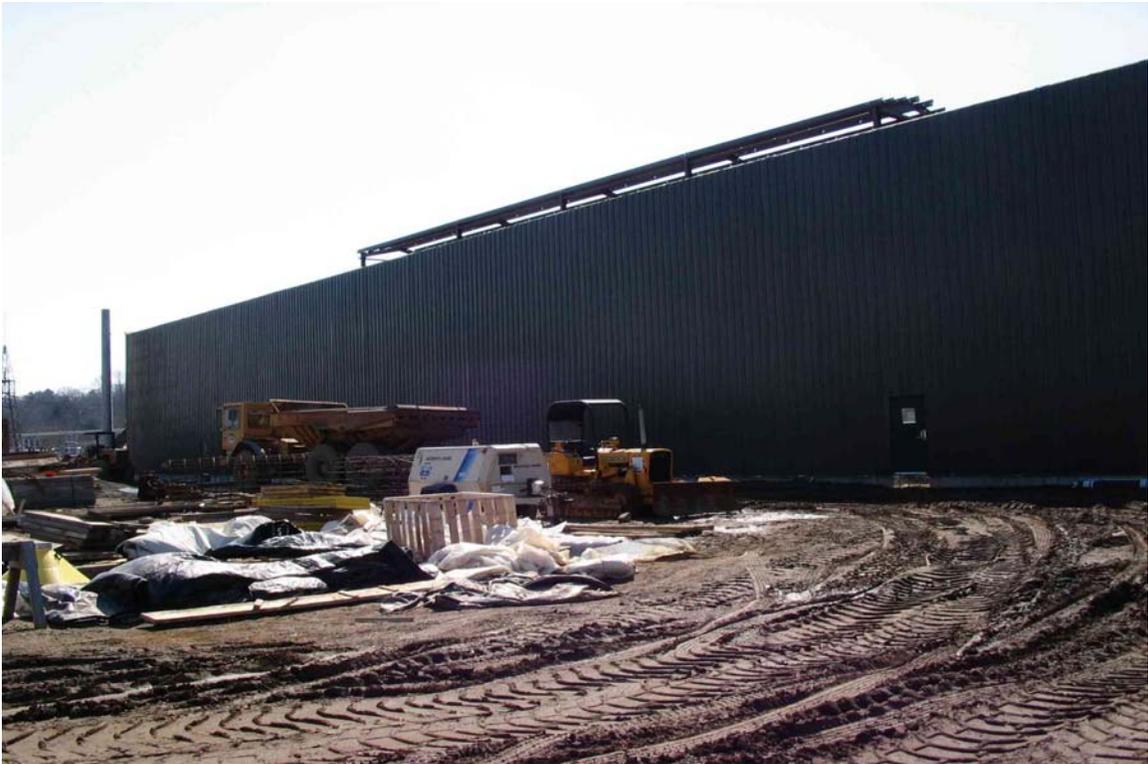
Siding and structural work continues on the GIS building with excavation and backfill occurring in surrounding areas. 3/18/05

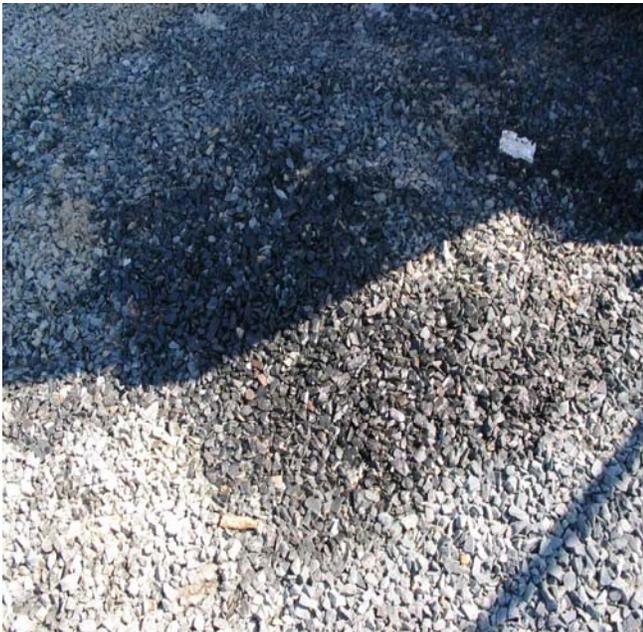
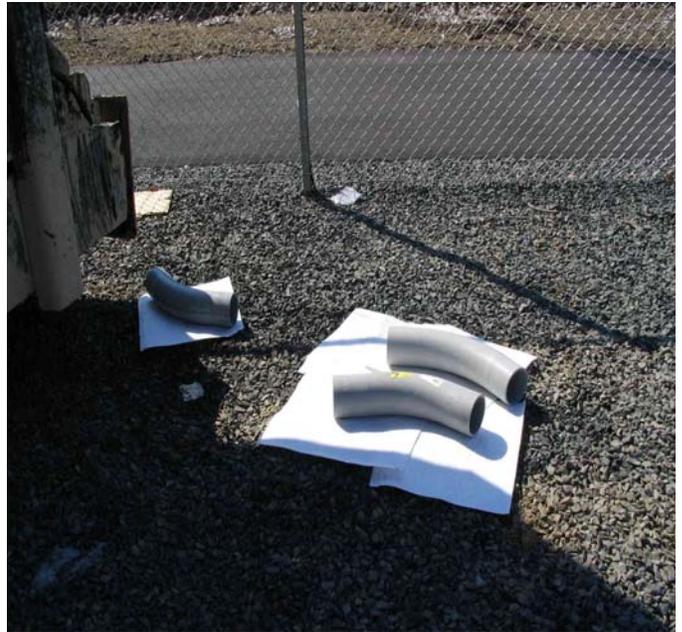
A small hydraulic oil spill had occurred on the gravel, likely as the result of a leaky hose on the caisson drilling truck. An absorbent pad was placed and the affected gravel was to be picked up. 3/18/05

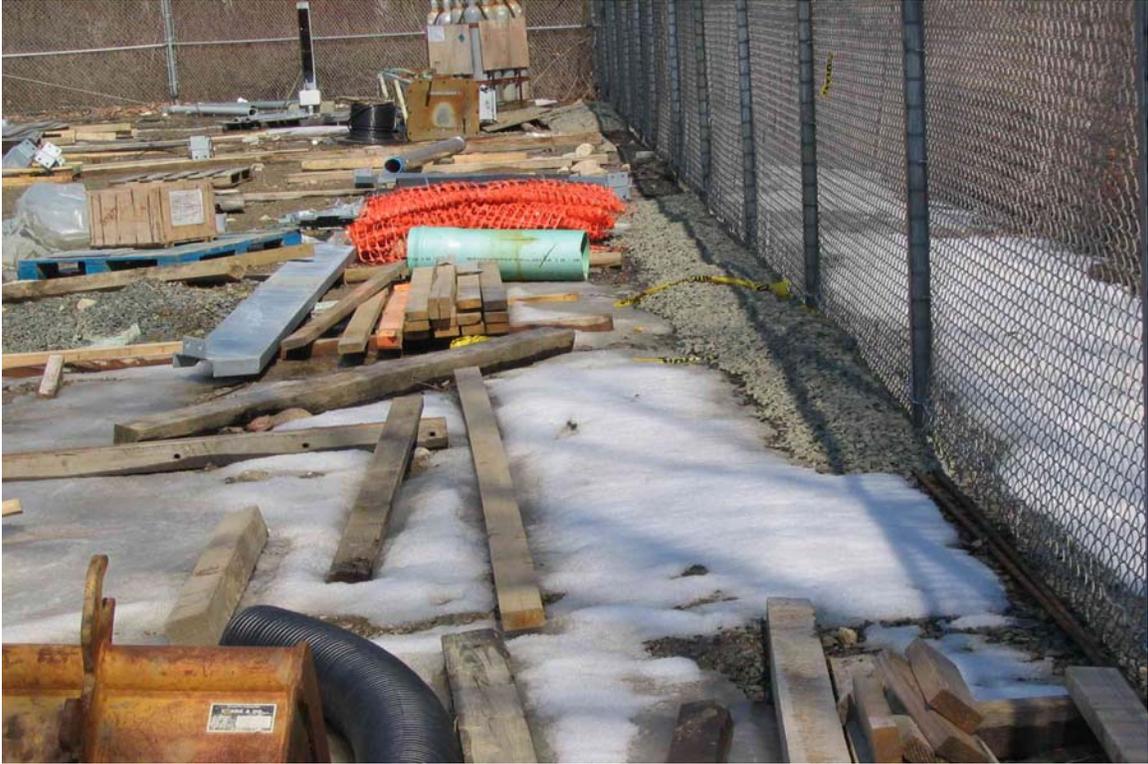
Additional stone was placed along the eastern perimeter fence but it needs to be continued on each end to cover all the low areas. 3/18/05

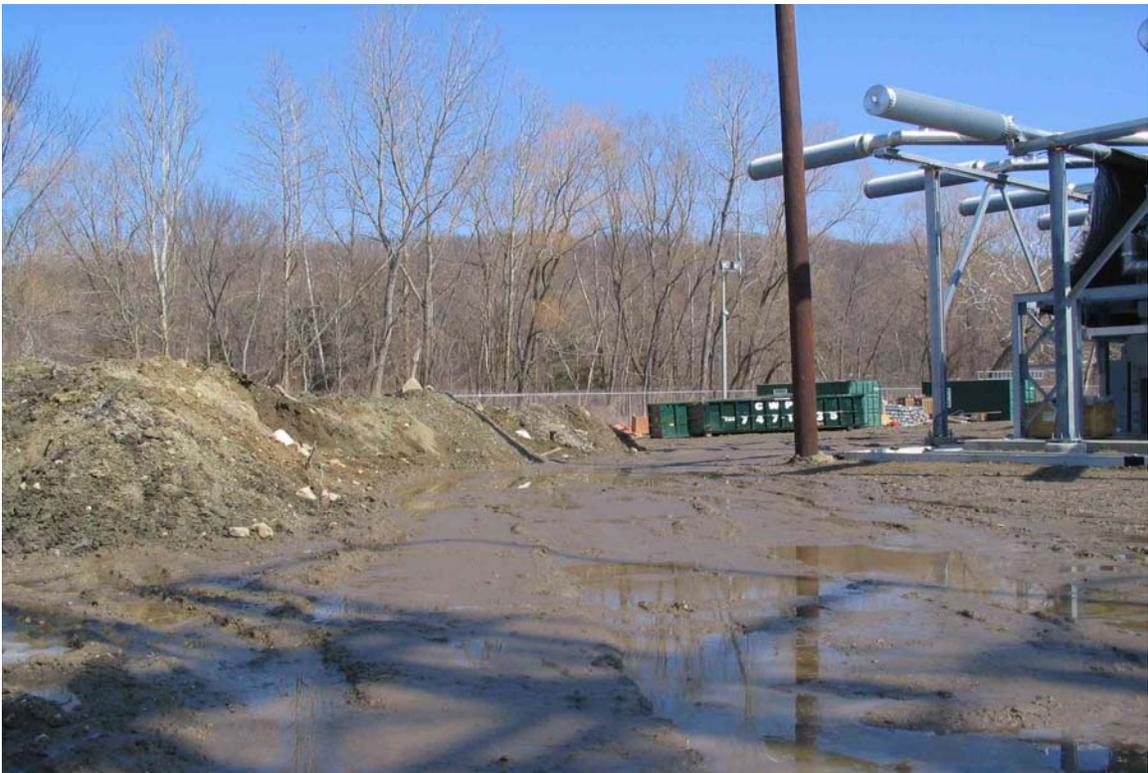
View of the stockpiles and general site conditions. 3/18/05
