Docket No. 217 – Development and Management Plan Inspection

Northeast Utilities Service Company Certificate of Environmental Compatibility and Public Need for the construction of a 345-kV electric transmission line and reconstruction of an existing 115-kV electric transmission line between Connecticut Light and Power Company’s Plumtree Substation in Bethel, through the towns of Redding, Weston, and Wilton, and to the Norwalk Substation in Norwalk, Connecticut.

Date: March 24, 2004

Location: Norwalk Substation Expansion

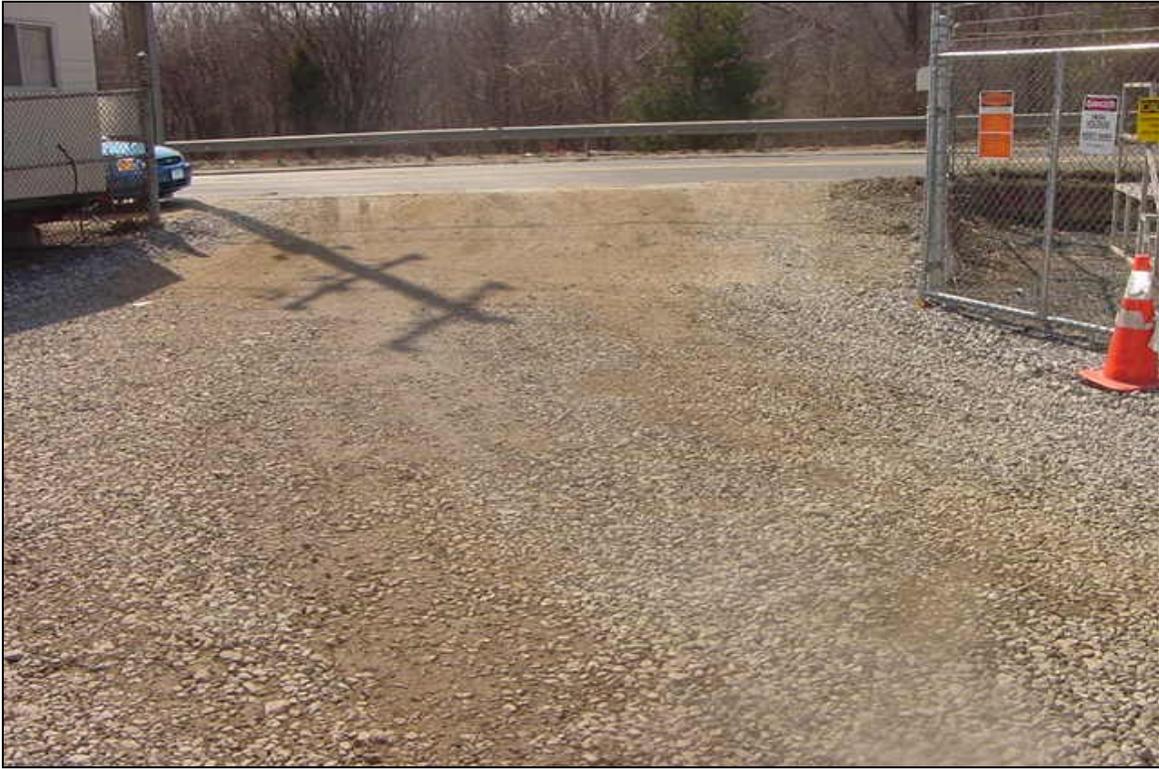
THE VIEW OF THE GRAVEL TRACKING PAD NEAR NEW CANAAN AVE. SOME SEDIMENT IS BUILDING UP HERE BUT NO TRACKING IS OCCURRING TO THE ROAD. 3/24/04

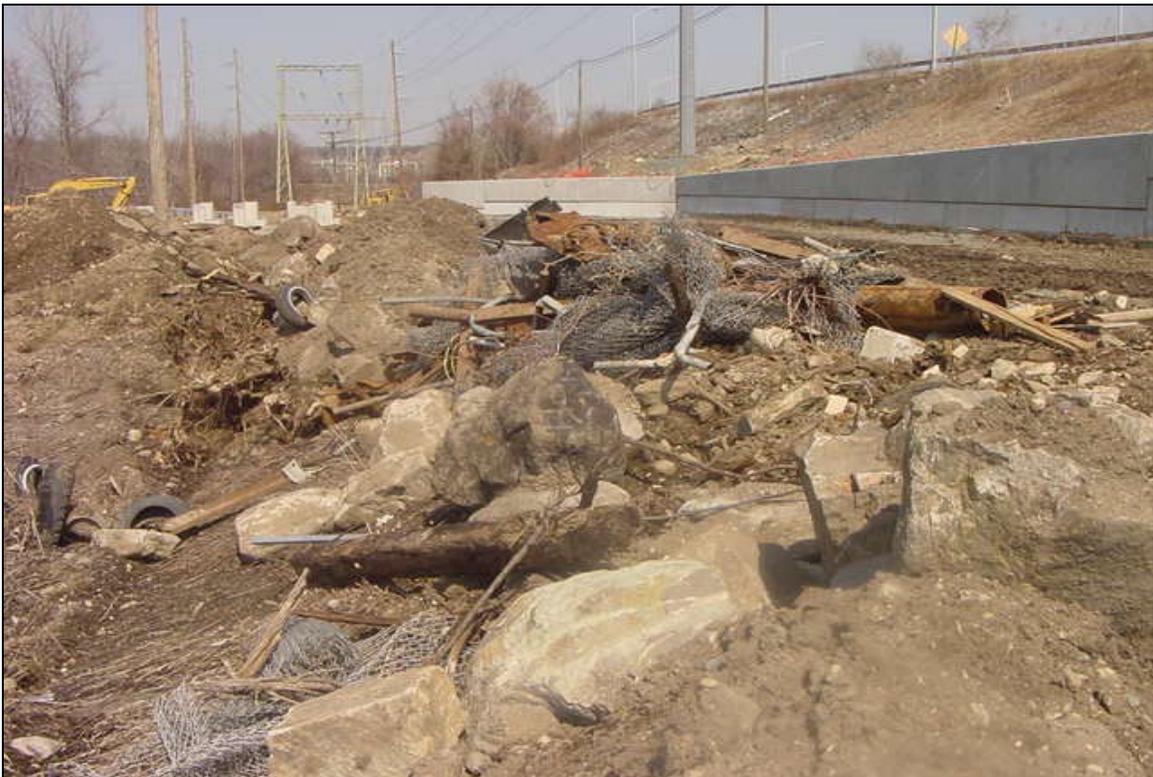
Areas of Inspection	Observation	Recommended Action
Additional/Miscellaneous Observations	<p>rain showers over Friday night into the weekend. 3/24/04</p> <p>- Plans are ongoing to test the mud and soils of the stockpile and then to remove what is not needed from the site.</p> <p>-Areas of bulky waste were observed and it will either be removed or the boulders will be returned as fill when possible.</p>	<p>along the bank and provide additional enforcement if needed.</p>

VIEW OF SOME OF THE BULKY WASTE TO BE REMOVED FROM EXCAVATION AND BOULDERS TO BE BURIED. 3/24/04

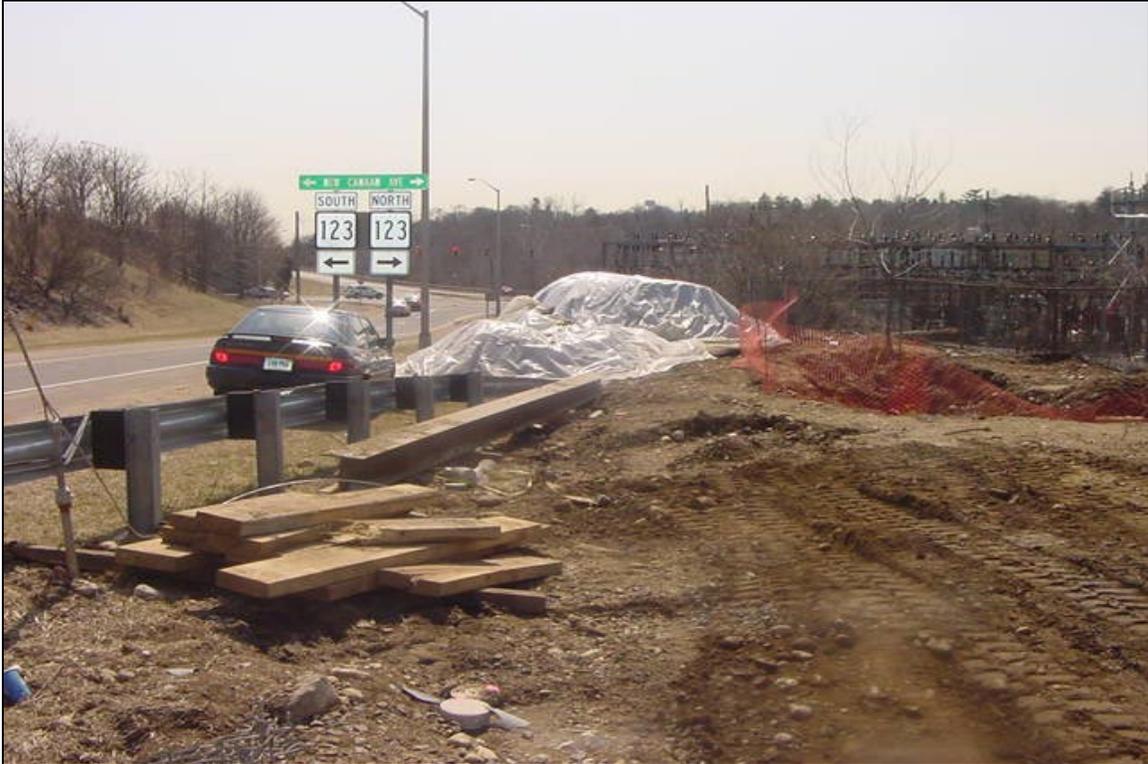
VIEW OF EXCAVATION NEAR ROUTE 7 RAMP. THE STOCKPILE REMAINS AND IS COVERED WITH PLASTIC. 3/24/04

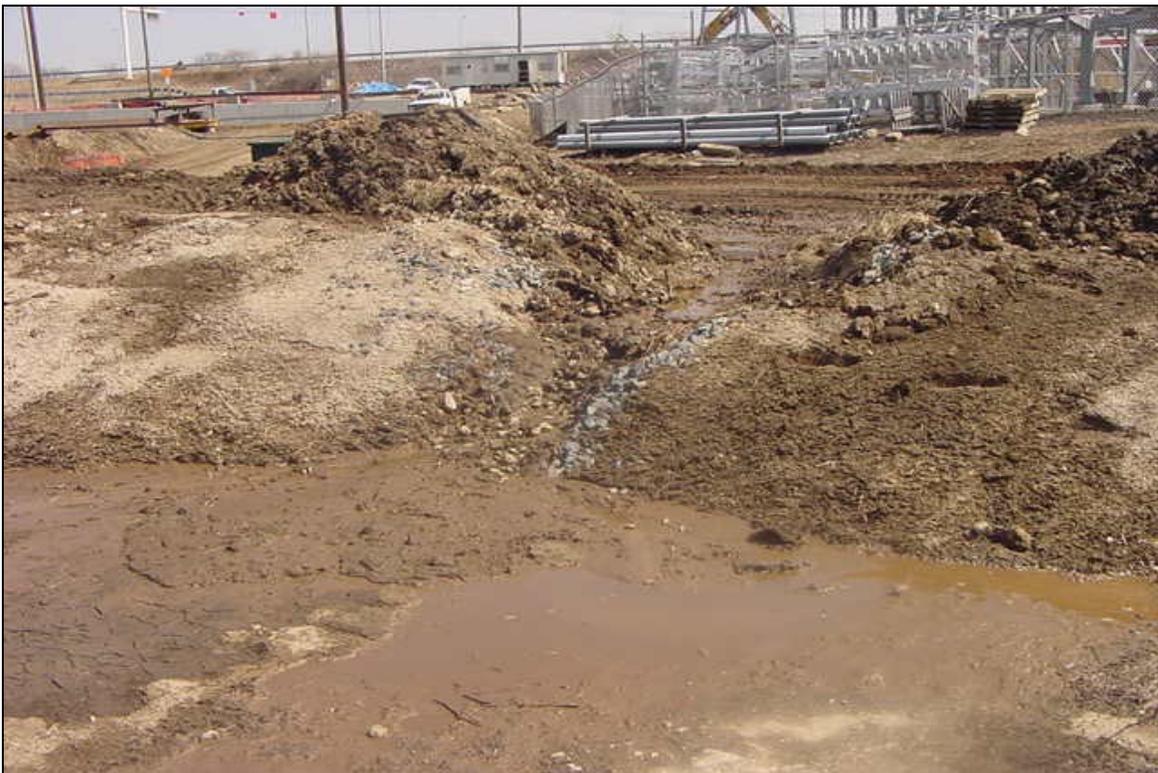
Areas of Inspection	Observation	Recommended Action
<p>Erosion and Sediment Controls contd.</p>	<ul style="list-style-type: none"> - The side inlet swale to the basin had received some noticeable sedimentation as the haybale had been removed to allow drainage from the access road. 3/24/04 - The northern swale is dry and free of sediment at this time 3/24/04 	<ul style="list-style-type: none"> - The haybale “check dam” will be replaced at this inlet to prevent additional sedimentation 3/24/04 - Continue to monitor the basin and outlets for any sediment laden flows and repair and stabilize any noted erosion on the banks or swales 3/24/04
	<ul style="list-style-type: none"> - A concrete washout station has been set up as requested with a haybale corral, and it has been used appropriately. 3/12-3/24/04 - No new washouts were observed at this inspection 3/24/04 	<ul style="list-style-type: none"> - Continue to use a few fairly contained locations for all concrete washouts. An additional station should be set up in another location if necessary. 3/24/04 - The dried concrete is not a problem but washout water in liquid state is high in pH and can be corrosive.

SWALE INTO THE DETENTION BASIN HAS RECEIVED SOME NOTICEABLE SEDIMENT FROM ACCESS ROAD RUNOFF. THE HAYBALE "CHECK DAM" WILL BE REPLACED. 3/24/04

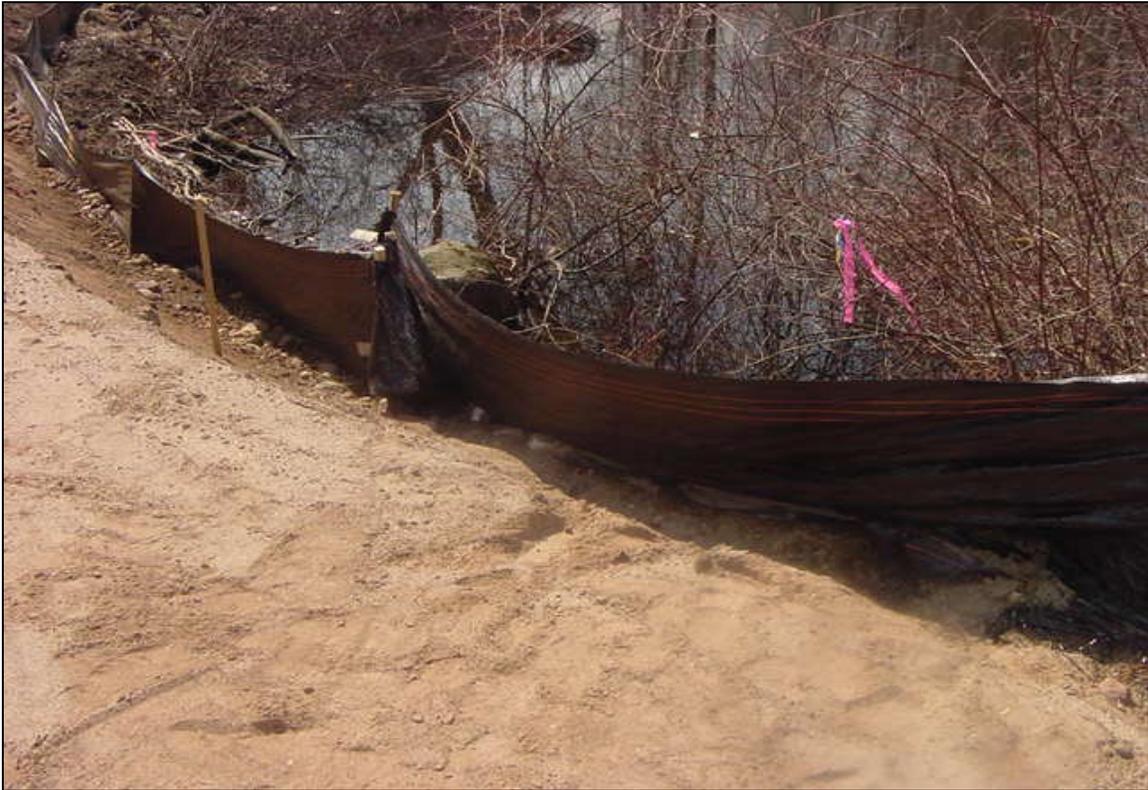
A PORTION OF THE SILT FENCE WAS NOT TOED IN PROPERLY FOLLOWING WORK IN THE AREA. THIS WILL BE REPAIRED. 3/24/04

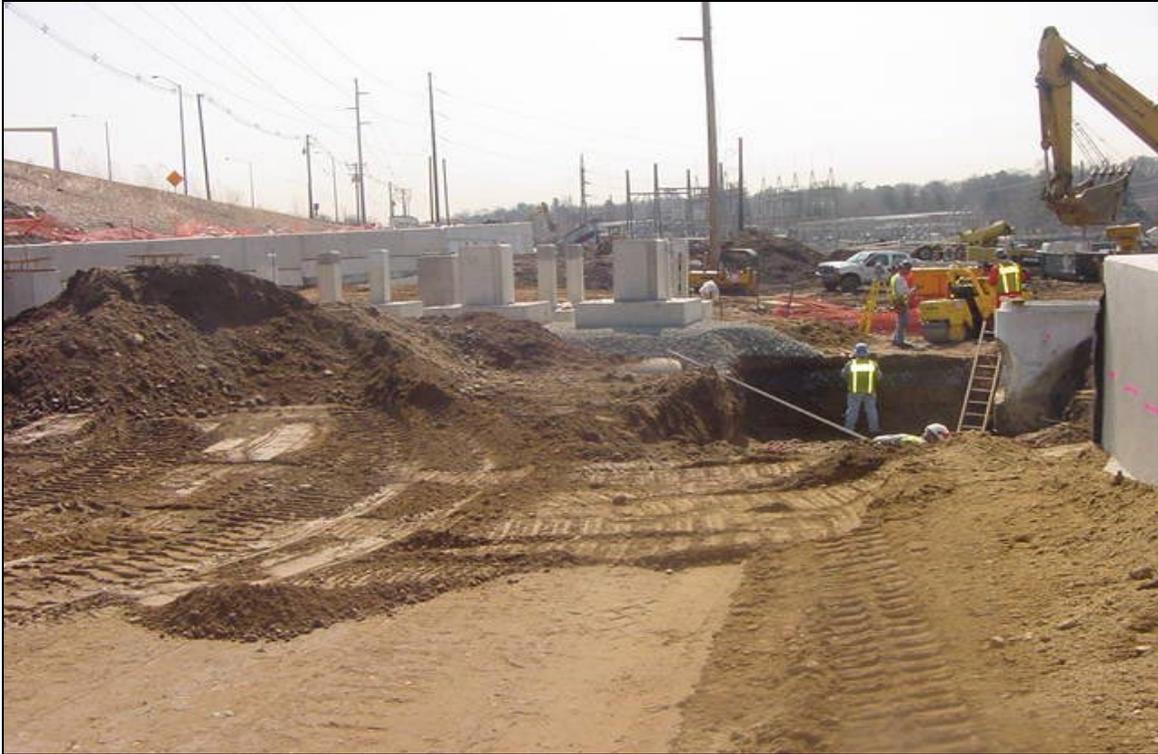
VIEW OF EXCAVATIONS AND FOOTINGS/FOUNDATIONS FOR TOWERS. THE AREA IS WELL CONTAINED. 3/18/04
