Docket No. 217 – Development and Management Plan Inspection

Northeast Utilities Service Company Certificate of Environmental Compatibility and Public Need for the construction of a 345-kV electric transmission line and reconstruction of an existing 115-kV electric transmission line between Connecticut Light and Power Company's Plumtree Substation in Bethel, through the towns of Redding, Weston, and Wilton, and to the Norwalk Substation in Norwalk, Connecticut.

Norwalk Substation

Plumtree Substation

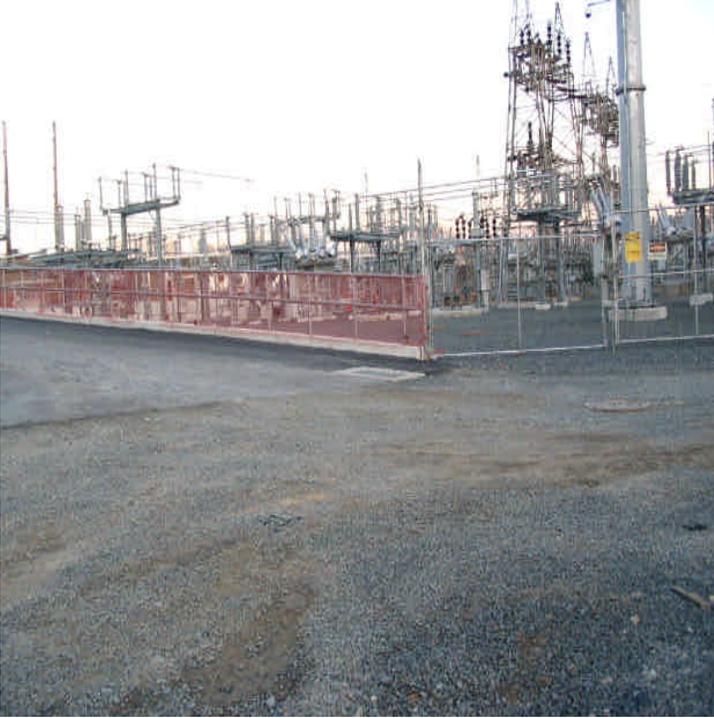
Norwalk Substation: Photo on the left shows an overall view of the live yard where work continues. Photo on the right shows the overflow channel where water levels were low at this time. 3/29/06.

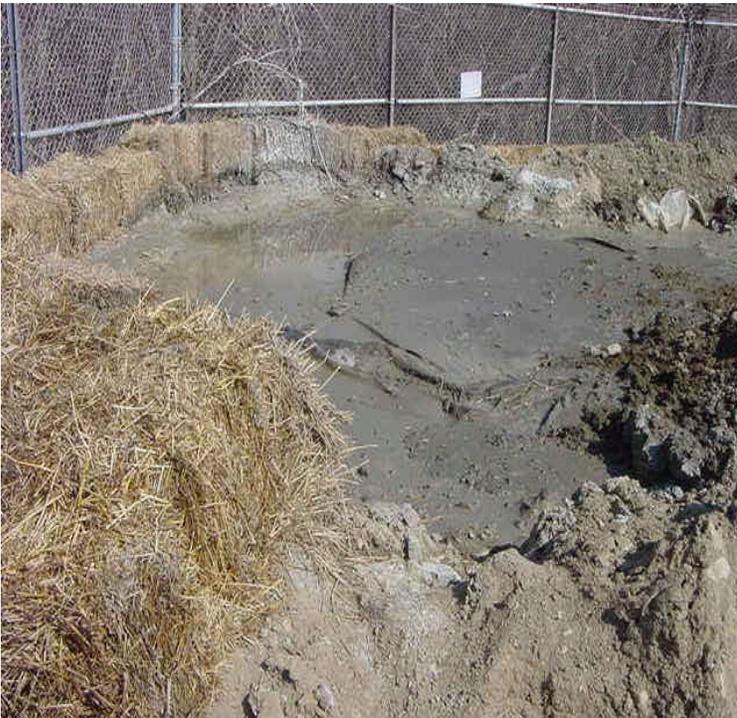
Plumtree Substation: Photo on the right shows the basin installed for drill cuttings, stone dust and water from the caisson drilling. The basin was no longer being used for dewatering activities but should be cleaned out and removed. Photo on the left shows caisson drilling and foundations within the yard. 3/31/06.

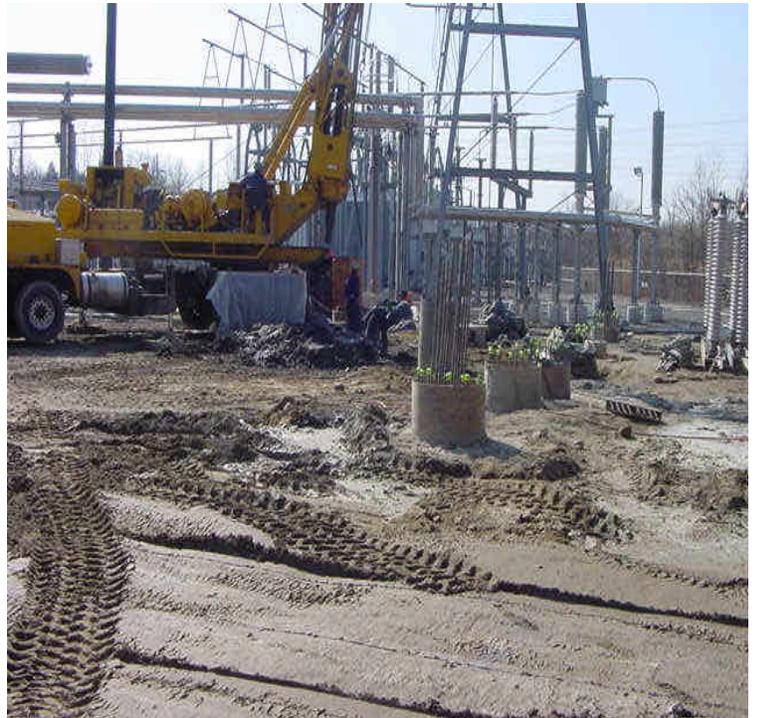
Areas of Inspection	Observation	Recommended Action	Corrected Action
Dewatering	<ul style="list-style-type: none"> - Dewatering or removal of stone dust from the caisson hole was being sent to a basin on site which is not currently large enough to handle all the material. This basin was full of sediment at the time of inspection and was no longer in use. - Crews are now dewatering to the stone yard on site. 3/31/06. 	<ul style="list-style-type: none"> - Sediment is building up in the stone yard. Clean and/or remove excess sediment when completed. 3/31/06. - See the erosion control section for more details. 3/31/06. 	
Blasting	<ul style="list-style-type: none"> - No blasting is occurring on site at this time. 	<ul style="list-style-type: none"> - None at this time. 	-N/A
Spills and Material Storage	<ul style="list-style-type: none"> - No spills or leaks were noted. Now that machinery has returned, continue to monitor. 3/31/06 	<ul style="list-style-type: none"> - The contractors should remain vigilant about securing and handling fuel containers. - Keep all vehicles maintained well (i.e. no apparent fluid leaks) if they will be used or stored on site. Check equipment status on a regular basis. - Report spills to the office immediately, even if they are being controlled. 	-N/A

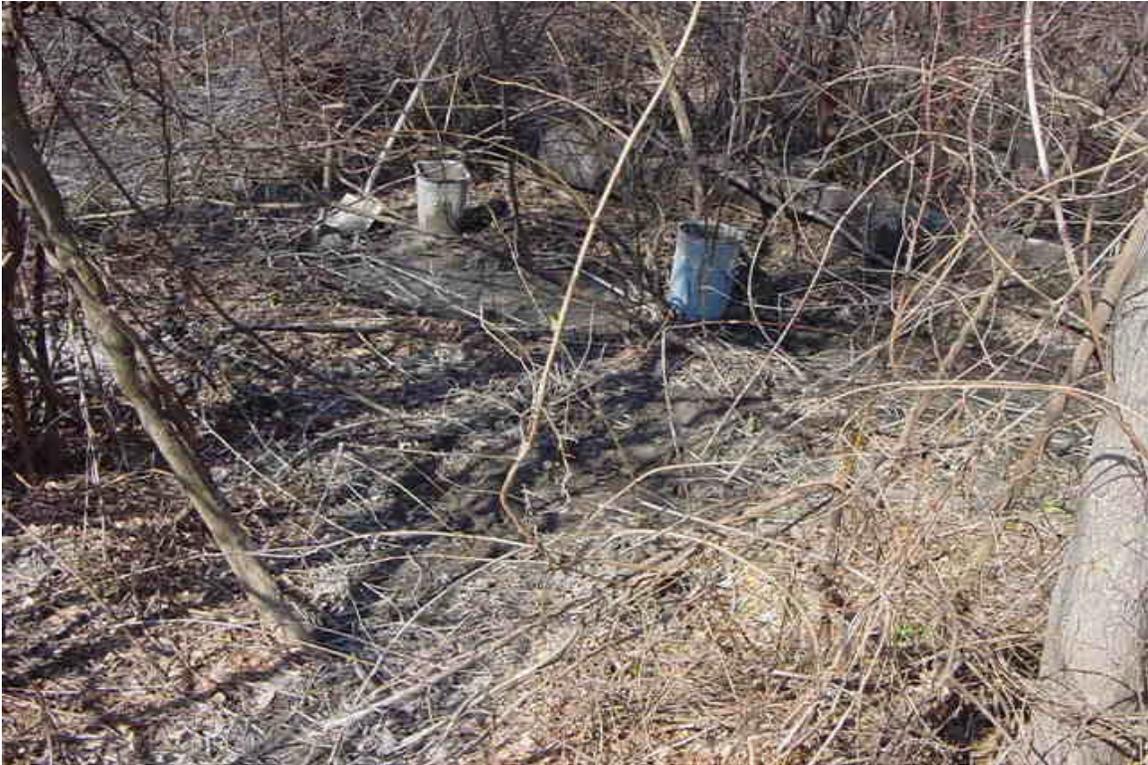
Inland Wetland and Watercourse encroachment and mitigation	<p>- Wetlands are located around the outskirts of the substation yard.</p> <p>- The sediment tracked into the wetlands and settled in several locations. 3/24-3/31/06.</p>	<p>-Crews will have to remove the sediment carefully from the wetlands ASAP. 3/24-3/31/06.</p>	<p>-A portion of the sediment has been removed from the wetland and crews are continuing to do so. 3/31/06.</p>
State species of concern, threatened and endangered species	<p>-Although there was no evidence of a nest in the previous stockpile, crews returning to the site at this time will have to remain aware of the fact the weather is warming and the wood turtle could return to the site in the spring. 3/15-3/31/06</p>	<p>- Move machinery carefully and perform daily walkdowns of the site each morning when the weather gets warmer. 3/15-3/31/06.</p>	<p>-N/A until the weather warms up.</p>

A portion of the sediment has been removed from the wetland adjacent to the basin. Crews continue to work in this area. 3/31/06.

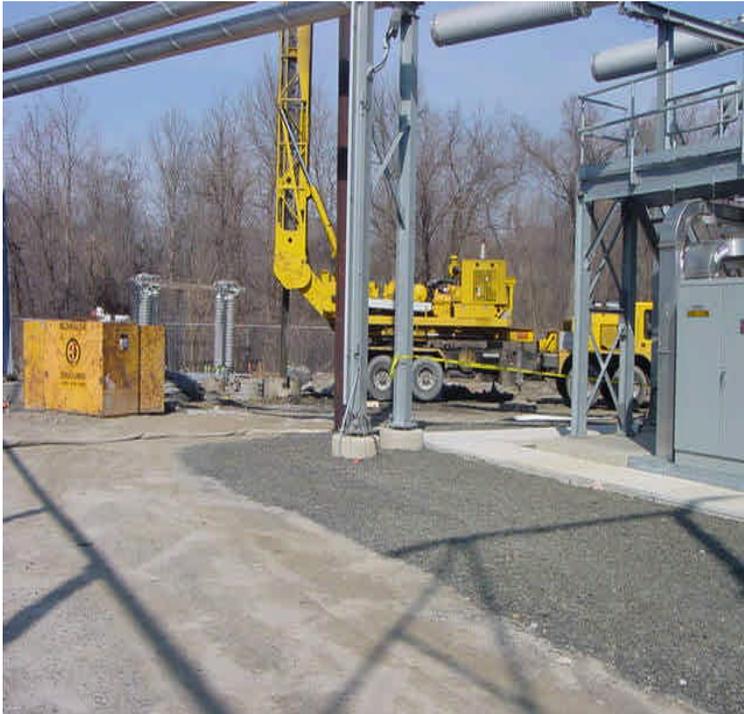
Areas of Inspection	Observation	Recommended Action	Corrected Action
	inspection. 3/31/06.		
Erosion and Sediment Controls (includes inspection within 24 hours of a storm event)	<p>- Haybales were installed adjacent to the stockpiles by the perimeter stone berm. Stock piles were scheduled to be removed from site by April 4th. 3/31/06.</p> <p>- A haybale basin was installed at the fence corner to hold drill cuttings, water and stone dust from the caisson drilling. Sediment spilled over or seeped through the bales and tracked into the adjacent wetland. 3/24/06</p> <p>- This basin is no longer being used for dewatering but sediment needs to be cleaned and removed. See dewatering section as well. 3/31/06.</p>	<p>-Continue to monitor that the controls are effective. Extend haybales if the piles are not removed. 3/31/06.</p> <p>-If the basin is to be used for future dewatering activities, the capacity will need to be increased and installation of a plastic liner may be necessary. The sediment will also have to be removed carefully from the wetland ASAP. See dewatering section as well. 3/24-3/31/06.</p> <p>- The basin should be removed and cleaned out if it is no longer to be used. 3/31/06</p>	<p>- Haybales were installed here.</p> <p>-A portion of the sediment has been removed from the wetland and crews are continuing to do so. 3/31/06.</p>

Photo on the right shows additional foundation drilling on site Photo on the left shows a view of the stockpile located at the perimeter fence. Stockpiles are scheduled to be removed from site, but if they are to remain, the haybale line should be extended. 3/31/06.
