Docket No. 217 – Development and Management Plan Inspection

Northeast Utilities Service Company Certificate of Environmental Compatibility and Public Need for the construction of a 345-kV electric transmission line and reconstruction of an existing 115-kV electric transmission line between Connecticut Light and Power Company’s Plumtree Substation in Bethel, through the towns of Redding, Weston, and Wilton, and to the Norwalk Substation in Norwalk, Connecticut.

Date: March 30, 2005

Location: Norwalk Substation Expansion

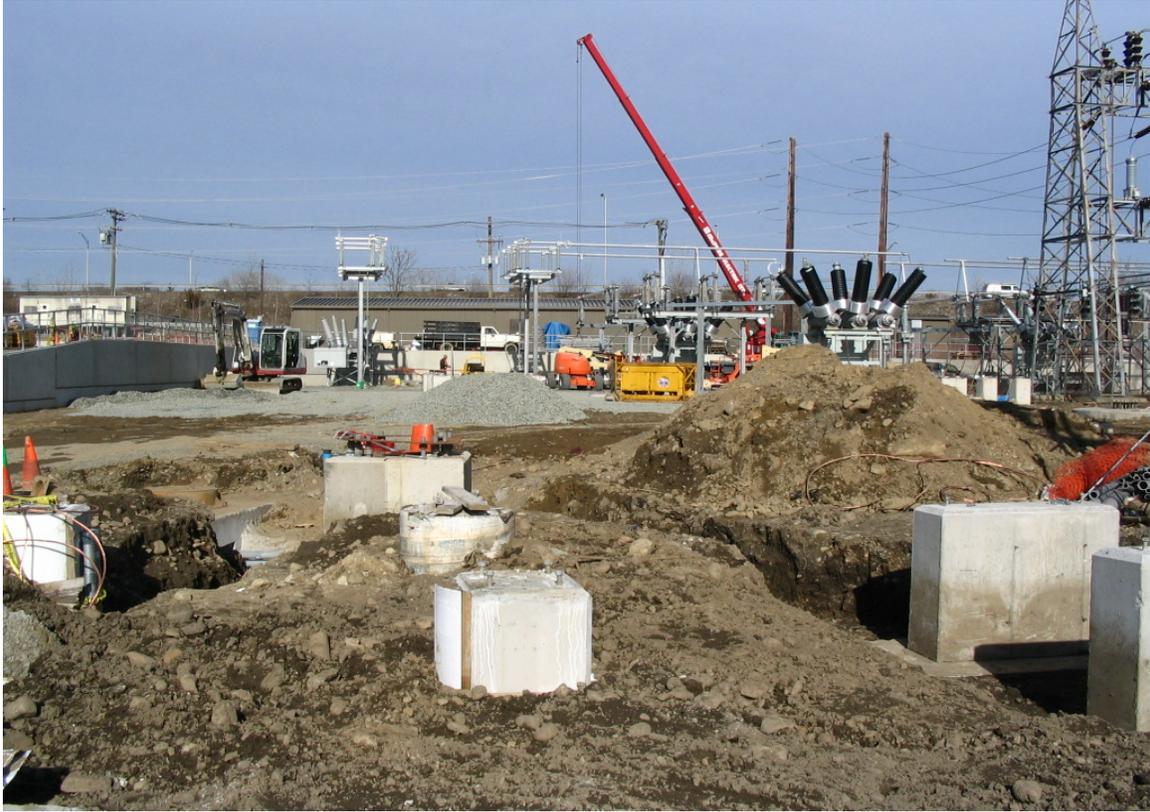
View of new structures and new footings within the expansion area below retaining wall #3. 3/30/05

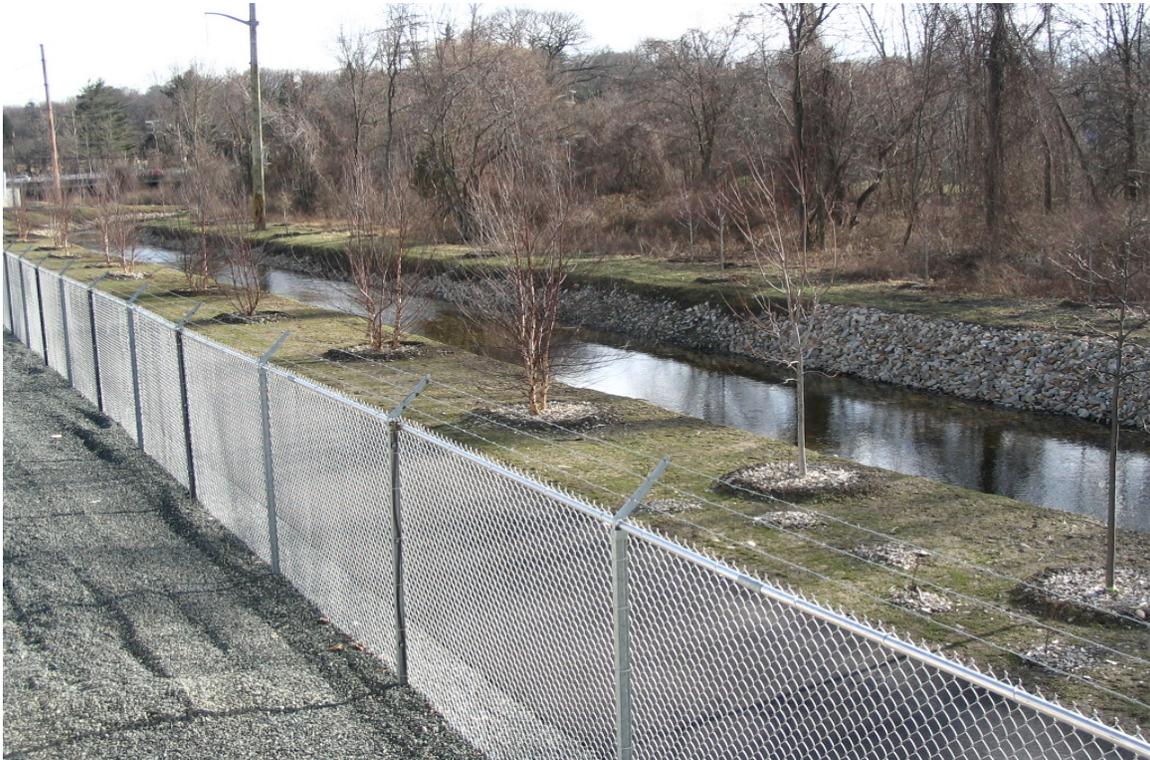
The overflow channel had a significant amount of water following the recent rain event and is working well. 3/30/05

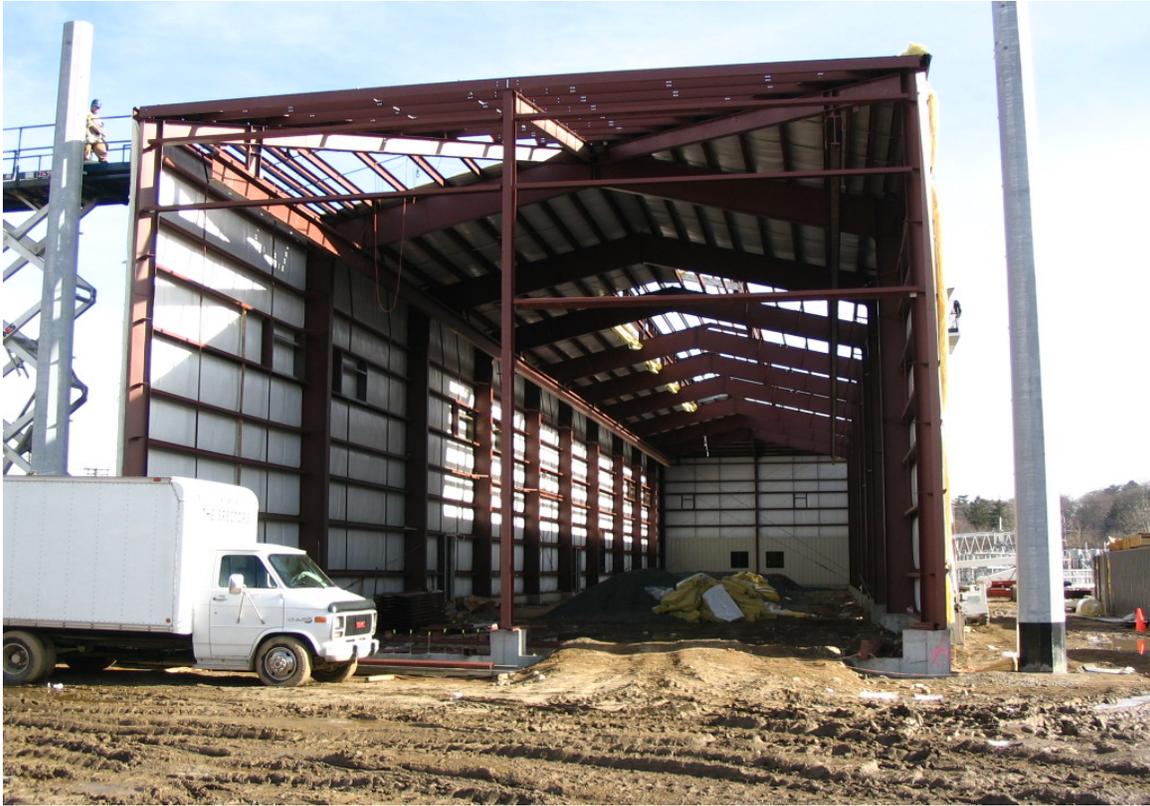
Siding and structure work continues on the GIS building. 3/30/05

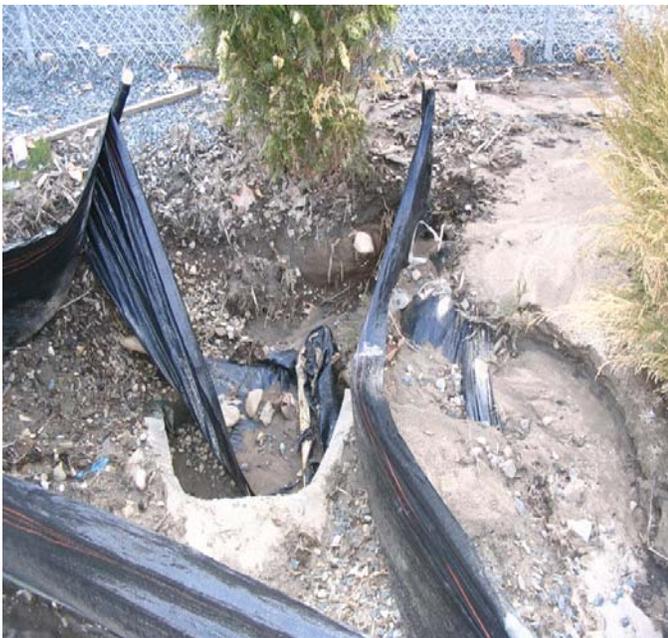
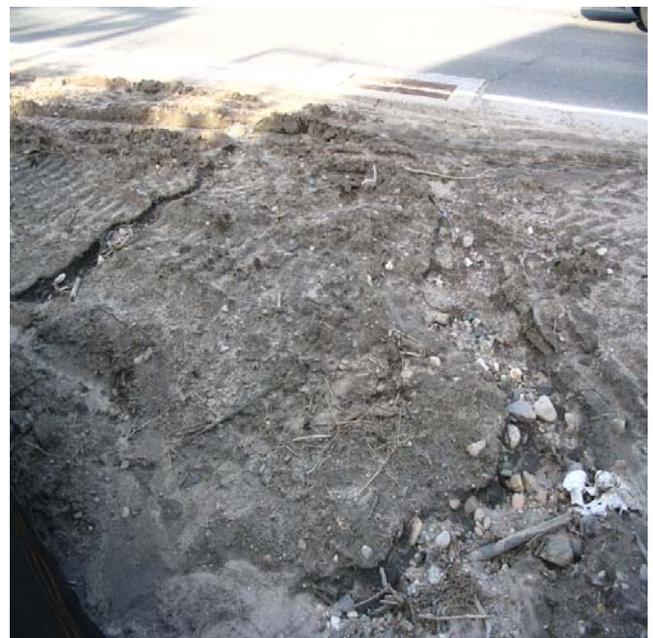
Areas of Inspection	Observation	Recommended Action
<p>Access Roads and Adjacent Roadways</p>	<ul style="list-style-type: none"> - Following the rainstorm, portions of the silt fence around the inlet were ripped down due to the volume of water. More on site and off site sediment continues to deposit here. A haybale should be placed here in anticipation of the weekend rain. 3/30/05 - Some silt from the minor erosion had been noticeable within the earthen swale and the area will require revegetation in the growing season. A haybale check dam may help prevent sedimentation until vegetation is established. 3/9-3/30/05 - Emergency DOT work continues on the New Canaan Ave bridge (Route 123) adjacent to the site. Areas of the bike path and bank adjacent to the bridge have been disturbed. 3/30/05 	<ul style="list-style-type: none"> -The silt fence will require repair however with the volume of water received here from the roadway, the weekend rain would likely just rip it again. 3/30/05 -A new haybale should be installed here before the weekend rain to help filter sediment loads. 3/30/05. - The earthen swale and surrounding area is still bare soil and may require additional stabilization in the future. A haybale checkdam could be installed to help alleviate sedimentation. 3/9-3/30/05 - Work is not associated with the project but is mentioned as a potential source of off-site sediment. Any areas disturbed on site will be restored per DOT. 3/30/05

The inlet near the Route 7 ramp continues to receive on site and off site sediment and the silt fence was torn down by the large volumes of water during the rain. Much of this is sand from the roadway as depicted by the gullies coming from this direction. 3/30/05

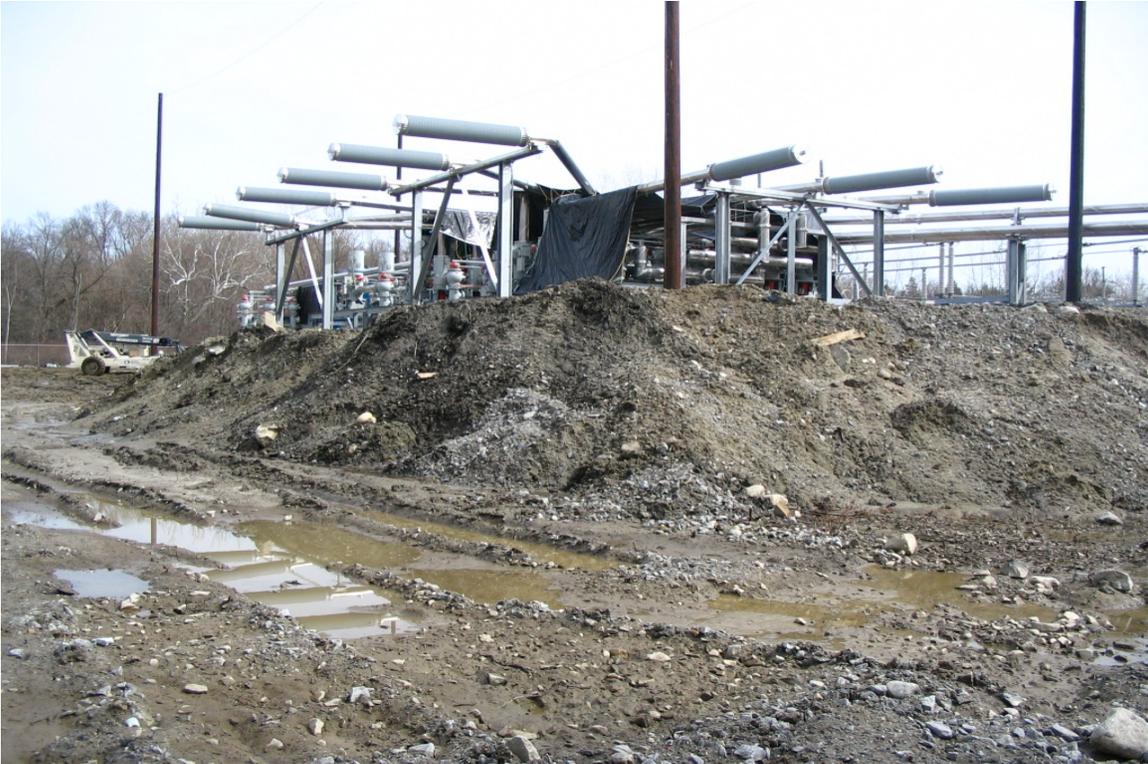
Plumtree Substation: View of the yard with the leftover stockpiles. 3/30/05

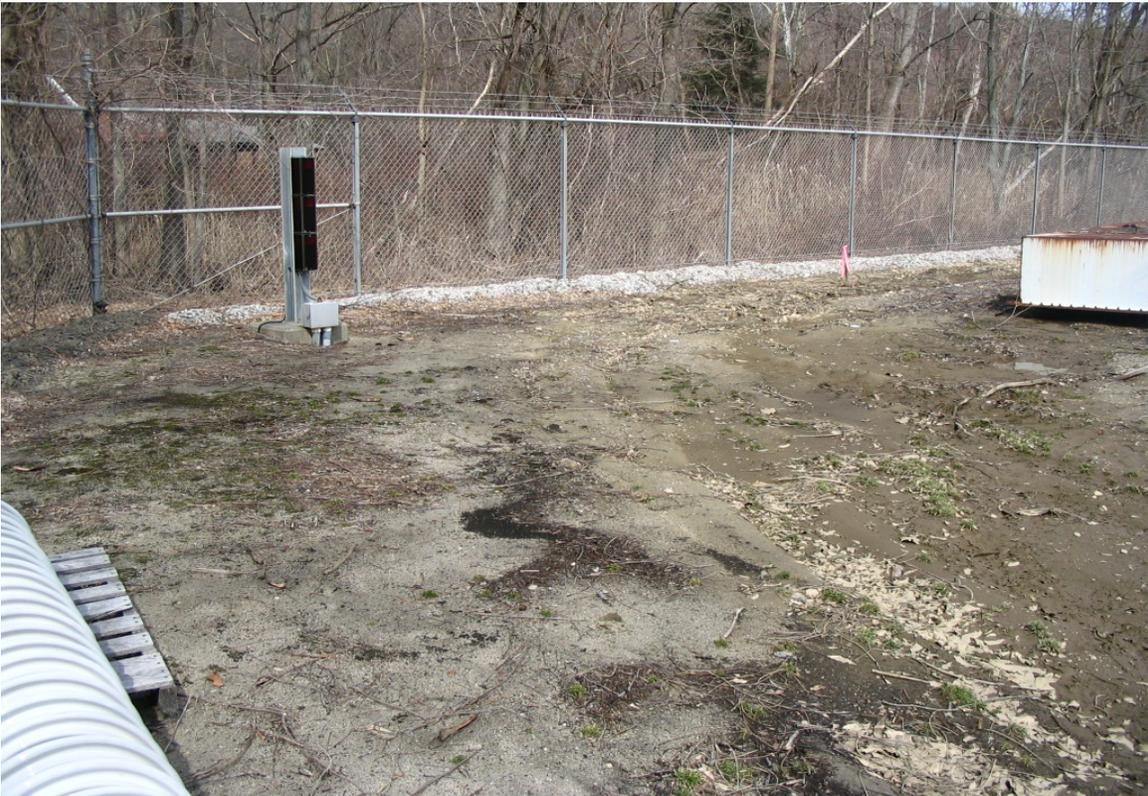
Although the yard fills with water following larger rain events, the stone berm has been very efficient at preventing run-off to the surrounding wetlands. 3/30/05
