Docket No. 217 – Development and Management Plan Inspection

Northeast Utilities Service Company Certificate of Environmental Compatibility and Public Need for the construction of a 345-kV electric transmission line and reconstruction of an existing 115-kV electric transmission line between Connecticut Light and Power Company’s Plumtree Substation in Bethel, through the towns of Redding, Weston, and Wilton, and to the Norwalk Substation in Norwalk, Connecticut.

Date: April 2, 2004

Location: Norwalk Substation Expansion

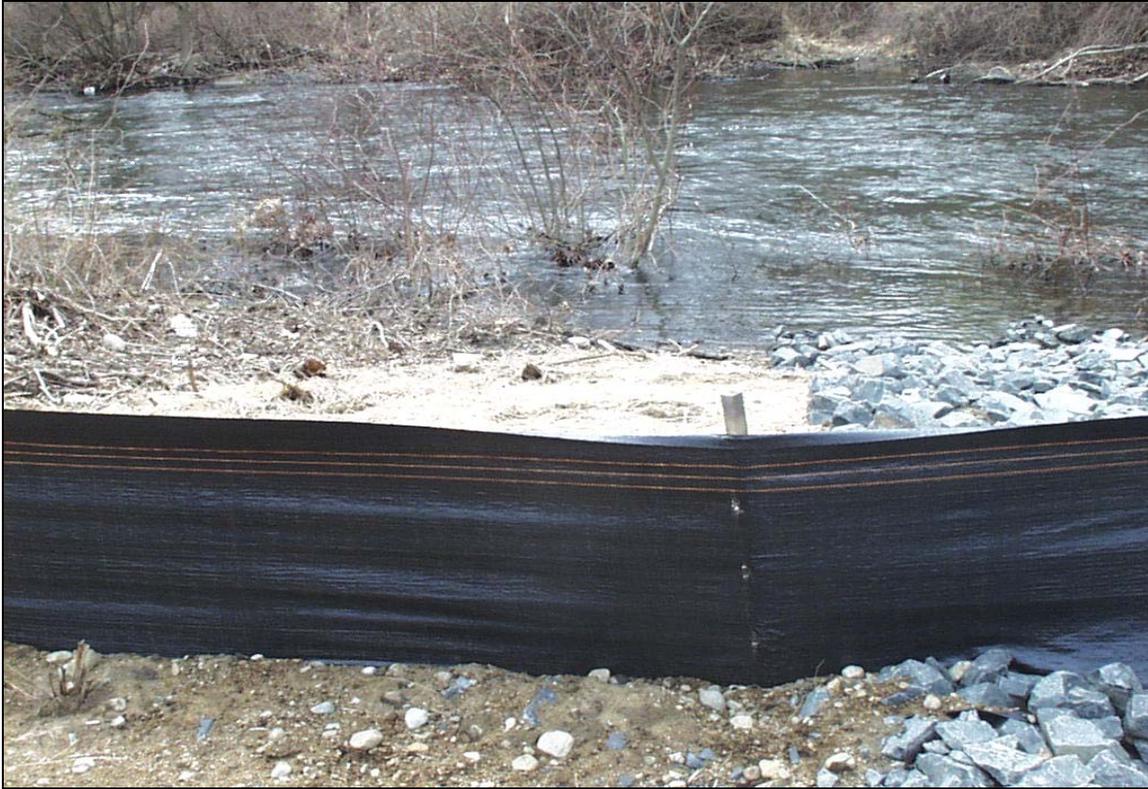
VIEWS OF THE MULCHED AREA AND RIPRAP OUTLET AT THE RIVERBANK. THERE WAS NO EROSION, SEDIMENTATION OR DAMAGE DUE TO THE RAINS. 4/2/04

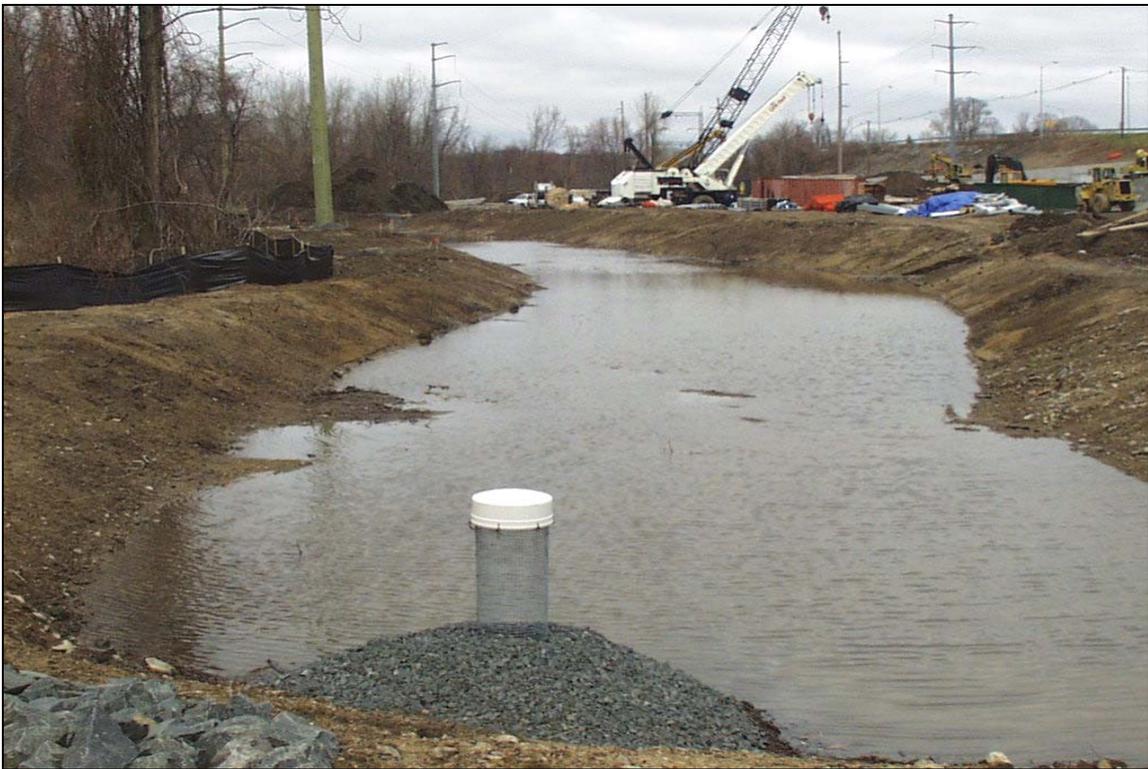
THE TEMPORARY SEDIMENT BASIN WAS RETAINING SOME WATER FOLLOWING SEVERAL INCHES OF RAIN. THE ENTIRE SITE HELD UP EXTREMELY WELL 4/2/04

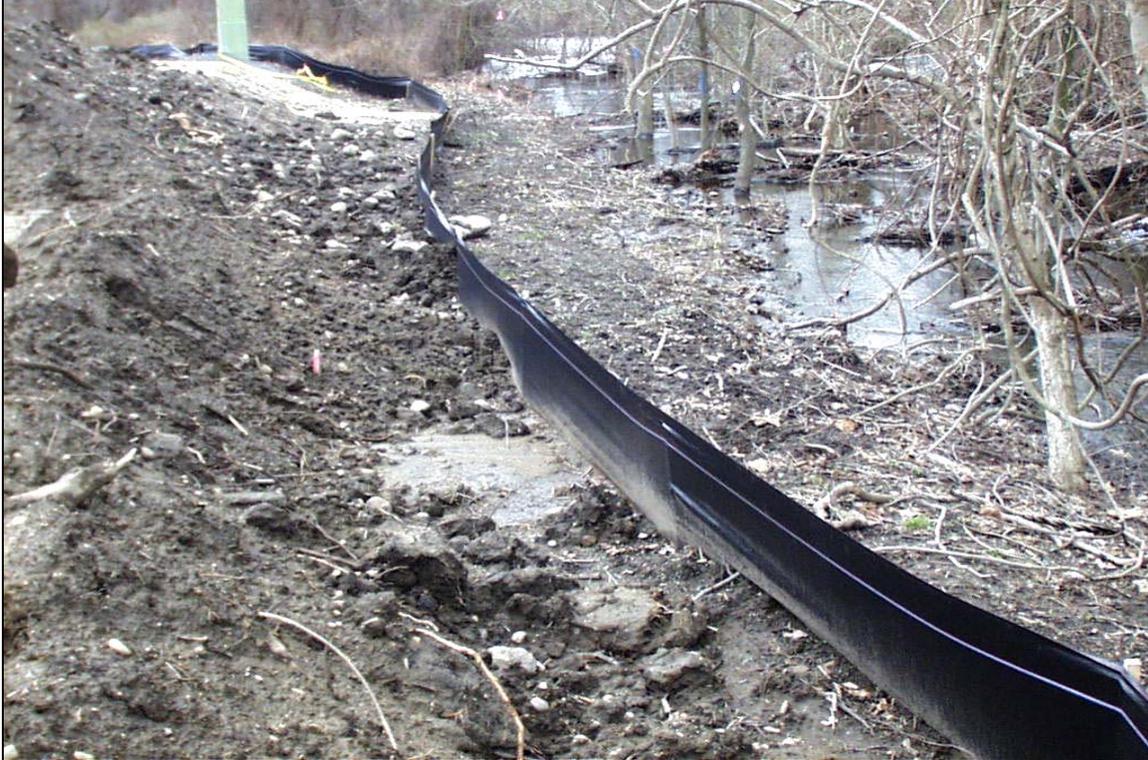
THE RIVERBANK IS CLEAR OF SEDIMENT AND EROSION FOLLOWING THE HEAVY RAINS. VEGETATION WAS ALSO NOTED GROWING ON THE BANKS. 4/2/04

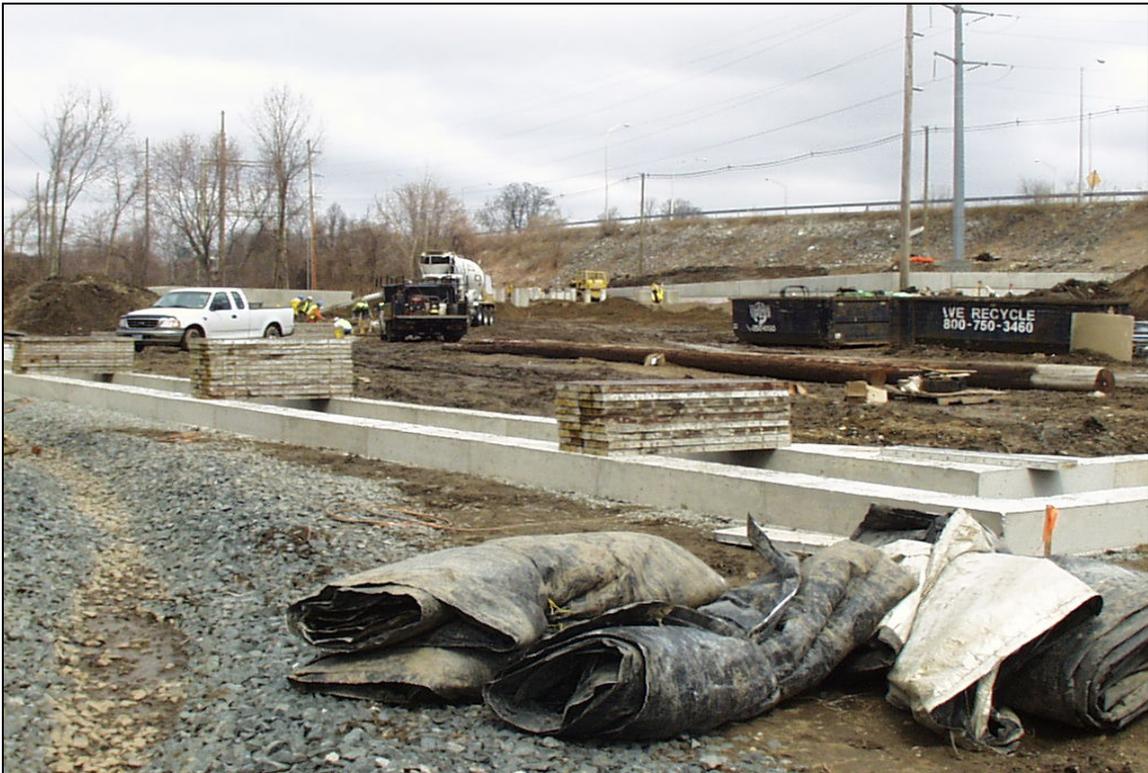
NEW FOUNDATIONS FOR RETAINING WALL #1 ON SITE. 4/2/04

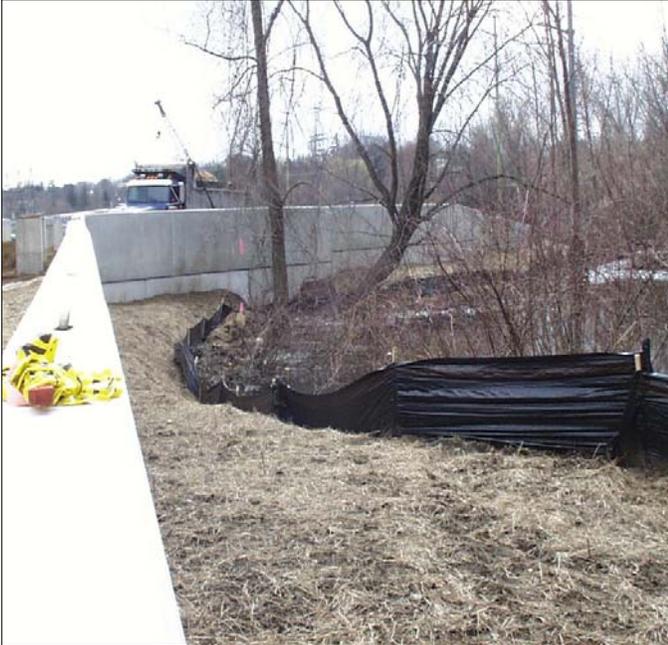
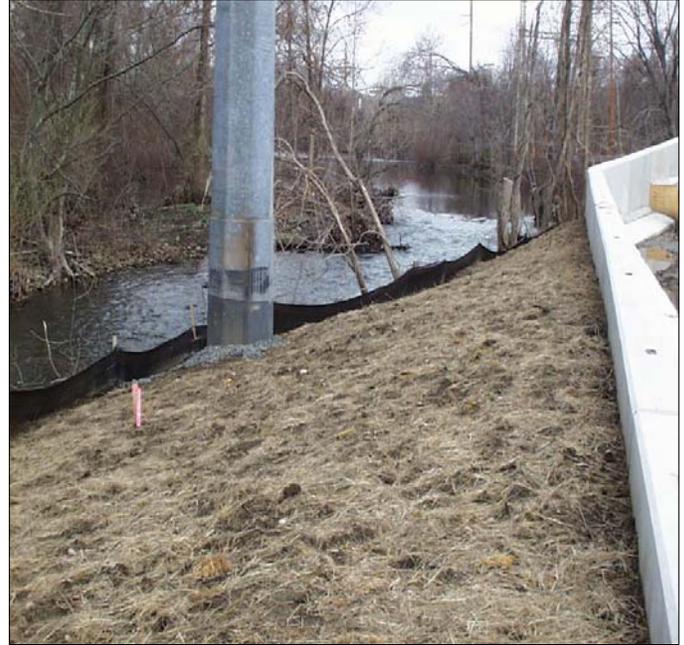
THE AREA NEAR THE RETAINING WALL WAS MULCHED AND SEEDDED AND WAS EXPERIENCING NO GULLYING, EROSION, OR SEDIMENTATION FOLLOWING THE RAINS. 4/2/04

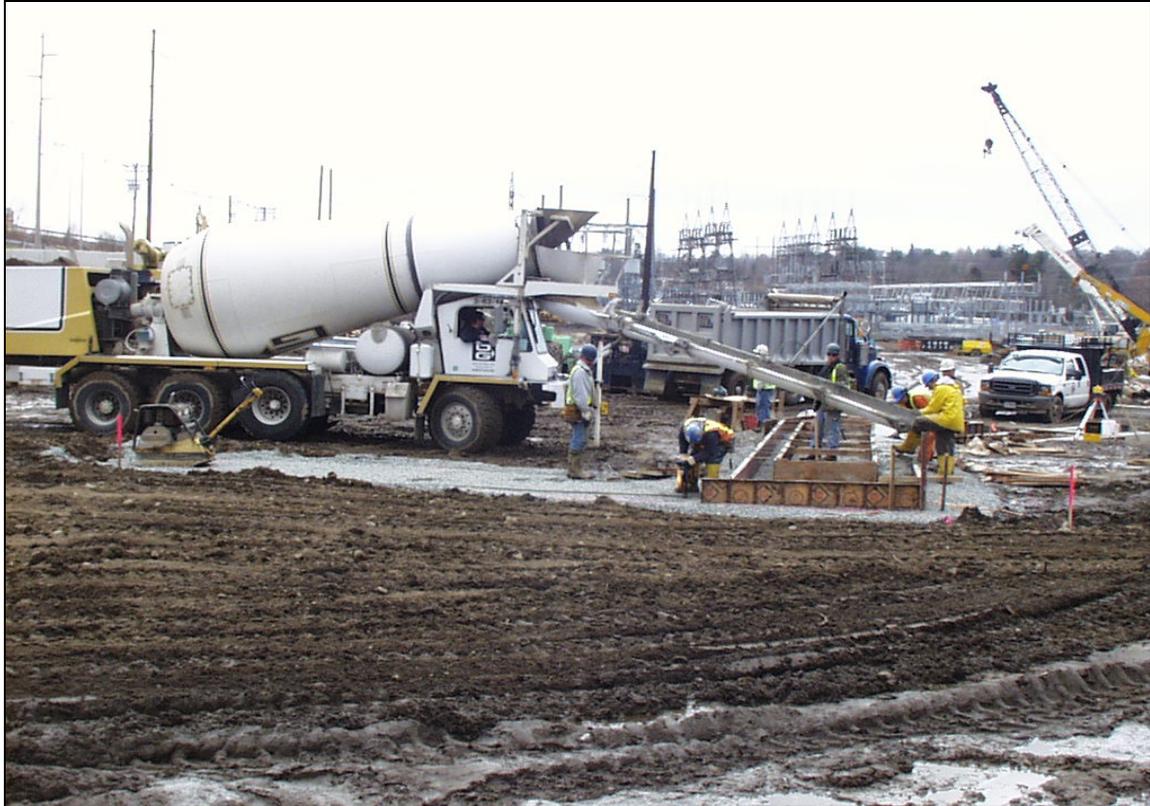
POURING CONCRETE FOR NEW FOUNDATIONS. THE TRUCK UTILIZED THE CONCRETE WASHOUT STATION DURING THE VISIT. 4/2/04

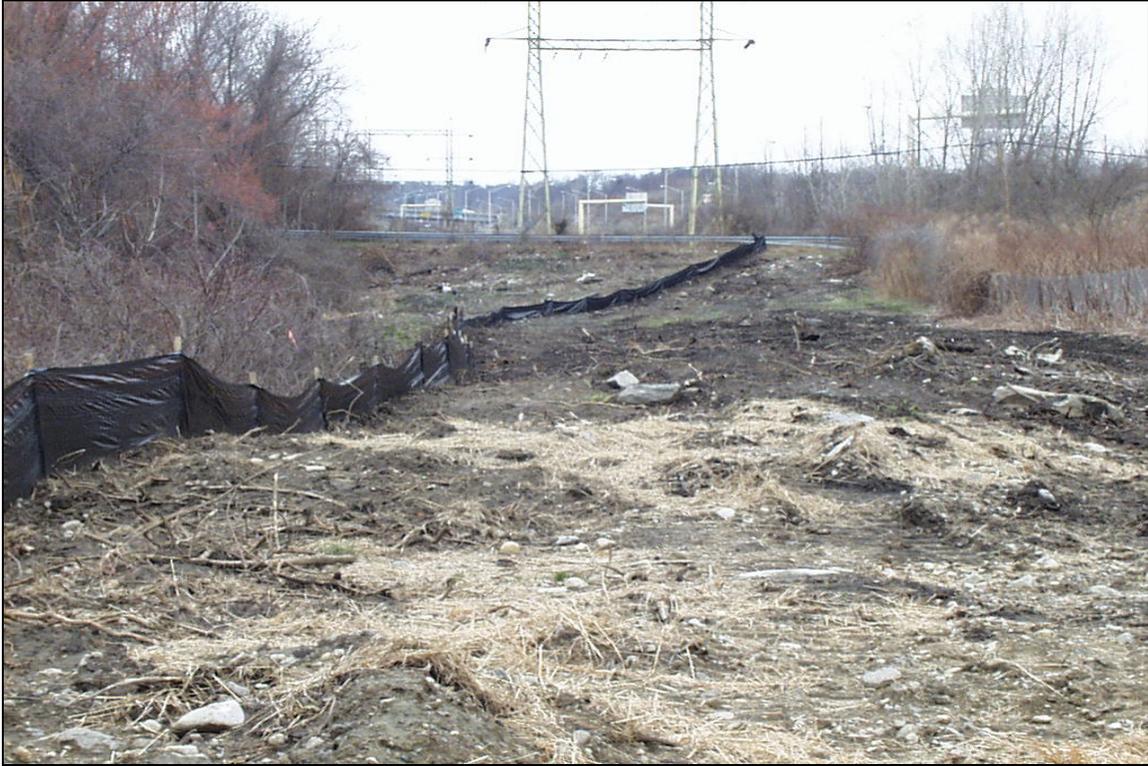
SILT FENCE WAS INSTALLED ALONG THE LENGTH OF THE RIGHT OF WAY ALMOST TO BRIDGE STREET IN ANTICIPATION OF FUTURE WORK. 4/2/04

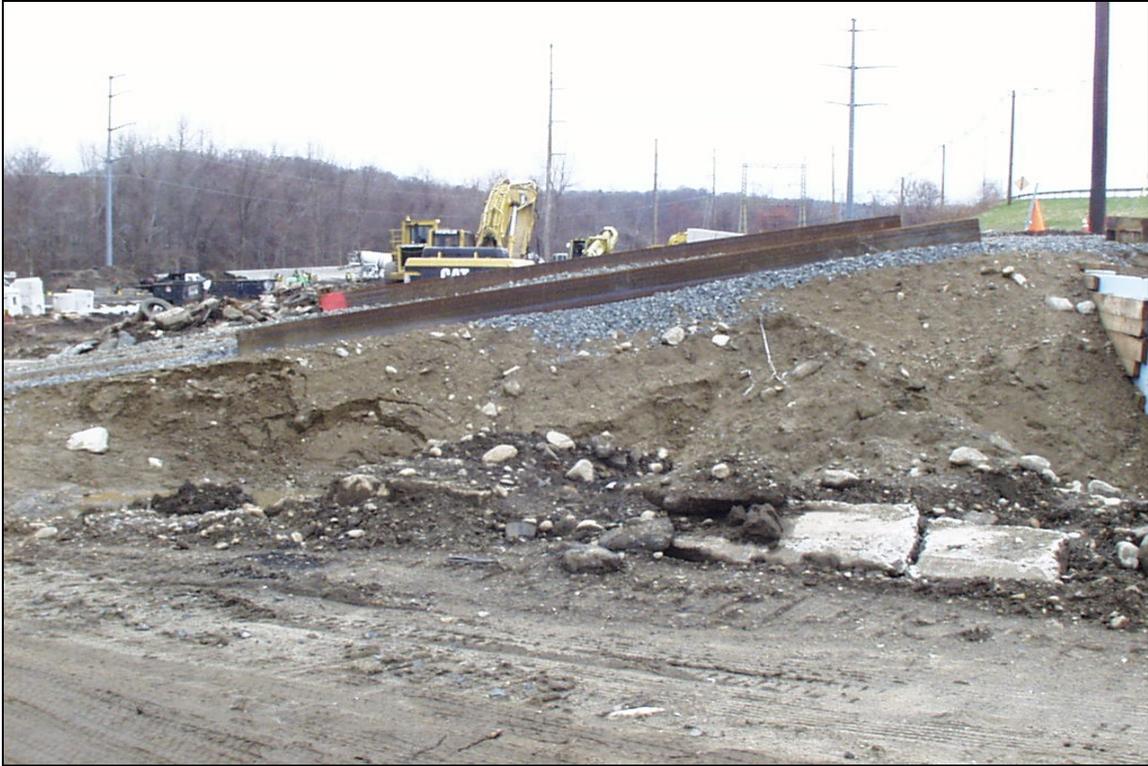
SOME MINOR EROSION ON THE ACCESS ROAD SLOPE. IT WILL BE REINFORCED WITH STONE. 4/2/04

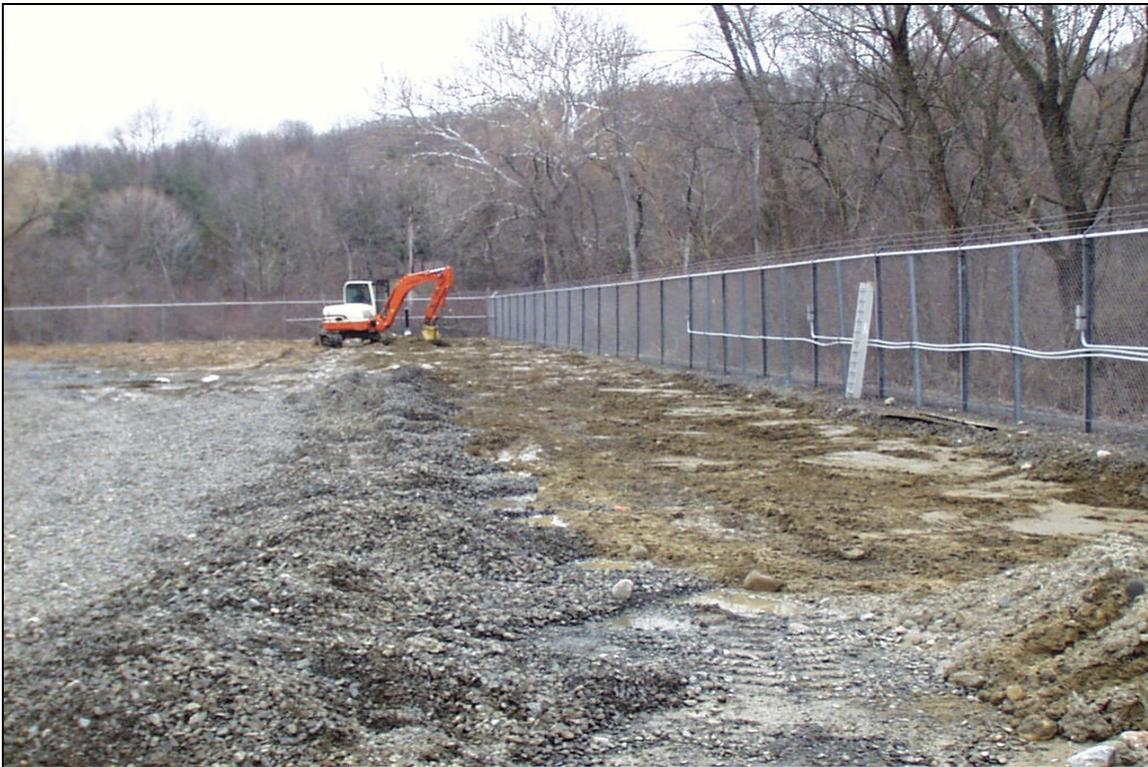
MINOR MAINTENANCE WORK AT THE PLUMTREE SUBSTATION FOR THE SURVEILLANCE SYSTEM. A SMALL TRENCH WAS DUG WITHIN THE YARD FOR CONDUIT INSTALLATION AND WAS FILLED WITHIN A DAY 4/2/04

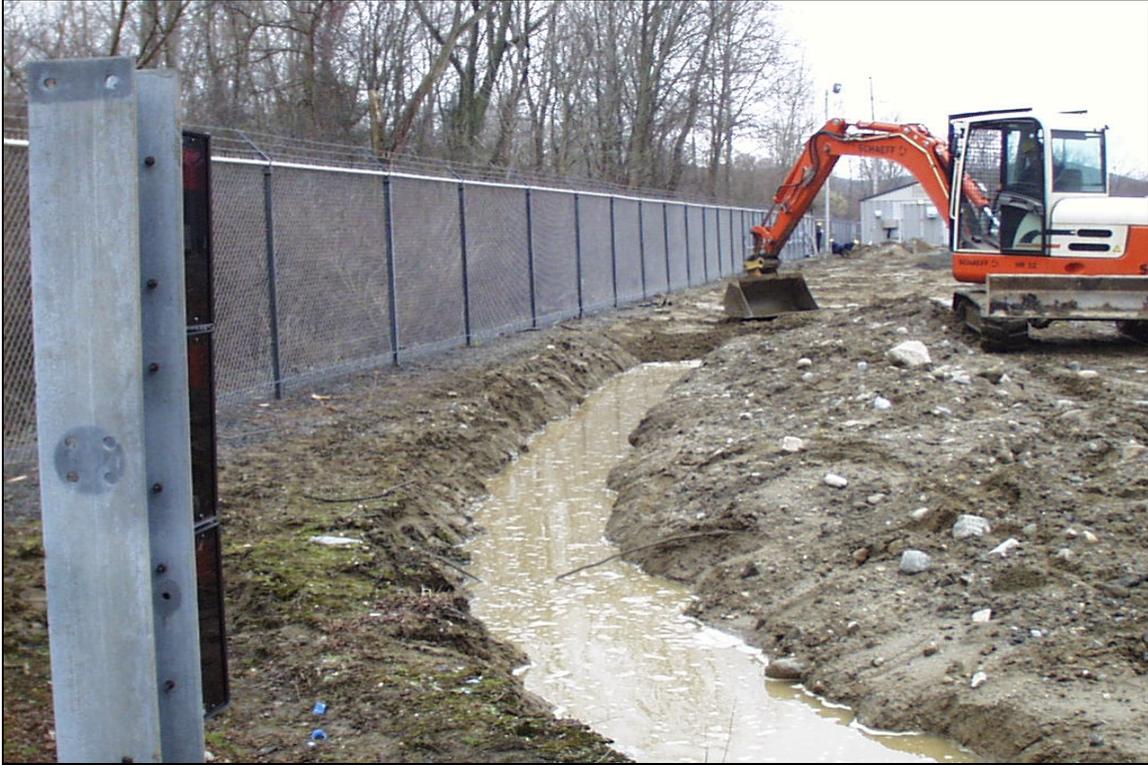
THE TRENCH WAS ALMOST COMPLETELY BACKFILLED AT THE TIME OF THE VISIT AND WAS FILLED BY THE END OF THE DAY. NO SEDIMENTATION HAD OCCURRED. 4/2/04
