**Docket No. 217 – Development and Management Plan Inspection**

Northeast Utilities Service Company Certificate of Environmental Compatibility and Public Need for the construction of a 345-kV electric transmission line and reconstruction of an existing 115-kV electric transmission line between Connecticut Light and Power Company’s Plumtree Substation in Bethel, through the towns of Redding, Weston, and Wilton, and to the Norwalk Substation in Norwalk, Connecticut.

**Date:** April 13, 2005

**Location:** Norwalk Substation Expansion

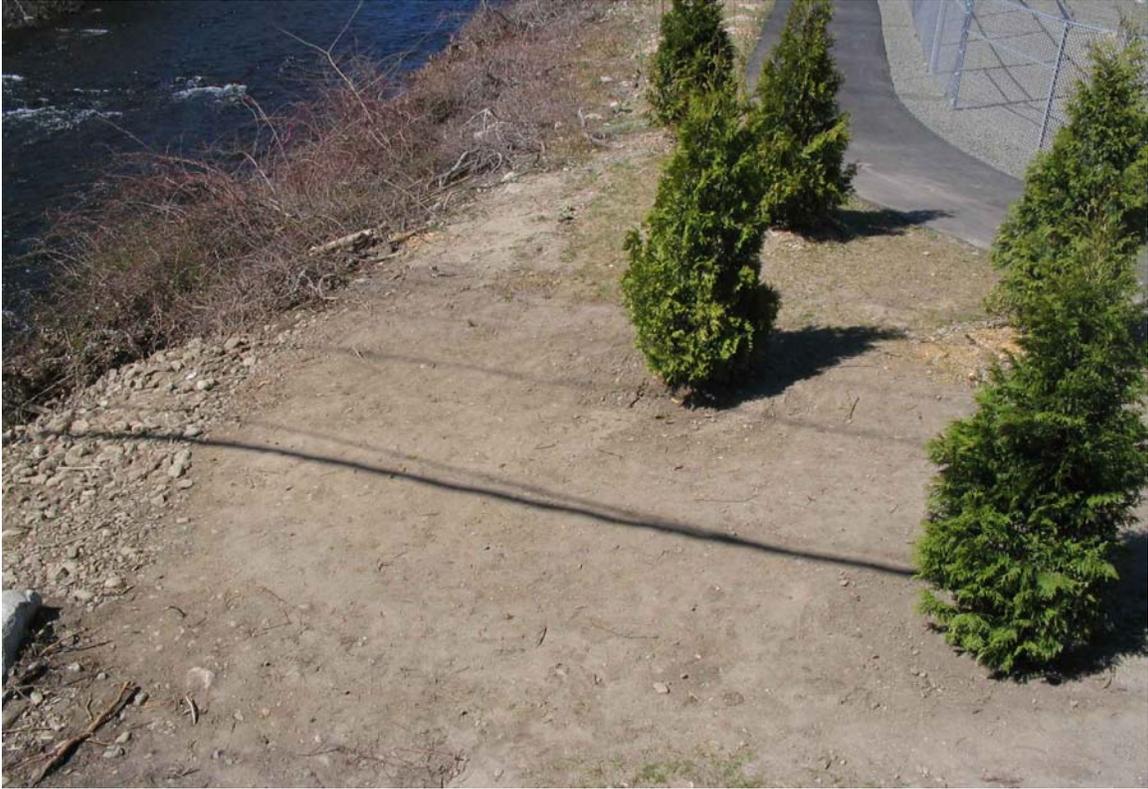
Norwalk Substation: Repair work on the bridge is completed and DOT has restored the riverbank and landscaping. They will also be seeding the area. (4/13/05)

Areas of Inspection	Observation	Recommended Action
<p>Access Roads and Adjacent Roadways</p>	<ul style="list-style-type: none"> <li>- The silt fence around the inlet has been partially repaired but more on site and off site sediment continues to deposit here. Erosion and washouts near the silt fence base are getting worse 4/13/05</li> <li>- Some silt from the minor erosion had been noticeable within the earthen swale and the area will require revegetation in the growing season. A haybale check dam may help prevent sedimentation until vegetation is established. 3/9-4/13/05</li> <li>- Emergency DOT work is completed on the New Canaan Ave bridge (Route 123) adjacent to the site. DOT stabilized the bank with stone and replaced the landscaping but has not reseeded the area. 4/13/05</li> </ul>	<ul style="list-style-type: none"> <li>-The volume of water going to this inlet is causing erosion at the base of the silt fence. 4/13/05</li> <li>-The best solution is vegetative cover here as soon as possible with the growing season. 4/13/05</li> <li>- The earthen swale and surrounding area has some minor growth but will likely require additional stabilization in the growing season. 4/6-4/13/05</li> <li>- Work is not associated with the project but is mentioned as a potential source of off-site sediment. DOT will be seeding the area in the near future. It should also be monitored for stabilization. 4/13/05</li> </ul>

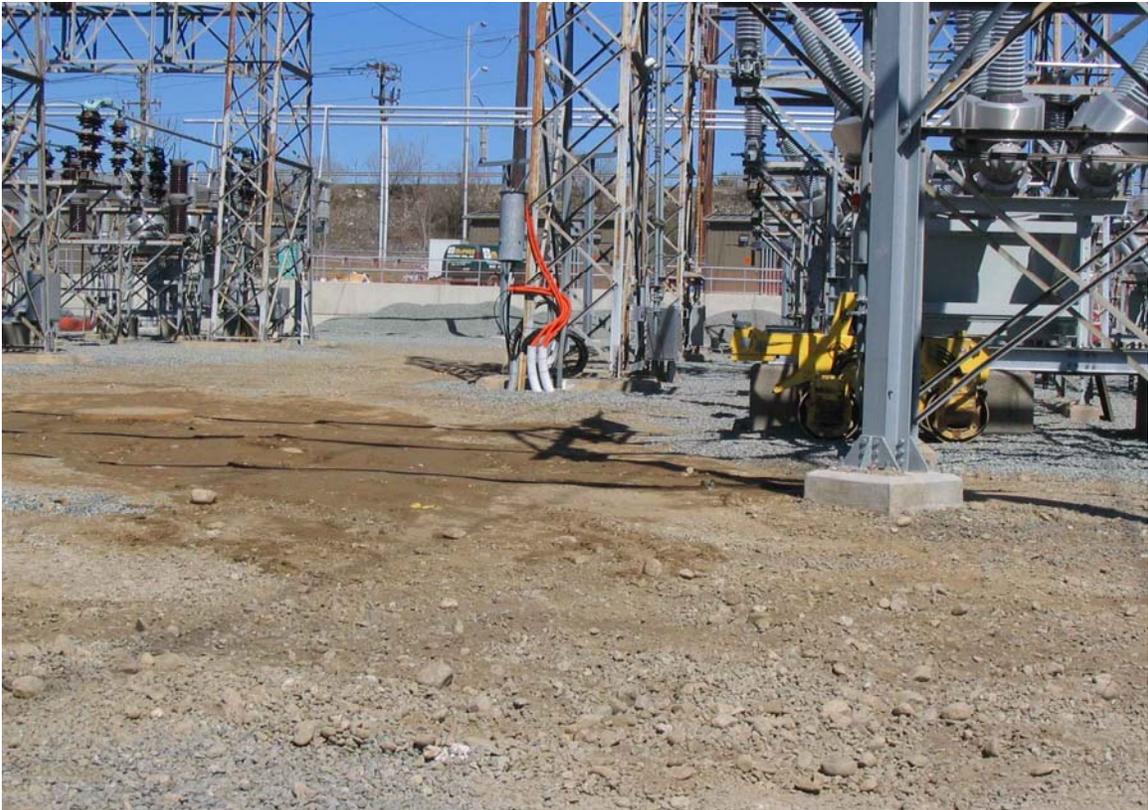
Backfilling and gravel spreading ongoing in the active yard (4/13/05)

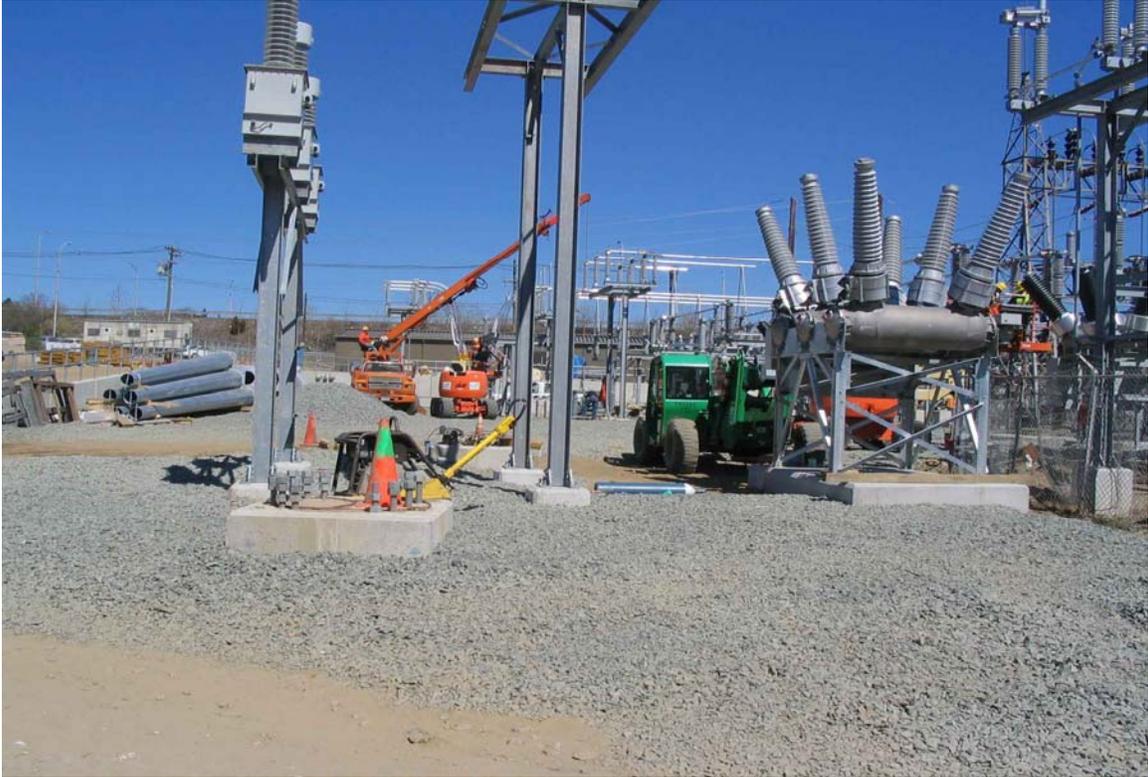
Structure work continues near retaining wall #3 in the expansion area. (4/13/05)

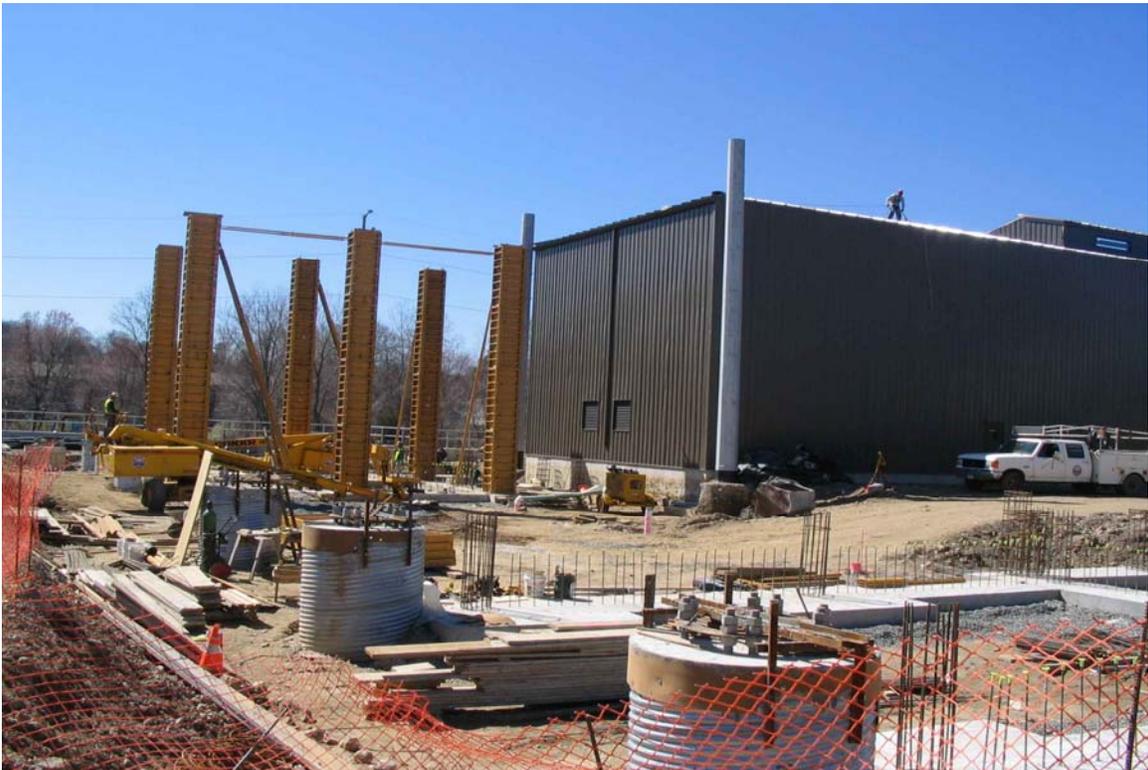
Work continues on the GIS building siding and nearby structures (4/13/05)

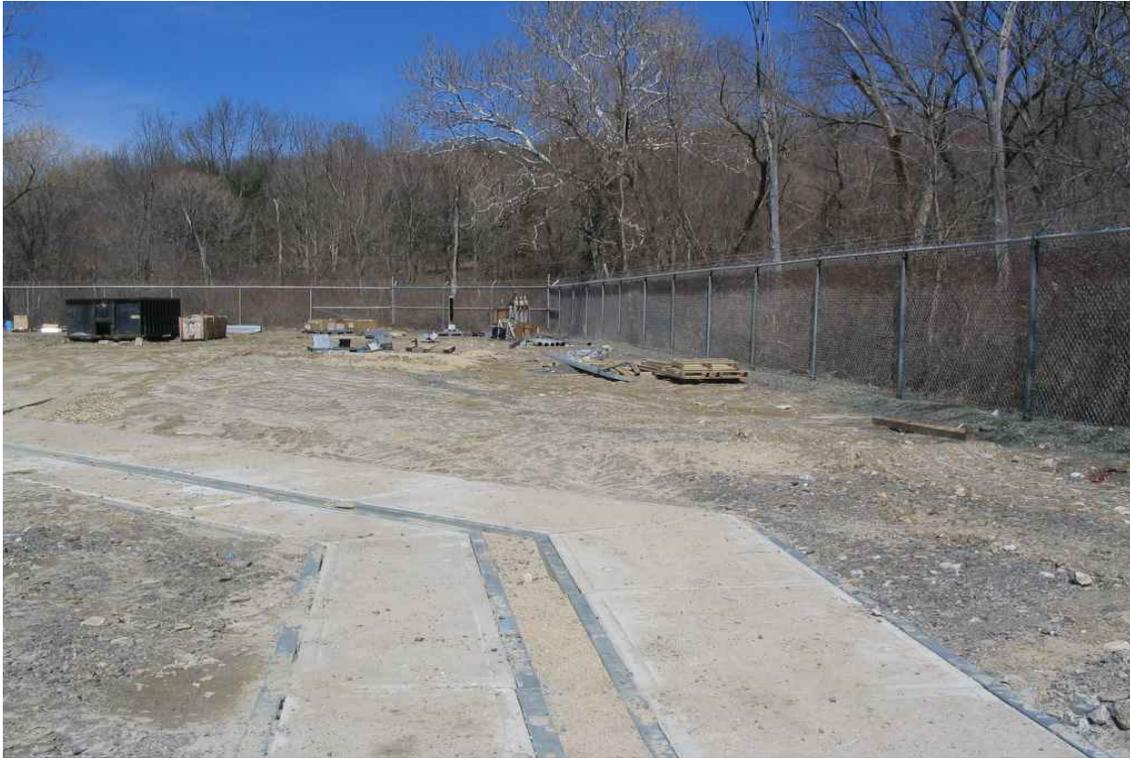
Plumtree Substation: Much of the old material storage area has been cleaned up, the underground conduits have been completed and the perimeter berm is in place. (4/13/05)

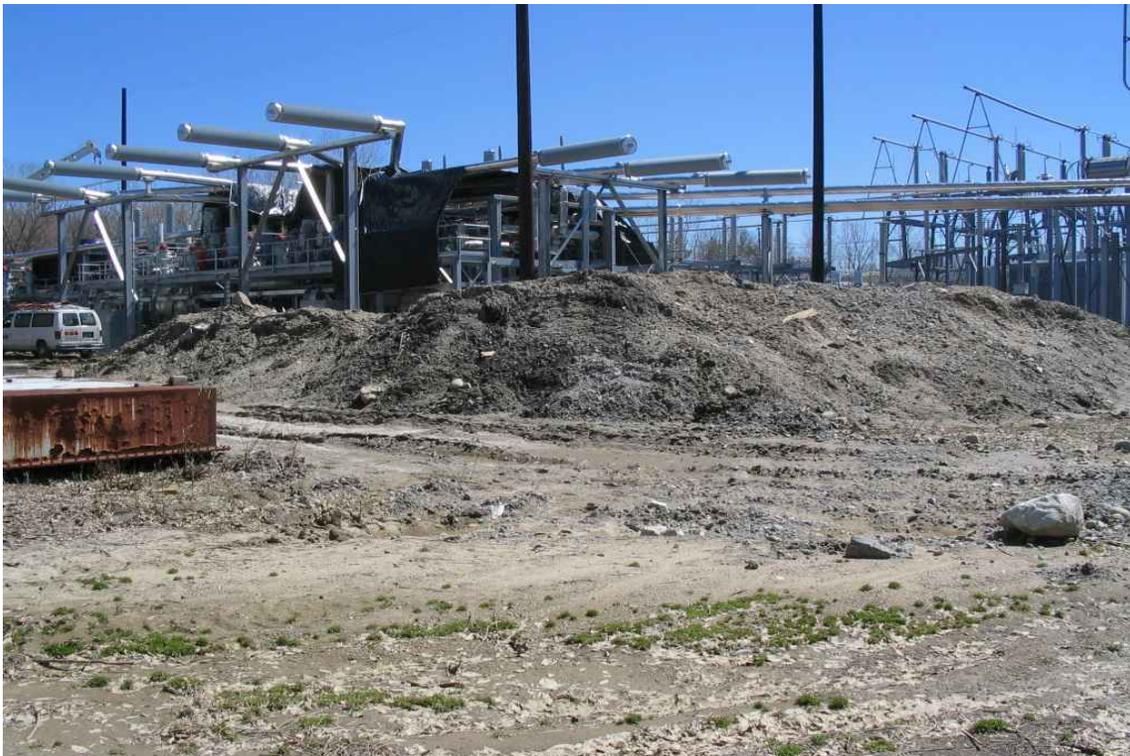
- A majority of the soil has been removed to appropriate off-site locations but some will remain on an as needed basis for the remainder of construction. Portions are not covered in plastic but are well within the site. 3/2-4/13/05	-Continue to monitor status and cover stockpiles with plastic if necessary. 3/2-4/13/05

View of the yard with the leftover stockpiles. Very little work involving soil disturbance is occurring at this time. (4/13/05)
