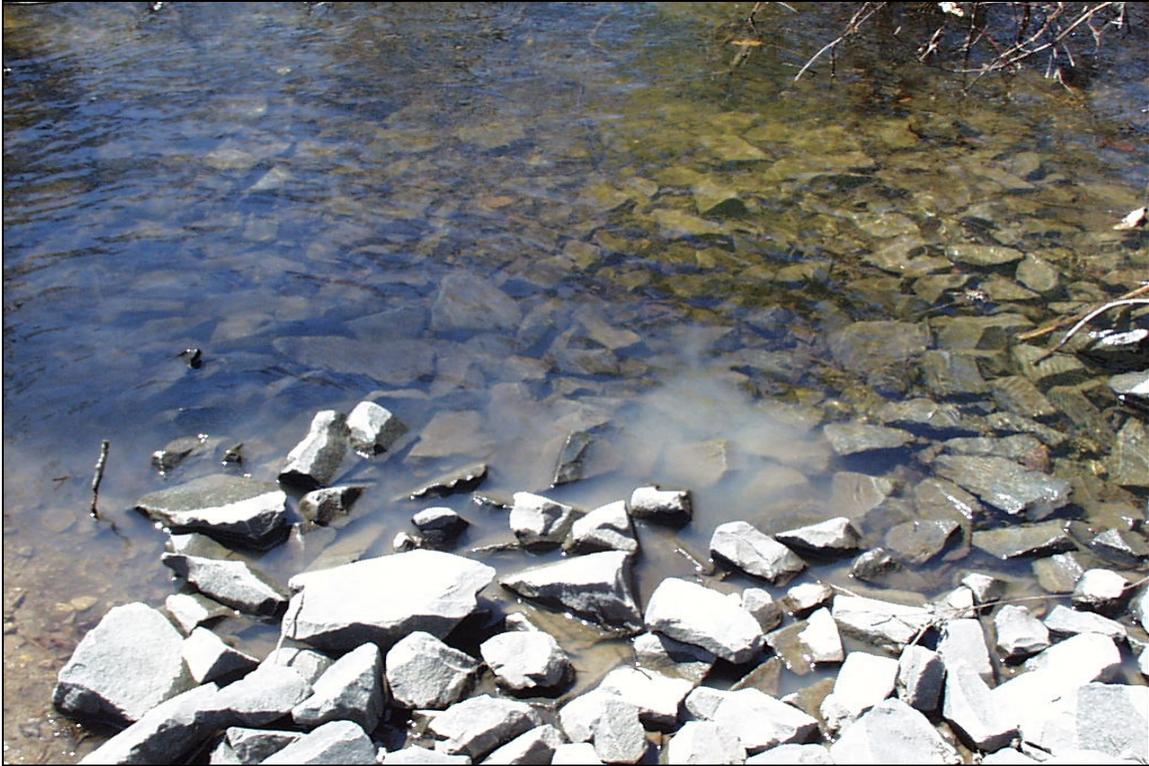
VIEW OF THE FINE SEDIMENT PLUME FROM THE BASIN OUTLET IN THE RIVER. IT DISSIPATED QUICKLY UPON REACHING THE WATER. 4/16/04

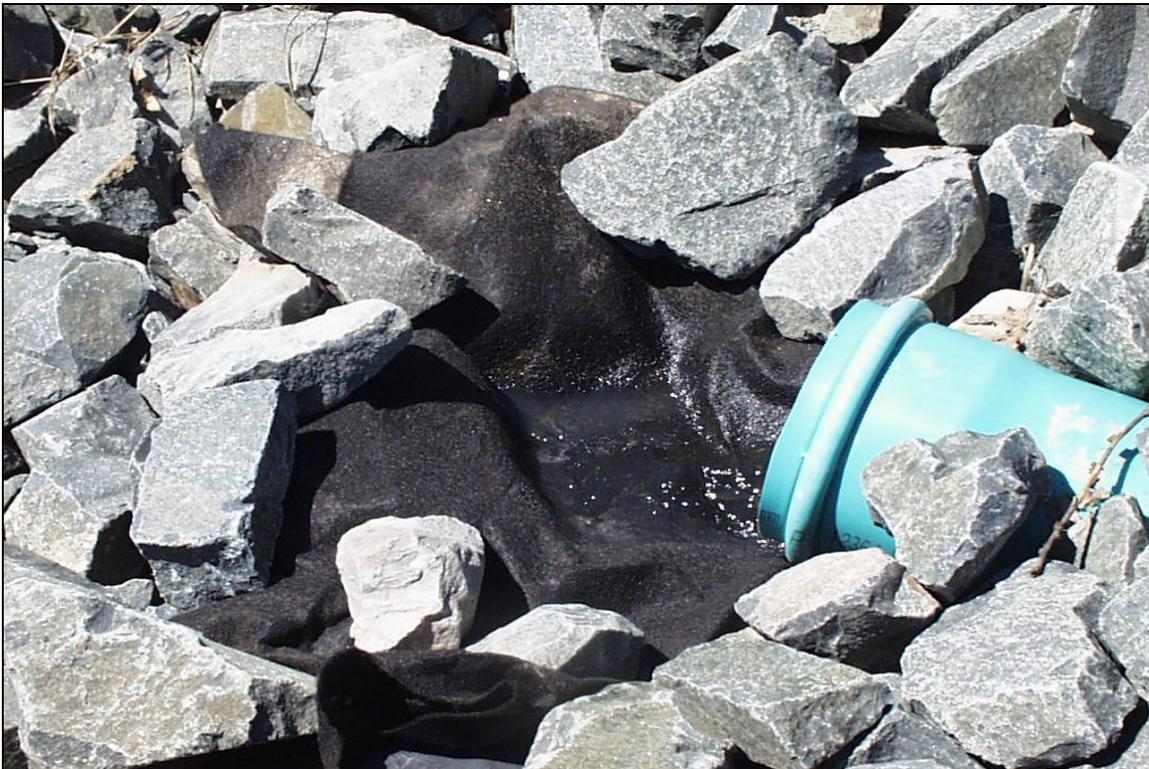
FILTER FABRIC WAS PLACED UNDER THE OUTLET IN AN ATTEMPT TO COLLECT THE SEDIMENT BUT THE PARTICLES ARE TOO FINE. 4/16/04

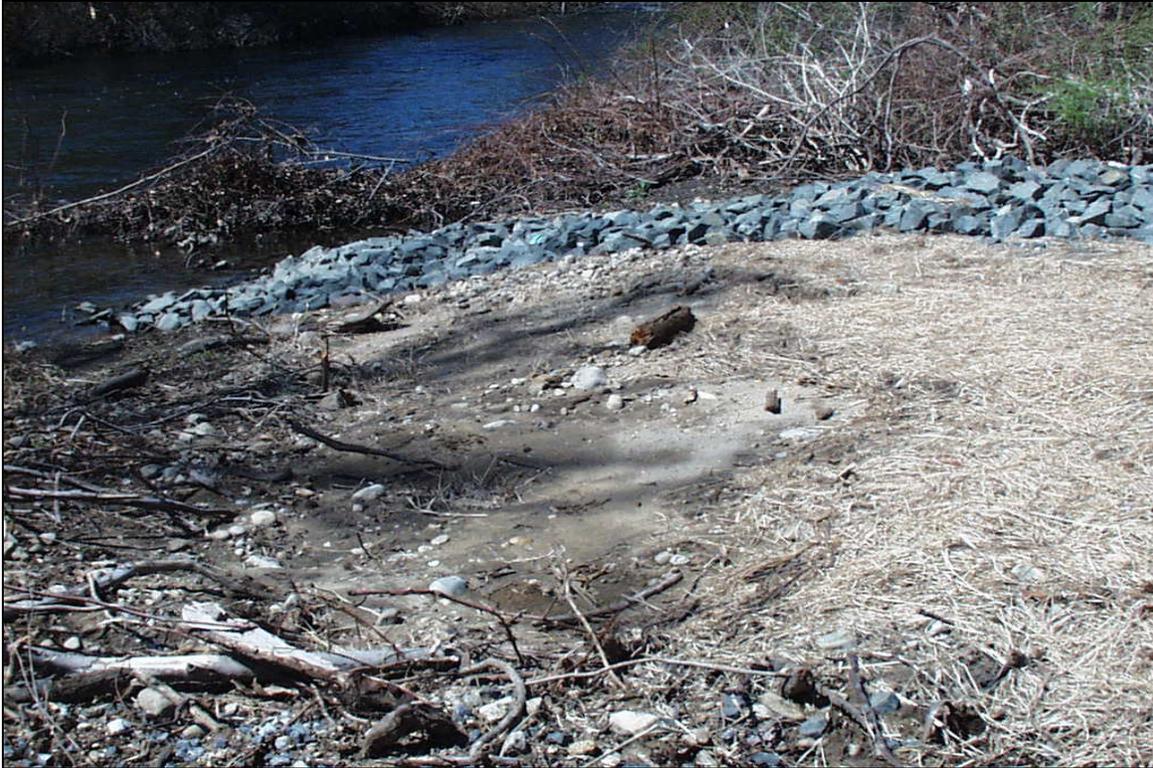
VIEW OF THE MULCH WASHED OUT NEAR THE AREA AT THE BASIN OUTLET AS A RESULT OF FLOOD WATERS ON THE BANK. 4/16/04

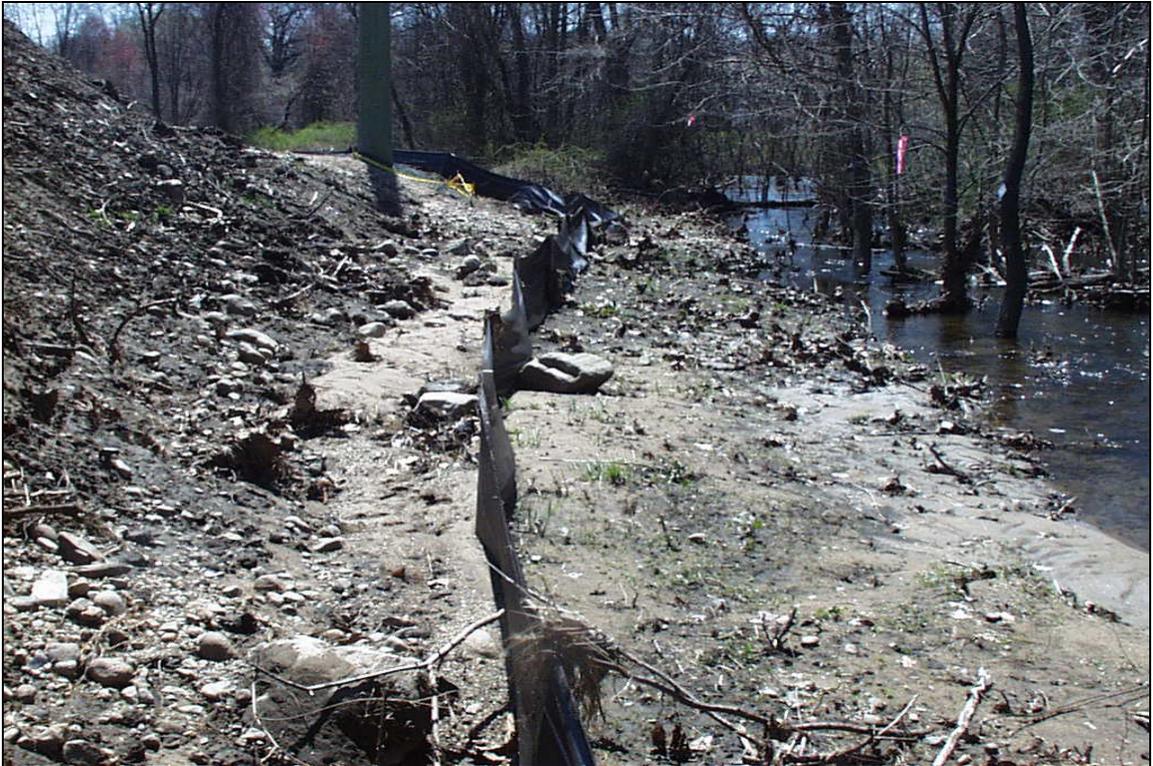
FLOOD WATERS HAD COME OVER THE SILT FENCE BEHIND THE STOCKPILE. SOME SAND/SEDIMENTATION TOOK PLACE AT THE BANK. 4/16/04

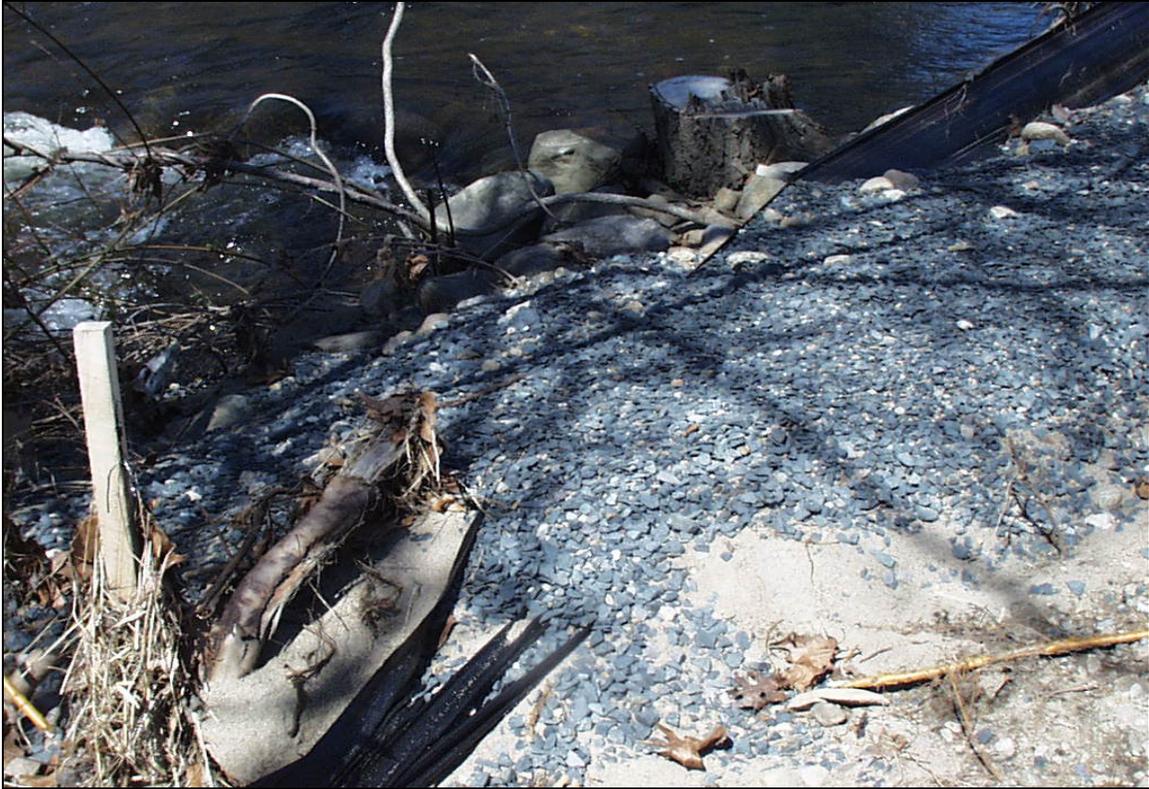
GRAVEL FROM A POLE/CASSION FOUNDATION HAD MIGRATED OVER THE SILT FENCE. IT SHOULD BE SHOVELED BACK TO THE WORK SIDE BY HAND. 4/16/04

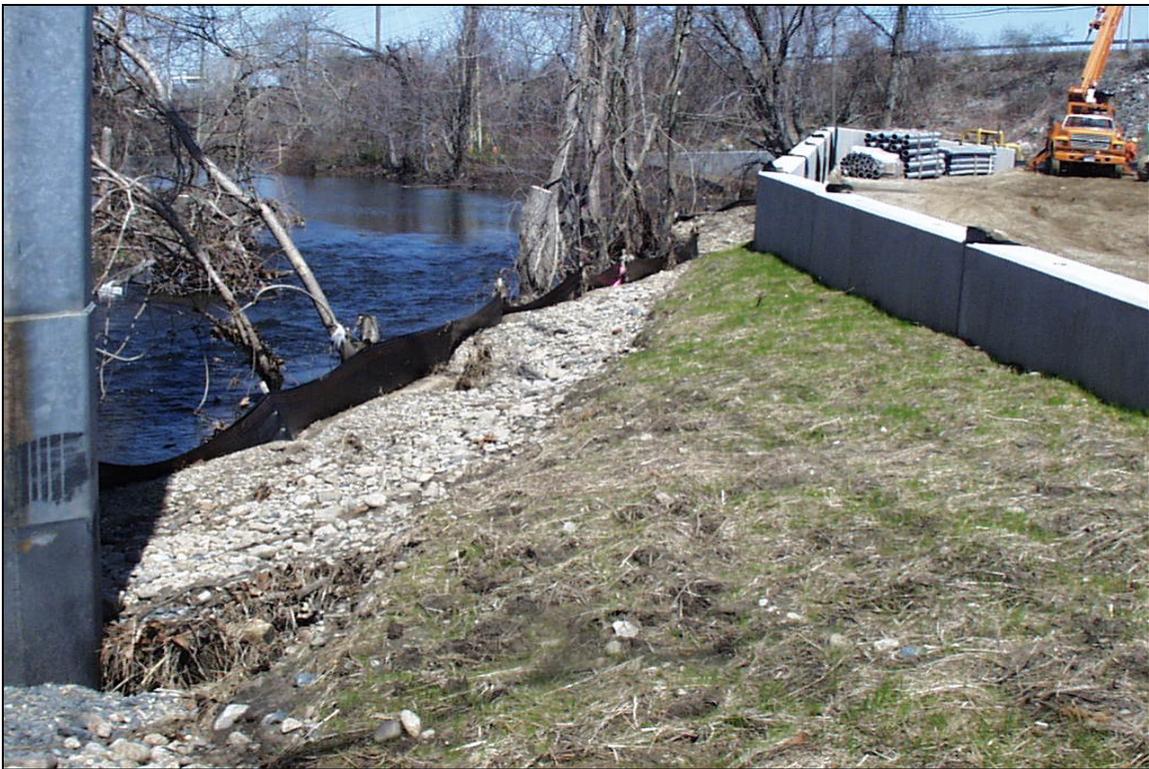
VIEW OF THE SCOURED AREA NEAR WALL #4. SEVERAL INCHES OF TOPSOIL WERE WASHED AWAY BY FLOODWATERS. 4/16/04

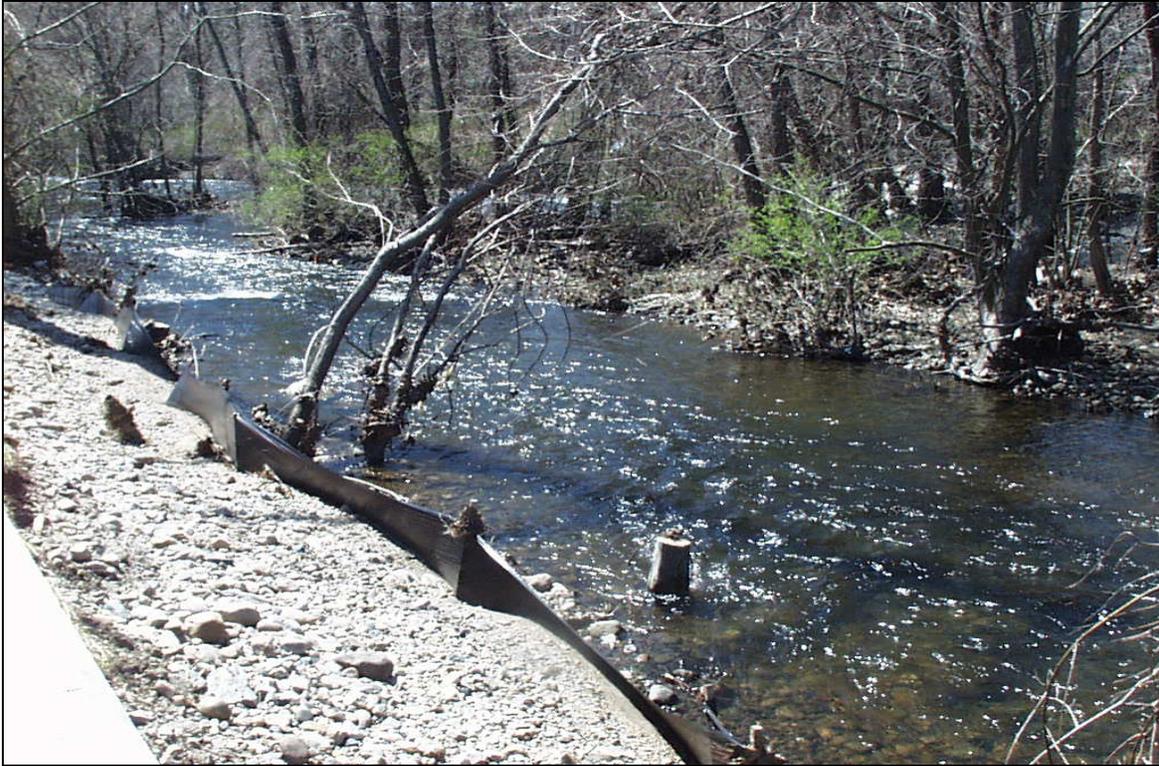
VIEW BEHIND WALL #4 AT THE SCOURED AREA. THE FLOODED AREA IN THE BACKGROUND USUALLY SERVES AS A DRY, OVERFLOW CHANNEL TO THE MAIN RIVER.
4/16/04

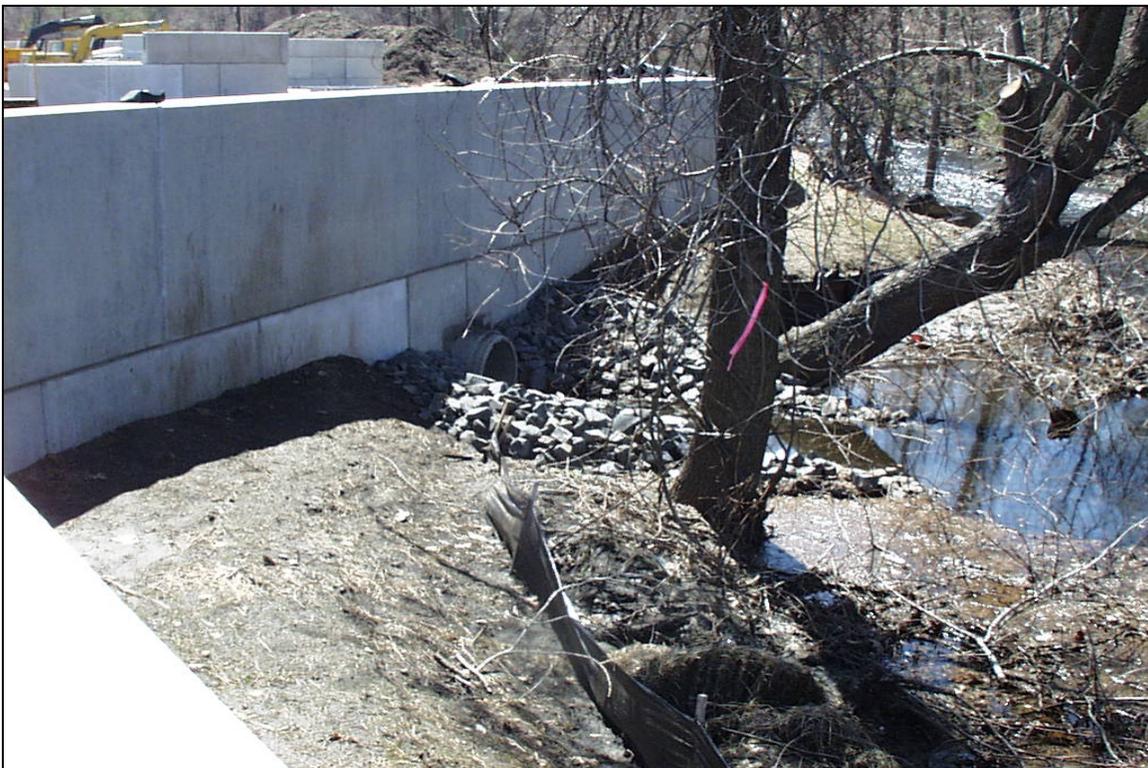
AREAS NEAR THE OUTLET HELD UP WELL. THE FLOOD WATERS DID NOT DISPLACE MUCH SOIL FROM THIS SIDE. 4/16/04

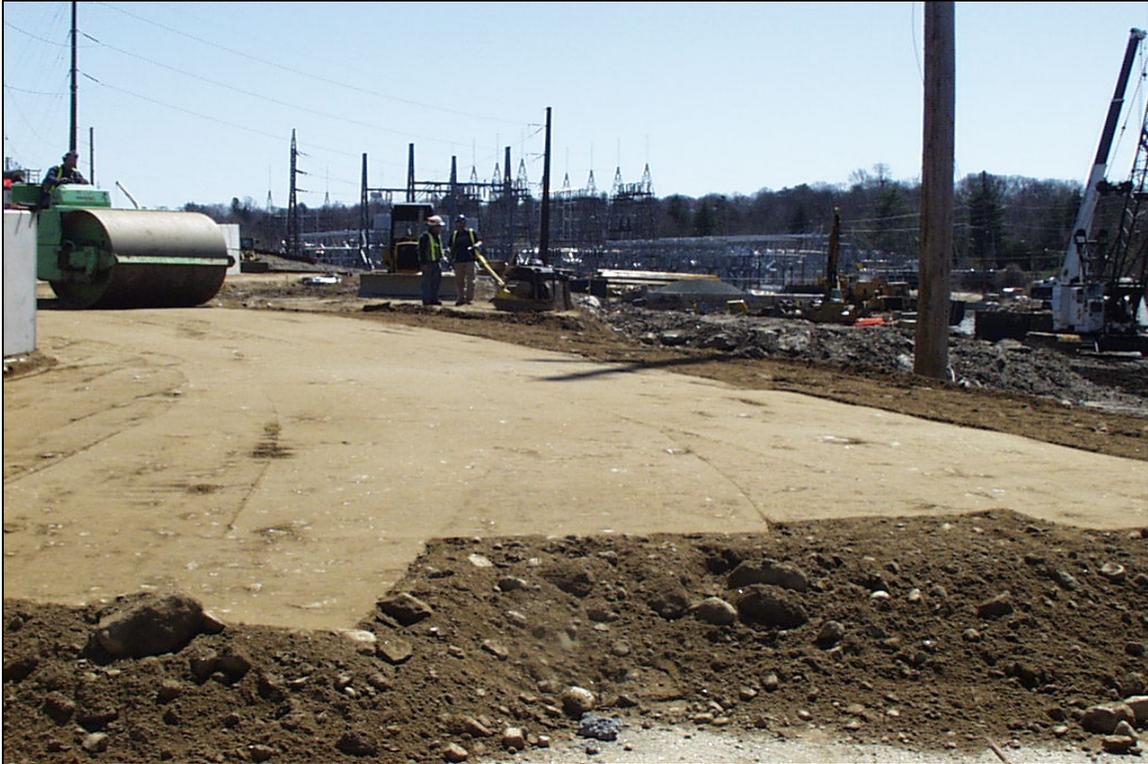
AREA BEING SMOOTHED AND GRADED FOR A FUTURE PARKING AREA . THIS WAS THE PREVIOUSLY EXCAVATED AREA, NOW BROUGHT TO GRADE. 4/16/04

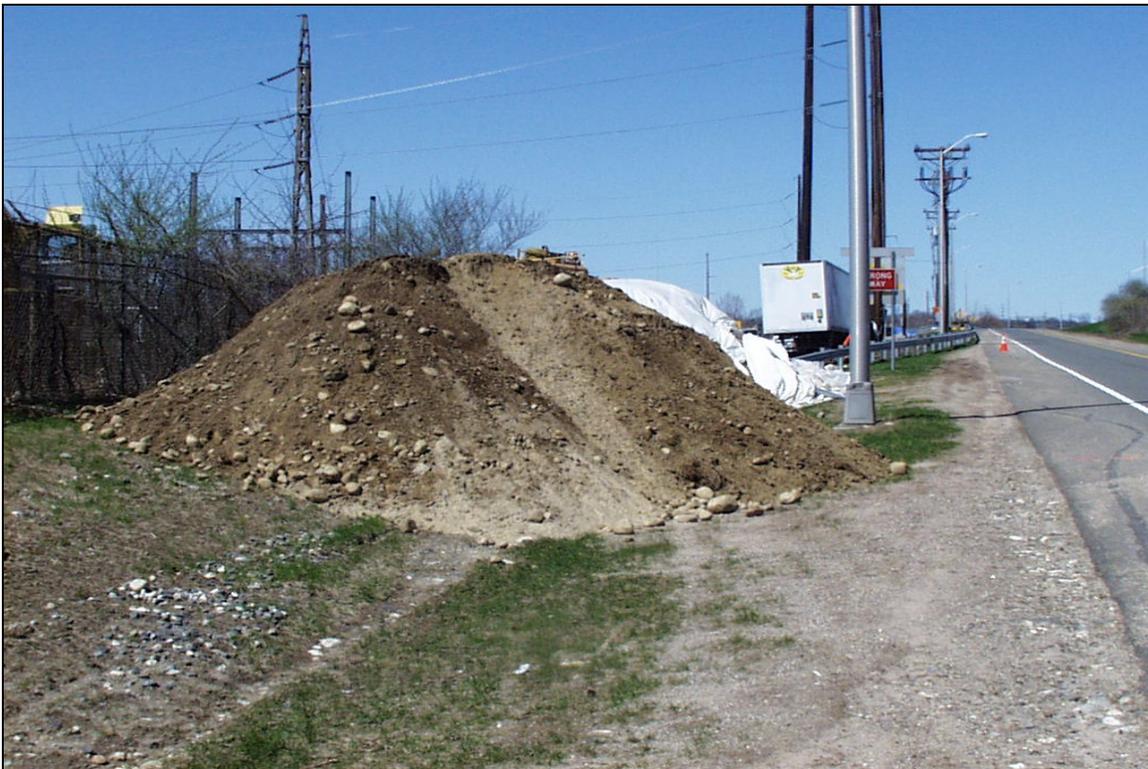
A SECOND STOCKPILE NEAR THE ROUTE 7 RAMP SHOULD BE COVERED IN PLASTIC LIKE THE PREVIOUS ONE OR PLACED WITH A FEW HAYBALES TO PREVENT ROADWAY SEDIMENTATION.
