**Docket No. 217 – Development and Management Plan Inspection**

Northeast Utilities Service Company Certificate of Environmental Compatibility and Public Need for the construction of a 345-kV electric transmission line and reconstruction of an existing 115-kV electric transmission line between Connecticut Light and Power Company's Plumtree Substation in Bethel, through the towns of Redding, Weston, and Wilton, and to the Norwalk Substation in Norwalk, Connecticut.

**Norwalk Substation**

**Date:** April 19, 2006

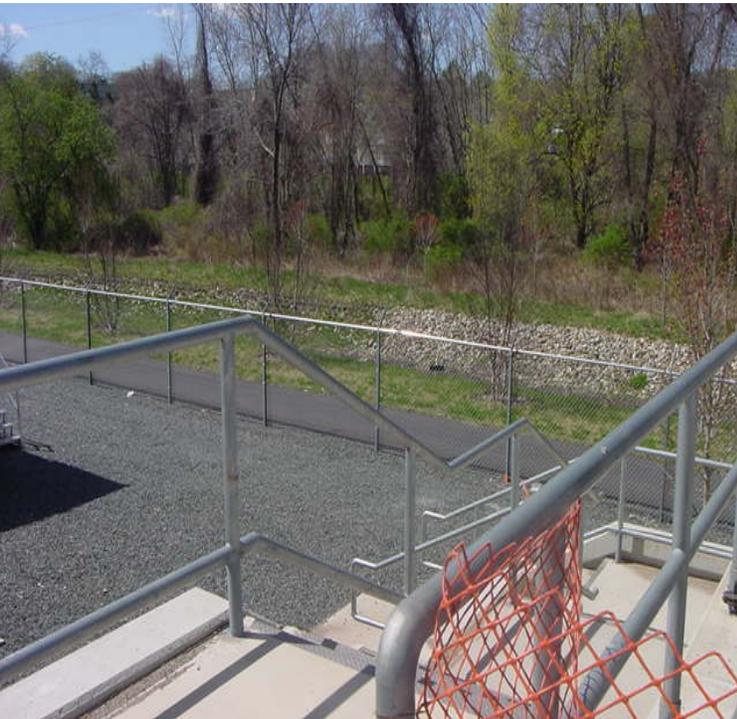
Norwalk Substation: Photo on the left shows a view of the overflow channel. The channel had no flow as the Norwalk River levels appear low. Photo on the right shows a general view of the bays adjacent to the GIS building. 4/19/06.

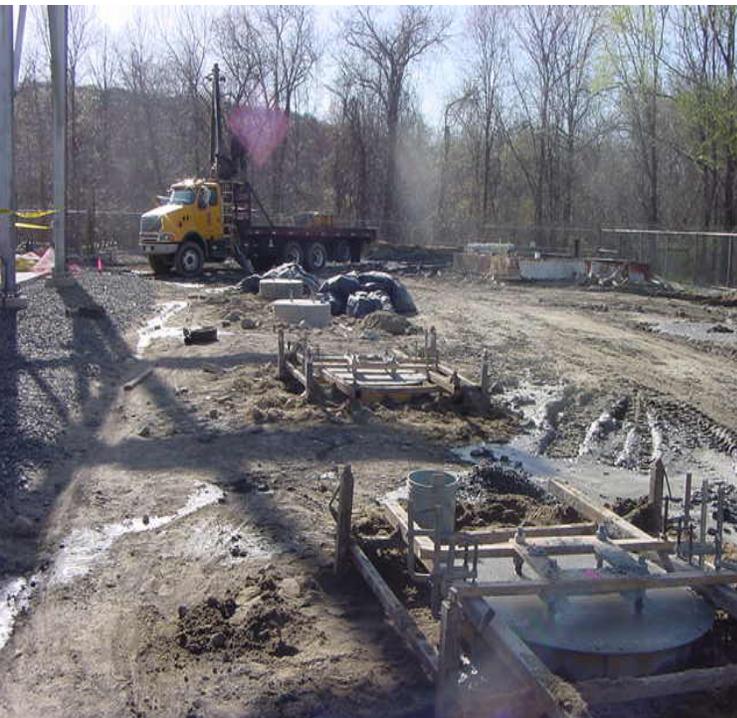
Plumtree Substation: Photo on the left shows work continuing within the substation yard on foundations and excavations. Photo on the right shows the rear of the substation yard. Standing water from dewatering efforts remain contained on site at this time. 4/19/06.
