Docket No. 217 – Development and Management Plan Inspection

Northeast Utilities Service Company Certificate of Environmental Compatibility and Public Need for the construction of a 345-kV electric transmission line and reconstruction of an existing 115-kV electric transmission line between Connecticut Light and Power Company’s Plumtree Substation in Bethel, through the towns of Redding, Weston, and Wilton, and to the Norwalk Substation in Norwalk, Connecticut.

Date: April 20, 2005

Location: Norwalk Substation Expansion

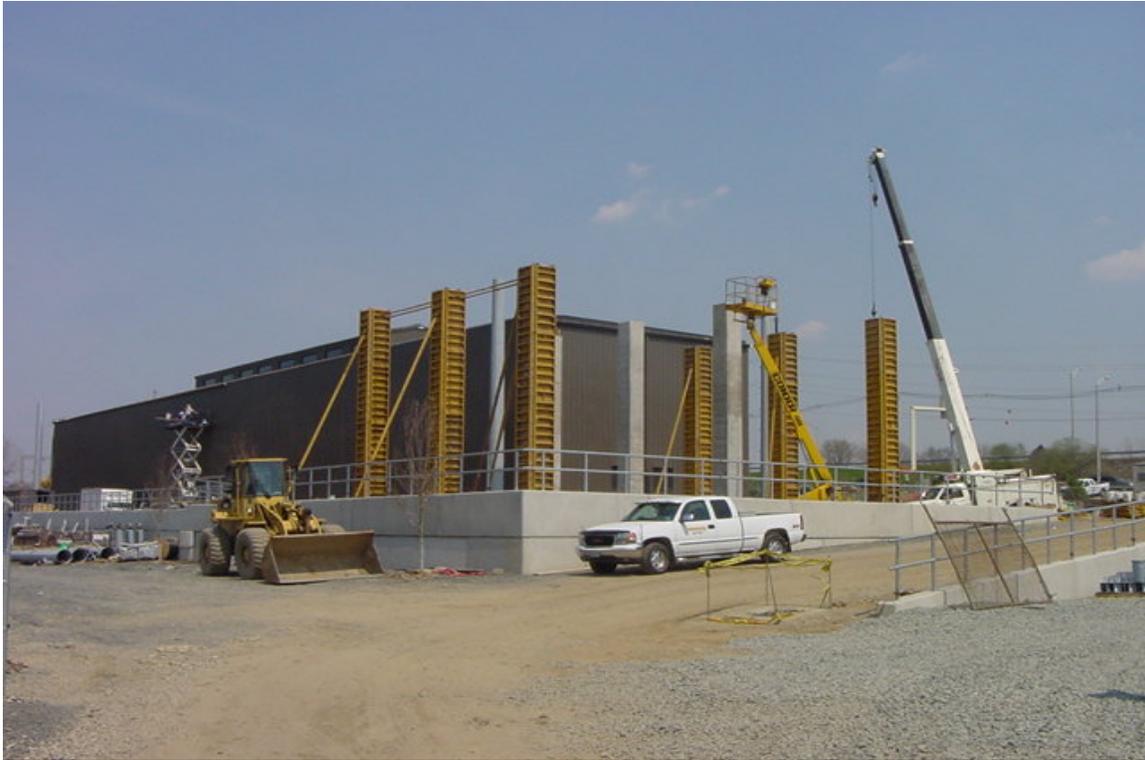
| Areas of Inspection | Observation | Recommended Action |
|---|---|--|
| <p>Foundation construction</p> | <ul style="list-style-type: none"> -Siding work for the GIS building is mostly complete. 4/20/05 -Work on the structures near retaining wall #3 and the | <ul style="list-style-type: none"> - None at this time. 4/20/05 - Soil stockpiles are well |

Norwalk Substation: Structure work continues near retaining wall #3 and the GIS building.
(4/20/05)

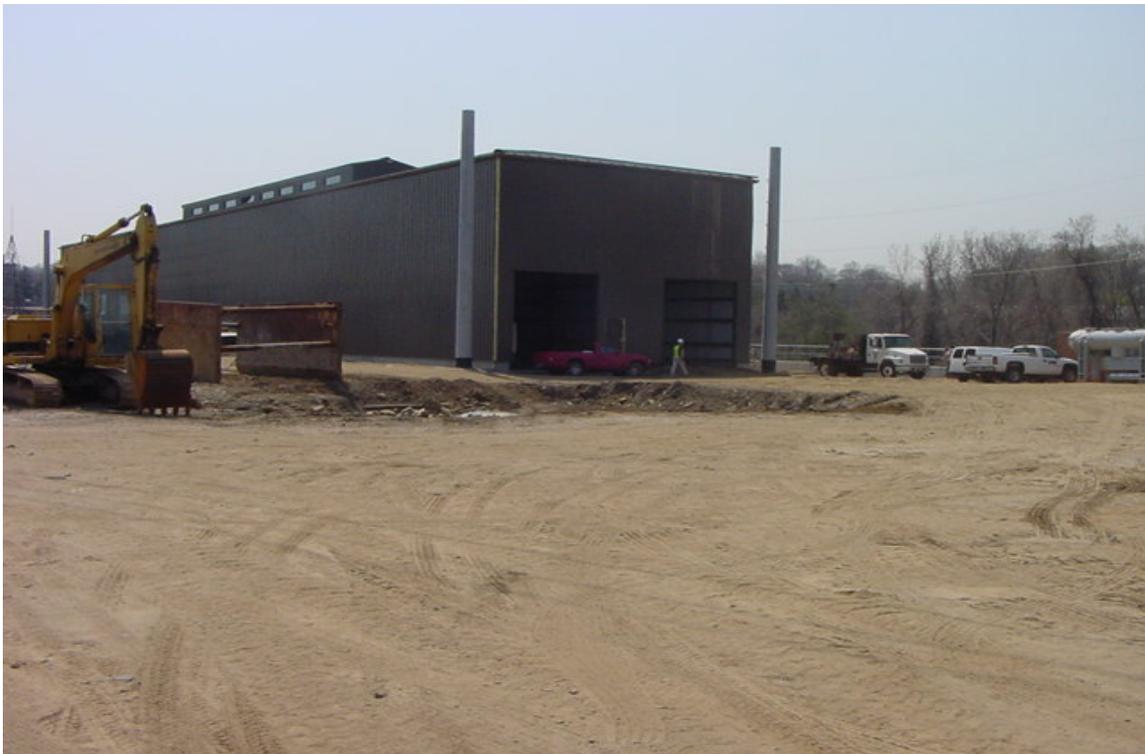
Siding work is completed for the most part on the GIS Building. Site conditions remain fairly dry.
(4/20/05)

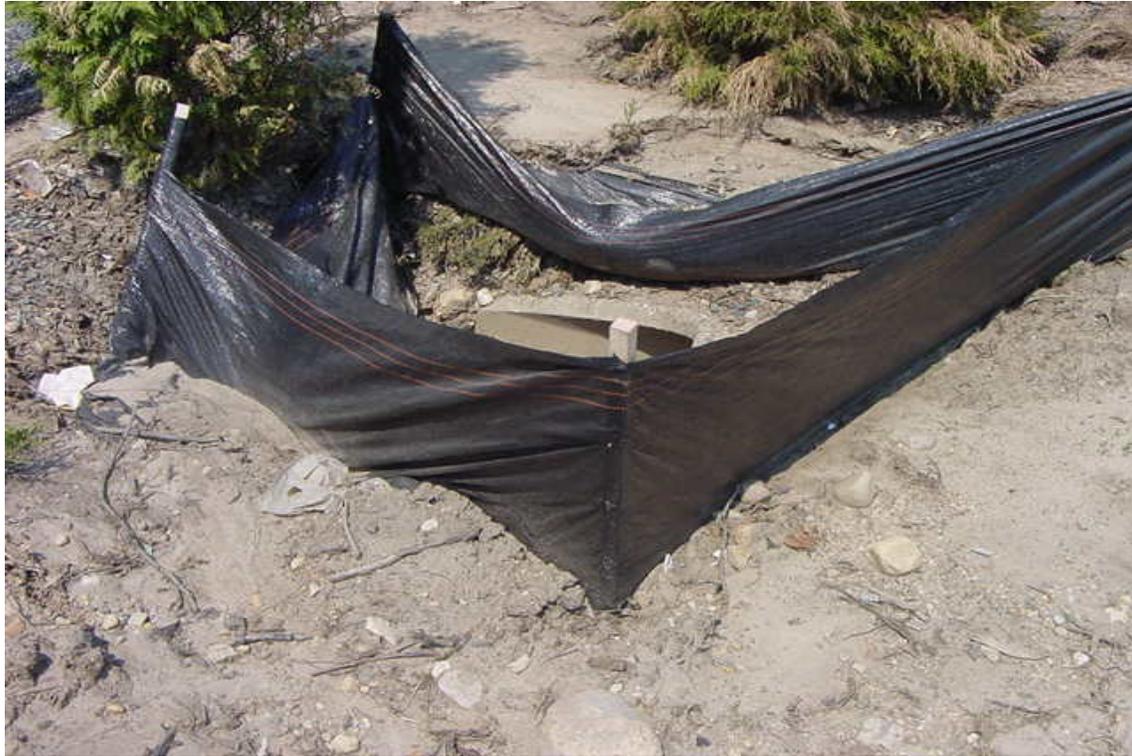
| Areas of Inspection | Observation | Recommended Action |
|---|--|--|
| | - The flared inlet near the Rt 7 ramp is receiving obvious stormwater flows from off site roadway and on site sources. It is apparent that much of the sediment is roadway sand and much of the runoff is from the street based on presence of gullies. The silt fence was partially repaired but erosion and washouts are occurring at the base. 4/13-4/20/05 | - Continue to monitor until stabilized as the surrounding area is still bare soil. Part of the sedimentation is from offsite street runoff which cannot be controlled by onsite actions. The best solution here is revegetation in the growing season. 4/6-4/20/05 |

Inlet located at Route 7 Ramp. This area should be stabilized with vegetation as soon as possible within the growing season. (4/20/05)

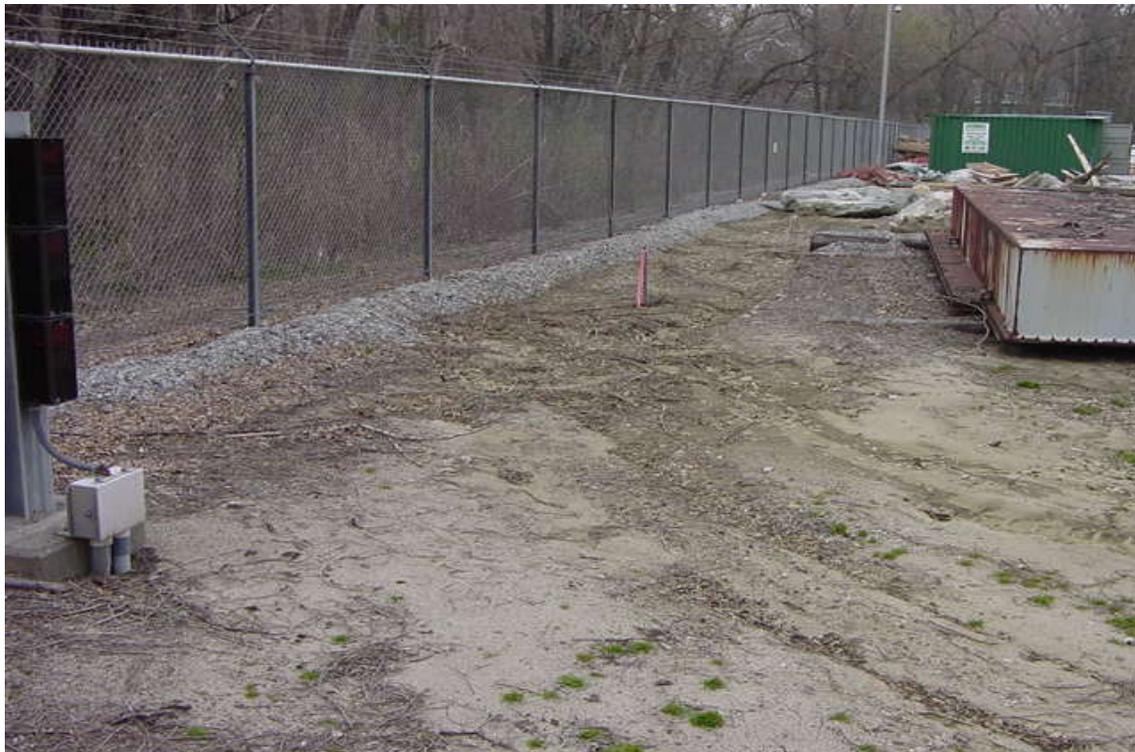
| Areas of Inspection | Observation | Recommended Action |
|---|---|---|
| Erosion and Sediment Controls (includes inspection within 24 hours of a storm event) | - The working areas of the site remain dry for the most part. The perimeter stone berm continues to work well. 4/20/05 | -Nothing at this time. 4/20/05 |

Plumtree Substation: The stone berm along the perimeter of Plumtree substation is well in place. (4/20/05)

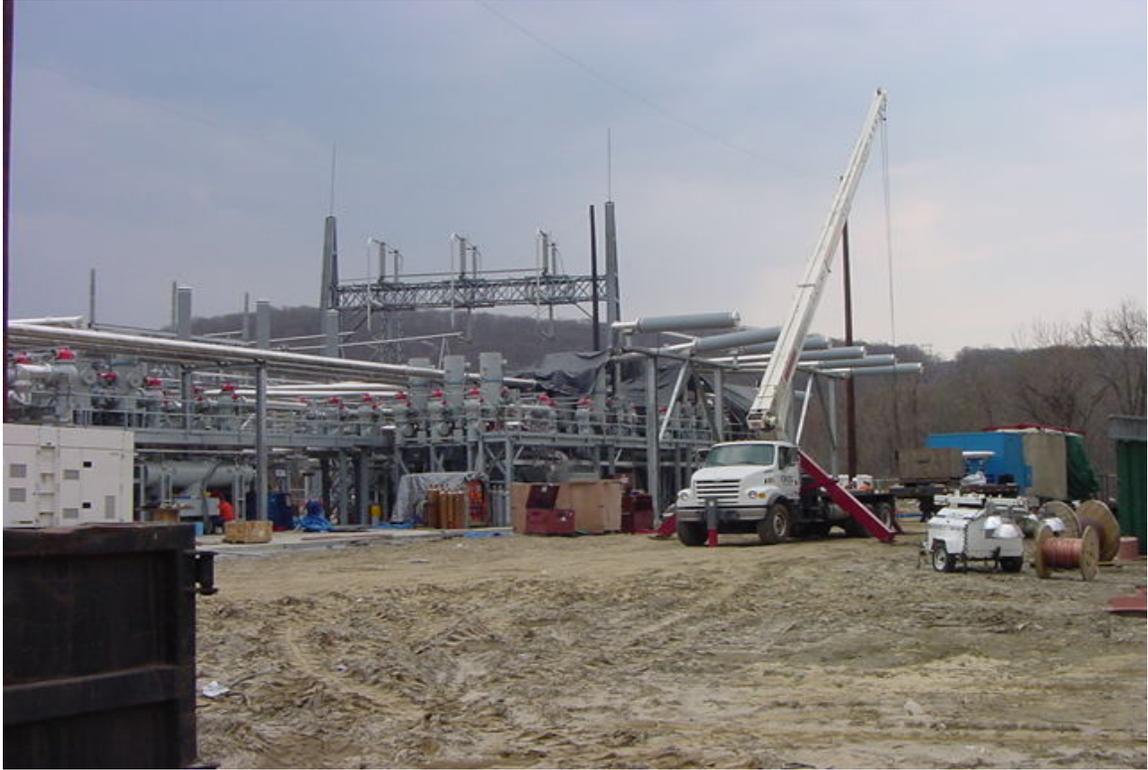
| Areas of Inspection | Observation | Recommended Action |
|---|---|---|
| Foundation construction | -The major work of connecting the equipment on the constructed slab to the existing equipment is on-going. 3/23-4/20/05 | - The areas are all contained at this time and there is little ongoing work that involves soil disturbance. 4/6-4/20/05 |

Internal work continues on slab but almost no soil disturbing work is occurring on site. (4/20/05)
