Docket No. 217 – Development and Management Plan Inspection

Northeast Utilities Service Company Certificate of Environmental Compatibility and Public Need for the construction of a 345-kV electric transmission line and reconstruction of an existing 115-kV electric transmission line between Connecticut Light and Power Company’s Plumtree Substation in Bethel, through the towns of Redding, Weston, and Wilton, and to the Norwalk Substation in Norwalk, Connecticut.

Date: April 21, 2004

Location: Norwalk Substation Expansion

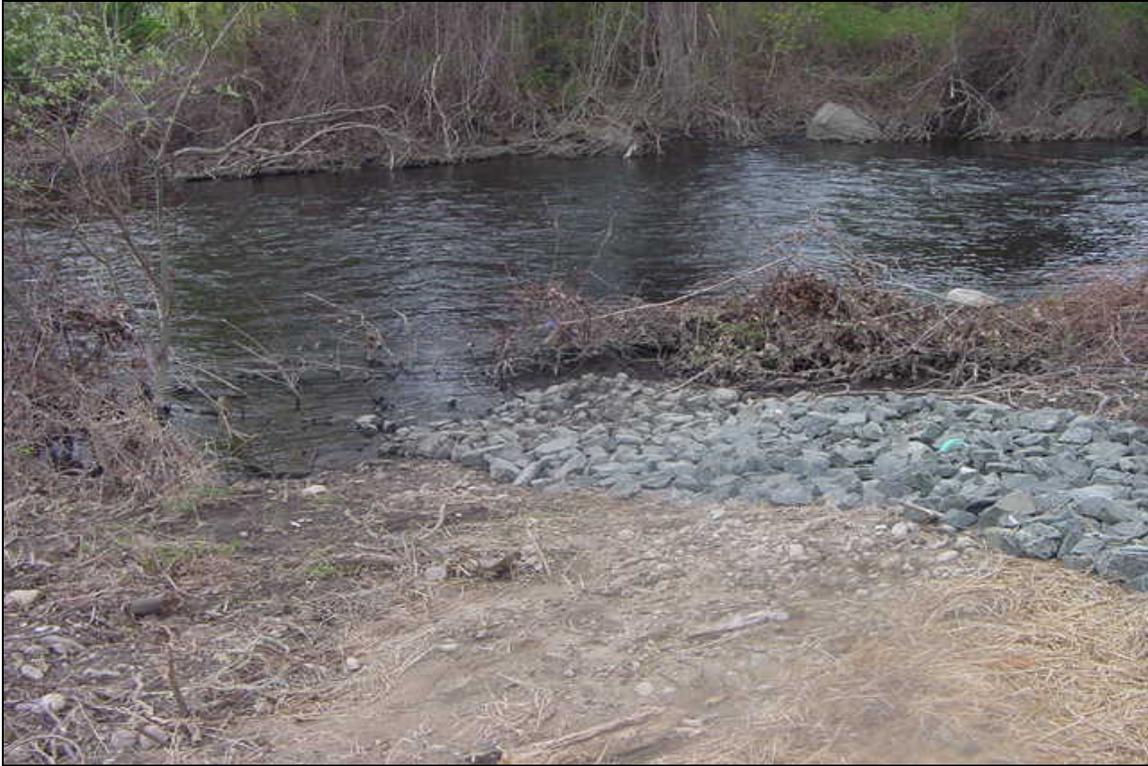
VIEWS OF THE OUTLET FROM THE SEDIMENT BASIN. THE FINE SEDIMENT PLUME IS NO LONGER FLOWING AND THE AREA IS NOT DEMONSTRATING OBVIOUS EROSION. 4/21/04

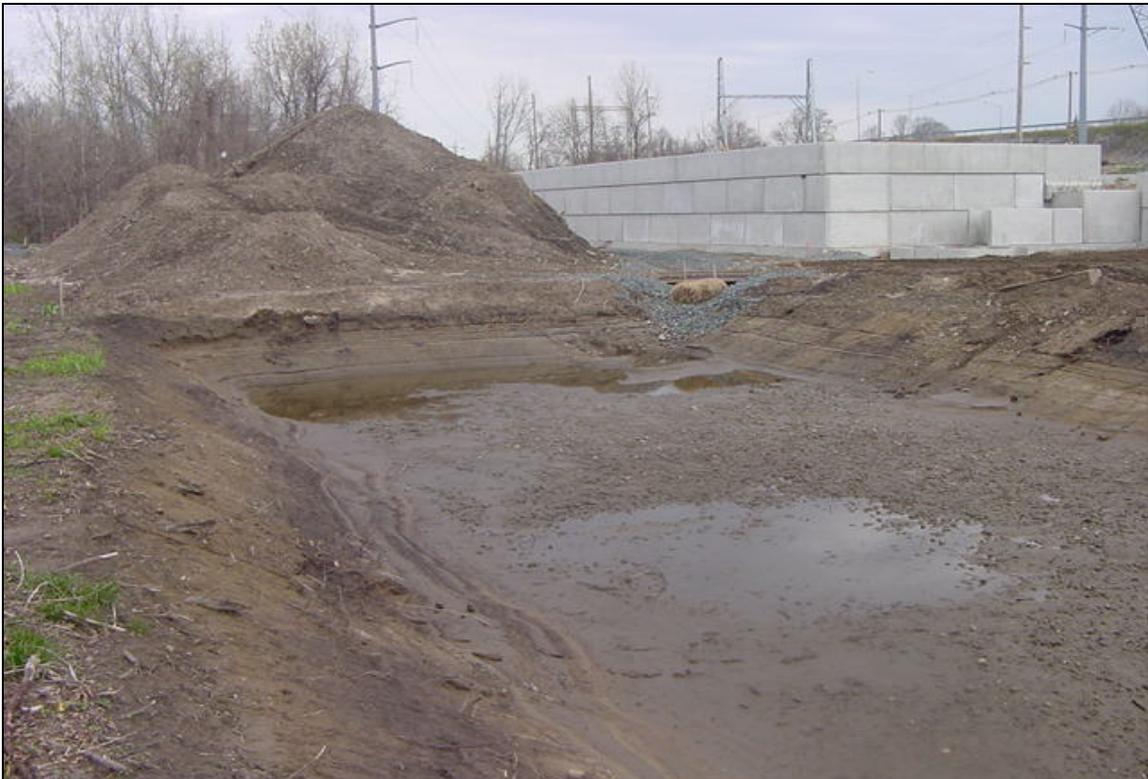
THE BASIN IS DRYING OUT AND SEVERAL INCHES OF MUD/SEDIMENT WERE LEFT BEHIND. SEVERAL AREAS OF MINOR EROSION ARE NOTED ON THE SLOPES. 4/21/04

<p>-. The topsoil stockpile will not be moved but will have to be utilized on site as needed. It remains in place with little migration of soil. 4/21/04</p>	<p>- The pile appears fairly stable but should continue to be monitored. 4/21/04</p>
	<p>- The temporary sediment basin had dried out and a few inches of mud and sediment remained from the stormwater. 4/21/04</p> <p>- Some minor erosion remained along the banks of the basin but nothing structurally degrading. 4/21/04</p>	<p>- If erosion on the slopes of the basin worsens, it should be repaired. 4/21/04</p>

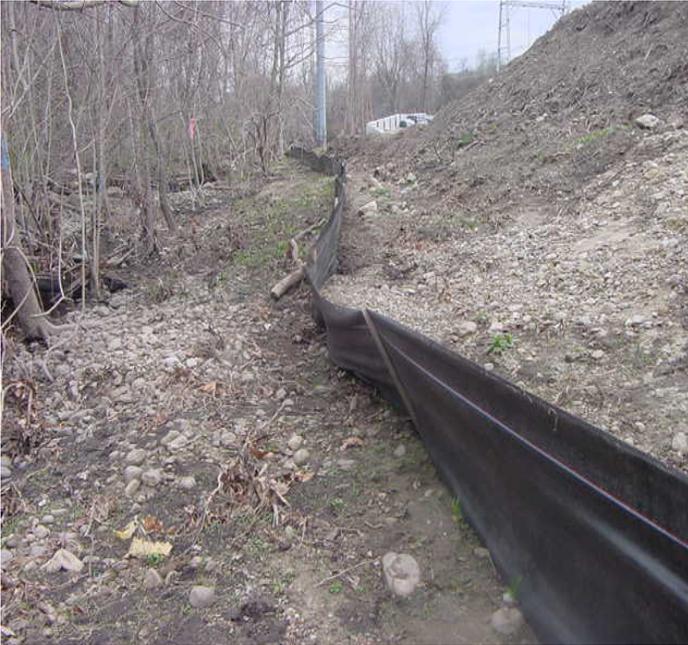
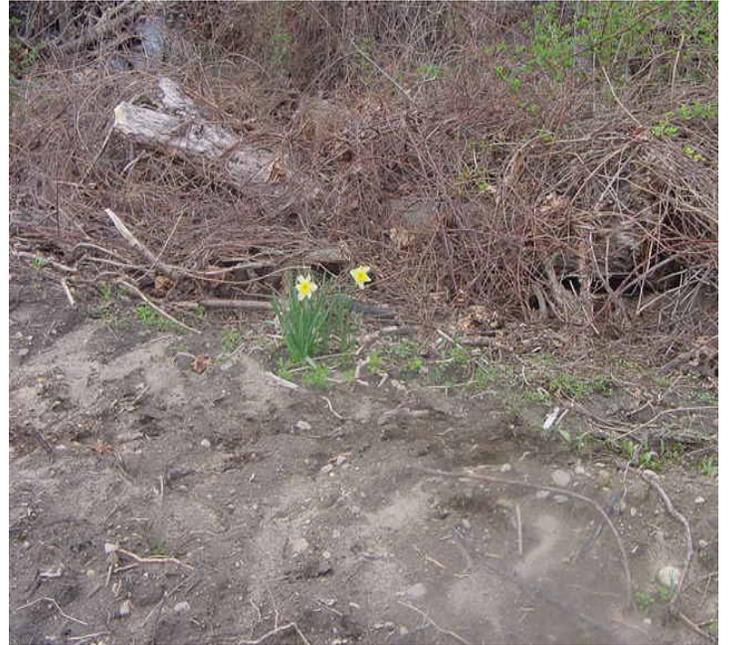
THE SILT FENCE HAS BEEN REPAIRED BELOW THE STOCKPILE AND SEDIMENT IS CONTAINED. SMALL AMOUNTS OF VEGETATION ARE RETURNING, INCLUDING DAFFODILS. 4/21/04

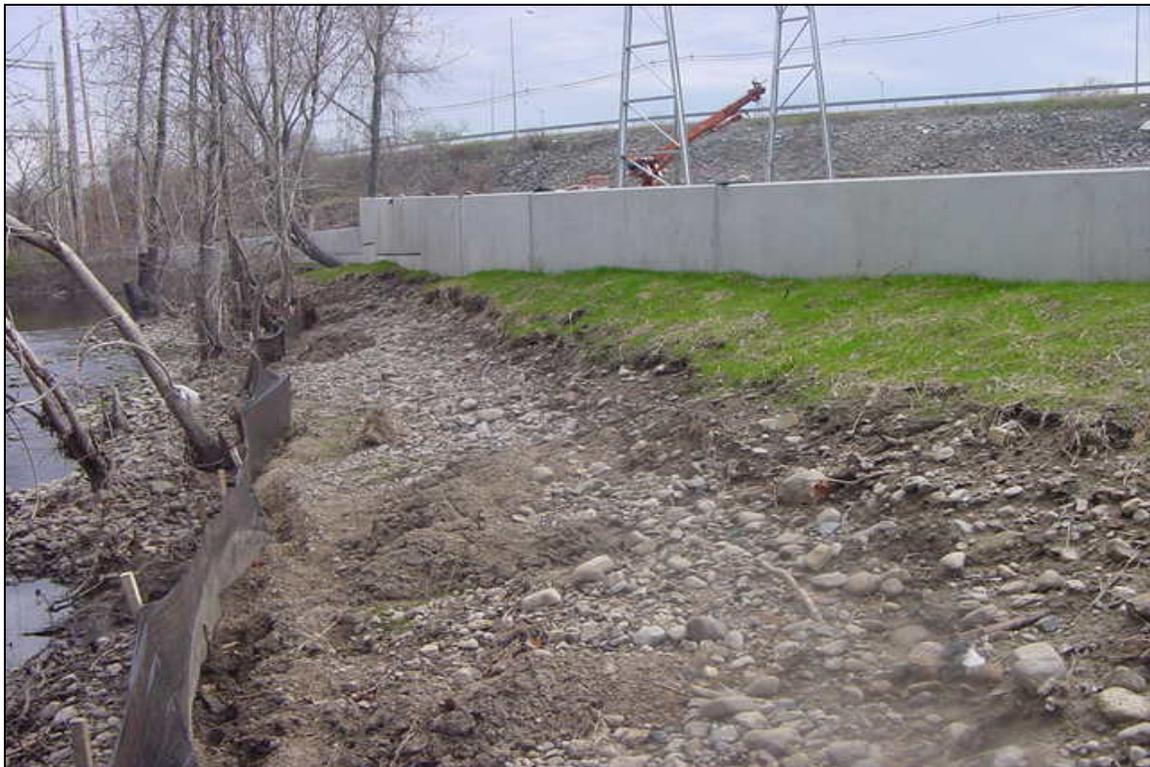
AREA SOUTH OF THE OUTLET WHERE SCOURING WAS MOST SEVERE. OPTIONS FOR STABILIZATION ARE BEING INVESTIGATED. 4/21/04

Areas of Inspection	Observation	Recommended Action
<p>Erosion and Sediment Controls contd.</p>	<ul style="list-style-type: none"> - The areas where the mulch washed away in the flood have not been backfilled and restored yet. Rocky scour remains below the retaining wall #4 on the southernly portion. 4/21/04 - Topsoil and emerging grass remain on the banks on the northernly portion of the bank below the retaining wall. 4/21/04 	<ul style="list-style-type: none"> - Investigate more structural methods for keeping the topsoil in place if a storm of this magnitude occurs again. Under normal conditions, it seems the seeded topsoil would have held. Options for stabilization continue to be investigated. 4/21/04
<p>Inland Wetland and Watercourse encroachment and mitigation</p>	<ul style="list-style-type: none"> - The silt fence has been repaired adequately following the flood event. 4/21/04 - The riprap outlet from the sediment basin is clear of sediment. The mulch that was swept away has not been restored but obvious erosion is not a problem. 4/21/04 - The area below retaining wall #4 on the southern portion remains rocky and scoured following the flood washout. The topsoil remains and vegetation is beginning to grow on the northern end. 4/21/04 	<ul style="list-style-type: none"> - Continue to monitor silt fence and repair as necessary, especially in portions closest to the river. 4/21/04 - Although some plant growth is occurring, prepare to vegetate the banks with additional seeding or planting if necessary. Continue to monitor and repair any erosion. 4/21/04 - Additional methods for stabilization are being investigated. Soil holding grids or coconut fiber logs with live stakings of shrubs are some suggestions BSC has. Riprap or establishment of major root systems may eventually be the only solution that would hold against a flood like this past one. 4/21/04

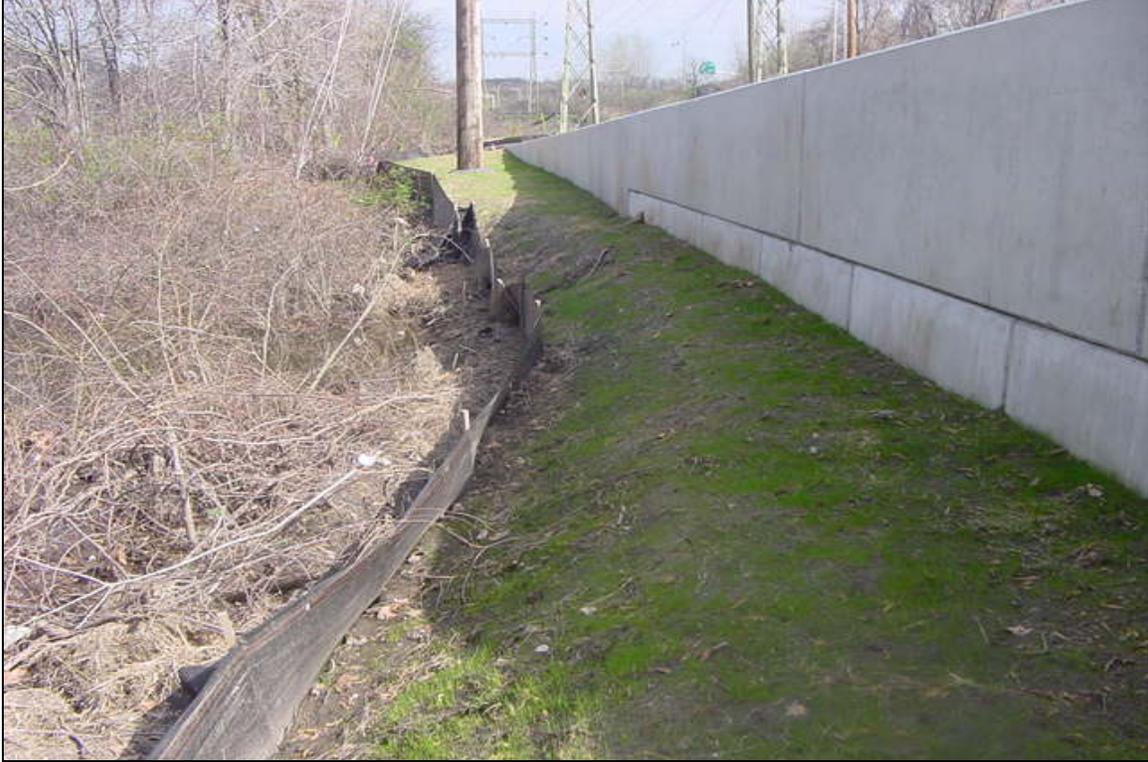
AREA NORTH OF THE OUTLET WHERE EROSION WAS NOT SEVERE AND VEGETATION IS RETURNING TO THE TOPSOIL AREA. 4/21/04

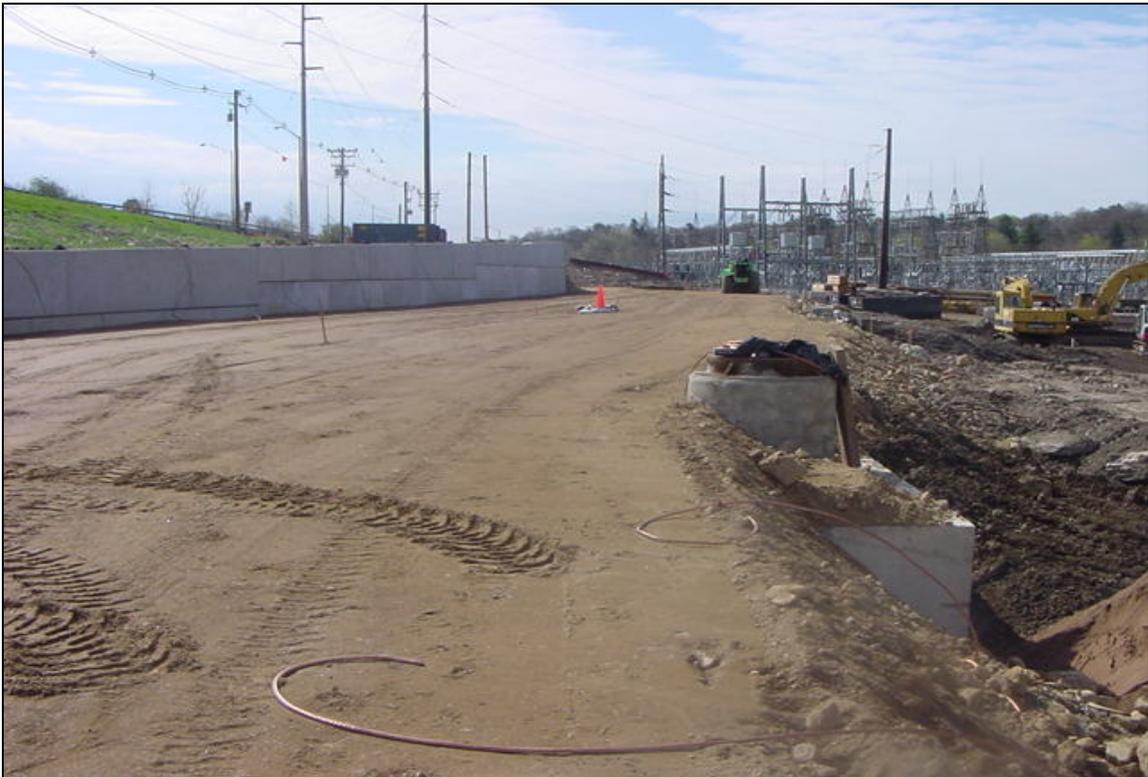
VIEW OF THE PARKING AREA NEARING ITS SUBGRADE. 4/21/04

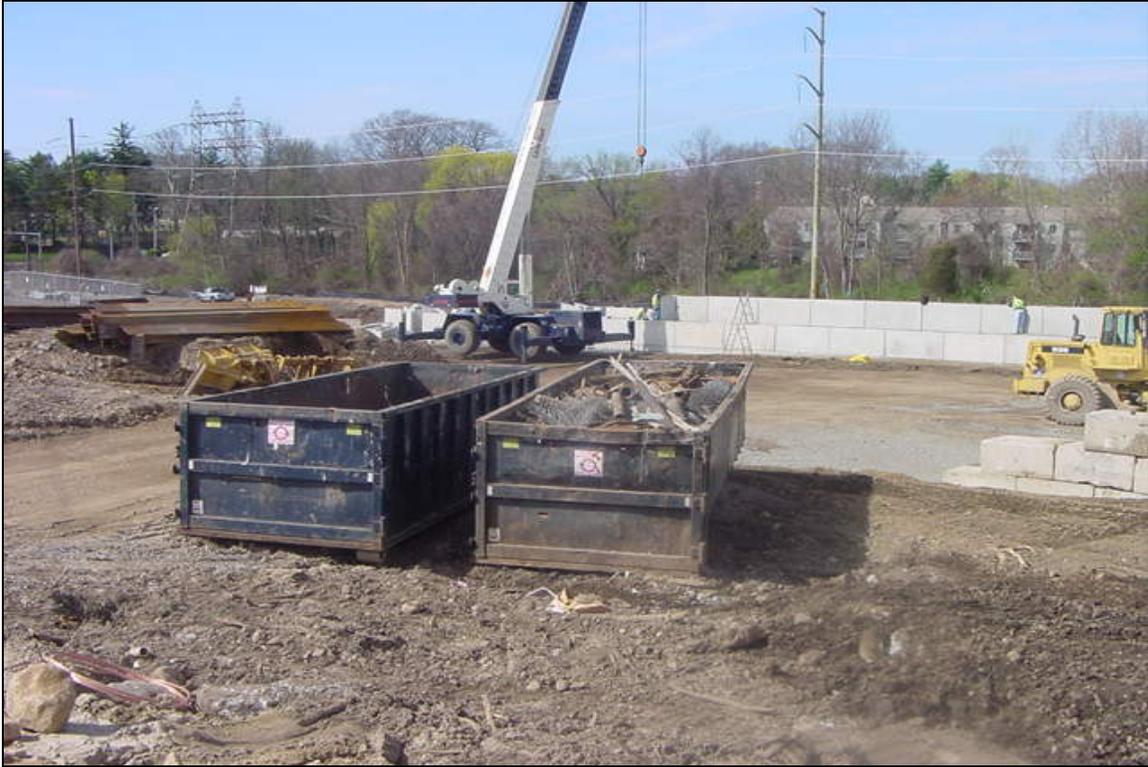
AREA WHERE THE BULKY WASTE HAS BEEN STRAIGHTENED UP AND THE DUMPSTERS WILL BE REMOVED FROM SITE SOON. 4/21/04

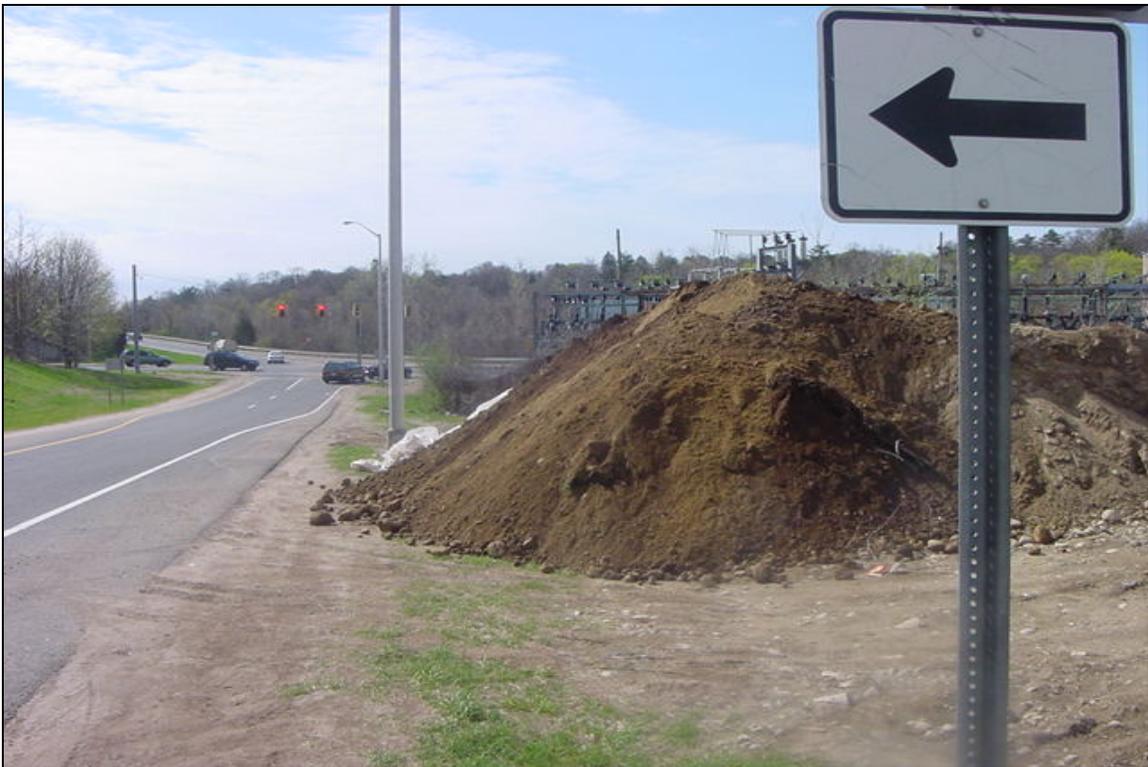
A SECOND STOCKPILE NEAR THE ROUTE 7 RAMP IS BEING COVERED WHEN IT IS NOT IN USE. A BARRIER MAY BE NEEDED TO PREVENT SPILLOVER ON THE ROADWAY. 4/21/04
