Docket No. 217 – Development and Management Plan Inspection

Northeast Utilities Service Company Certificate of Environmental Compatibility and Public Need for the construction of a 345-kV electric transmission line and reconstruction of an existing 115-kV electric transmission line between Connecticut Light and Power Company's Plumtree Substation in Bethel, through the towns of Redding, Weston, and Wilton, and to the Norwalk Substation in Norwalk, Connecticut.

Norwalk Substation

Plumtree Substation

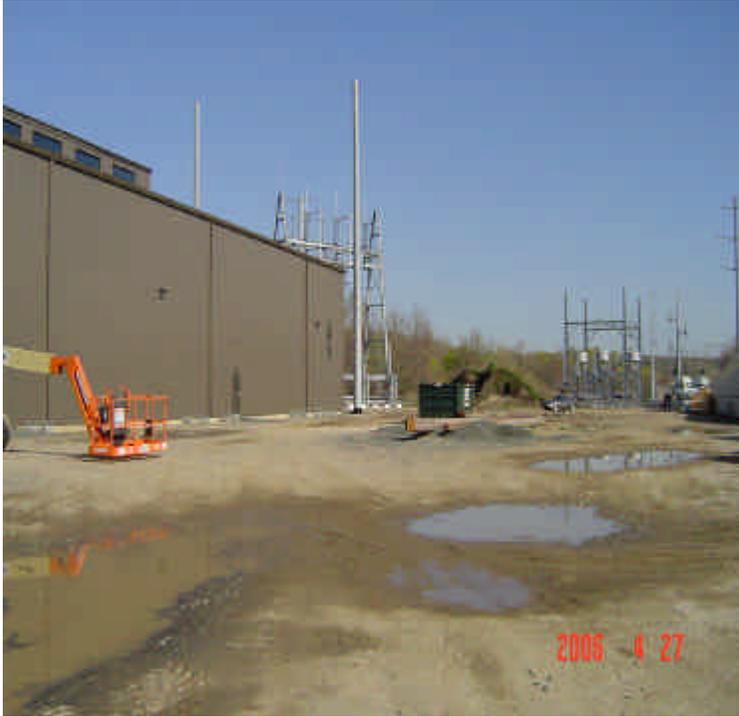
Norwalk Substation: Photo on the left shows an overall view of the yard. Topsoil will be spread adjacent to the building soon. Photo on the right shows a view along the bike path where the flooded river had left leaves along the perimeter fence. 4/26/06.

Additional Observations	- The topsoil stockpile is scheduled to be spread out within the yard near the GIS building. 4/26/06

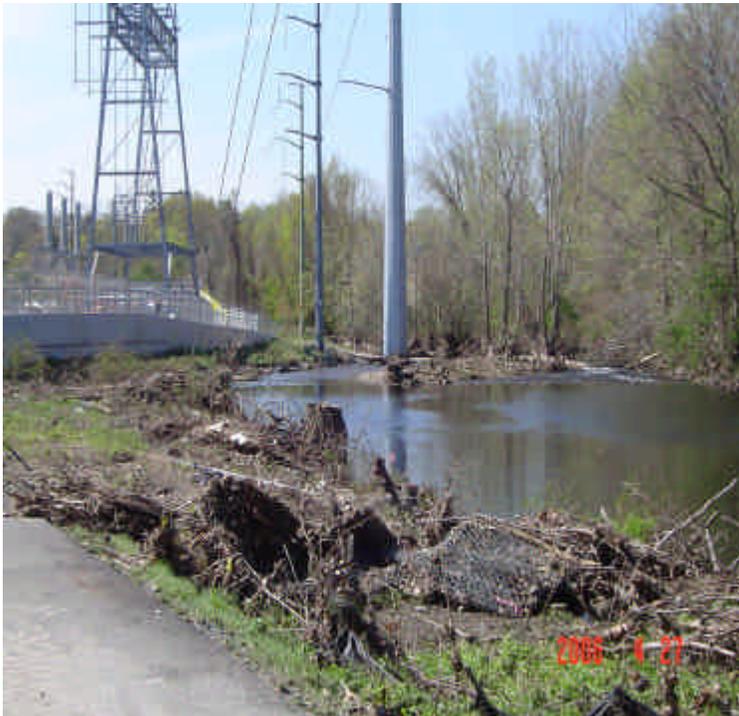
Photo on the left shows the view towards the substation where some clearing had occurred. The flooded river levels created some disturbance here. Photo on the right shows where the flooding caused some erosion along the retaining wall. It will be repaired. 4/26/06.

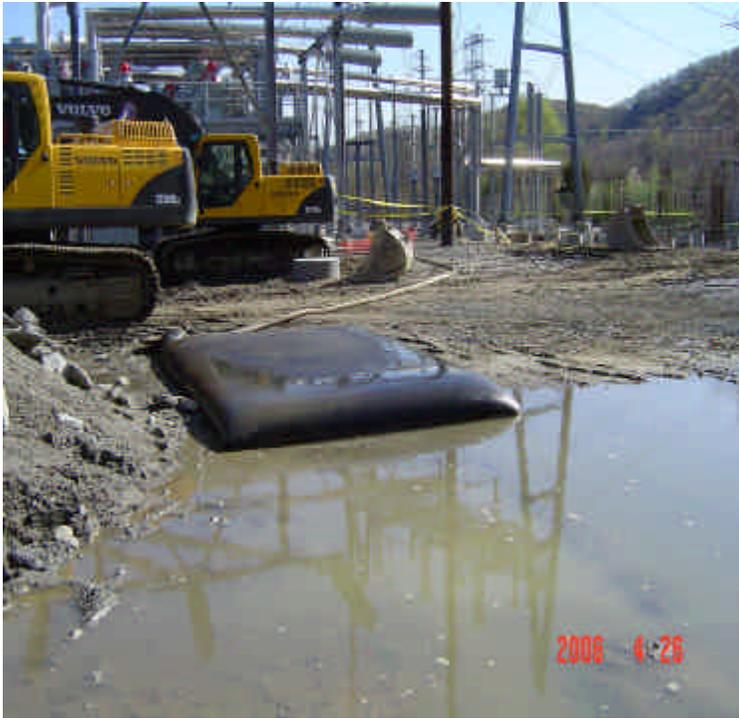
Plumtree Substation: Photo on the left shows dewatering occurring to a filter bag within the yard. Photo on the right shows the ongoing excavation and foundation work on site. 4/26/06.

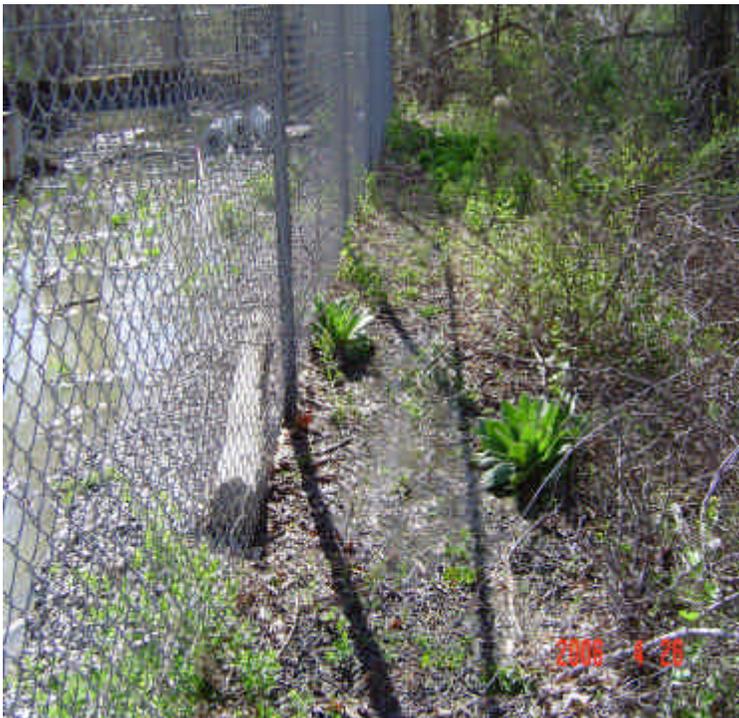
Photo on the left shows some water escaping through the stone perimeter berm from the yard. The water was filtered fairly well but continue to monitor whether additional controls are needed. Photo on the right shows the adjacent wetland where shovels and pails were left behind from the efforts to remove sediment. 4/26/06

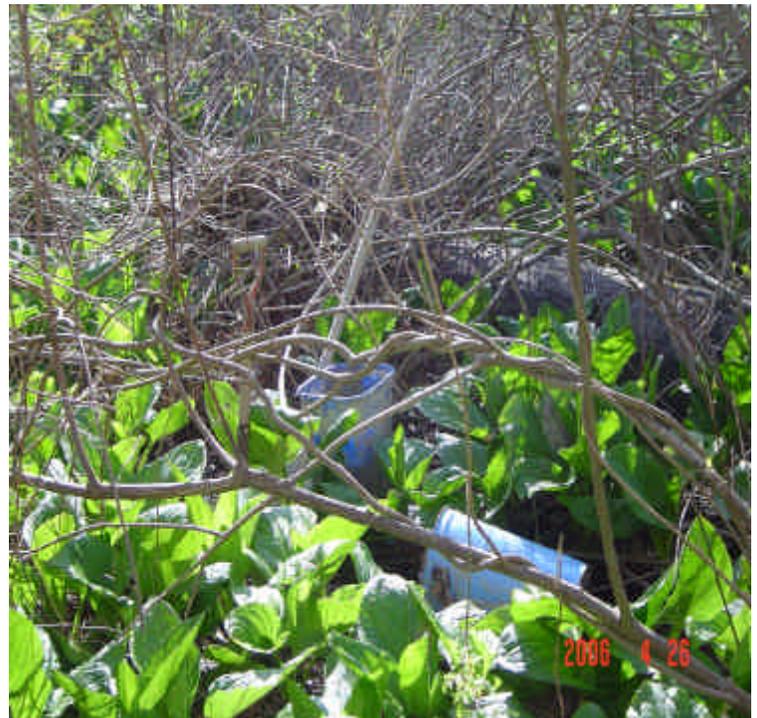
Inland Wetland and Watercourse encroachment and mitigation	- Wetlands are located around the outskirts of the substation yard. -Shovels and pails from the wetland cleanup remained in the wetland. 4/26/06	-Continue to monitor them. Ensure that sediment does not leave the yard. 4/26/06. - The materials should be returned to the station yard. 4/26/06	N/A. - N/A
