**Docket No. 217 – Development and Management Plan Inspection**

Northeast Utilities Service Company Certificate of Environmental Compatibility and Public Need for the construction of a 345-kV electric transmission line and reconstruction of an existing 115-kV electric transmission line between Connecticut Light and Power Company's Plumtree Substation in Bethel, through the towns of Redding, Weston, and Wilton, and to the Norwalk Substation in Norwalk, Connecticut.

**Date:** May 18, 2005

**Location:** Norwalk Substation Expansion

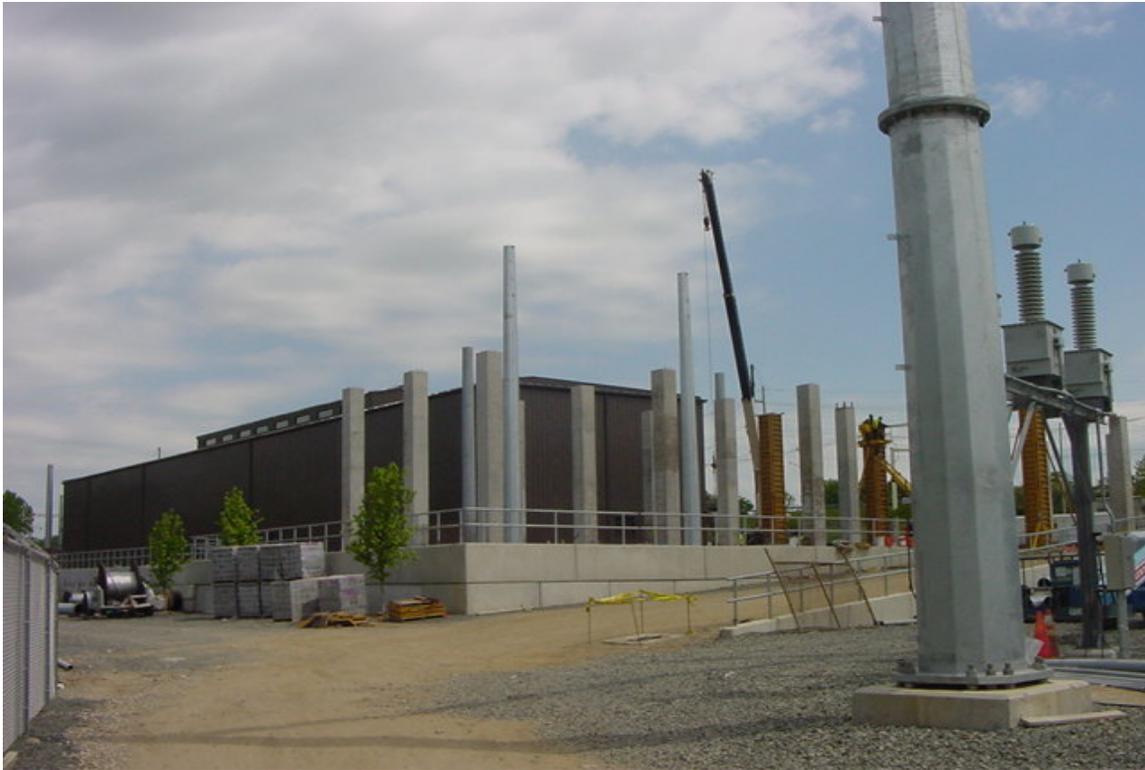
Norwalk Substation-Structure work continues near retaining wall #3 and the GIS building. (5/18/05)

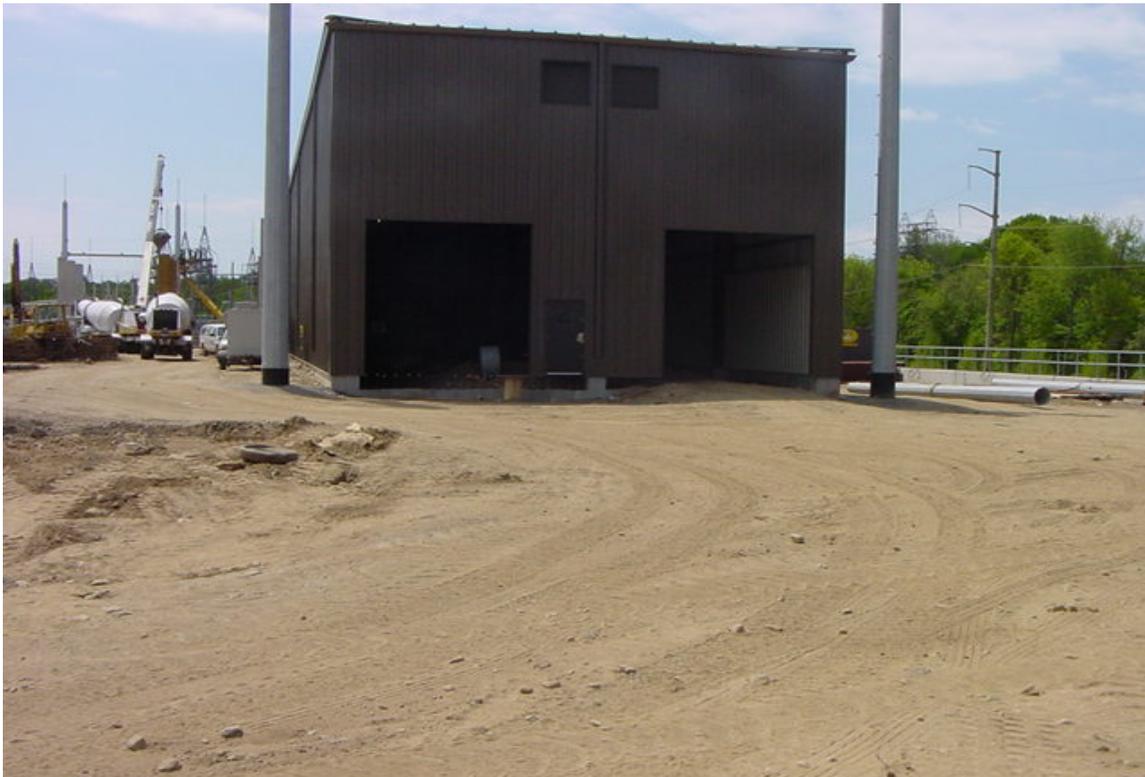
View of the rear of the GIS building where exterior work on the building has been completed. (5/18/05)

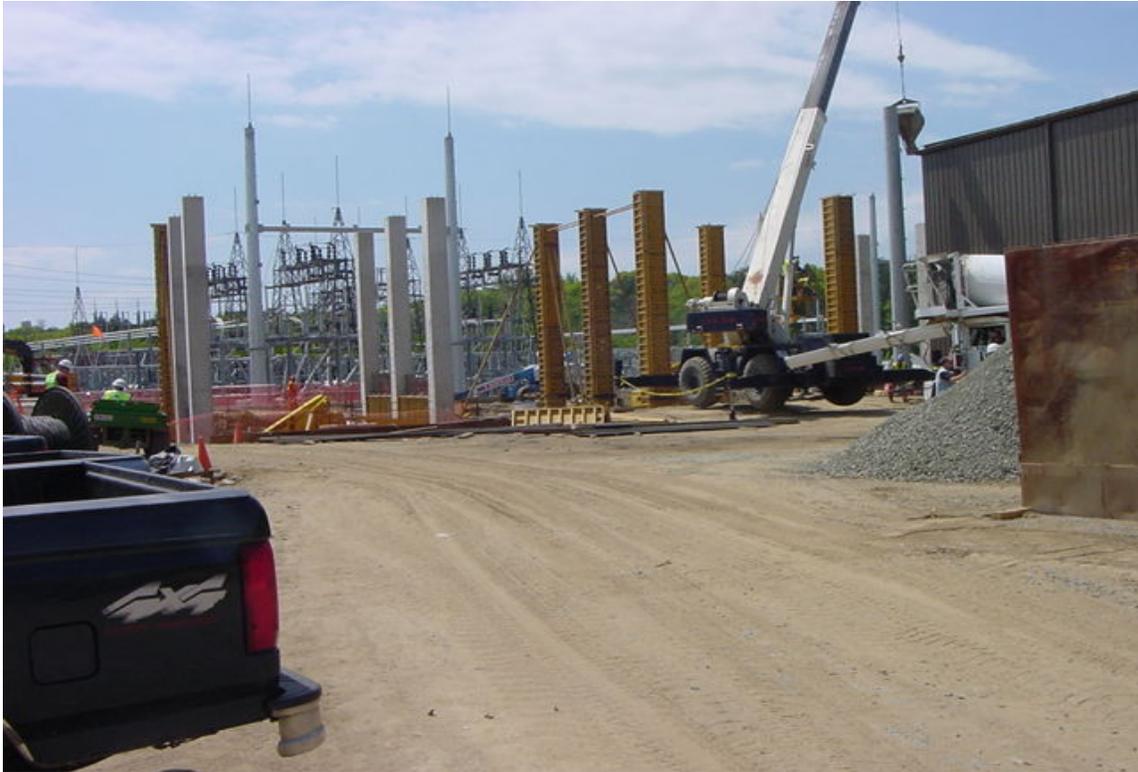
Pouring concrete in the area of GIS Building and the control house. (5/18/05)

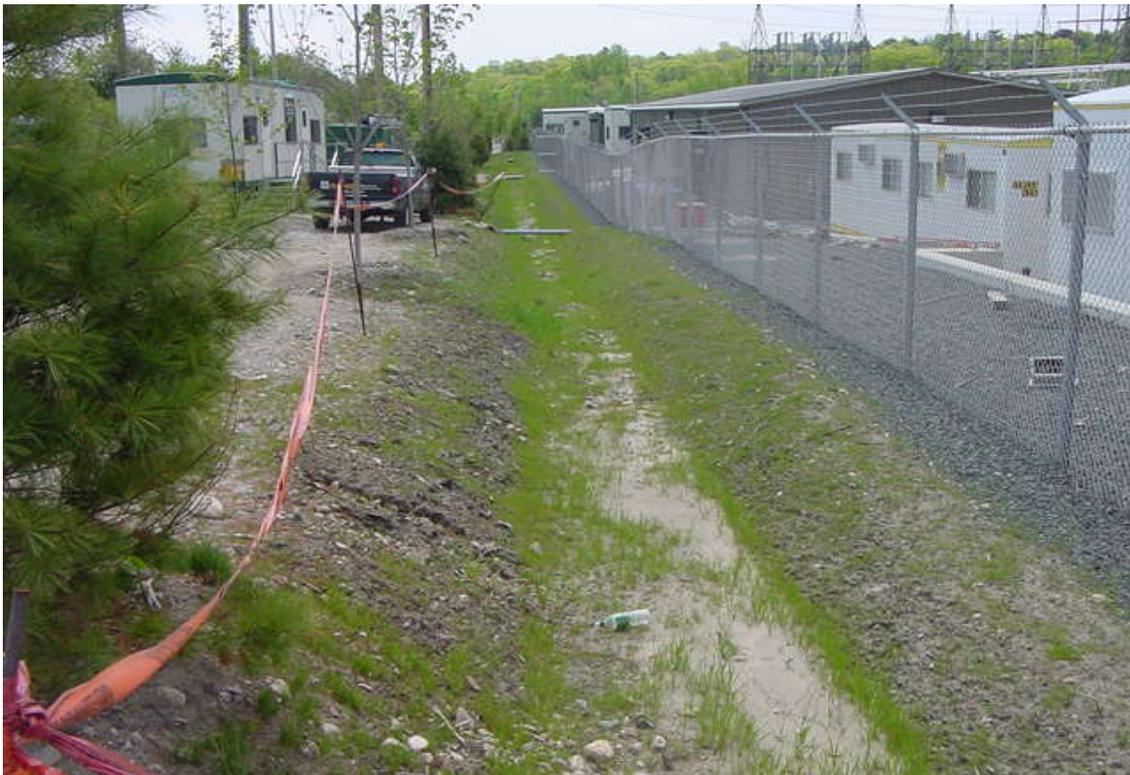
Drainage swale along eastern portion of the site with some vegetative growth. (5/18/05)

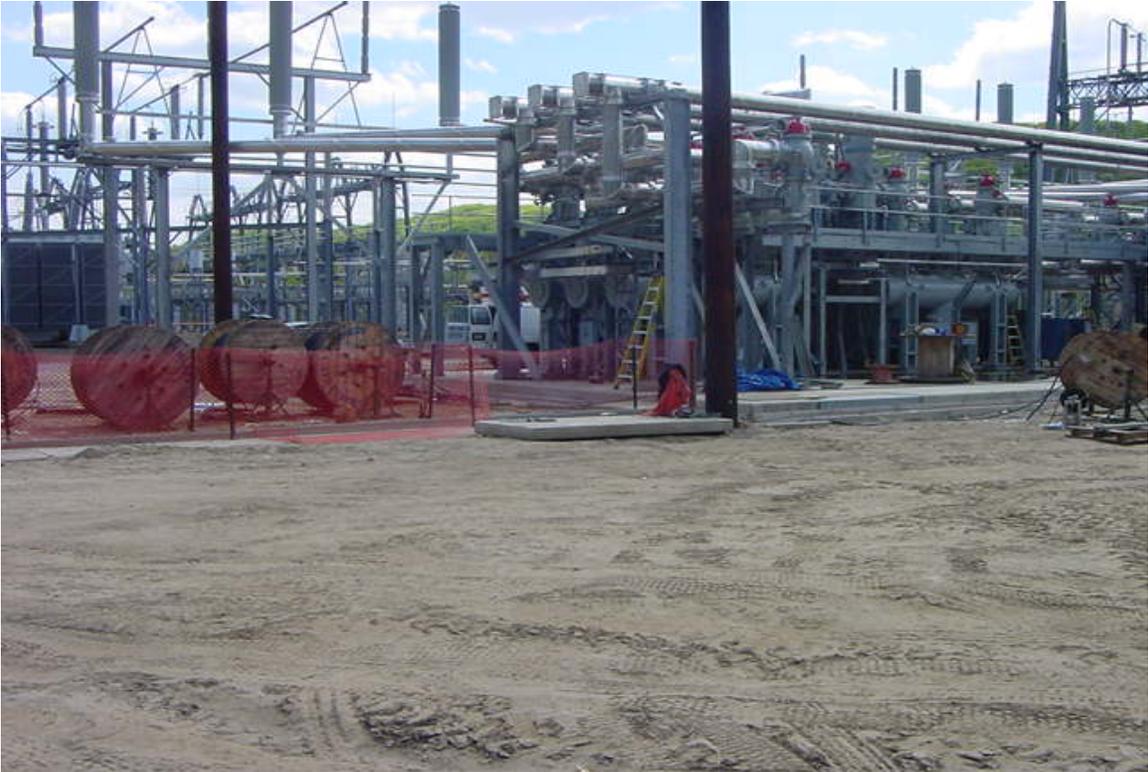
Plumtree Substation- Pulling of underground cables to the slab. (5/18/05)

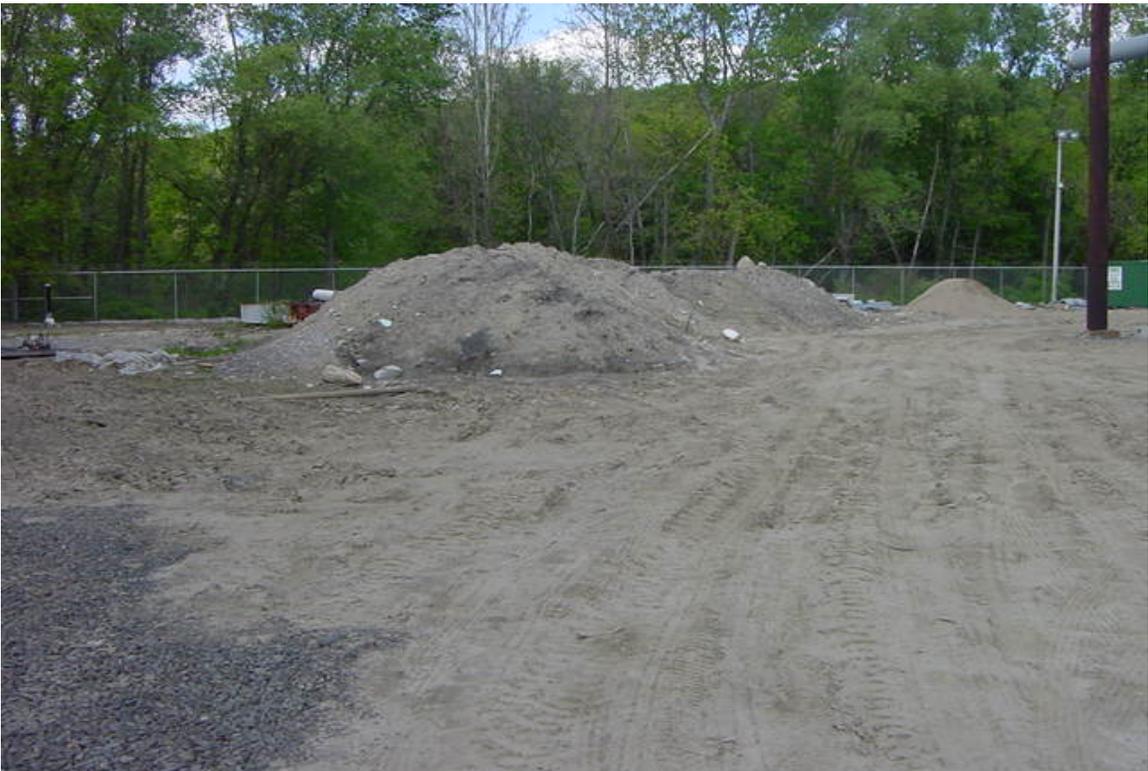
Soil stockpiles that are internal to the site and are contained at this time (5/18/05)
