**Docket No. 217 – Development and Management Plan Inspection**

**Date:** May 20, 2004

**Location:** Norwalk Substation Expansion

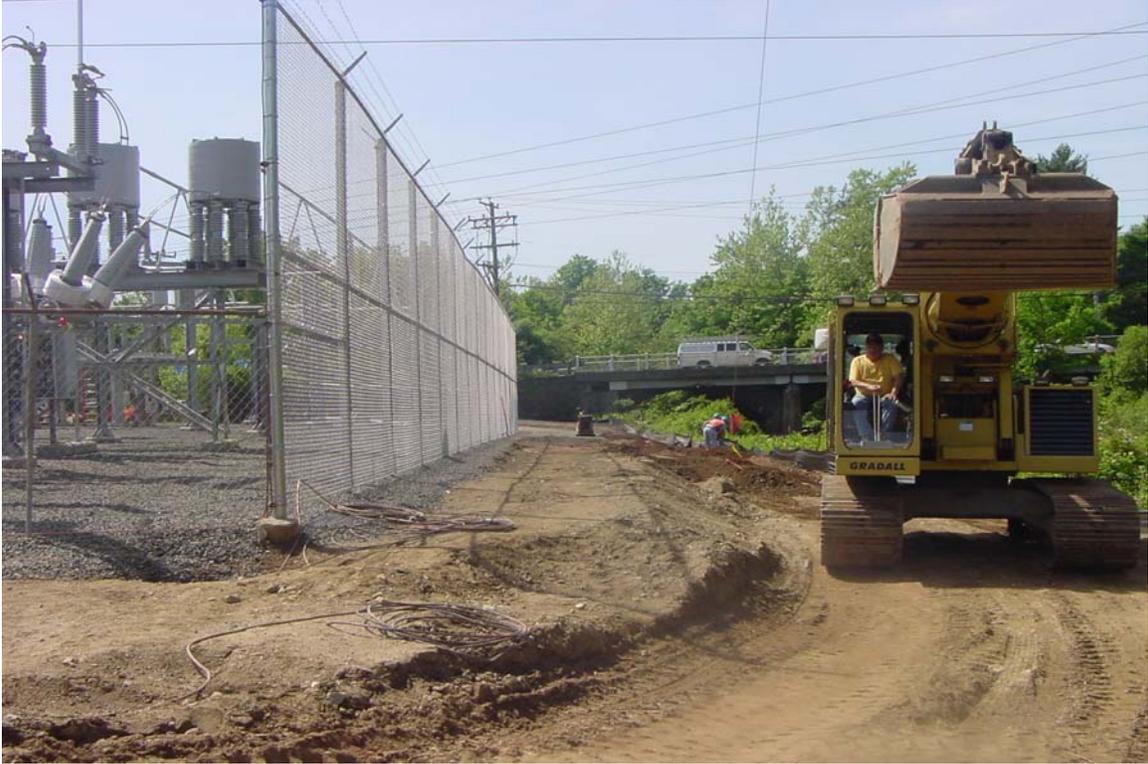
THE NEW AREAS OF THE SUBSTATION YARD HAVE BEEN FENCED IN AND WORK IS ON GOING ON THE BIKE PATH. 5/20/04

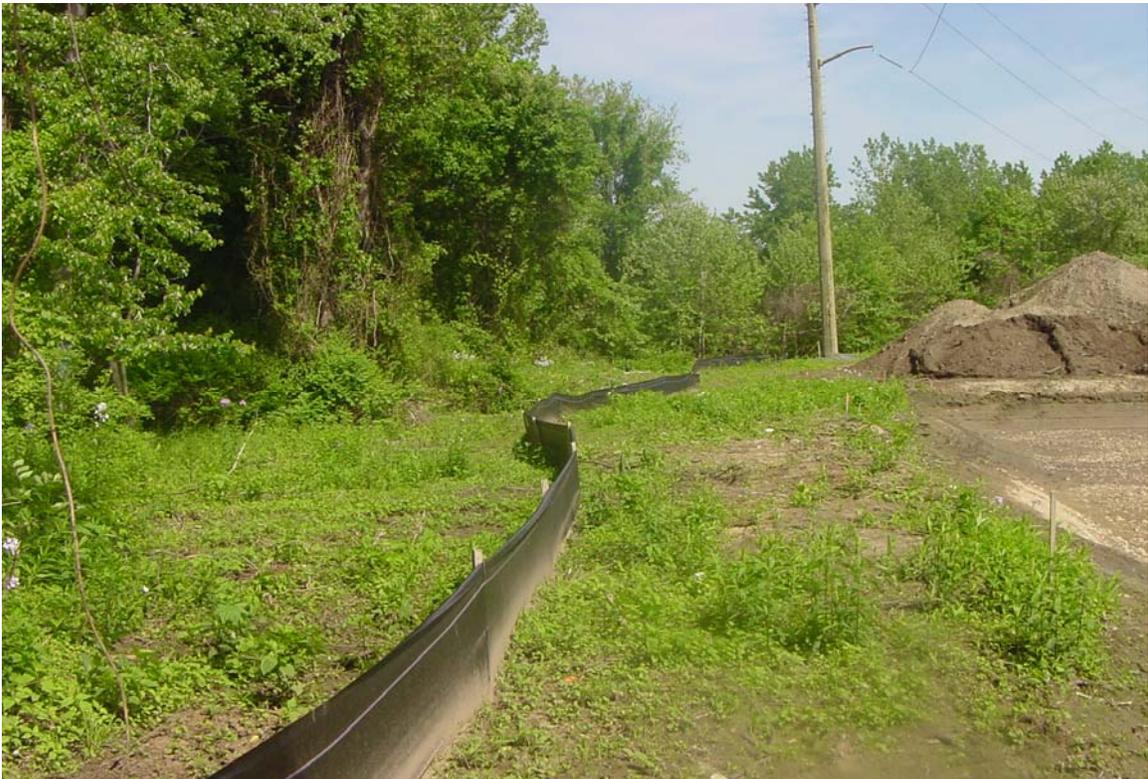
VEGETATIVE GROWTH ON BOTH SIDES OF THE SILT FENCE. SOIL IS ALSO BEING PULLED FROM THE SOUTHERN END OF THE STOCKPILE SEEN IN THE BACKGROUND 5/20/04

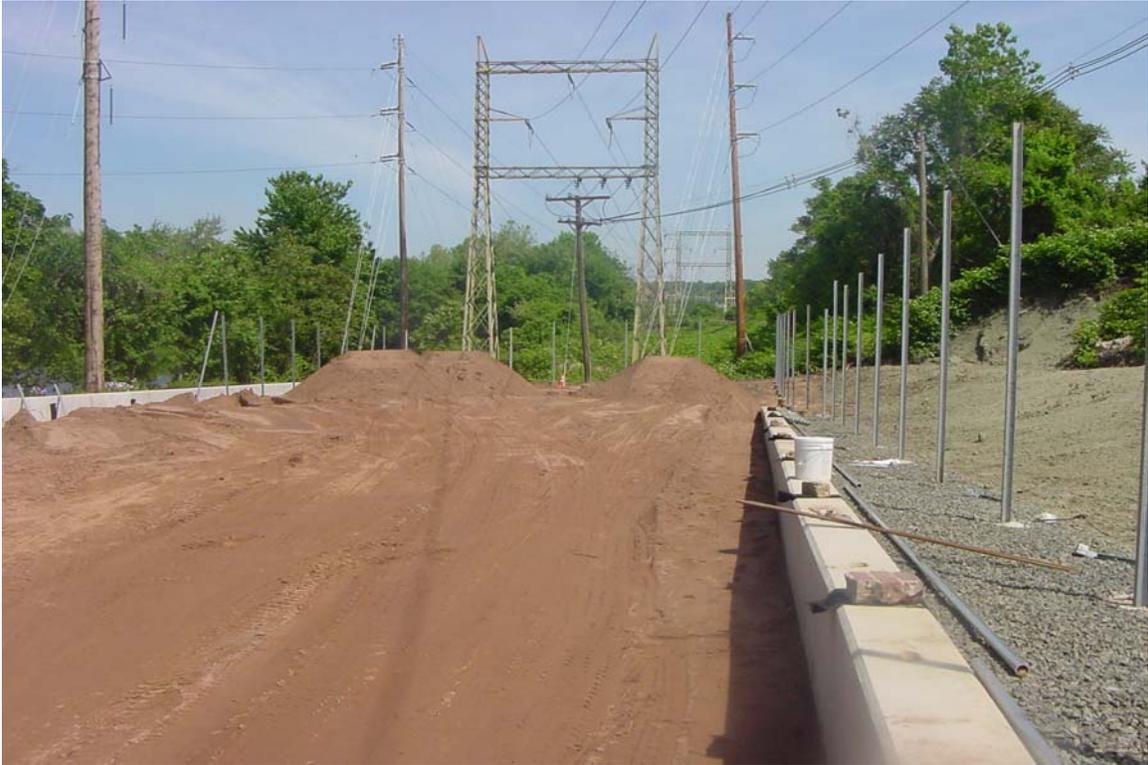
VIEW TOWARDS THE NORTHERN END OF THE SITE BEING BROUGHT TO SUBGRADE. 5/20/04

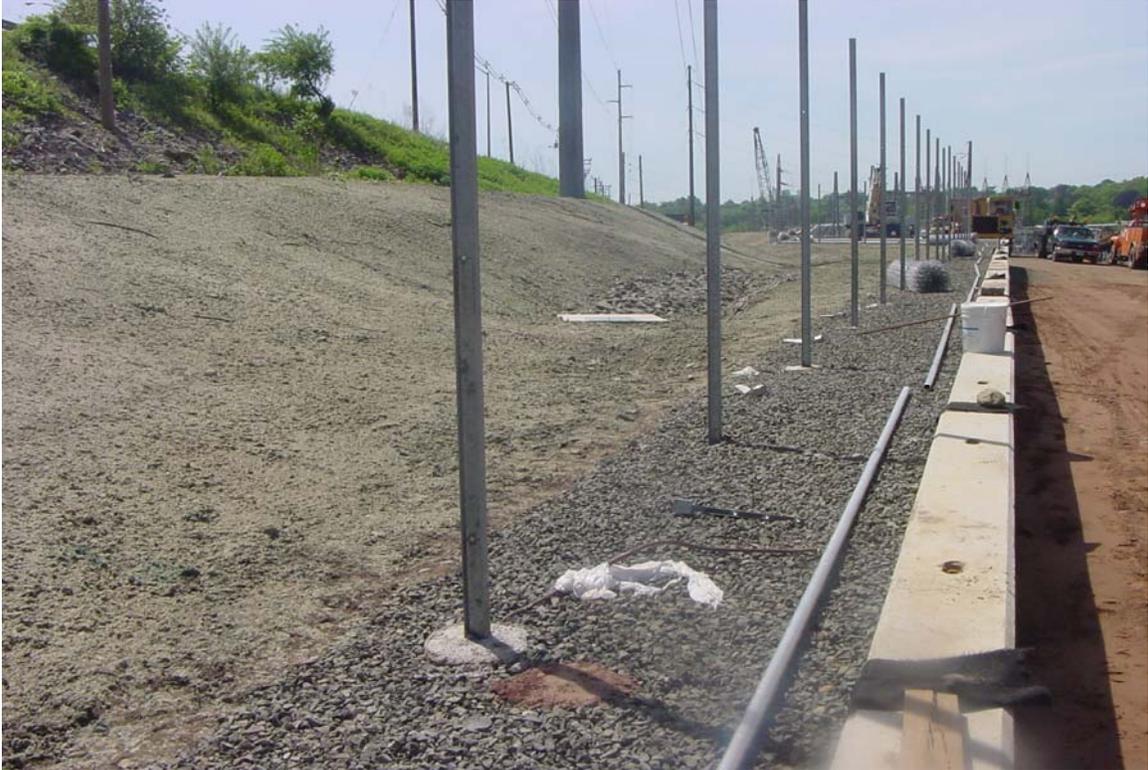
THE AREA BELOW ROUTE 7 RAMP AND ABOVE WALL 5 HAS RECENTLY BEEN HYDROSEEDDED. GROWTH WILL BE MONITORED. 5/20/04

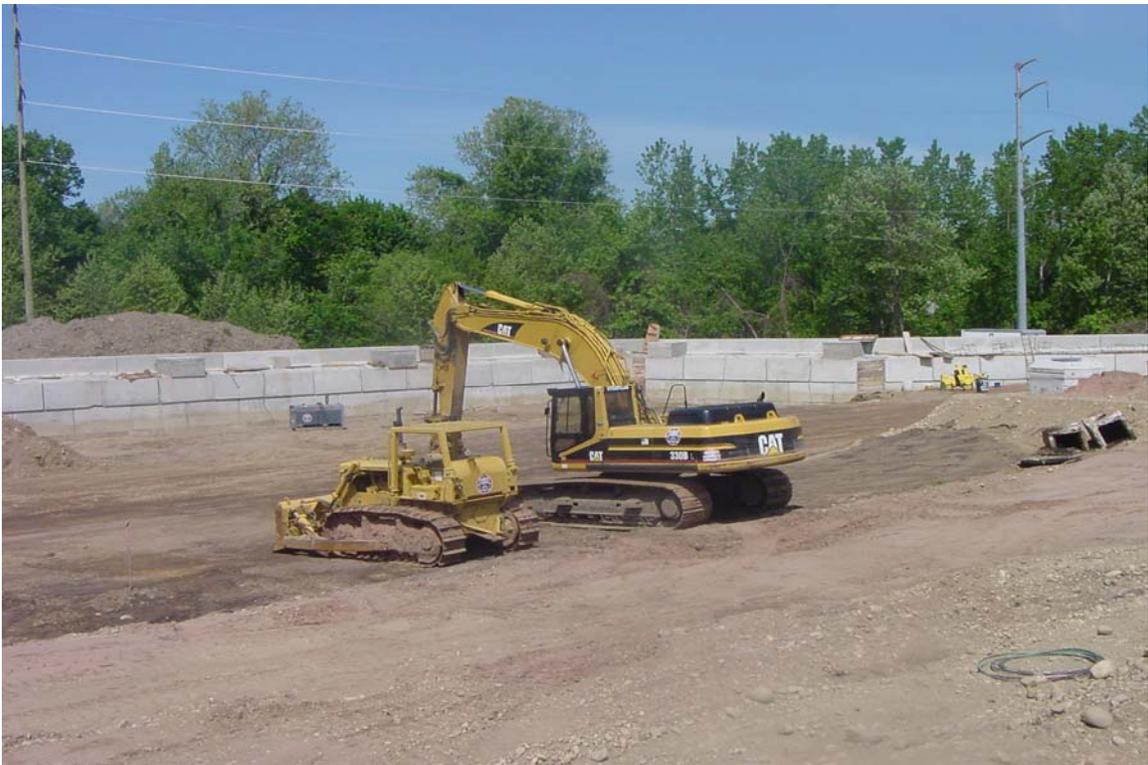
VIEW OF OLD EXCAVATION AREA NEAR WALL 1. MONROE SOILS HAVE BEEN REMOVED FROM THE SITE. 5/20/04

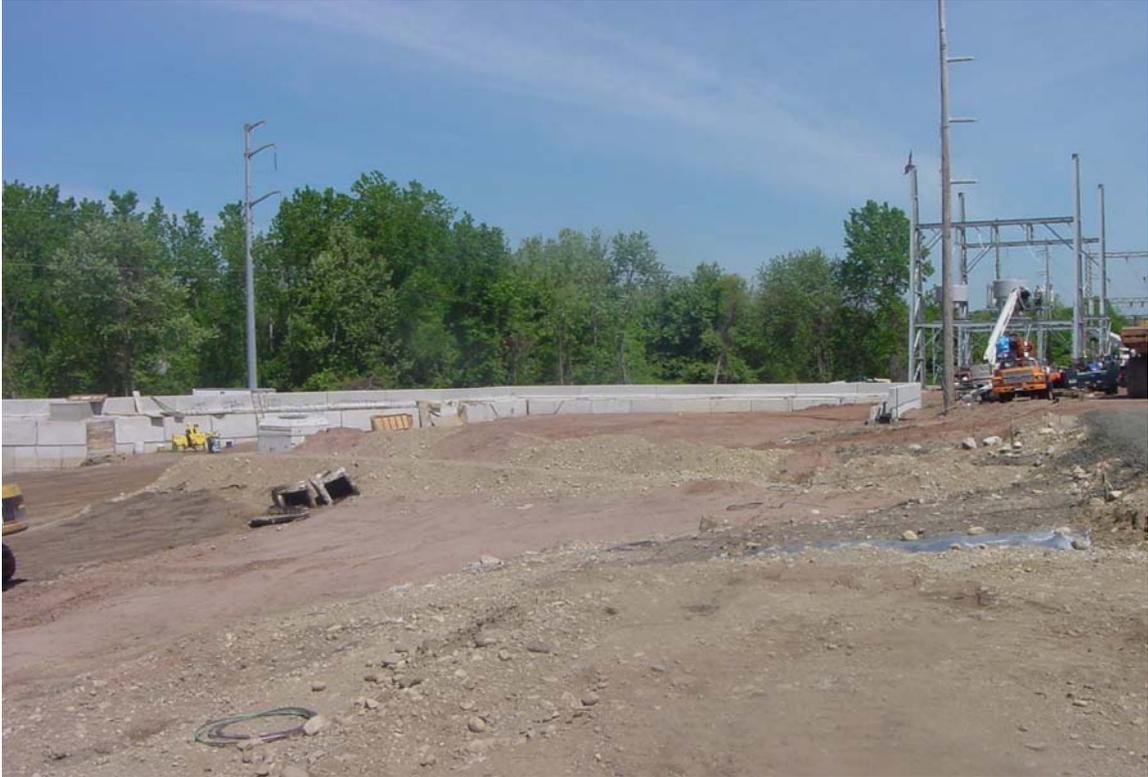
OVERVIEW OF SITE LOOKING TOWARDS THE NORTHERN END AND RETAINING WALLS. 5/20/04

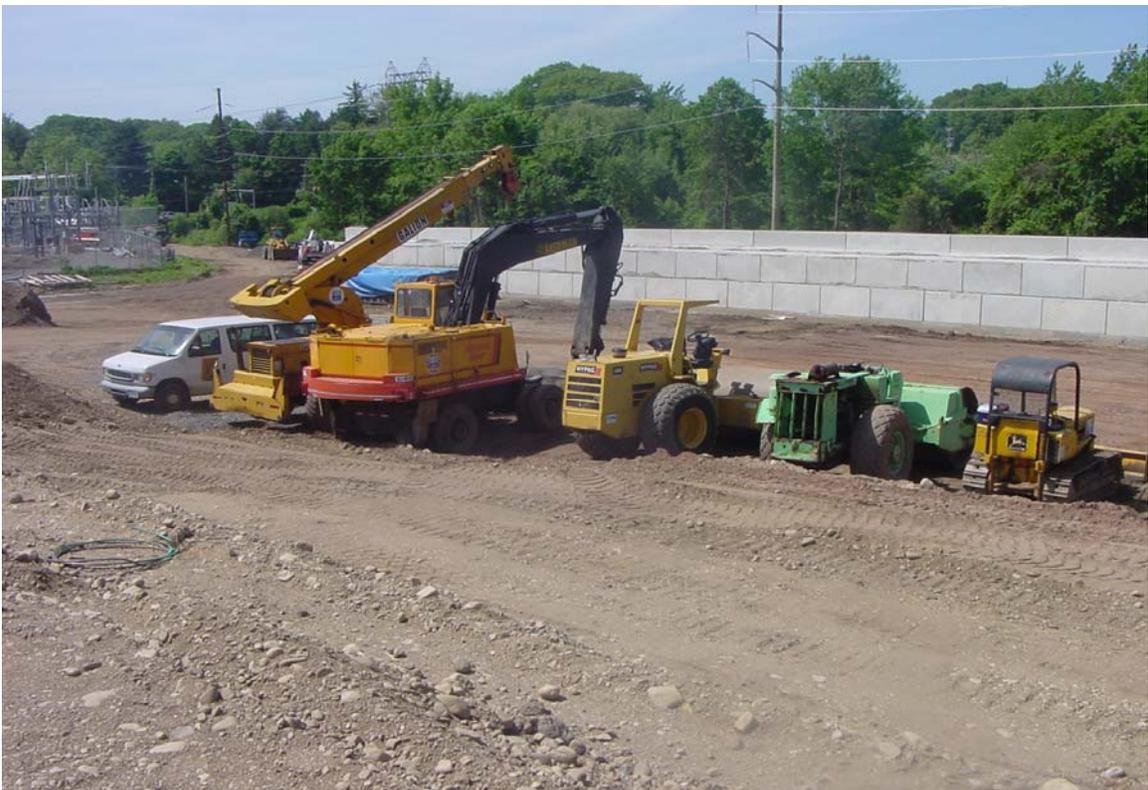
OVERVIEW LOOKING TOWARDS SOUTHERN END OF SITE AND END OF WALL 1. MONROE SOIL STOCKPILES HAVE BEEN REMOVED. 5/20/04

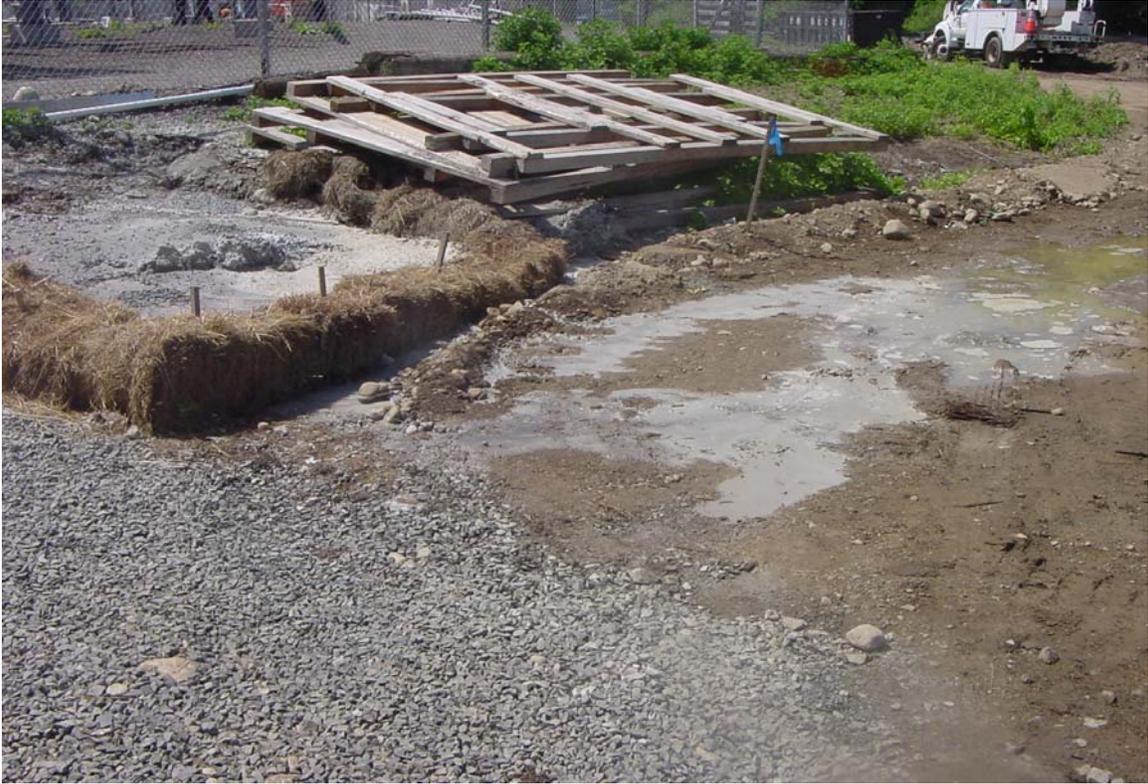
THE CONCRETE WASHOUT STATION CONTROLS WERE MAINTAINED AS RECOMMENDED LAST WEEK. HOWEVER THE AREA HAS OVERFLOWED AGAIN BUT REMAINS WELL WITHIN THE SITE.  
5/20/04
