Docket No. 217 – Development and Management Plan Inspection

Date: June 3, 2004

Location: Norwalk Substation Expansion

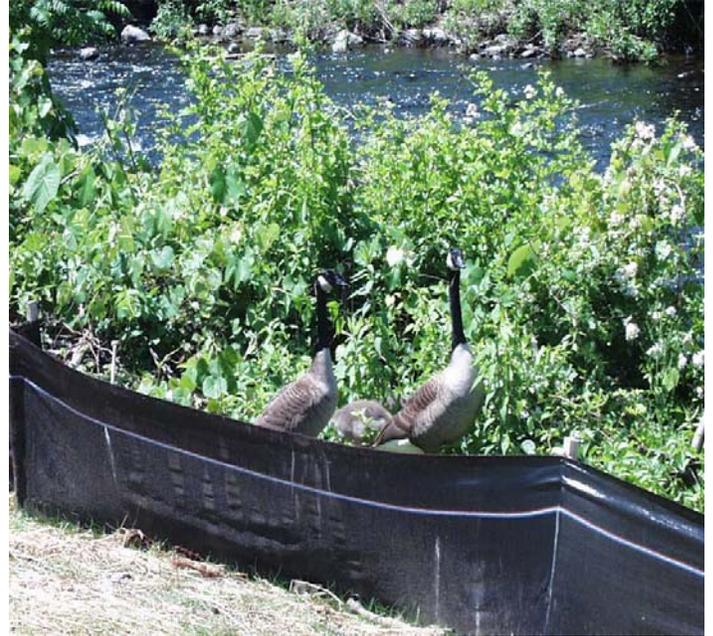
THE AREA ADJACENT TO THE SOUTHERN PORTION OF THE BIKE PATH HAS BEEN MULCHED AND GRASS COVER IS ALREADY BEGINNING TO GROW. A CANADA GOOSE FAMILY WAS NOTED ALONG THE RIVER 6/3/04

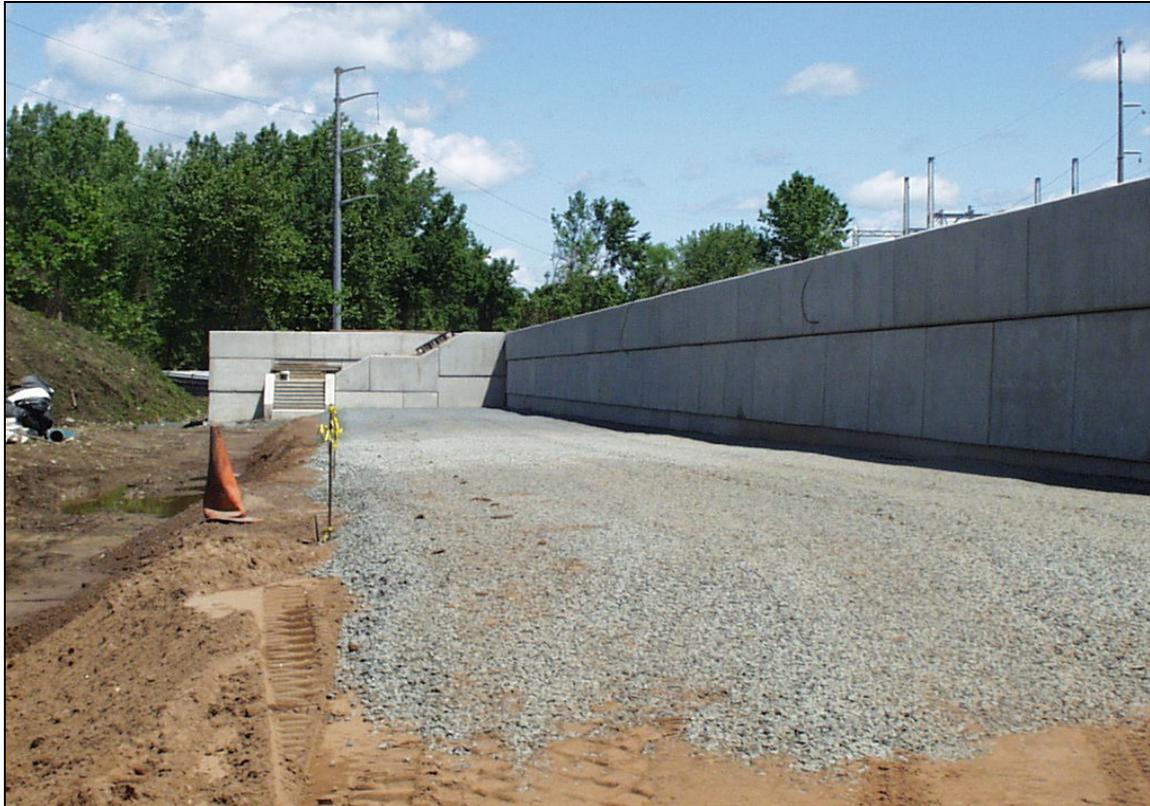
VIEW OF SITE TO THE WEST OF WALLS 1 AND 2. THIS AREA IS AT GRADE AND A STONE BASE WAS PLACED. IT WILL BE USED FOR TEMPORARY STORAGE OF STEEL, PVC, ETC. 6/3/04

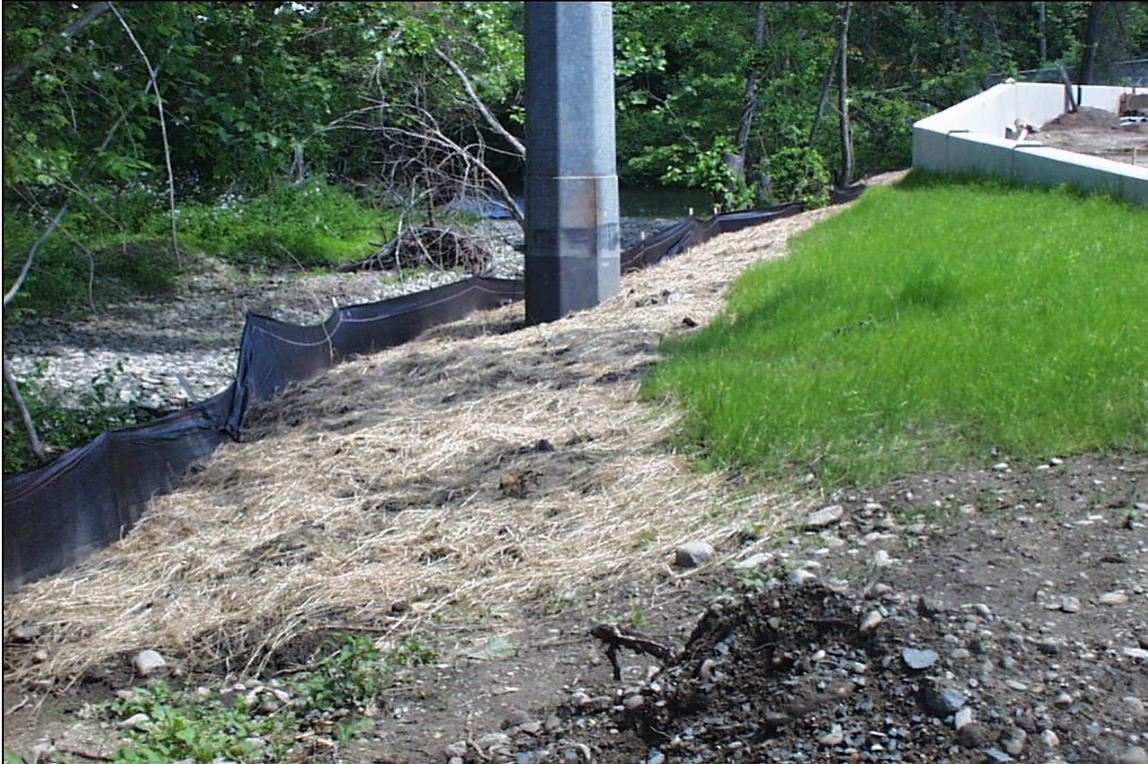
<p>- The scoured area below wall 5 has been placed with stone, topsoiled, seeded and mulched with straw in accordance with the D&M plan. 6/3/04</p>	<p>-Monitor for sufficient vegetative growth and future stabilization. 6/3/04</p>

THE FLOOD-SCOURED AREA BELOW WALL #5 HAS BEEN FILLED WITH LARGER STONE AND TOPSOIL AND HAS BEEN SEEDED IN ACCORDANCE WITH THE D&M PLAN. 6/3/04

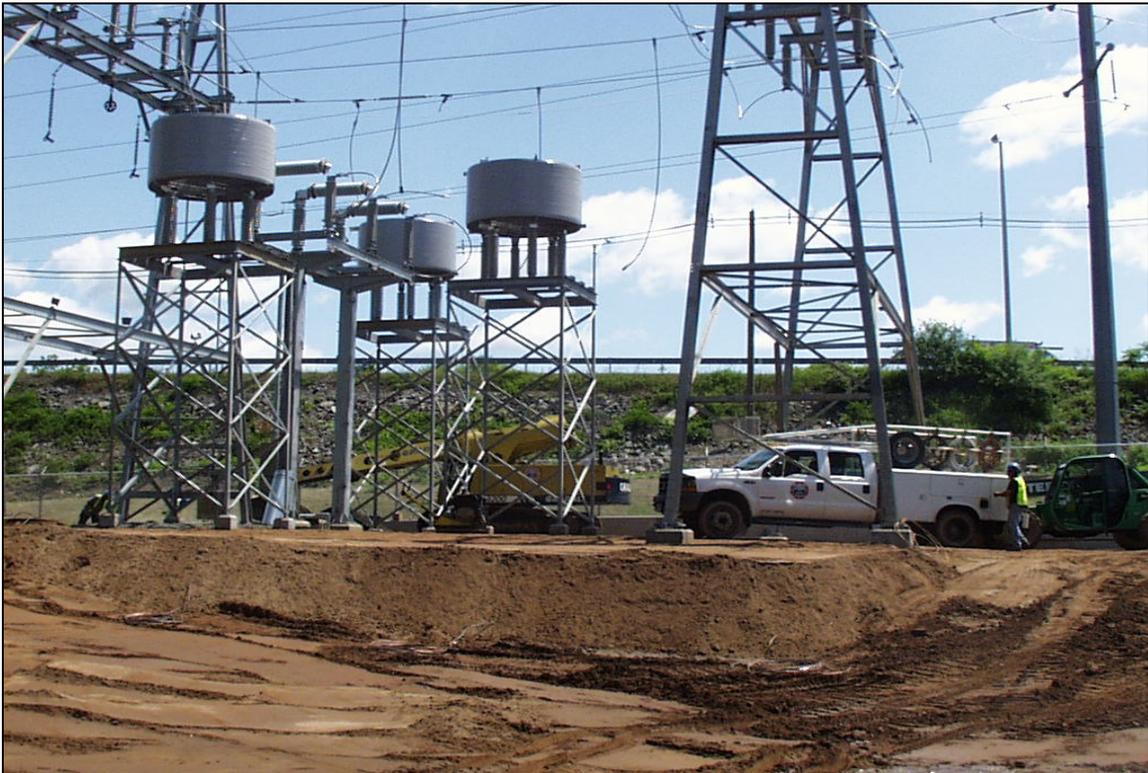
THIS AREA TOWARDS THE NORTHERN END OF THE NEW EXTENTS OF THE YARD, IS BEING FENCED IN AND IS BEING BROUGHT TO GRADE. 6/3/04

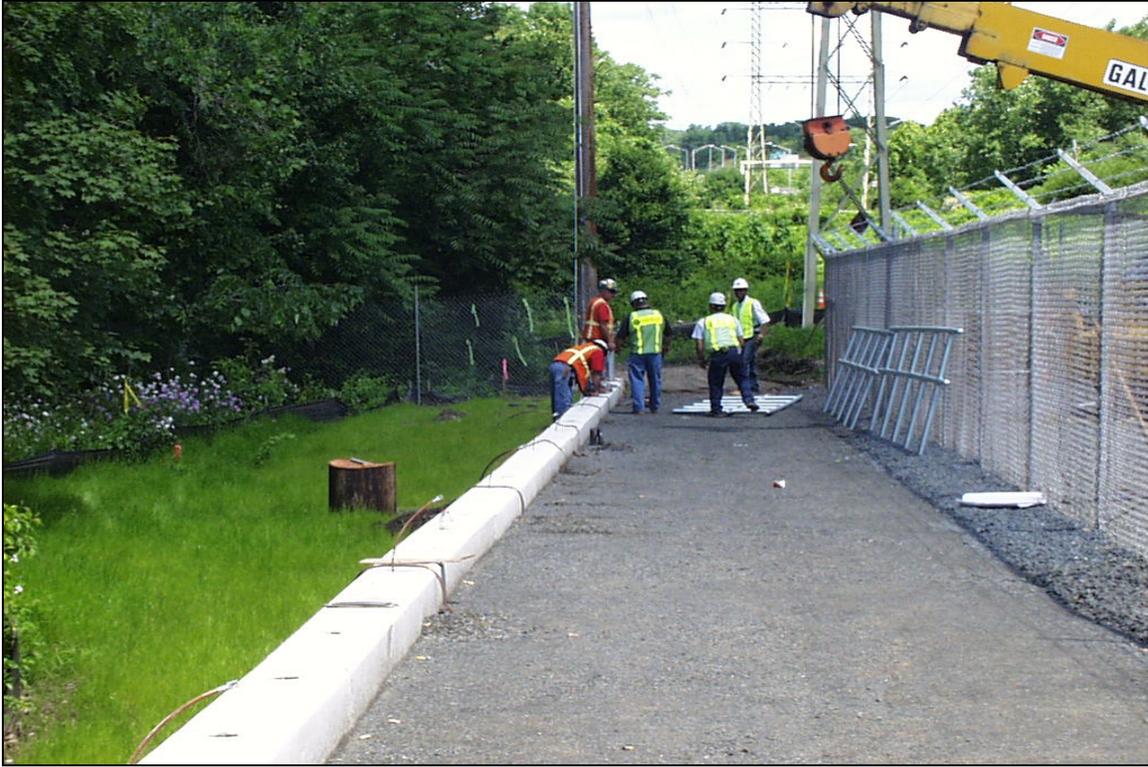
VIEW OF STONE BASE OF THE BIKE PATH. A RAILING IS BEING PLACED ALONG/IN WALL #5 FOR SAFETY. 6/3/04

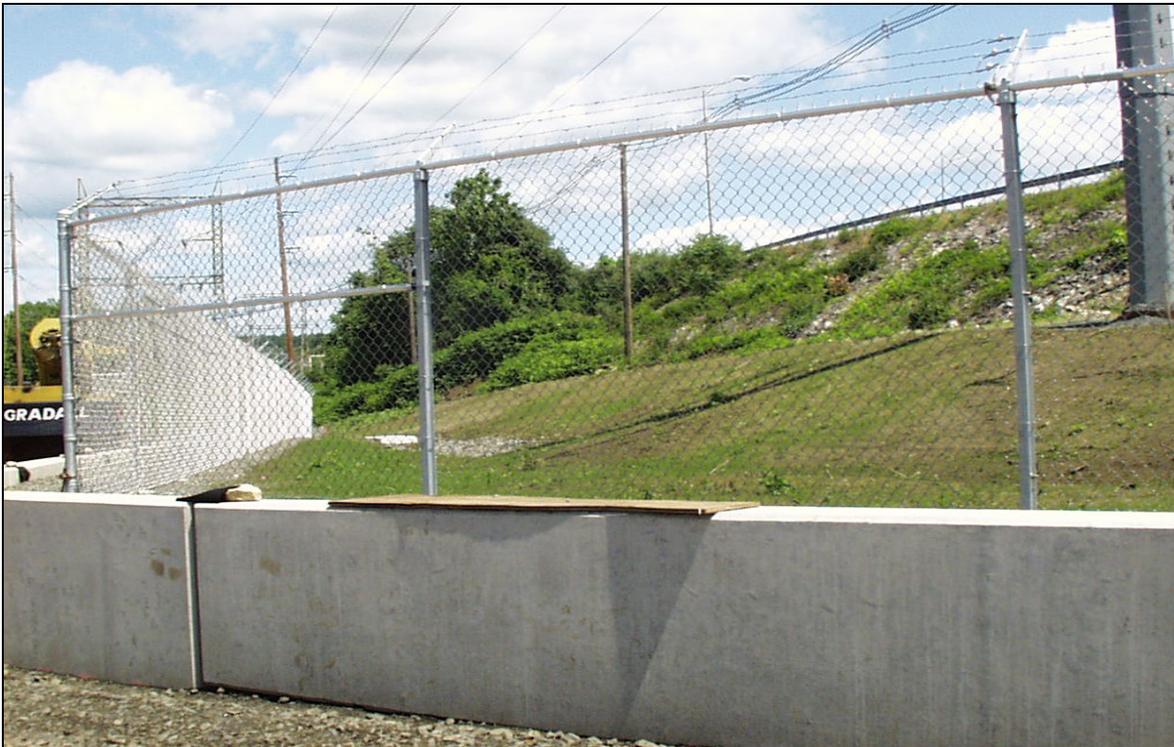
THE RECENTLY HYDROSEEDDED AREA ABOVE WALL#4 IS ALREADY STARTING TO DEVELOP GRASS COVER. 6/3/04

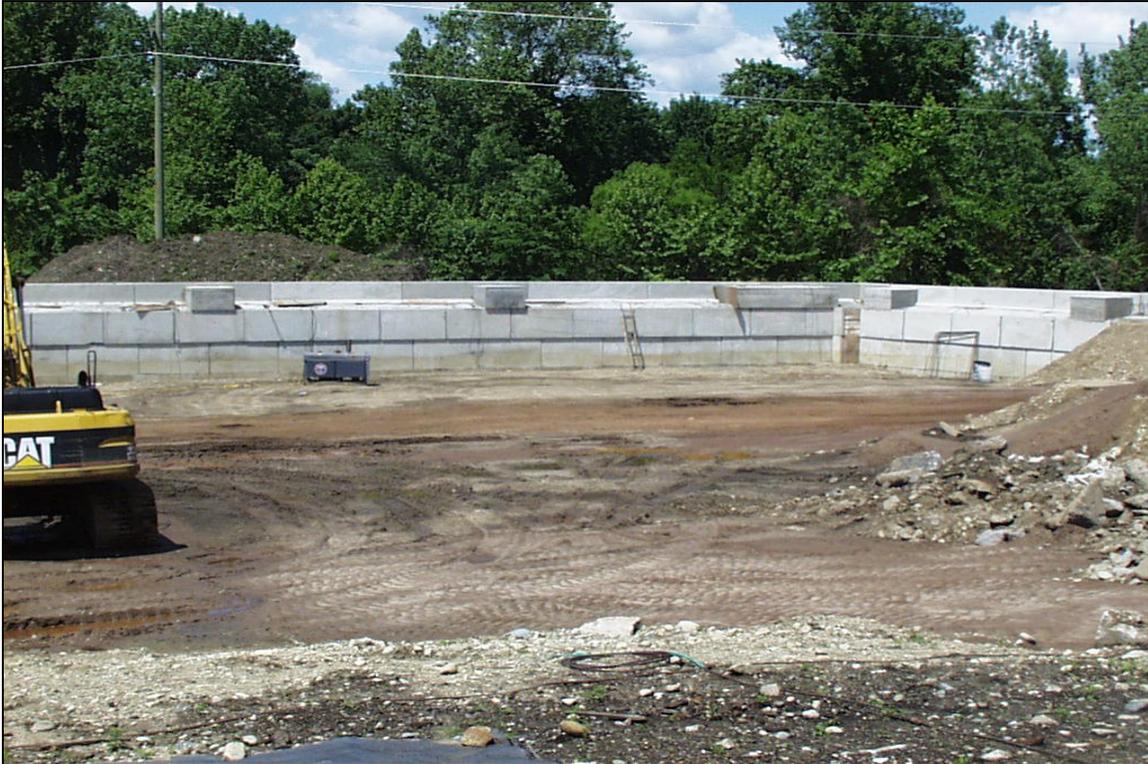
VIEW OF THE AREA AT WALLS #1&2 WHICH HAS NOT YET BEEN BACKFILLED. THE NEW SOIL SOURCE IS BEING TESTED AND APPROVED. 6/3/04

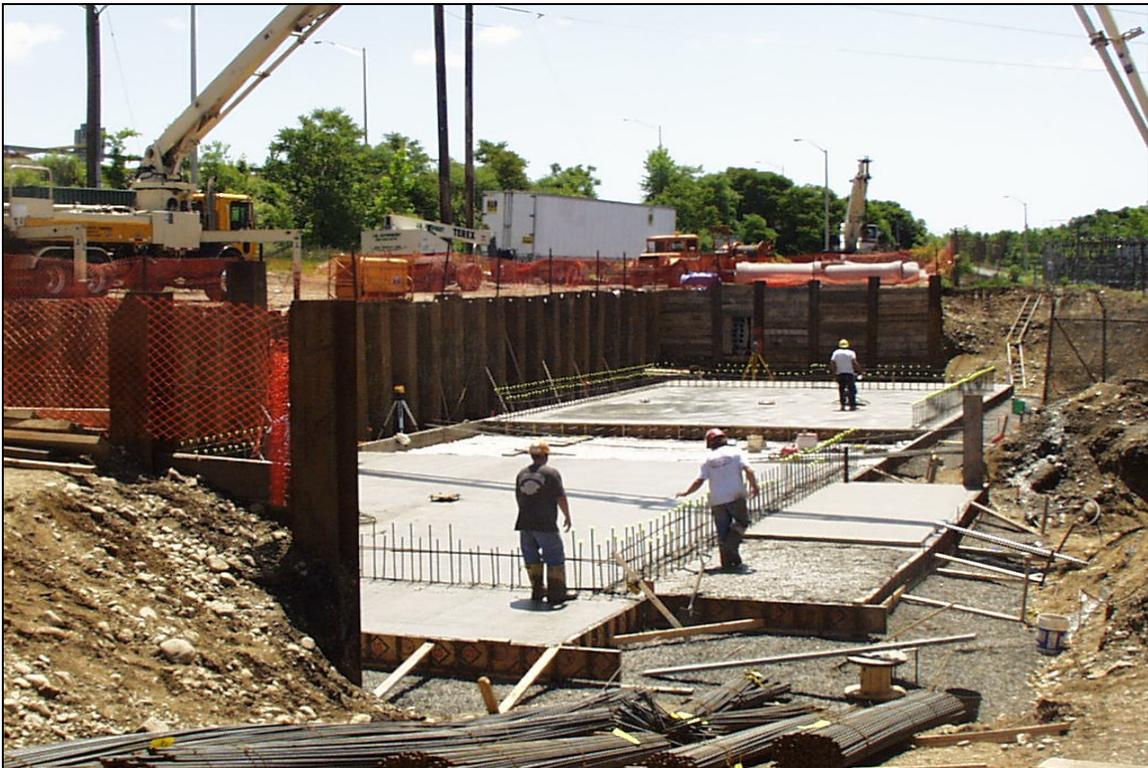
VIEW OF FOUNDATION WORK ON THE CONTROL BUILDING. CONCRETE WAS BEING POURED 6/3/04
