Docket No. 217 – Development and Management Plan Inspection

Northeast Utilities Service Company Certificate of Environmental Compatibility and Public Need for the construction of a 345-kV electric transmission line and reconstruction of an existing 115-kV electric transmission line between Connecticut Light and Power Company's Plumtree Substation in Bethel, through the towns of Redding, Weston, and Wilton, and to the Norwalk Substation in Norwalk, Connecticut.

Norwalk Substation

Date: June 7, 2006

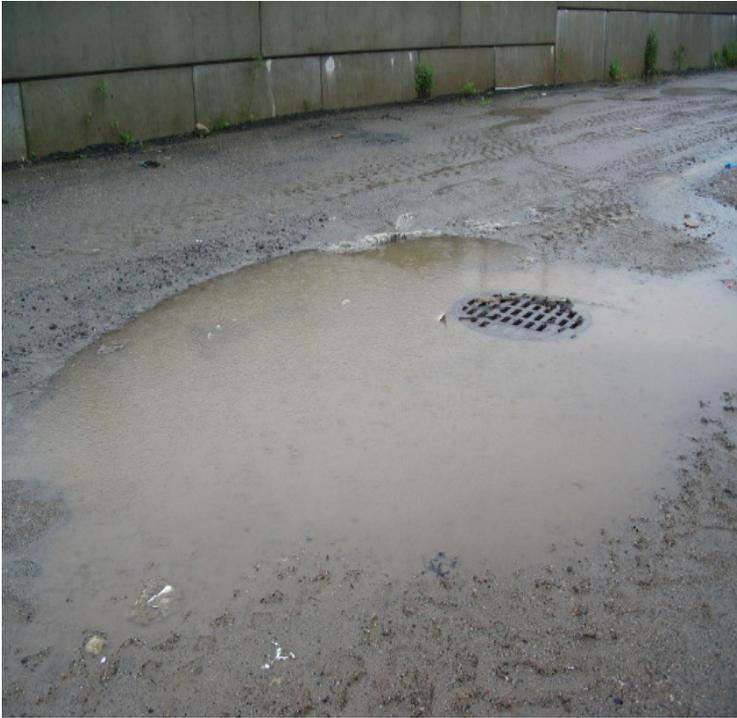
Norwalk Substation: Photo on the left shows where turbid run-off water is ponding around an inlet on site. This is leading to turbid water reaching the Norwalk River from the outlet shown in the photo on the right. 6/7/06.

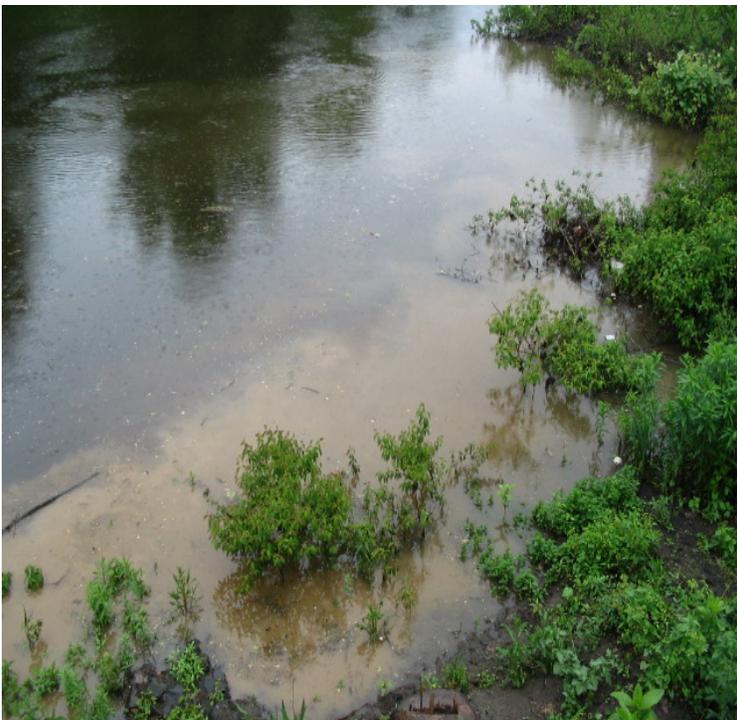
Photo on the left shows the plume of turbid water within the backwater of the Norwalk River. Photo on the right shows where the area adjacent to the GIS building was recently landscaped with evergreen plantings. 6/7/06. (Note: there are no photos of Plumtree due to the heavy rain)
