Docket No. 217 – Development and Management Plan Inspection

Northeast Utilities Service Company Certificate of Environmental Compatibility and Public Need for the construction of a 345-kV electric transmission line and reconstruction of an existing 115-kV electric transmission line between Connecticut Light and Power Company's Plumtree Substation in Bethel, through the towns of Redding, Weston, and Wilton, and to the Norwalk Substation in Norwalk, Connecticut.

Norwalk Substation

Date: June 14, 2006

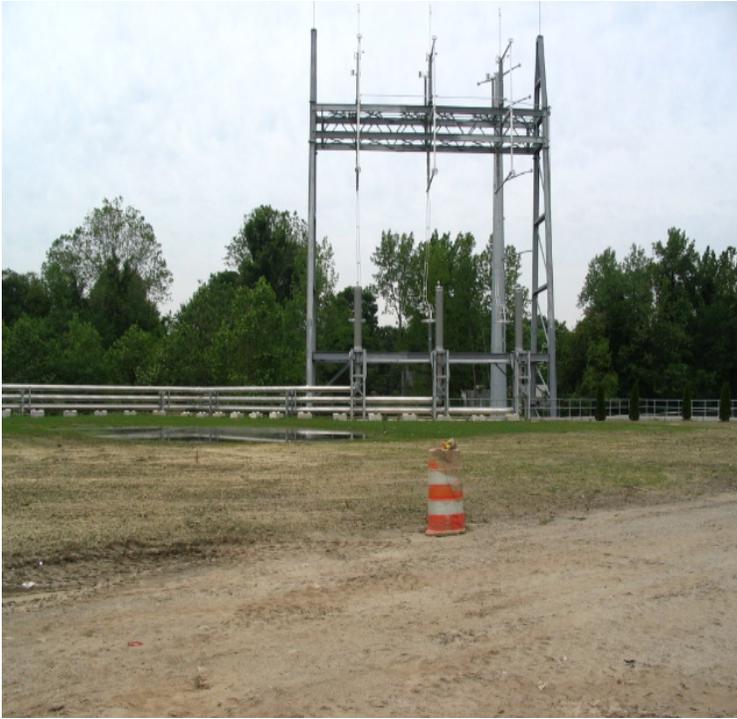
Norwalk Substation: Photo on the left shows a view of the yard and the grass growth occurring in the hydroseeded area. Photo on the right shows a view of the Norwalk River. Turbid water was not coming from the outlet at this time but the grate on site still needs controls in place for the next rain event. 6/14/06.

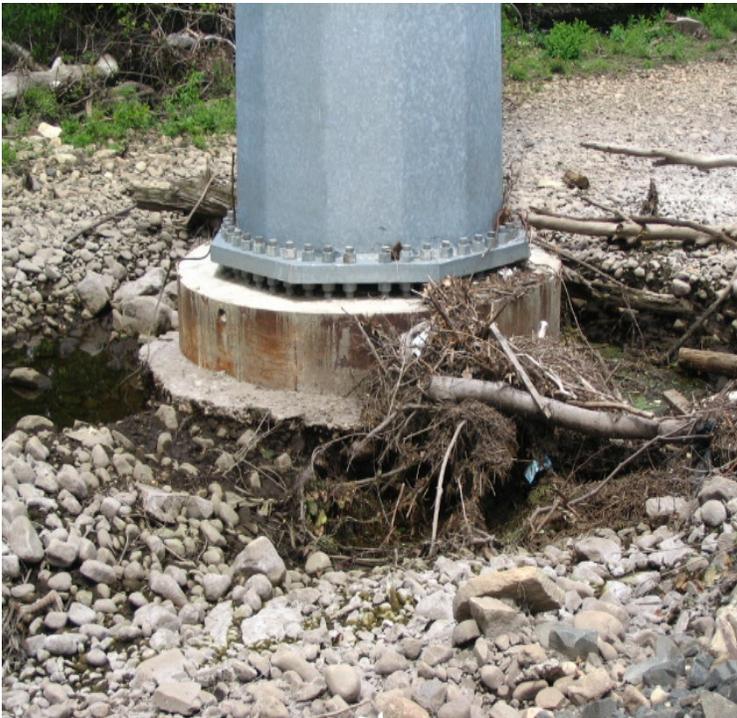
Photo on the left shows further erosion around the base of the 345kV turning structure in the river. This should be evaluated. (Plumtree Substation): Photo on the right shows an overview of the yard and work at Plumtree. 6/14/06.
