Docket No. 217 – Development and Management Plan Inspection

Northeast Utilities Service Company Certificate of Environmental Compatibility and Public Need for the construction of a 345-kV electric transmission line and reconstruction of an existing 115-kV electric transmission line between Connecticut Light and Power Company's Plumtree Substation in Bethel, through the towns of Redding, Weston, and Wilton, and to the Norwalk Substation in Norwalk, Connecticut.

Date: June 22, 2005

Location: Norwalk Substation Expansion

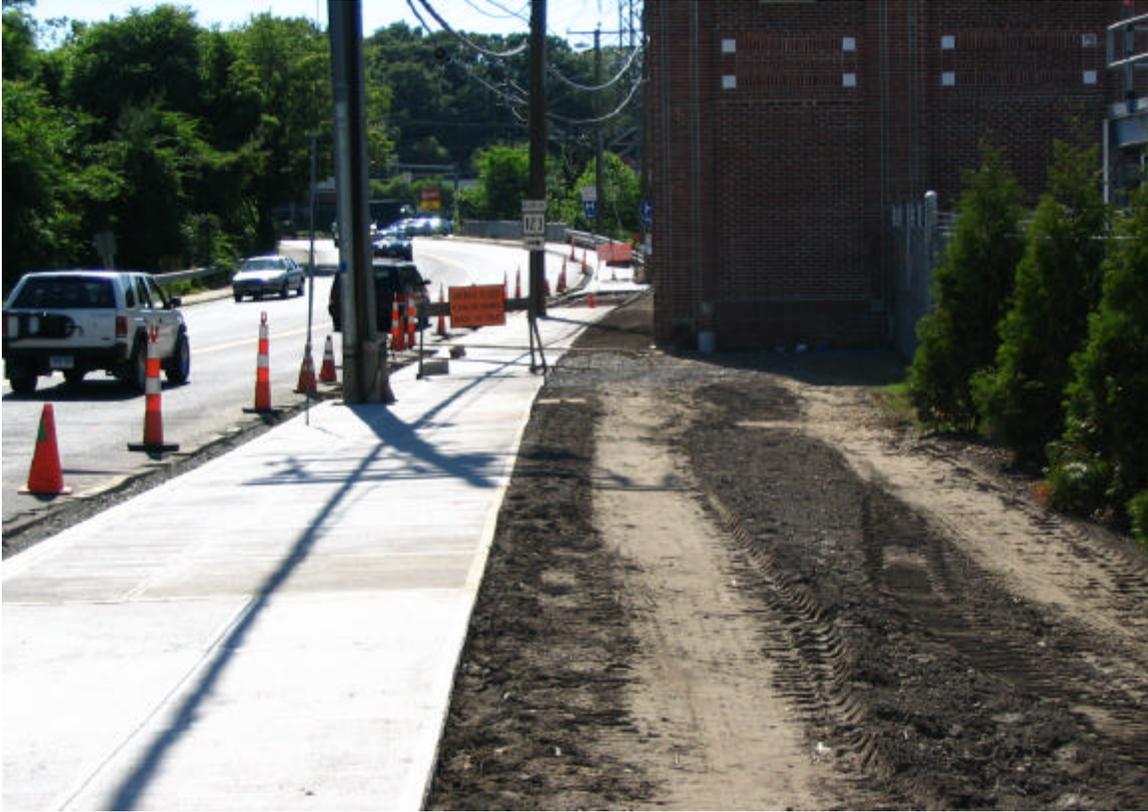
Norwalk Substation- Work continues out in front of the substation on the New Canaan Ave sidewalk. 6/22/05

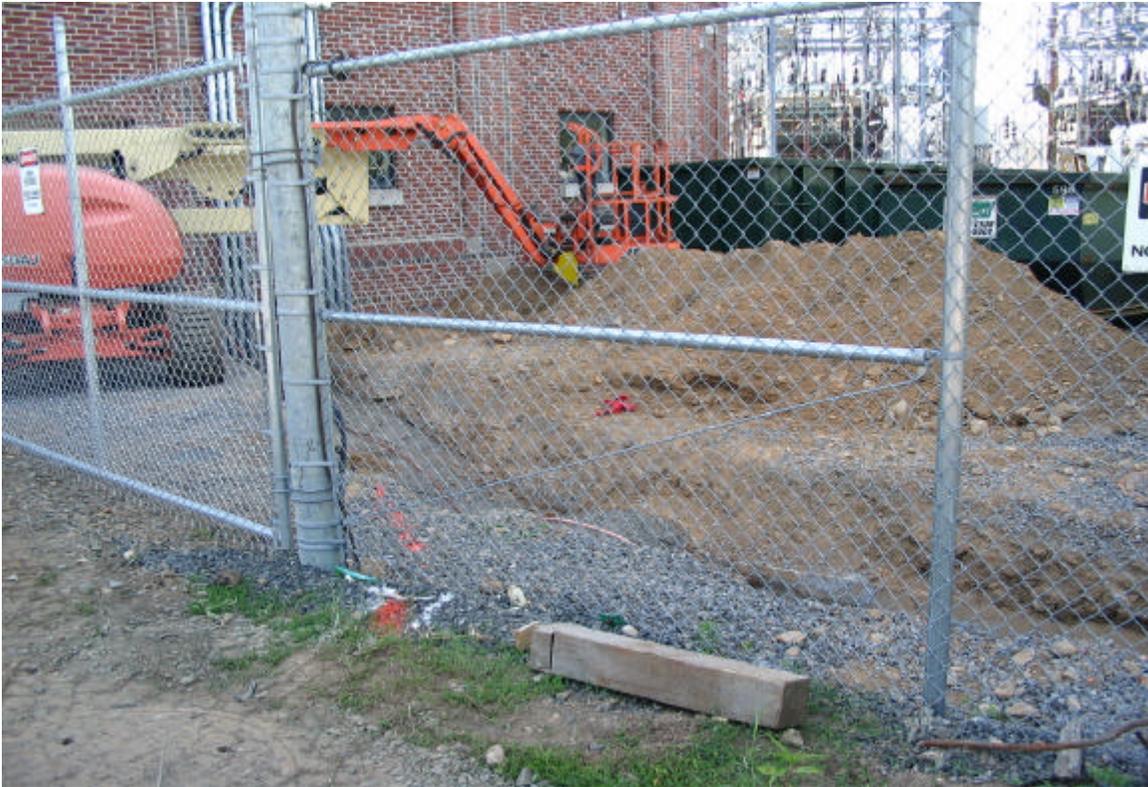
View of the small excavation within the live yard near the sidewalk work. 6/22/05

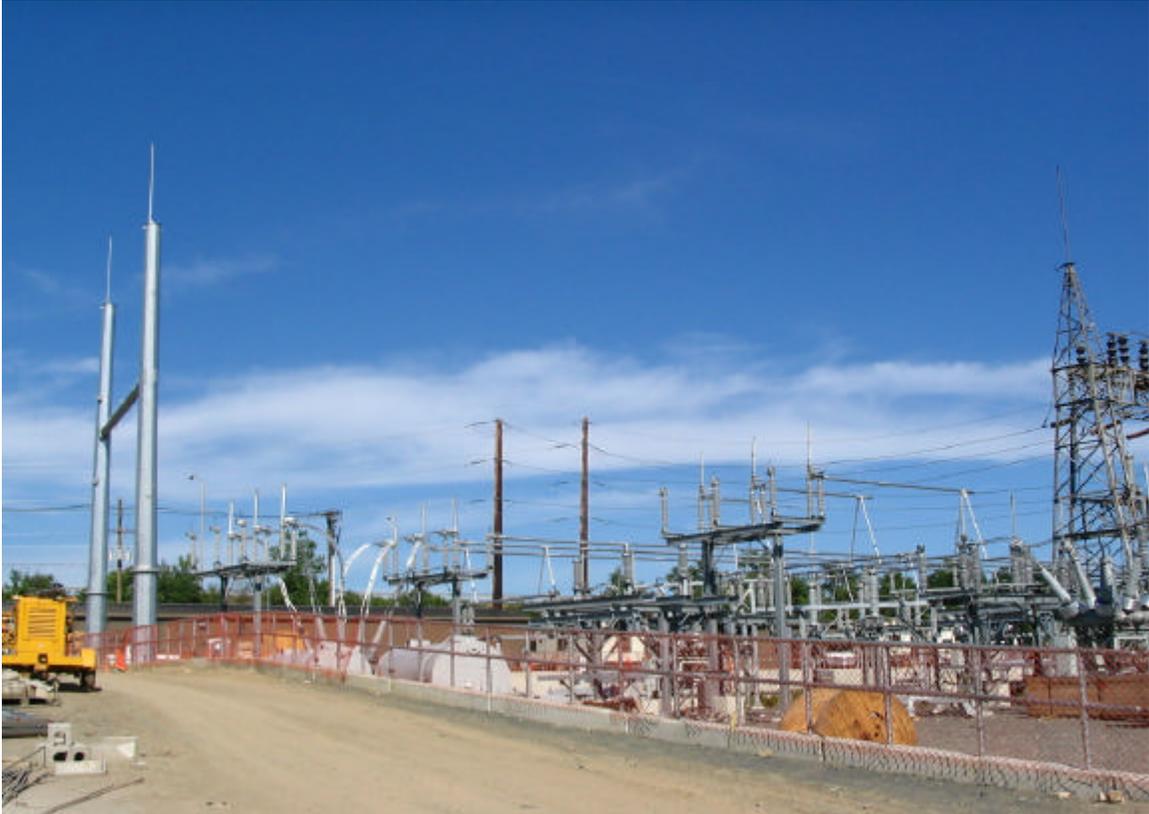
Overall view of the structures and towers installed in the expanded portion of the yard. 6/22/05

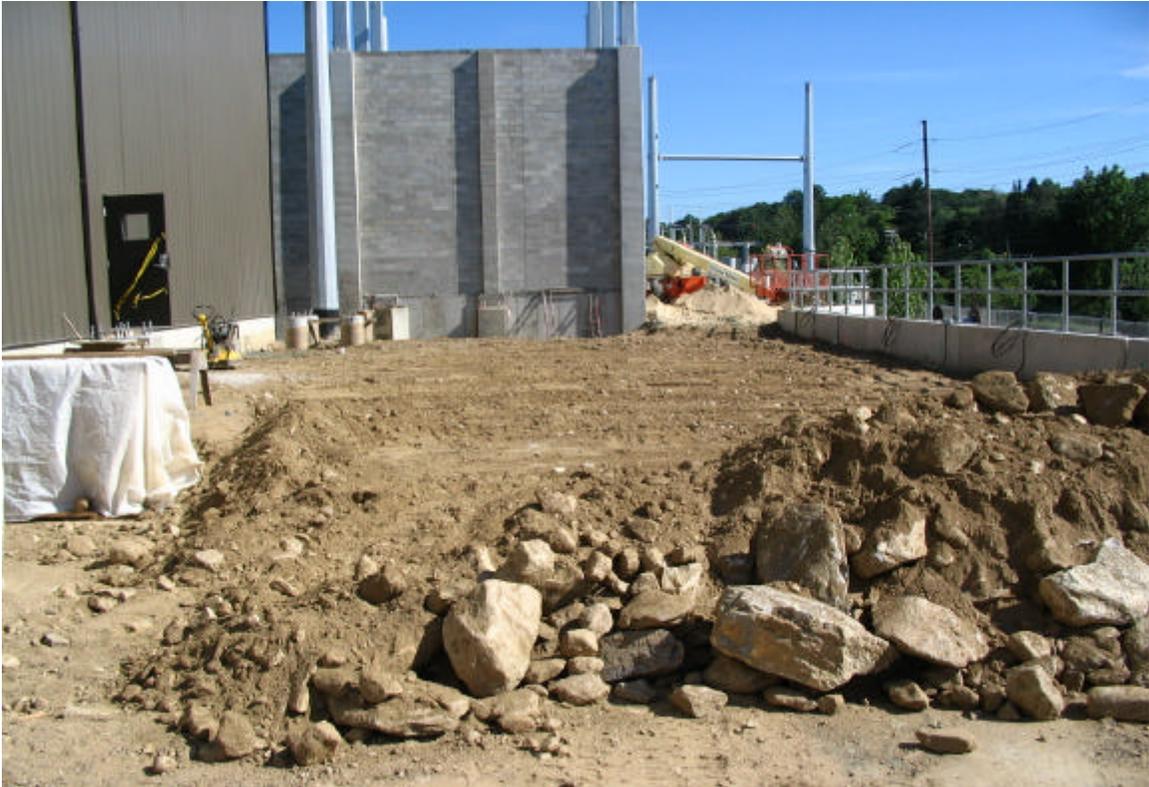
View from the back of the GIS building where several smaller areas of excavation and backfill are occurring. 6/22/05

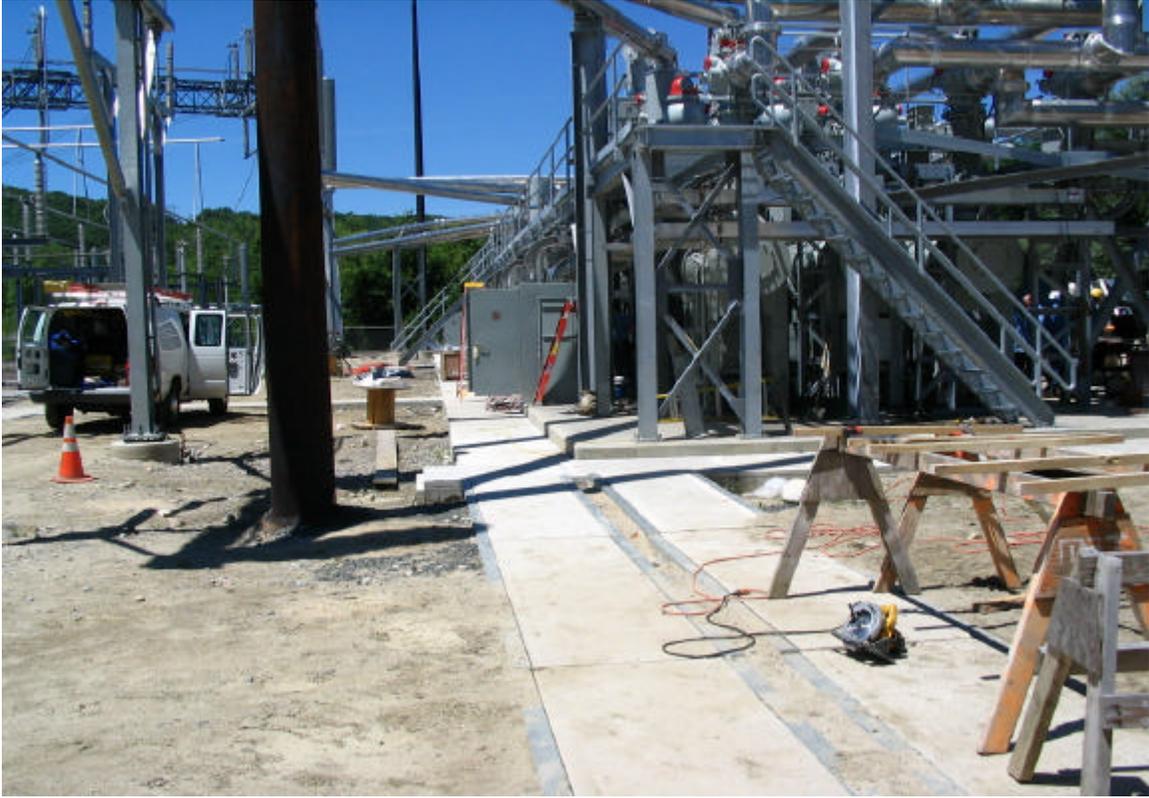
Plumtree Substation- Trench boxes have been closed and only electrical work is occurring on site.
6/22/05
